Prevention of Foundation Piping at Arapuni Dam using Discrete Cut-off Walls

Michael Revis, Nigel Connell
Damwatch Services Ltd, Wellington, NZ

ABSTRACT

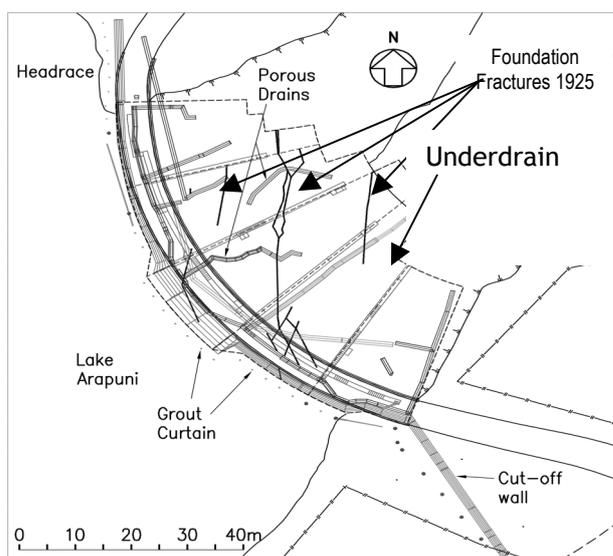
Figure 1: Plan view of Arapuni Dam.
(Foundation fissures noted during construction are shown in blue)

The dam site is in an area of multiple ignimbrite flows from volcanic eruptions. The main dam footprint is founded on a 40-50m thick sheet of Ongatiti Ignimbrite, a point-welded tuff. The upper part is very weak, with unconfined compressive strength between 2 and 6 MPa. The lower half (the “Hard Zone”) is stronger, with strengths up to 28 MPa. Three major sub vertical fissures were mapped during dam construction crossing in a N-S direction across the dam footprint (Figure 1).

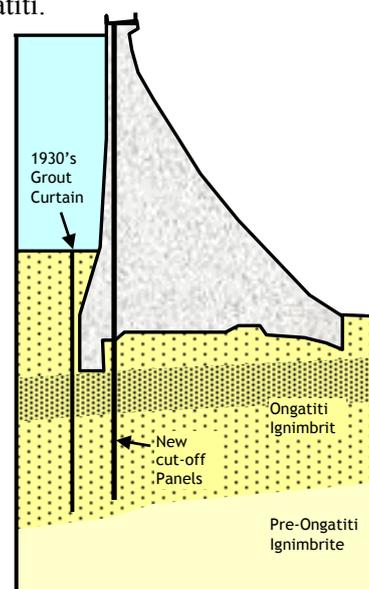
Figure 2: Typical cross section of dam showing cut-off location

The 64m high horizontal curved concrete gravity dam includes original features of the dam including concrete cut-off walls extending 65m below the crest and 20m into the left and 33m into the right abutment (Figure 1). A network of porous (no-fines) concrete drains extend under the dam/foundation interface referred to as the “underdrain” (Figure 1). The underdrains discharge seepage water to the downstream toe, where seepage is measured with v-notch weirs. In June 1930 the reservoir was dewatered for repairs which included a grout curtain along the heel and abutment cut-off walls (Figure 2). It was a single row cement curtain not physically connected to the dam.

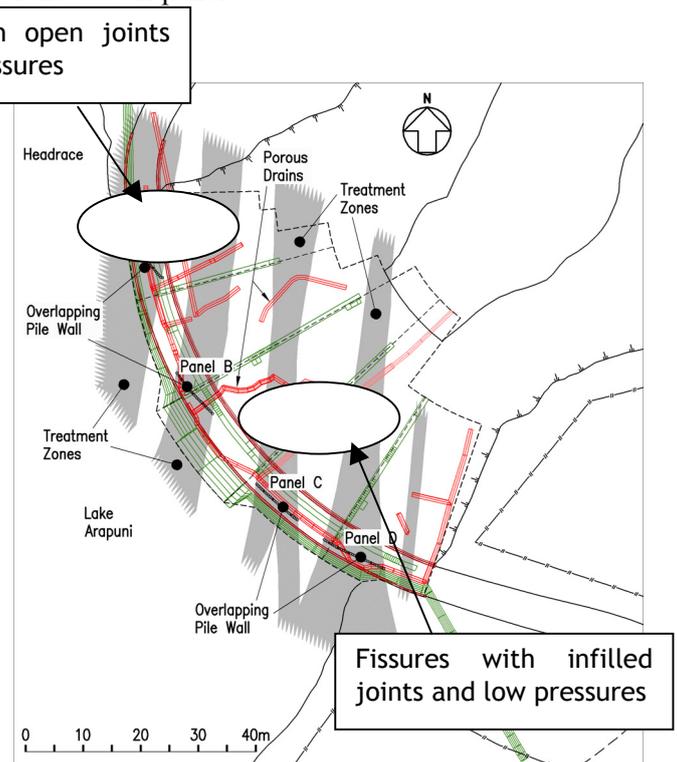
Figure 4: Plan of long-term seepage control remedial works

The joints that make up the fissures varied in width from less than 5mm up to 100mm. The nature of the joints varied with extensive areas infilled with nontronite clay, some infilled with oxides of manganese, others open with no infill and some tight rock on rock joints. Treatment panels were located as shown in Figure 4 so that:

- Panels A and B treated the Far Left and Left Fissures respectively which have open joints and near lake level pressures; and
- Panels C and D treated the Main and Right Fissures which have lower pressures with joints infilled with highly erodible nontronite clay.

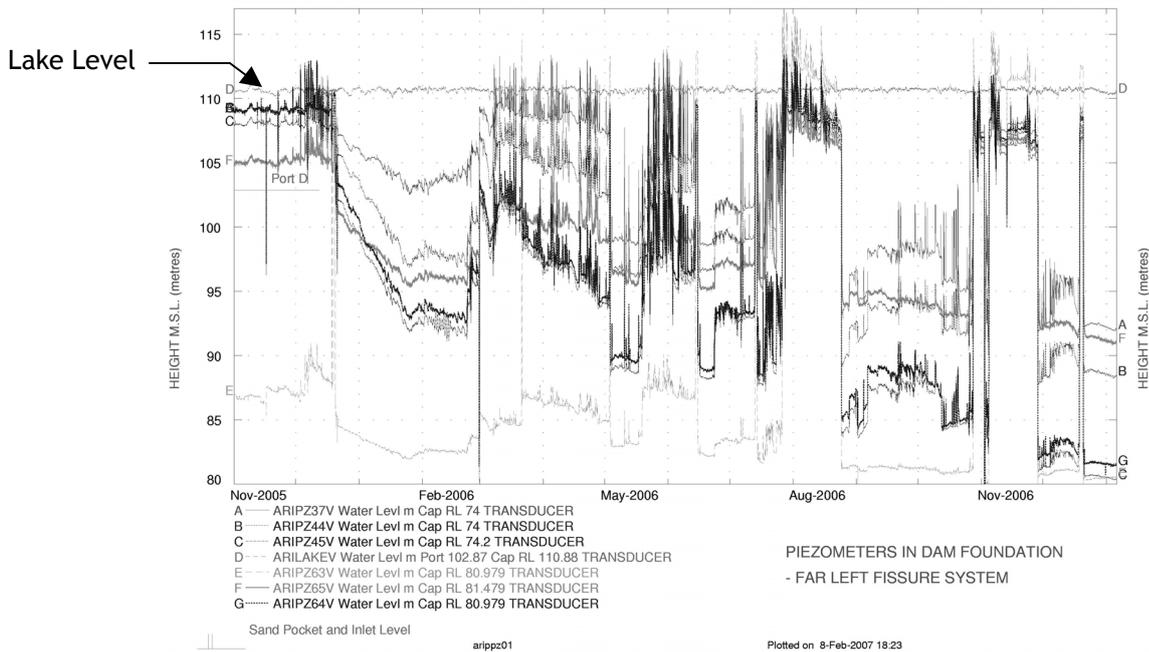
Figure 5: Pressures in the Far Left Fissure during construction.

The Left and Far Left Fissure showed rapid pressure fluctuations of up to 5m in response to changing water level in the open slot as drilling progressed as shown in Figure 5.
