‘Stuff happens’ - A case history of a safety incident while assessing slopes in Waioeka Gorge

D. L Stewart¹ and B. O’Loughlin²

Keywords: Safety Incident, Waioeka Gorge, landslides, field mapping

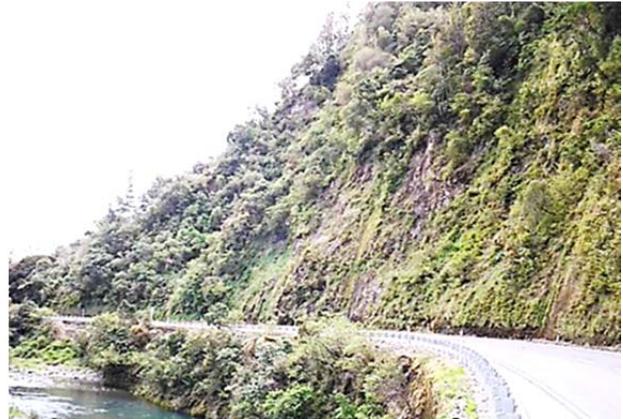
The Waioeka Gorge is a 48km long section of highway between Opotoki and Gisborne (Figure 1). The terrain is typically very steep (Figure 2) with slopes rising to up to 600m above the highway and covered in (largely native) forest (mini Fiordland). The highway was built in the 1960's and was a very challenging engineering feat given the proximity of the river to the very steep sided hills. Some of the three fatalities which occurred during construction may have been attributable to rock fall as this was the greatest risk to building. The highway is prone to continuous rockfall events such that the maintenance contractor travels the road twice a day to clean up rock and slip debris. The highway has a low traffic volume (approx. 1300 vpd). The gorge has a high annual rainfall. Cellphone coverage is not available through most of the gorge.

Figure 2. Typical steep slope in Waioeka Gorge

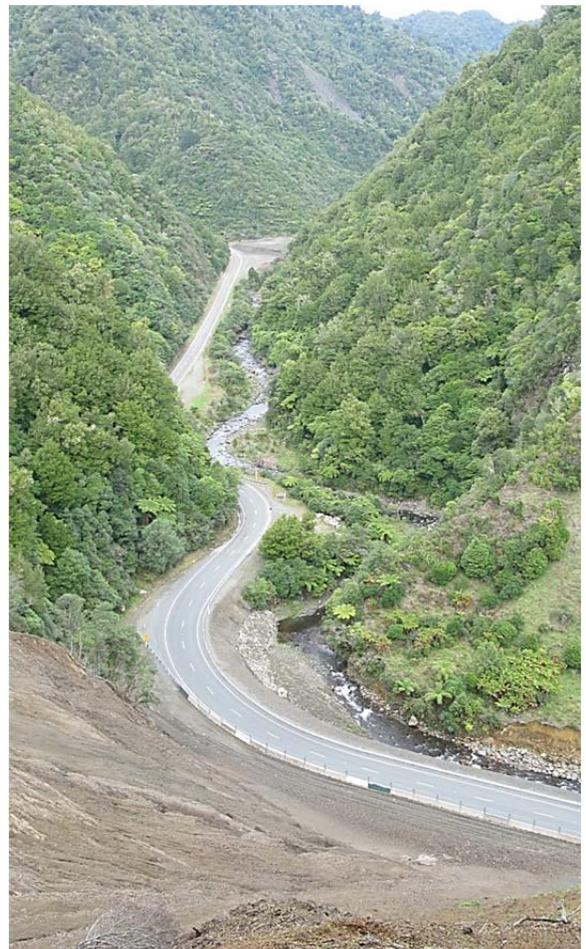
The field work for Stage 2 of the project proposed visits to four potential landslide sites including the 150m high slopes adjacent to the 2012 Sandy Slip site (Figure 3) and three others slopes of 200 to 500 m height (including Figure 2).

Figure 3. Waioeka Gorge looking down the March 2012 landslide scar. May 2013 photo.

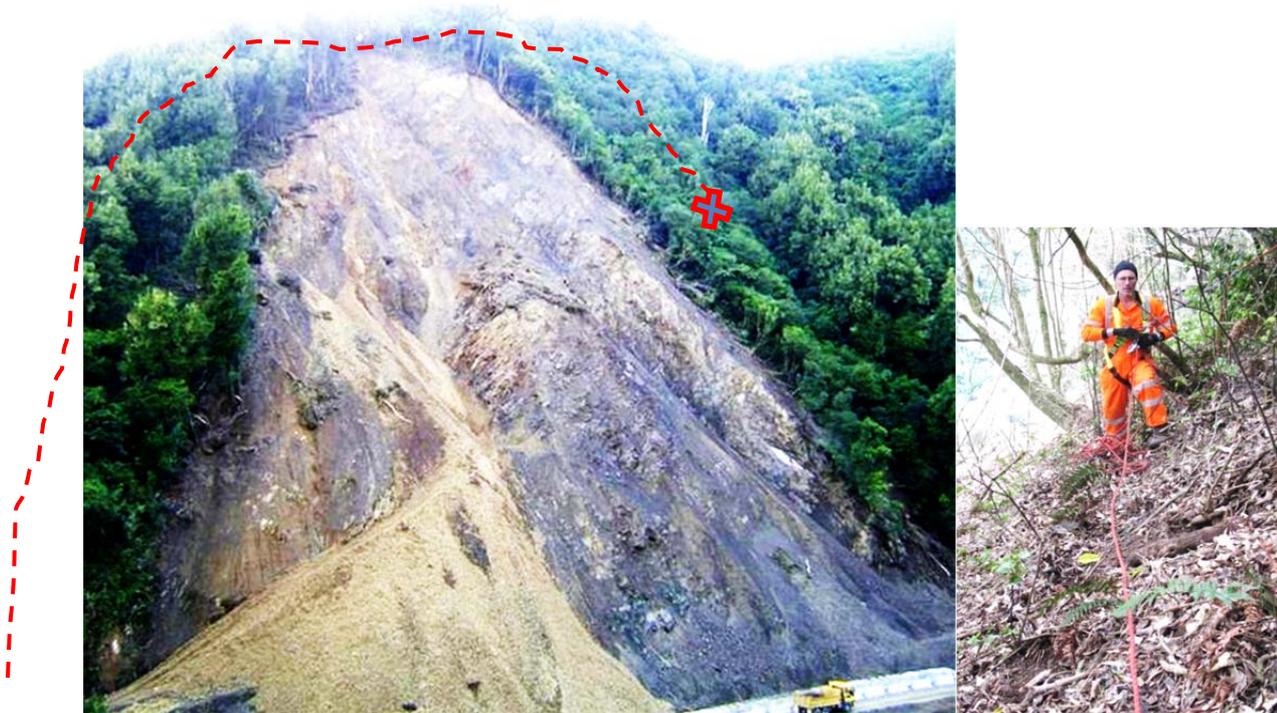
The inspection started mapping along the base of the slope from the road and then climbing up bushed slope to the west of the 2012 slip (Figure 4) inspecting features of interest identified from the LiDAR assessment. Inspections of the top of the slip were made at the slip crest while roped to the abseil support person (Figure 5). The inspection continued down the eastern flank of the slip in the bush toward road level. Approximately 1/3 of the way down (100m above road level), the guide (the abseil contractor) slipped on a tree root and fell heavily on his shoulder. It became clear that he wasn't able to continue as he was in severe pain and had dislocated his shoulder. We concluded that he was unable to continue and that help was needed.

Figure 4. Sandy Slip site in April 2012 partway through debris clearing, showing route of 25 May 2013 inspection and incident site (x). GDC photo. Figure 5. Set-up for short roped inspection of landslide head scarp prior to descending toward road.
