State Highway 5 Tumunui tomo - a case of road resilience to piping in the Rotorua-Taupo area

P Martins
Beca Ltd, Tauranga, NZ
pedro.martins@beca.com (Corresponding author)

ABSTRACT

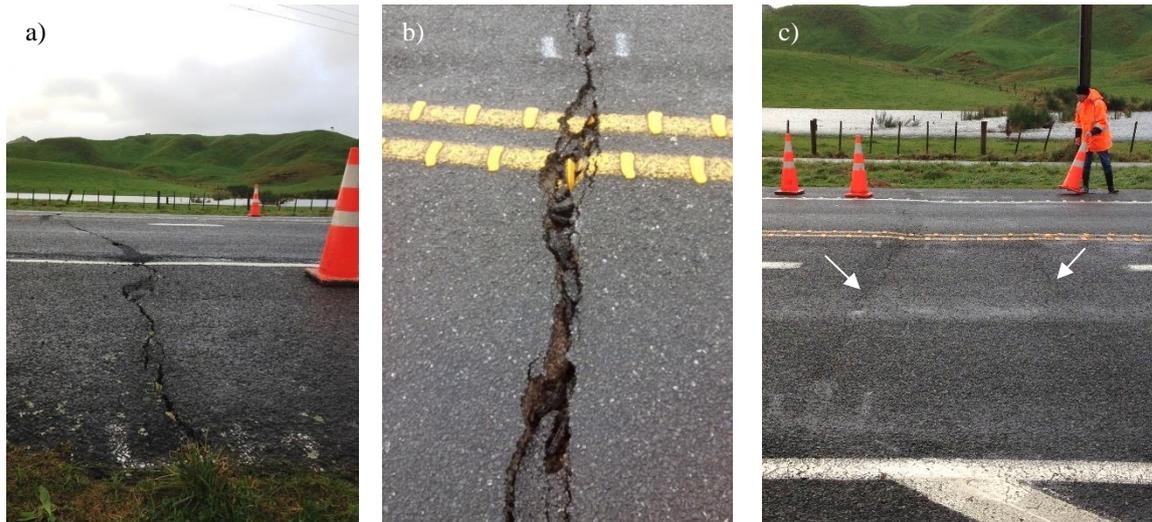
A site walkover was carried out on the same day to assess the damage to the road and to develop an initial understanding of the geological process that caused the damage. It was observed that a 12m long section of the road, bound by cracks extending across the whole width of the pavement, had dropped about 30mm (Figure 1). Aligned with the dropped road section, tomos had developed in paddocks in the properties on both sides of the road. To the west, a 10m wide tomo had extended for more than 100m, terminating as a natural tunnel into a hill (Figure 2). Groundwater was observed at the base of the new tomos, flowing from east to west and then “disappearing” into the tunnel.

Figure 1: Observed damage to the road. a) North crack; b) Detail of the north crack; c) South cracks, as indicated by the arrows.

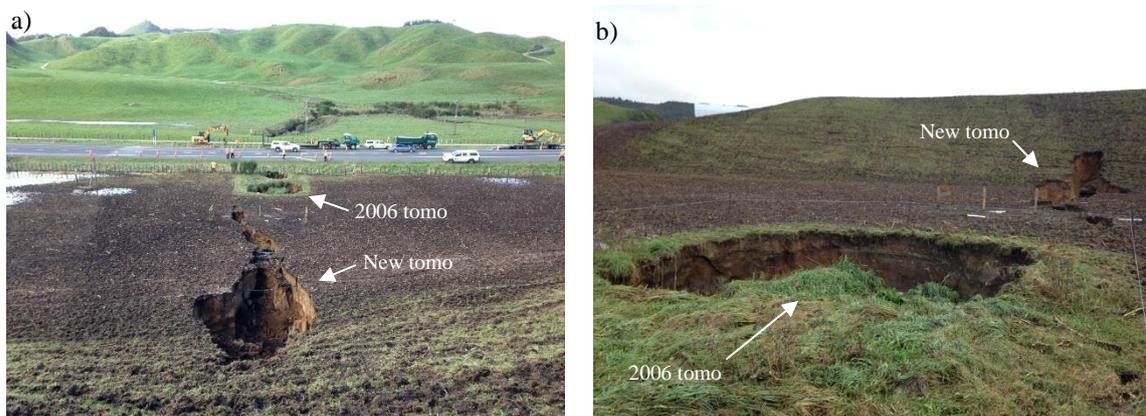
Figure 2: Sinkholes/tomos developed in the adjacent properties. a) Looking east from the hill towards the road. b) Looking west from the road towards the hill.

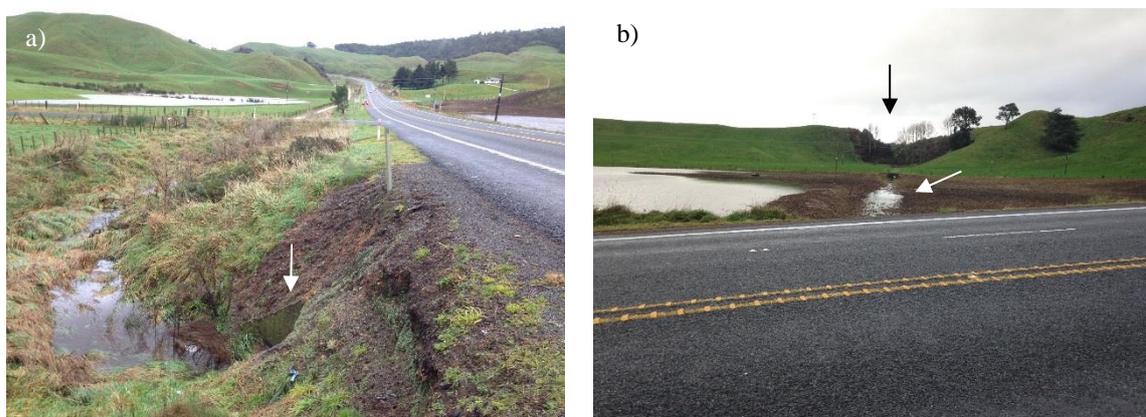
An inspection of the existing surface drainage system identified that the swales and culverts were too high to drain the water that ponds in the paddocks adjacent to the road (Figure 3).

Figure 3: The existing surface drainage is too high to drain water ponding in the area. a) Culvert (as indicated by arrow) supposed to drain water from ditch on the east side of the road to swale on west side. b) Swale (white arrow) supposed to drain water to gully downstream (black arrow).

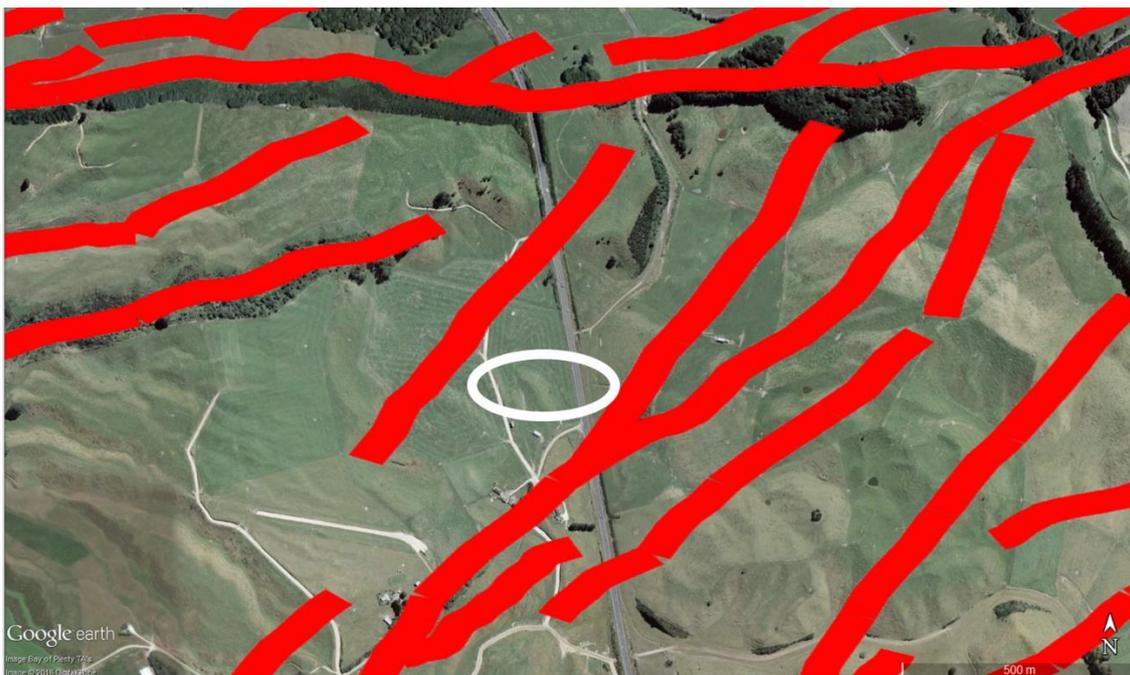
Although a number of active faults are present in the wider Rotorua region associated with the Taupo Rift Zone, in the Tumunui area in particular, no active faults are known to exist, as indicated in Figure 4 (New Zealand Active Faults Database, 2016). In addition, whilst the vast majority of the active faults in the region are NE-SW oriented, in Tumunui the orientation of the gully on the east side of the road and the recently developed tomos is closer to E-W. Therefore it is considered unlikely that the piping process affecting SH5 is associated with active faults.

Figure 4: Active faults in the Tumunui area (New Zealand Active Faults Database, 2016). White ellipse indicates section of road affected by tomos.

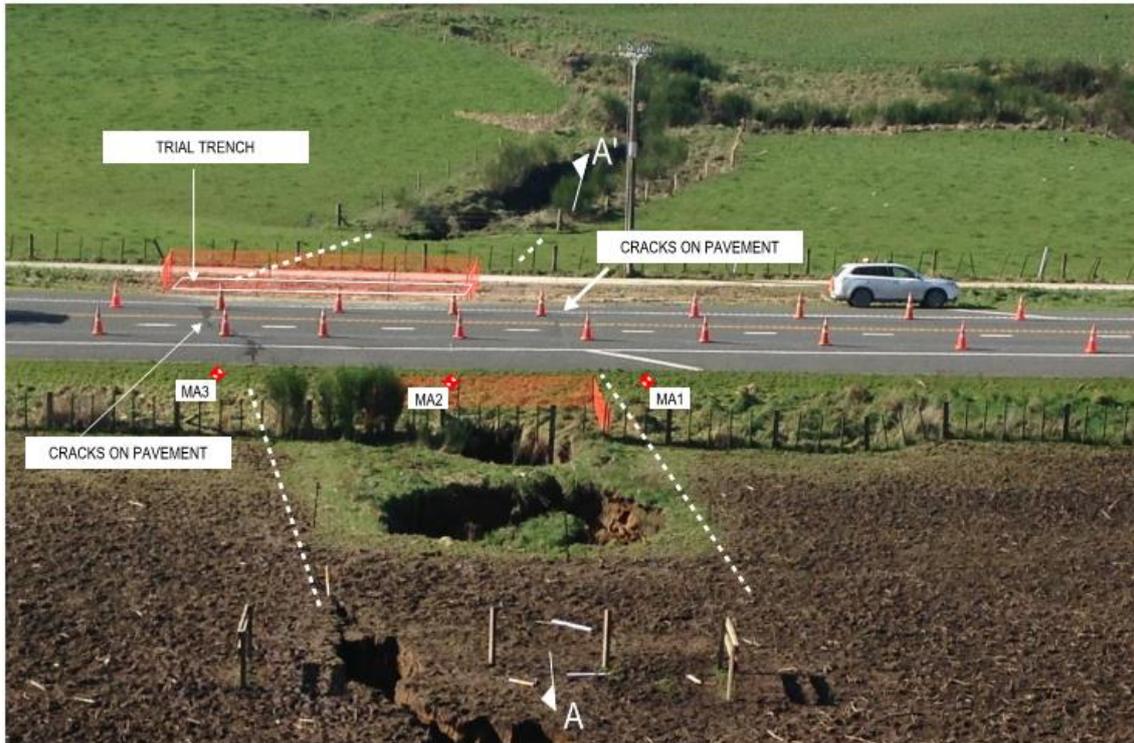
Figure 5: Location of ground investigations. Dashed lines indicate position of cracks observed. Section line A-A' is also indicated.

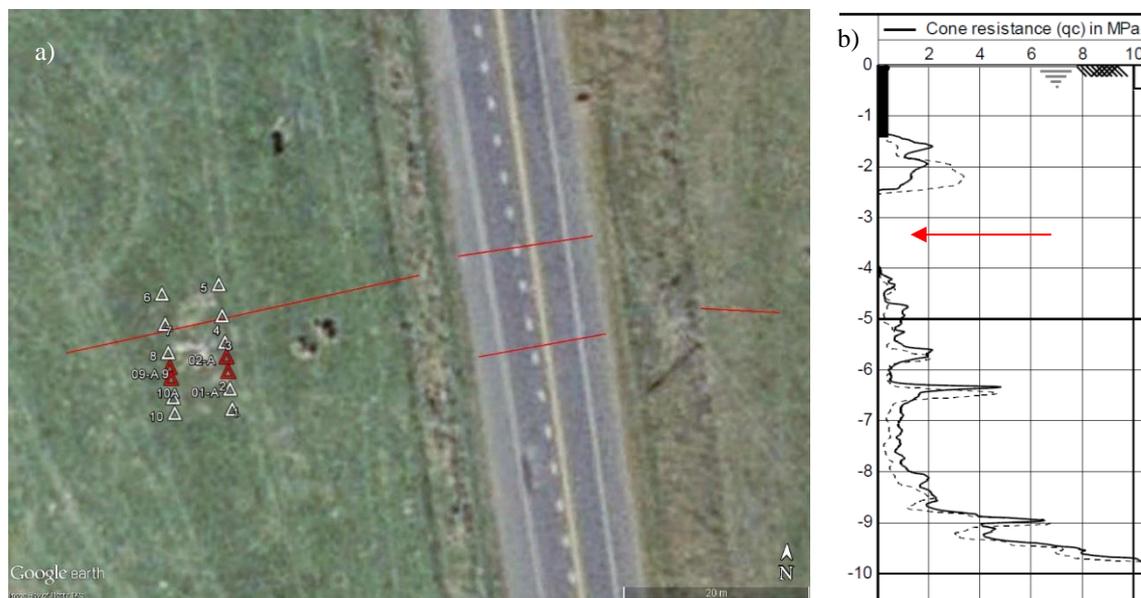
In addition to the investigations mentioned above, about a year before the piping event affected the road, 14 Cone Penetration Tests (CPTs) to up to 10m depth were carried out by Pattle Delamore Partners Ltd (PDP) for First Gas Ltd (First Gas) on the adjacent property to the west of the site. The location of these CPTs, as well as some representative results are indicated in Figure 6.

Figure 6: CPTs on adjacent property to the west. a) Test locations: red triangles indicate location of potential voids. Red lines indicate position of cracks observed. b) CPTs where potential voids were intercepted, as indicated by red arrow.

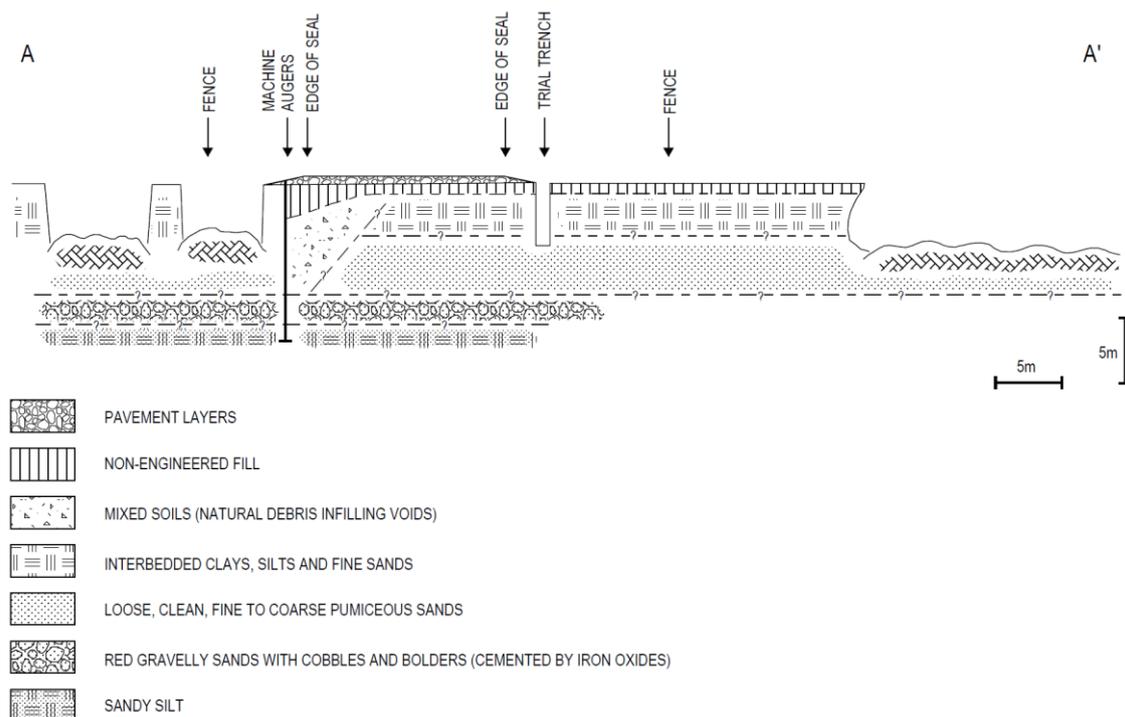
Figure 7: Section A-A' illustrating the ground model for the site.

Based on the key points described above, it was concluded that the layer of loose pumiceous sands was the main zone where the piping (silt/sand transport) process was developing, and that the top of the layer marked the roof of the piping system. It was considered that the underlying cemented gravelly sands with cobbles and boulders would likely mark the base of the system.

The width of the piping zone was interpreted to be likely around 12m, as marked by the cracks on the pavement. It was also concluded that the piping was well developed under the road and downstream (i.e. to the west).

Lastly, it was concluded that the cover above the tomo was up to 4m thick and the shallow soils were unable to naturally bridge a tomo of the interpreted size.

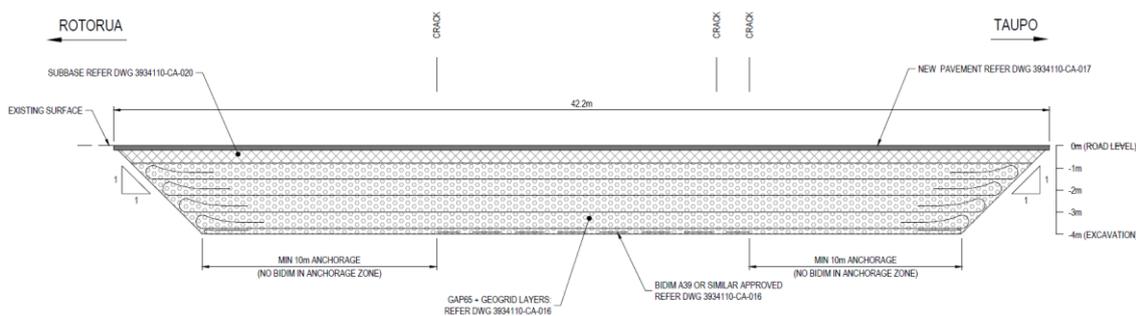
Figure 8: Long section of the geogrid-reinforced soil raft.

The preferred option was a medium-term solution consisting of a geogrid-reinforced soil raft, able of spanning the voids whilst providing enough robustness to avoid sudden collapse should the cavities enlarge as the erosion progresses.

The final design of the geogrid-reinforced soil raft was carried out based on BS 8006-1:2010. A long section of the raft is illustrated in Figure 8.

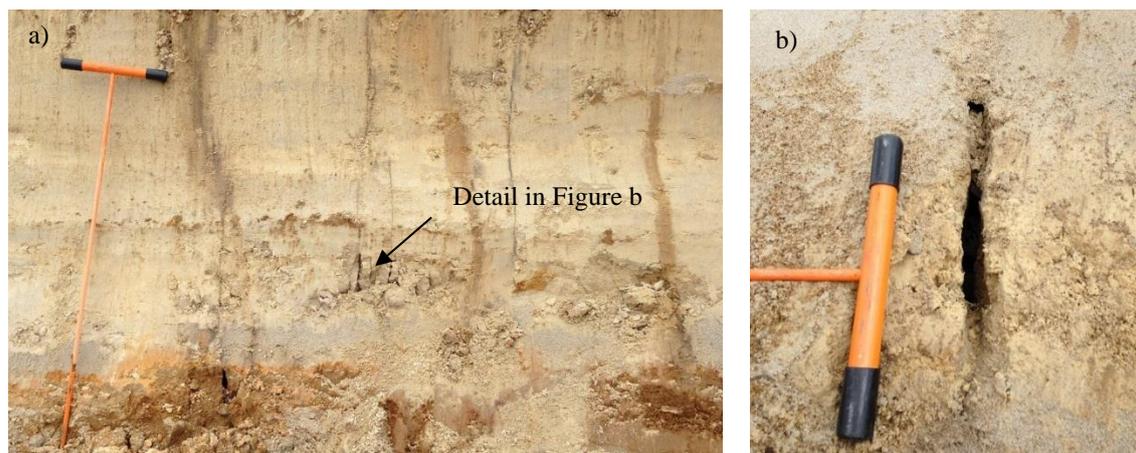
During construction, the anticipated ground model was generally confirmed and no significant voids or cavities were encountered in the excavation to 4m depth. Some small cavities up to 200mm long and 20mm wide were observed along a set of widely spaced subvertical fractures oriented at around N75E, as illustrated in Figure 9.

These subvertical fractures were only observed within the 12m wide zone delimited by the north and south cracks in the pavement. The north and south cracks themselves were found to be surface traces of the subvertical fractures, and could be traced along the full height of the east and west walls of the excavation. No displacements were observed across any fractures at the site.

Figure 9: Small-scale piping along subvertical fractures on the west wall of the excavation.
