Bluff Road Coromandel: Rockfall Risk Management, Public Perception and Influence

C G C Hughes
Opus International Consultants, Auckland, NZ
Chris.Hughes@opus.co.nz (Corresponding author)

K J Read
Opus International Consultants, Hamilton, NZ*.
KenR@cmwgeosciences.com

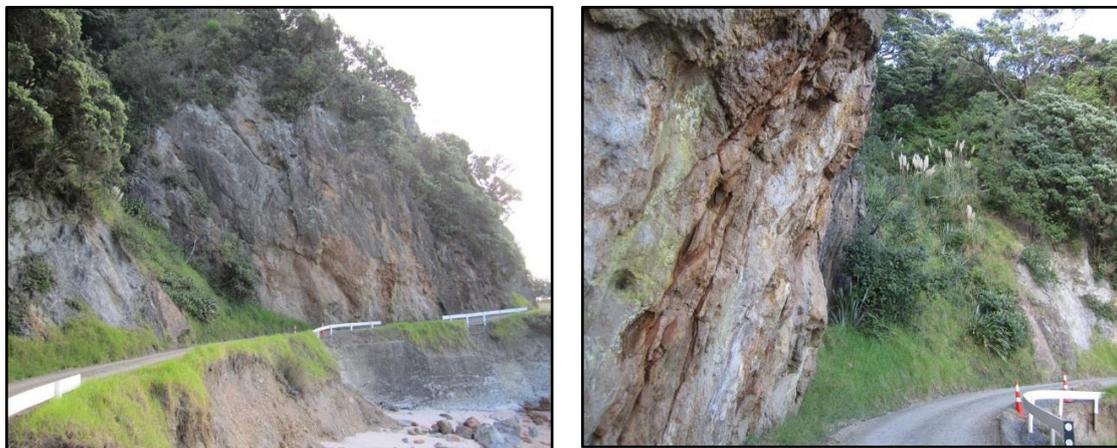
At one location close to the western end of the road, the road is overhung by a near vertical 20m high bluff of variably weathered and hydrothermally altered andesite, that is also locally sheared and closely fractured, Figure 2. Three major discontinuity sets are present. Two of them, dipping out of the face at angles of between 30 and 50° and a second dipping out of the face at 70 to 80° promoted planar and toppling failure respectively. The third, near vertical set, has a strike at

almost 90° to the face and act as release planes for block failures. Weathering and hydrothermal alteration has particularly picked out the vertical discontinuities trending into the face, which are locally concentrated and may be localised fault or shear zones. The published geological information indicates these to be the Matarangi Andesite of the Coromandel Group of Miocene age (New Zealand Geological Survey 1976).

Figure 2: Views of Bluff Road section of concern showing overhang, fracturing and weathering/alteration

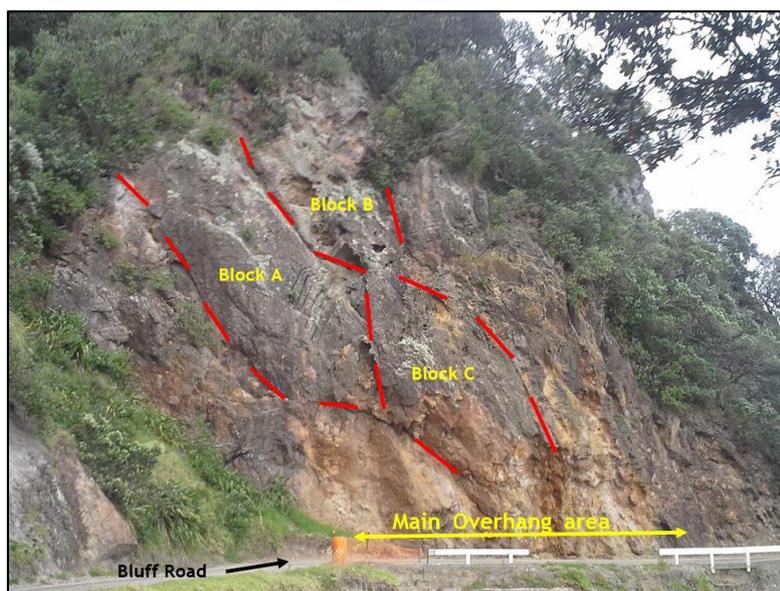
There was a section at the east end of the overhang where three distinct blocks were visible and where if these were to fail the rockfall volumes could be significant ($>10\text{m}^3$), Figure 3.

Figure 3: Potential failure masses observed in 2014.

At that time, we considered there was a high likelihood of small rock blocks (up to 0.5m diameter) continuing to fall onto the road. However we also considered that there was a high likelihood of a large volume ($>10\text{m}^3$) planar / wedge type rockslide that would block the road, sourced from any of, or all the blocks A to C shown on Figure 3.

Work commenced in November 2015 to remove blocks B and C plus a section of material to the right of these blocks (Figure 3). This work was to consist of scaling and blasting to remove approximately 350m³ of rock and the installation of 350 m² of passive mesh held in place by bolt anchors at the top and bottom of the slope. Scaling and blasting was completed prior to the Christmas holiday shutdown after which the placement of mesh was to be carried out. As works were not complete the road was temporarily closed over his period with signage and fencing erected.

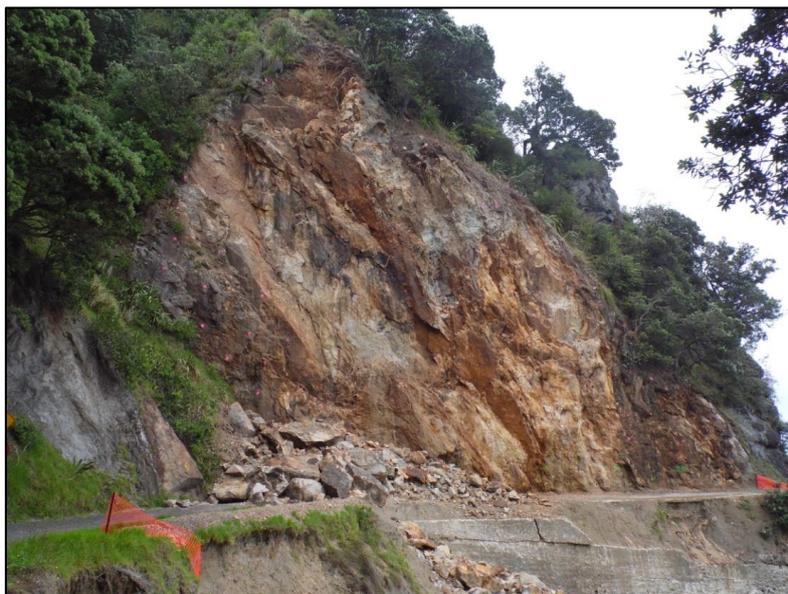
A significant rock-fall occurred after heavy rain on the 25th of December (Figure 4). It is unclear if this was also related in part to the effects of the work, such as blasting and stress relief opening fractures.

Figure 4: Rockfall of 25 December 2015.

A review of the discontinuity and weathering profile exposed after the December 2015 rockfall concluded that previously unknown discontinuities and deeper weathering and alteration of the rock mass indicated there was a greater risk of ongoing and potentially large volume rockfalls than previously understood.

Significant additional costs would be incurred to continue and the decision was made to discontinue work and close the road. The community was informed and barriers and signs erected to prevent pedestrian access. Rockfall debris was left in place to deter vehicle access. There is a footpath over the bluff that allows alternative pedestrian access.

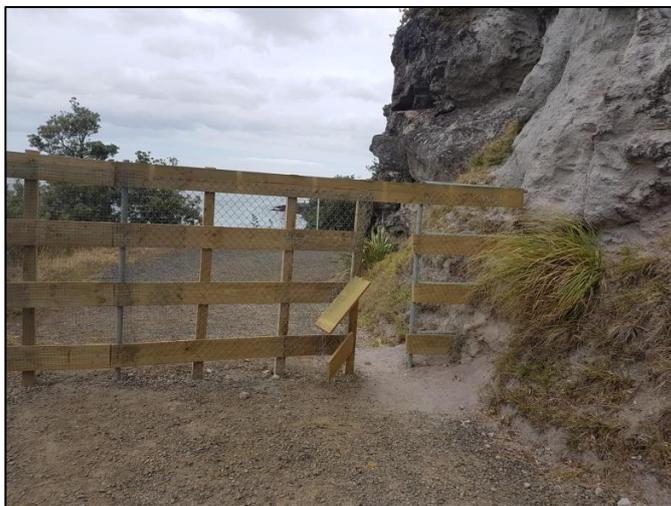
However, over the next year the fences and barriers were repeatedly cut and broken down by members of the public seeking to use the road as a short cut between the two communities and to popular fishing and diving marks (Figure 5 and 6).

Figure 5: Vandalised fencing

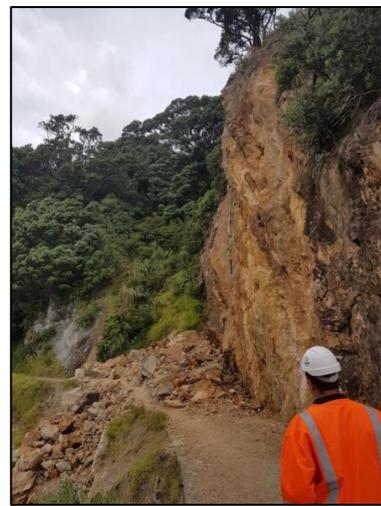
Figure 6: Footpath past debris

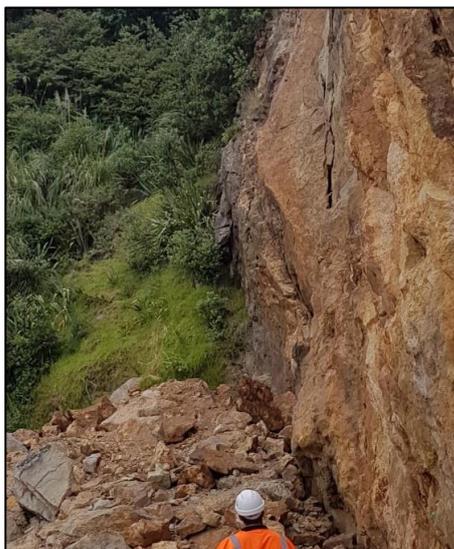
This was despite clearly hazardous conditions, as exhibited by wide open fractures, isolated fallen blocks (Figure 7 and 8), signage / barriers and warnings in the press.

Figure 7: Open fractures above path

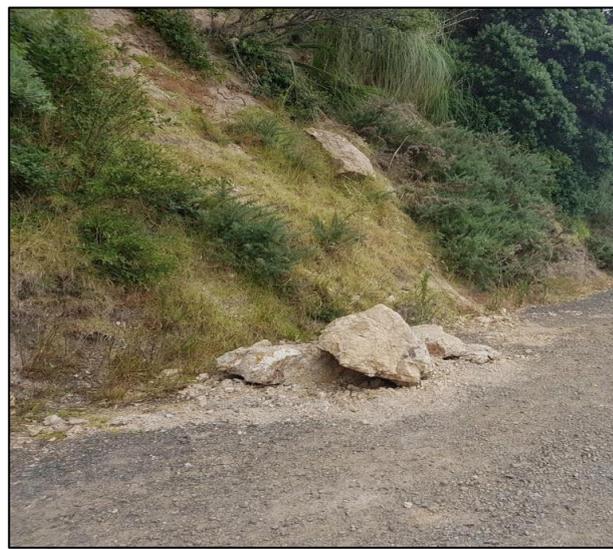
Figure 8: Fallen blocks on footpath
