Landslips in Northland Observations from Select Case Studies

David Buxton - Northland Geotechnical Specialists

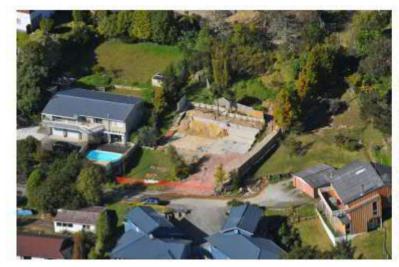
Figure 2. House site in Lingham Crescent, Torbay where a home damaged by slow movement (700 mm on 30 July 2008) of a creeping landslide was evacuated and later demolished. Site evidence suggests the landslide is an old feature that was active before the site was developed, and reactivated by the prolonged rainfall in July 2008.

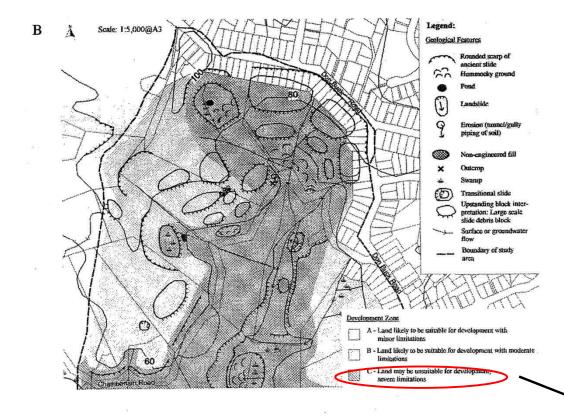
Figure 1. Extracts from slope grade and lithologic map (A) and observed slope movements overlain on resultant slope instability hazard map (B).

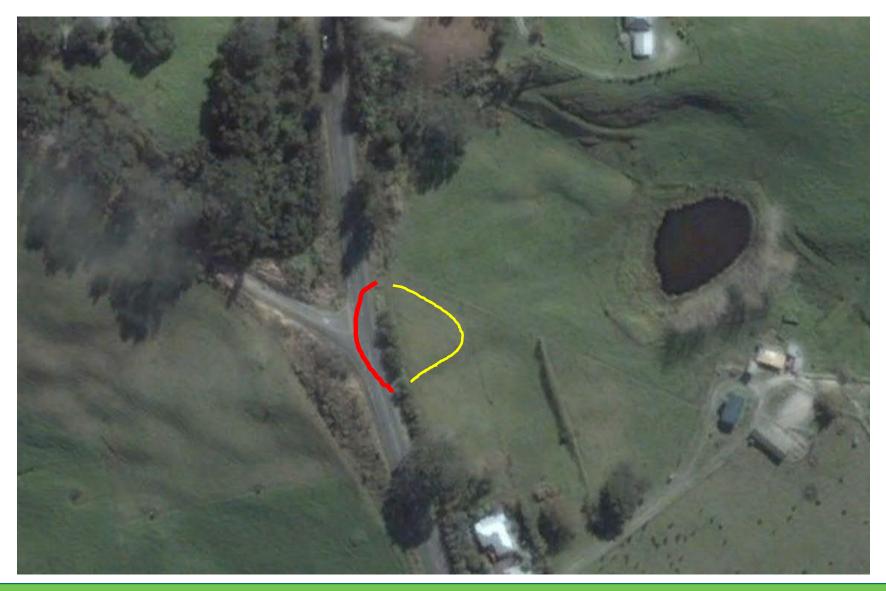
### 4 - Mangawhai

The LiDAR contours indicate a 9m fall over 45m horizontal distance between the headscarp and toe – an average of 1V:5H or 11°, indicating a very low strength failure plane must exist.

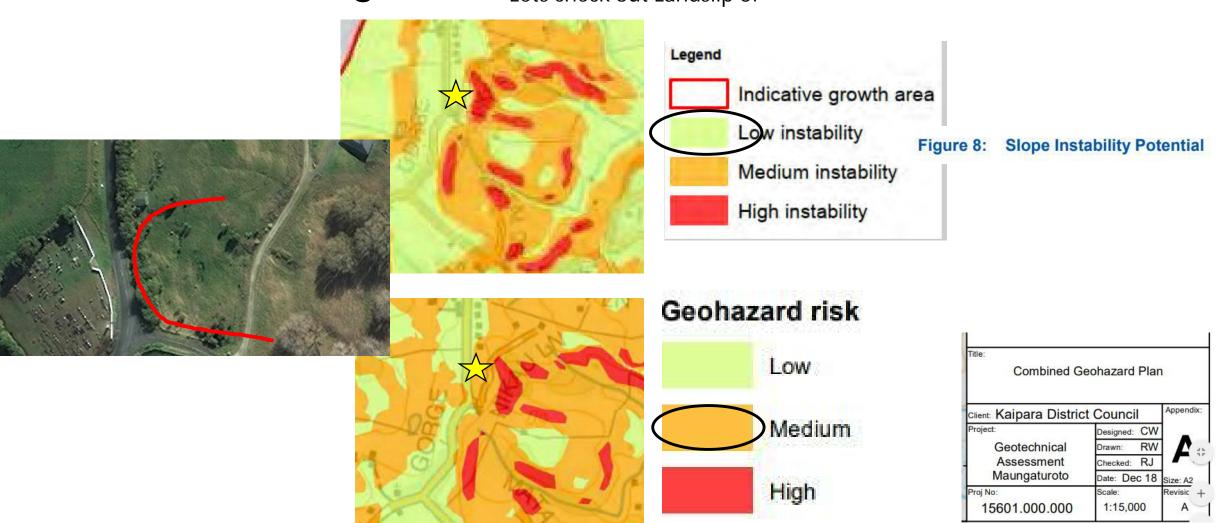
#### Lets check out Landslip 5:

Unfortunately not the excellence we saw with Landslip 2 Zoning

In my opinion the slope angle thresholds are unconservative. They are of concern as others will it is likely they will be referenced and relied on in the future by some.

Based on slope angle alone the maps will always be insensitive to actual landslip features.

Landslip 4 in
Pakiri Formation
on 11° Slope!!!

Many Allochthon
Units are too
weak to stand
this steep
