OMOKOROA POINT  
LAND STABILITY INVESTIGATION

REF: 4487/2  
MAY, 1980

PREPARED FOR:

Tauranga County Council,  
Private Bag,  
TAURANGA

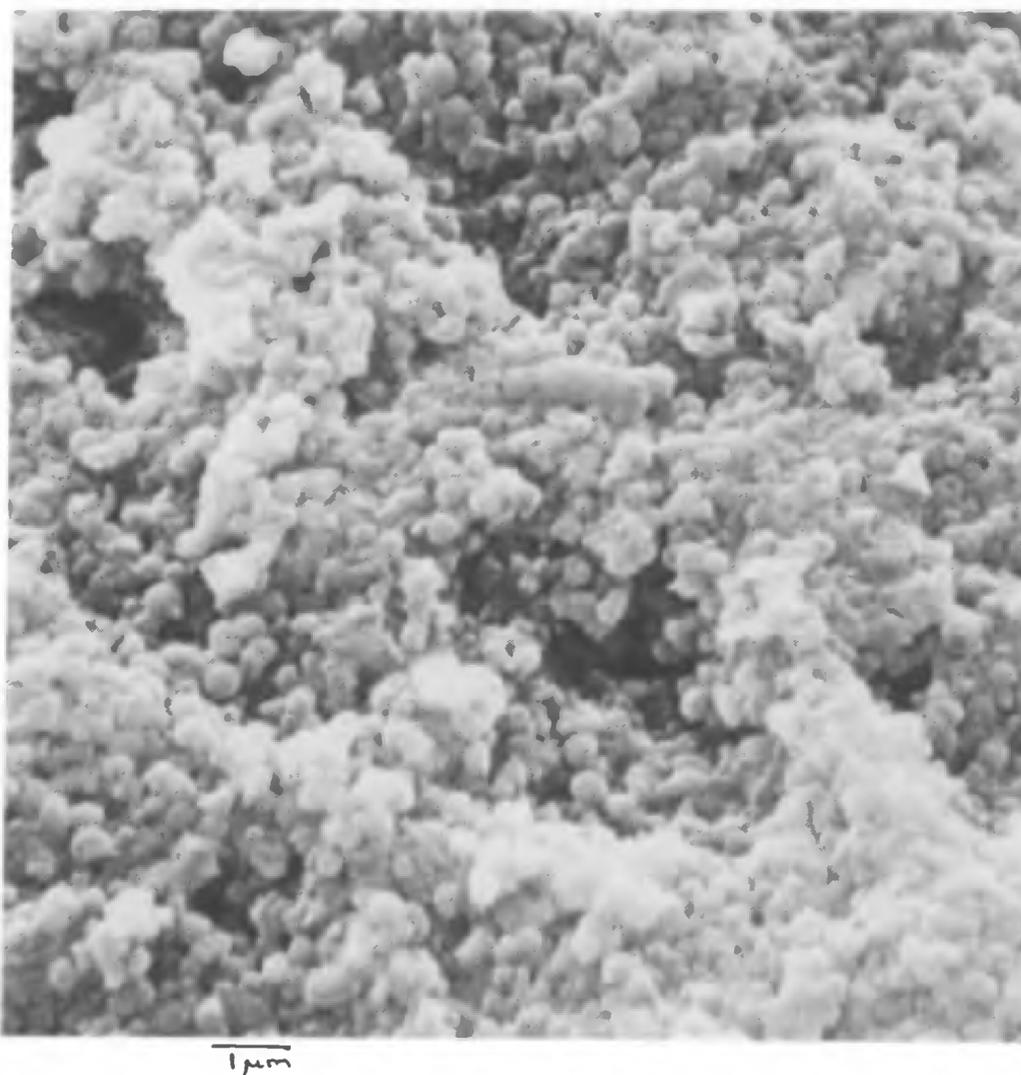
The soil sample supplied to Soil Bureau, D.S.I.R., (sample 4/13), was also subjected to an electron microscopic scan. The results indicate that the Halloysite is of an unusual spherical variety as shown in Fig. 6.1. The soil structure consists essentially of a mass of halloysite spheres with diameters of about 0.2 microns with no evidence of cementation between particles. These particles appear to be single crystalline units and not aggregations of smaller particles. It seems that the sensitivity of the soils results from very low attraction or bonding forces between the loosely packed particles. Thus although clay mineral particles predominate in the soil, long range interparticle forces are essentially absent and structural collapse can readily occur. The studies carried out on this soil by Soil Bureau lends some support to the inactive - particle theory of soil sensitivity (Cabrera & Smalley, 1973).

Fig. 6.1 Scanning electron microscope picture of spherical halloysite particles comprising sensitive soil from bore-hole 4, depth 20.6 m. Magnification 7,500 times.

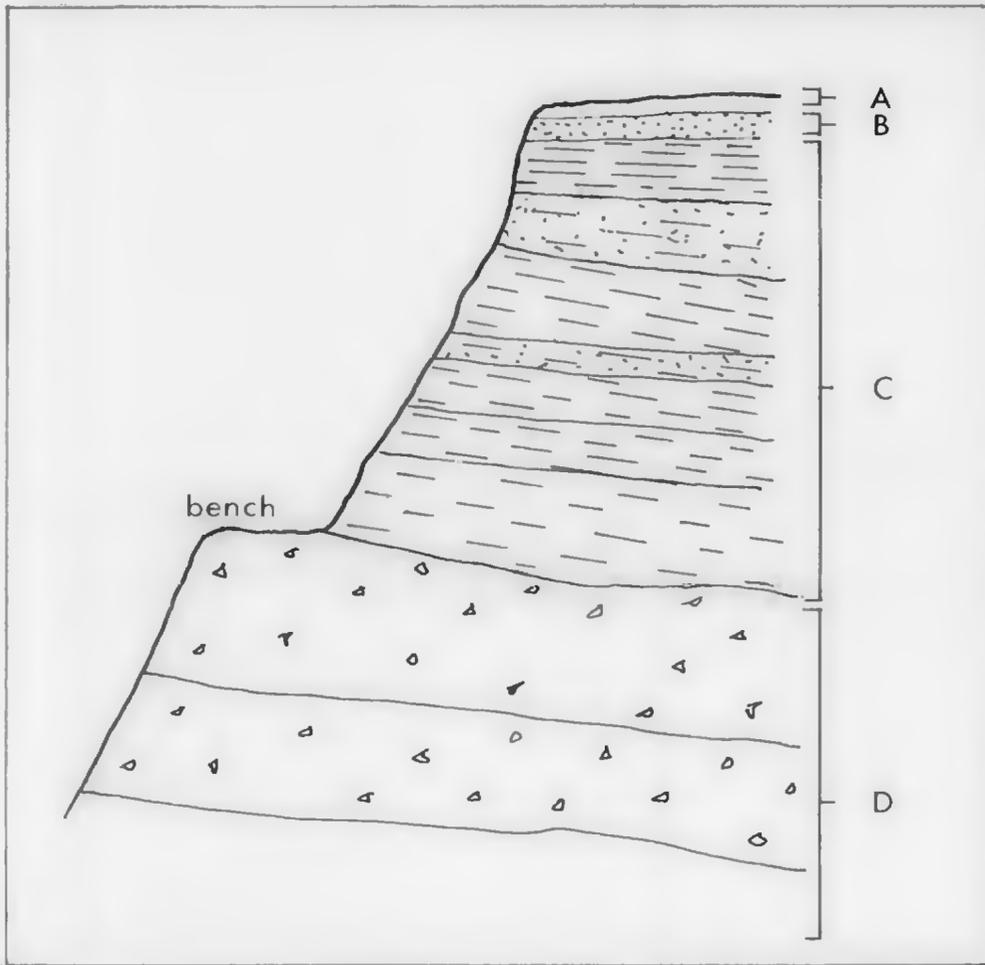
Figure 7.1 Cross section of face of Landslip.

The face of the landslip was examined by both writers on 13 August and subsequently revisited several times. The trace of the landslip face at the surface is a tight arc. Hairline cracks parallel to the surface trace were present on the Bramley Drive properties on 13 August. Cracks extended across the patio terraces on 9 and 11 Bramley Drive prior to the failures on 21 August and one crack had broken a brick on a terrace at 9 Bramley Drive. There were otherwise few signs of deformation and disturbance adjacent to the landslip.

The face consisted of two steep portions separated by a gently sloping bench. The level of the bench was immediately above the contact between the Tauranga Formation and the older ashes. The lower portion of the slip face, largely within the Tauranga Formation, was a smooth, planed surface. The failure surface was partially buried at the centre of the face but clearly visible at both margins. The upper portion of the face was more irregular with protruberant resistant ridges and blocks.

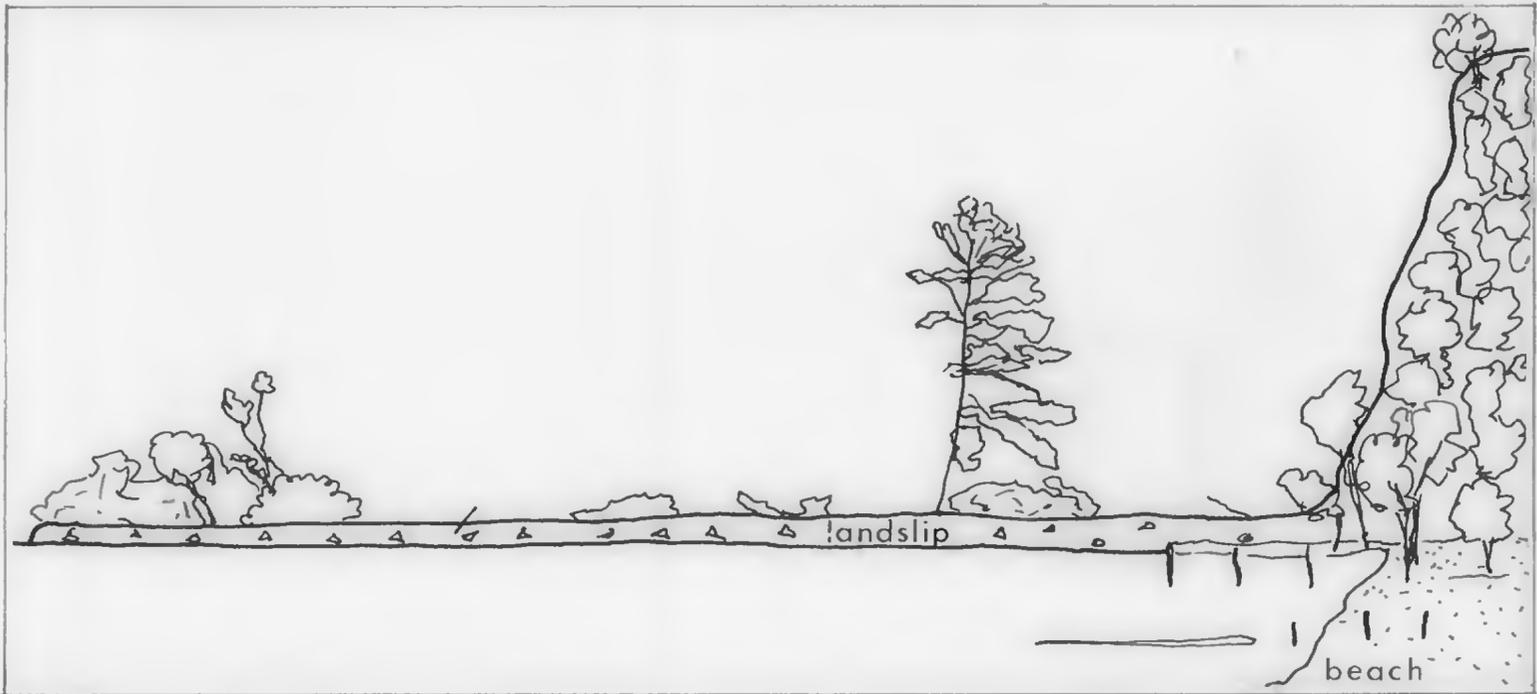
Figure 7.2 Plan view of deposit of 11 Bramley Drive Landslip. Approximate width of box 150 metres.

by coherent blocks up to one metre in diameter. Logs originally lining the beachfront had been propelled outwards and now ringed the deposit. Very little debris had over-ridden the logs. High mobility of the failed mass was clear from the distance travelled by the material and its unusually flat profile (Figures 7.2 & 7.7).

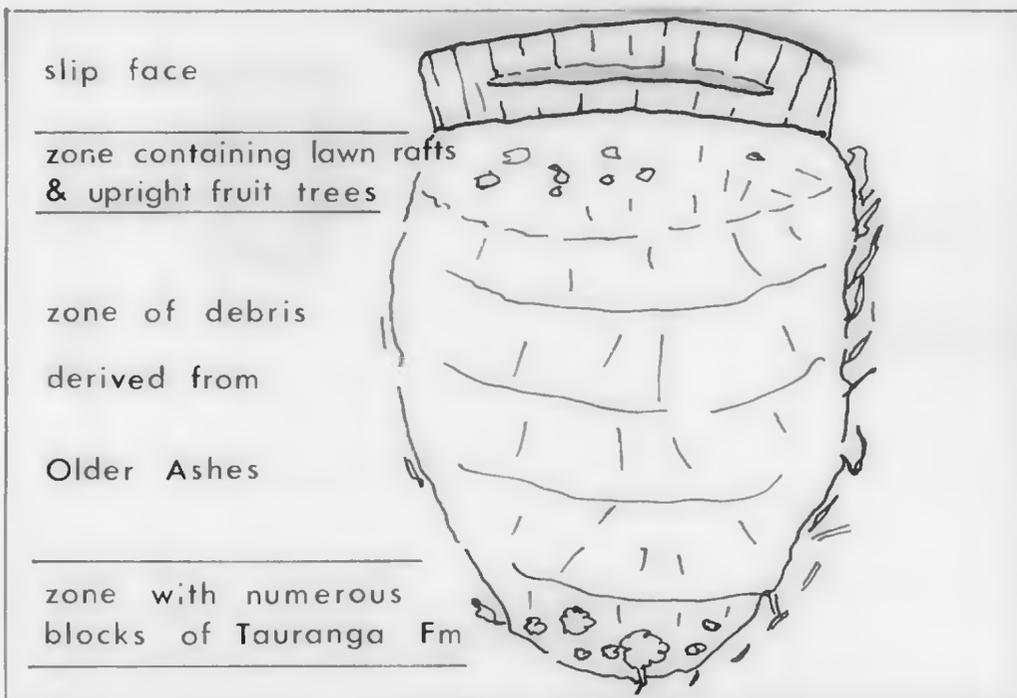
Figure 7.3 Map view of deposit of 11 Bramley Drive Landslip, showing concentric zonation of debris.

The subsequent failures of 21-22 August produced a similar but smaller zoned deposit with the axis of the deposit at approximately  $30^{\circ}$  to the axis of the main deposit. Redistribution of material by tidal processes commenced immediately after the failures and the deposit has now been substantially modified.

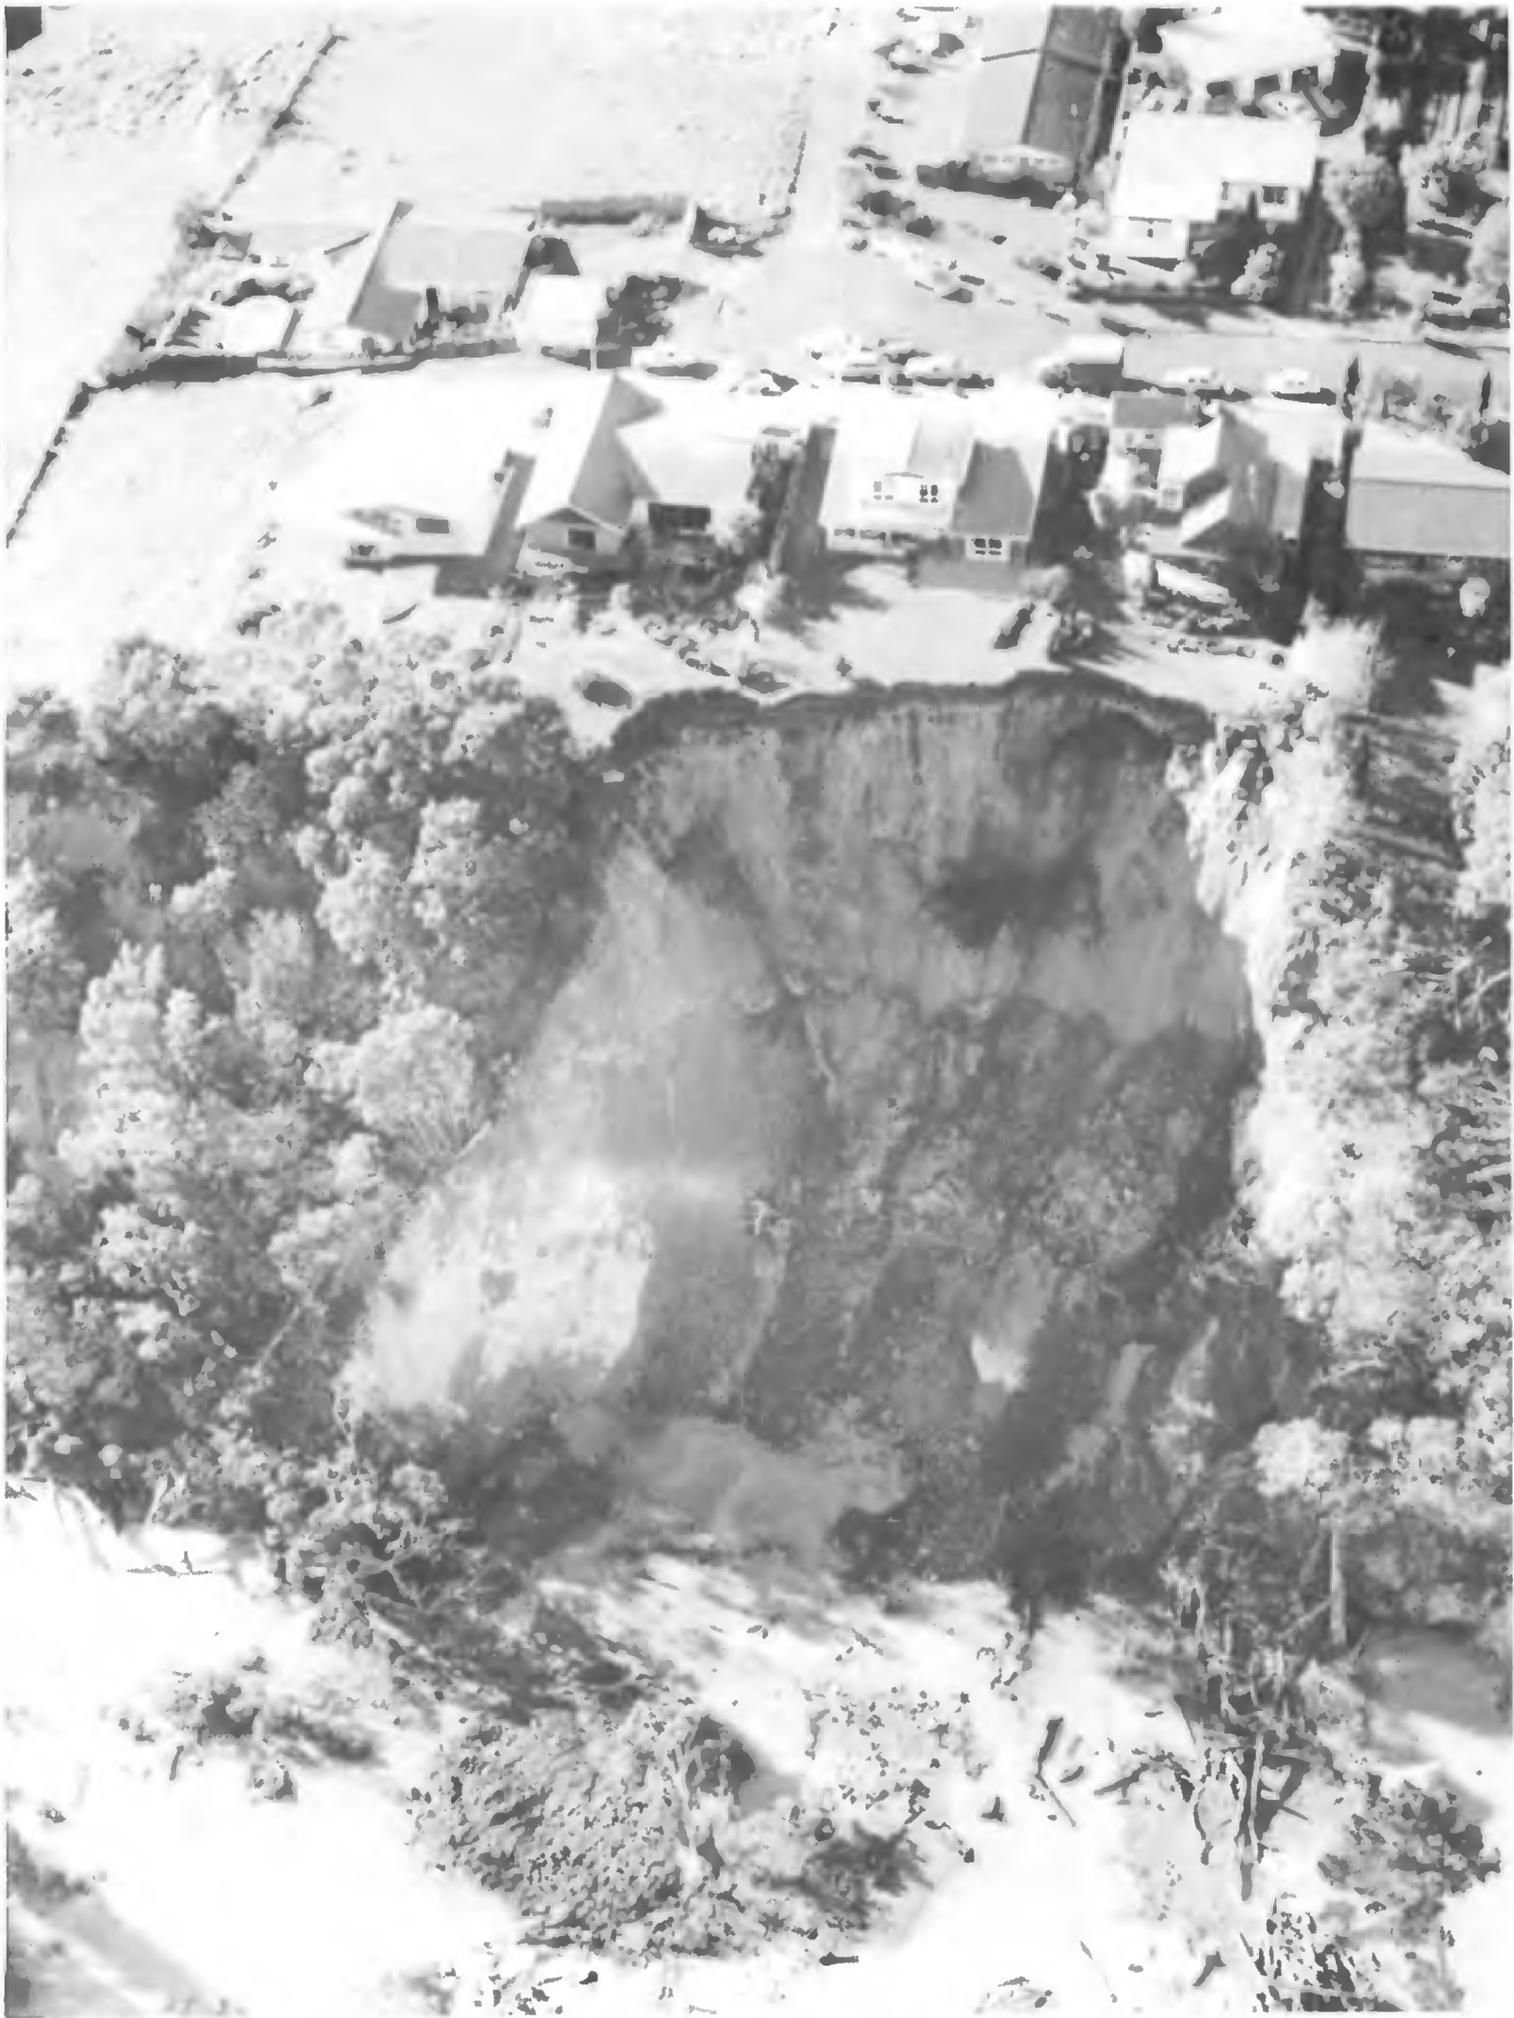
Fig. 7.4 The Bramley Drive Landslip  
taken 10th August 1979.

An arcuate segment of seacliff 60 m wide and about 16 m deep, centred on 11 Bramley Drive, failed and collapsed into the sea at 1100 h on 9 August (Figure 7.4). The failure removed much of the Esplanade Reserve fronting 9 and 11 Bramley Drive, and a substantial portion of these properties. There were few precursory indications of the failure. Concentric cracks up to 5 cm in width in the lawns of 9 and 11 Bramley Drive were first observed at approximately 1045 h on 9 August, which prompted two local residents to descend the seacliff and the failure was observed by these residents and a third person at the top of the cliff. Their accounts suggest failure was catastrophic and the failed material slid outwards as a single mass. The mass entered the sea at considerable velocity sweeping a number of large logs over 1 metre in diameter outwards from the base of the cliff for distances up to 150 m. The entry into the sea generated waves of one metre amplitude observed at Pahoia Point five kilometres distant. Arcuate tension cracks were still present after the failure, parallel and adjacent to the cliff edge on 9-13 Bramley Drive and extending into 15 Bramley Drive.

A second failure occurred at 0500 h on 11 August removing a further 9 m deep segment of the cliff-face. This failure extended to a patio immediately adjacent to the dwelling on 11 Bramley Drive. The failure occurred in darkness and was therefore unobserved.

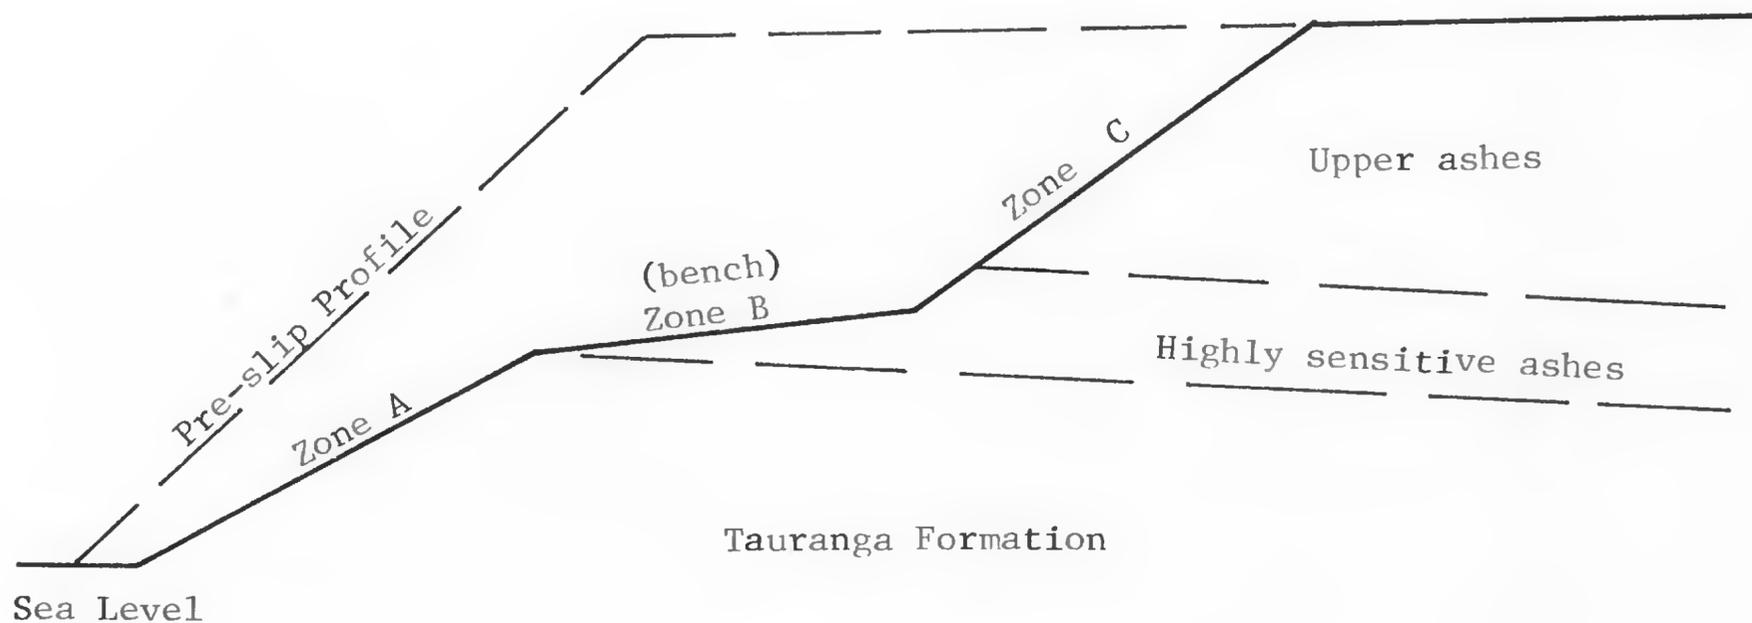
Fig. 8.1 Typical Landslip Profile

The type of failure mechanism described in the preceding section for Bramley Drive appears to be fairly typical of many of the previous landslips along the coastline, as might be expected from the similar geological conditions encountered in the boreholes to those existing at Bramley Drive. Similarities in the mode of past failures is also confirmed by eye witness accounts of these events. The type of failure produces a rather distinctive slip profile shown in Figure 8.1.

A fairly well defined low angle 'bench' is produced by failure through the zone of weak, highly sensitive ashes. Steeper overall failure slopes occur in both the underlying Tauranga Formation and the overlying more rigid ash layers.

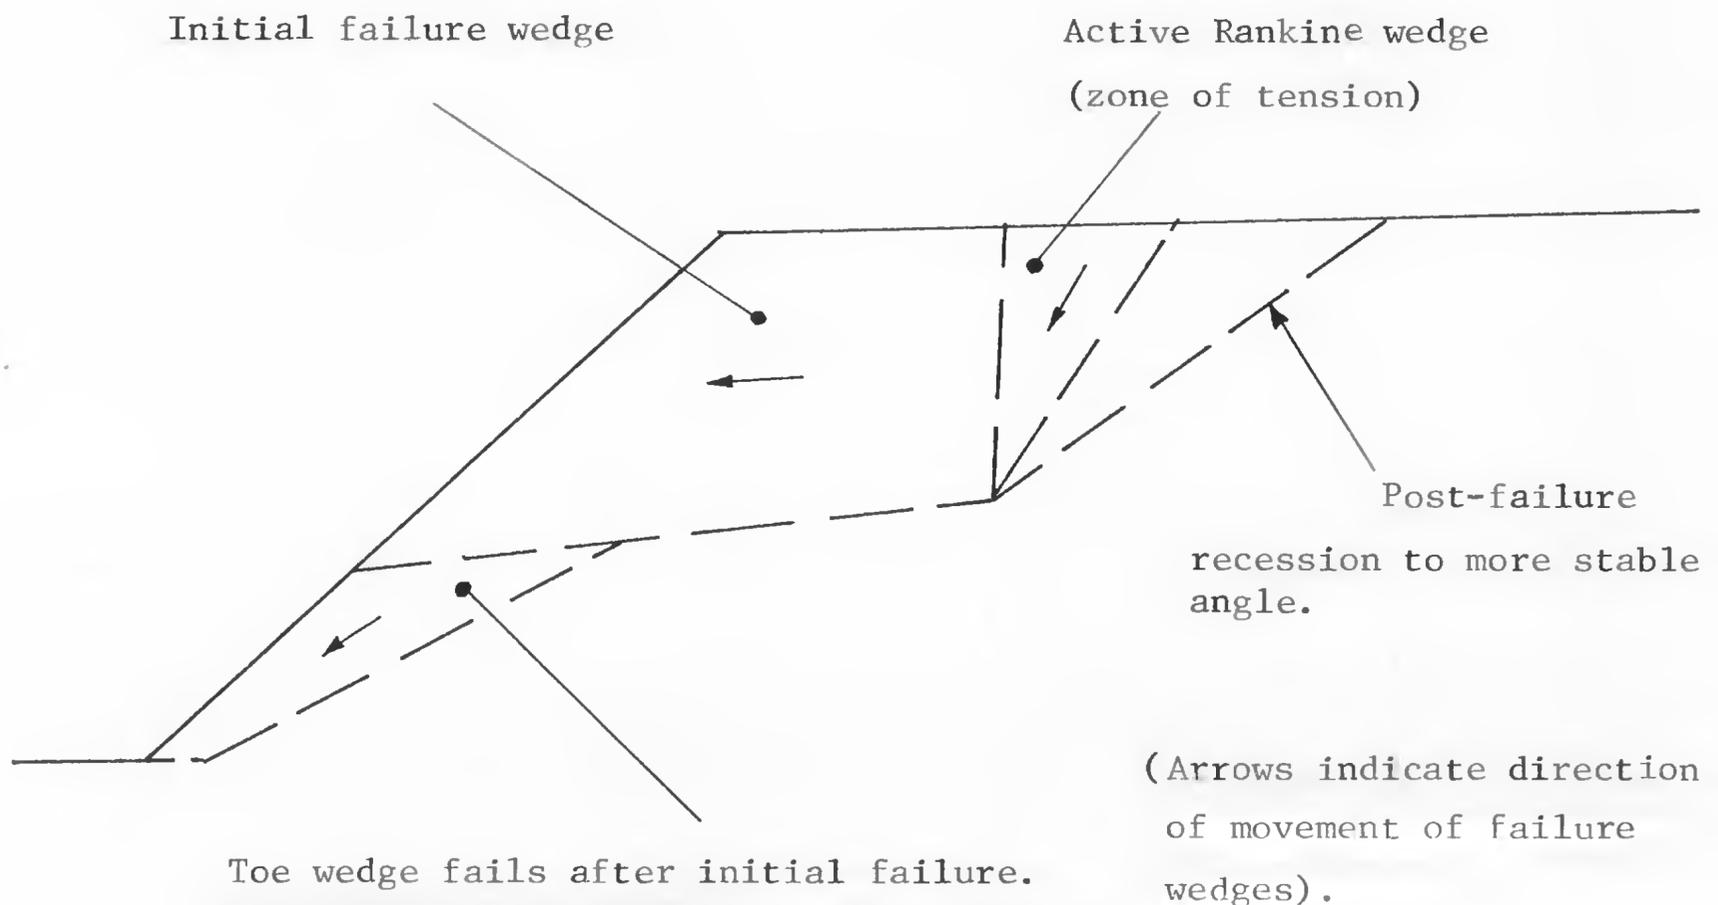
Fig. 8.2 Two-dimensional model for wedge failure.

As mentioned in Section 8.2 the slip has characteristics of both translational and flow slides and does not conform to the more typical rotational slide mechanism. The profile of the failure plane is also inconsistent with the type of failure plane that would be expected in a rotational failure.

Translational sliding of a large soil block seems to have occurred initially as a consequence of failure and liquification within the highly sensitive soil layer. Movement of this block could then have promoted failure of a toe wedge in the more competent Tauranga Formation. An 'active wedge' developed behind the main soil block would produce a zone of tension and post-failure recession of the soils within this wedge zone would be likely to occur, possibly extending beyond the limits of the active wedge.

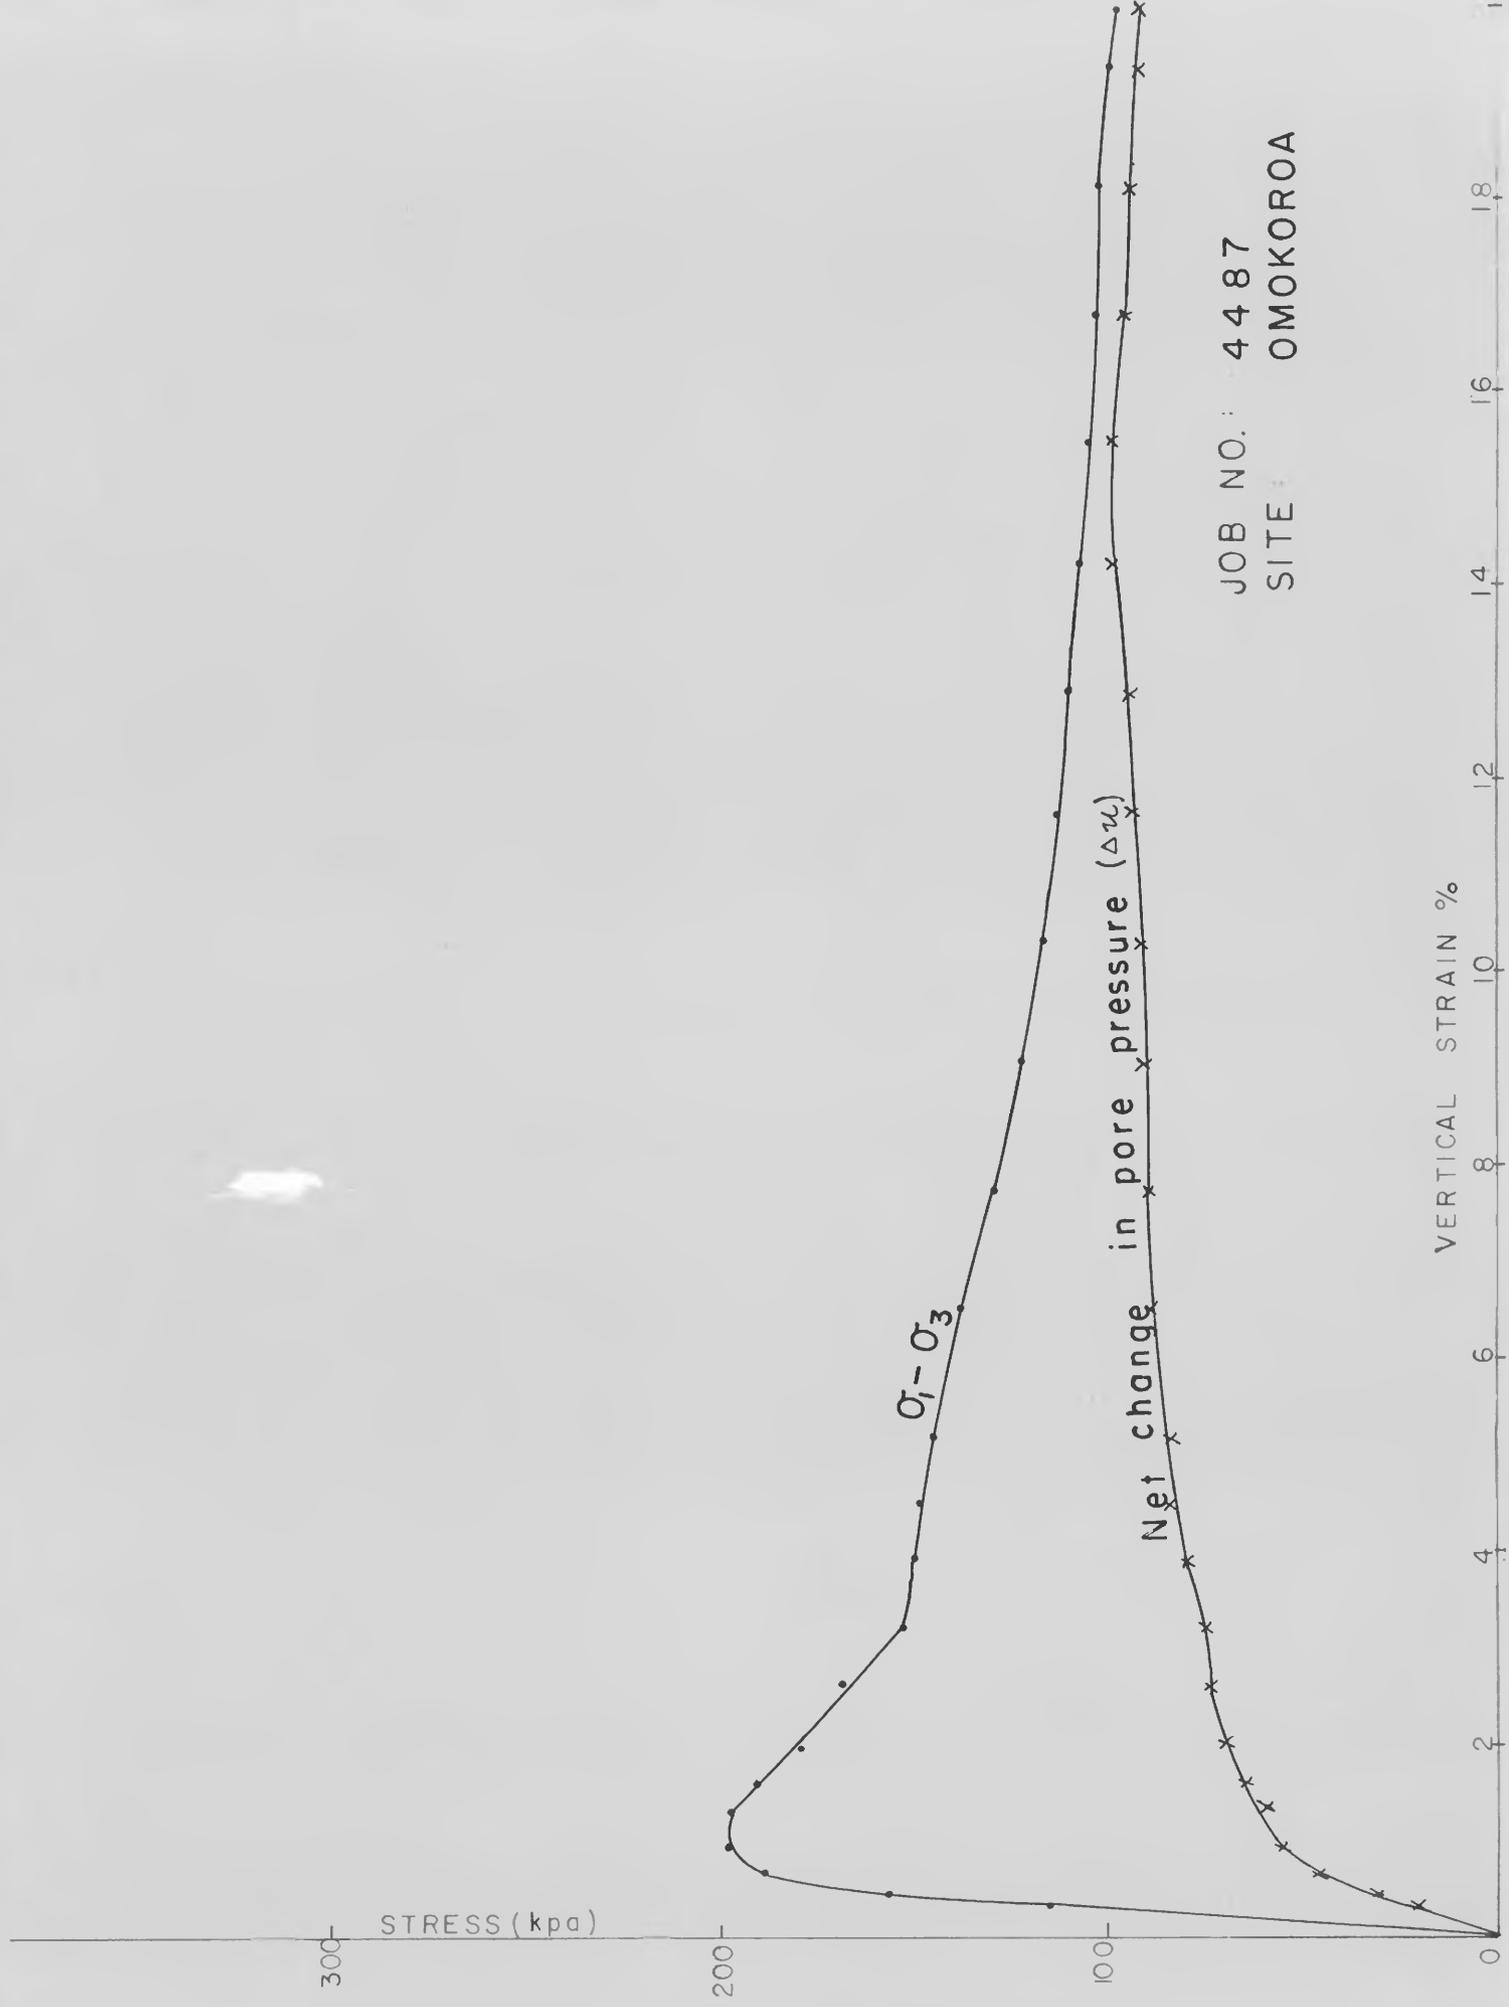
FIG. 2

In the case of the effective stress tests, loading was continued well beyond failure up to axial strains of 20%. Deviator stress and pore pressure plotted against strain are shown on figures 2 to 4. The significant aspect of these graphs is that the deviator stresses reach a peak at fairly small strain, indicating sudden brittle failure, then decreases with further strain, however, the pore pressure continues to increase even after the deviator has reached its maximum. This behaviour reflects the unstable skeleton structure of the sensitive clay. As the clay shears the soil structure collapses and the clay suffers a great decrease in volume. As this occurs large positive pore pressures are induced as load is transferred from the soil skeleton to the water held in the voids, since the sample is sheared undrained. The effect of this

is to decrease effective stresses and greatly reduce the overall shear resistance of the soil immediately after failure. These stress curves predict therefore that soil failure is likely to be sudden and that very great strength loss will occur after failure. Because of this unstable nature of the soil, it is difficult to choose realistic average strength parameters for use in practical stability calculations. Shear strength values considerably less than those at peak strength are liable to be more realistic for analysis.
