Canal Failure, Ruahihi Hydro Electric Power Scheme, Bay of Plenty, New Zealand

L.E. OBORN

SUMMARY The Ruahihi power station canal failed on 20 September 1981, one day after being officially opened. Water losses from the canal, and a number of slope failures resulting from these, were observed soon after the canal was filled for the first time.

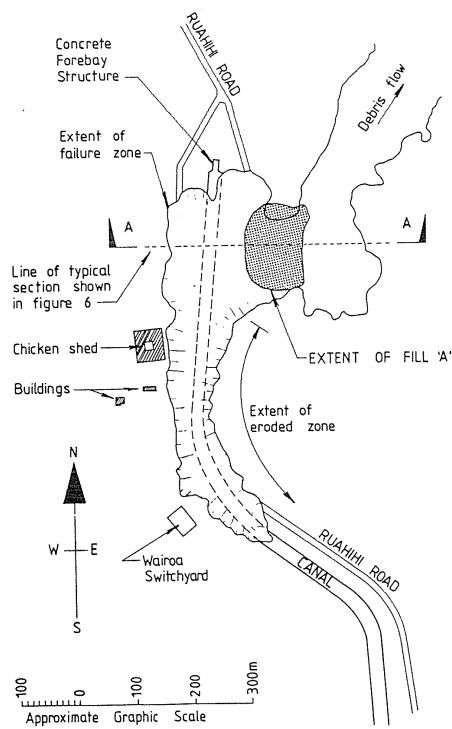
FIGURE 2 PLAN OF FAILURE AREA

The section of the canal that failed (see Figure 2) was near the eastern margin of an interfluvie, both sides of which were formed, and continually modified by natural valley side and head erosion.

In the section of the canal that failed (see Figures 2 and 3), the north-trending canal was sited towards the eastern margin of the broad crest of an asymmetrical ridge. The eastern flank of the ridge has been shaped, and was continually being modified by natural erosion. Water issuing from the base of the slope induced slope instability by slumping. The process, although continuous, was not rapid on an engineering time scale. The canal invert was in cut, a few metres below ground level. The canal embankments and lining were all constructed of "brown ash".

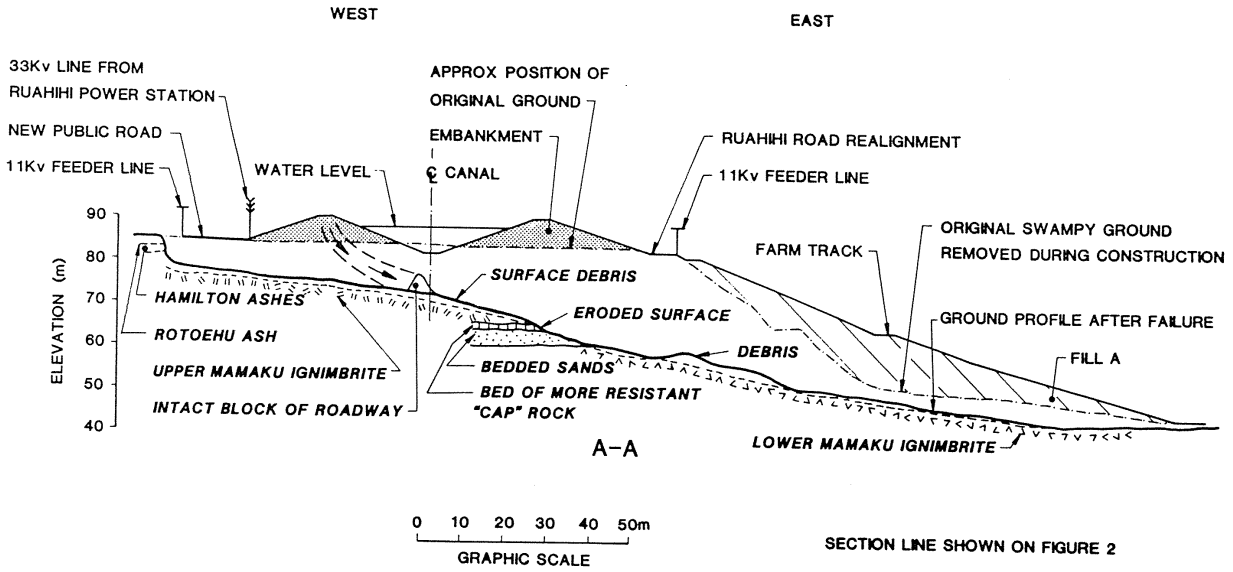
FIGURE 3 PROFILE OF FAILURE AREA SHOWING PRE AND POST FAILURE SURFACES AND GENERALISED GEOLOGY

The sequence of deposits in the area, which is composed entirely of airbourne volcanic materials, is summarised in Table 1 (see also Figure 3).

Apart from the upper 4 to 5 m of tephra (volcanic ash, see Appendix 1) the deposits near the failed section of the canal are Mamaku Ignimbrite (in this area essentially unwelded, in places weathered, loose and uncemented pumice breccia - see Appendix 1). The subsurface configurations of the ignimbrite are highly irregular because of its mode of deposition, and of Post-depositional erosion. Apart from these features, there are few mappable geological structures. Topographic lineaments can be identified in a few places on aerial photographs, and these may be related to past faulting, but this has not been demonstrated. None of these passes through the failed area. Jointing has been identified in the Mamaku Ignimbrite elsewhere in the region, but none was observed in the chasm cut by the failure.

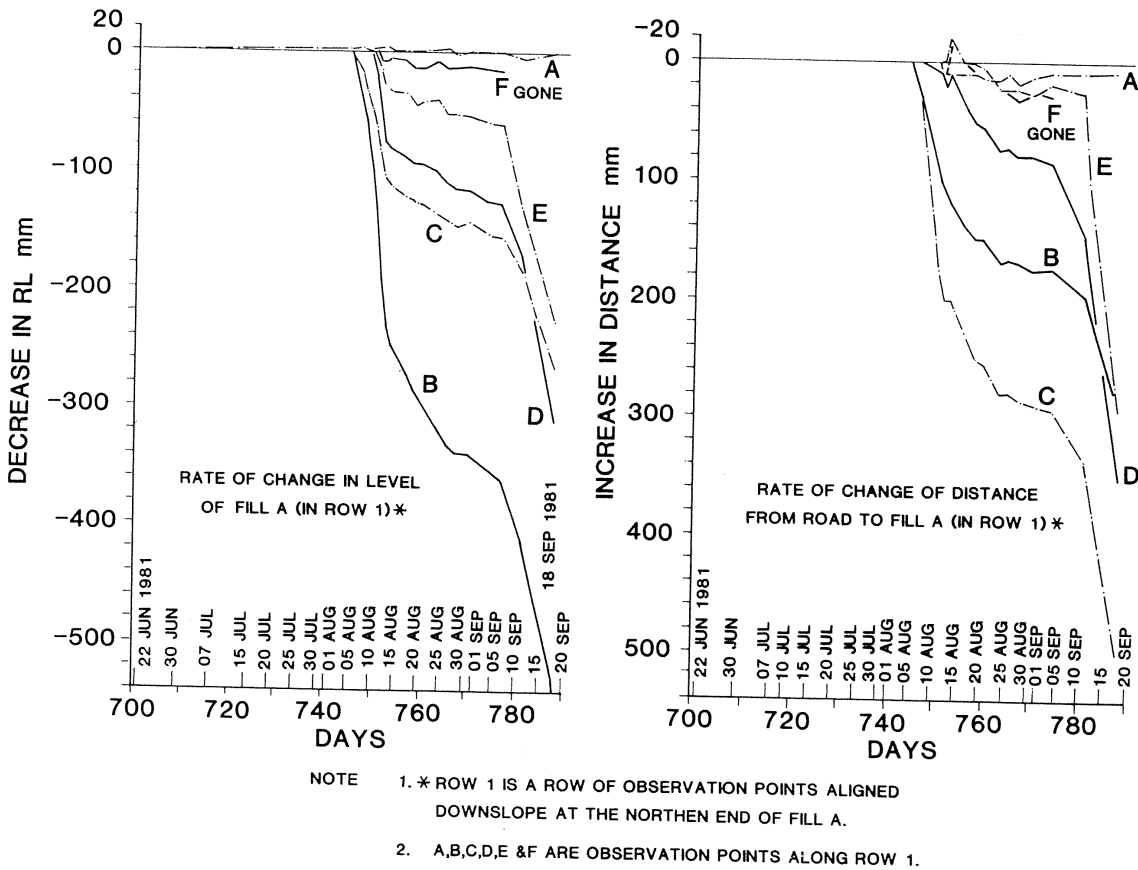
FIGURE 4 TYPICAL VERTICAL AND HORIZONTAL MOVEMENTS OF FILL A

The remedial work on the crack that had been formed on 5 August had been completed by 10 August. By this time also a network of observation points had been installed, and daily measurements on fill movements had been initiated: seepage was also being monitored. Observations showed that Fill A continued to move, both vertically and horizontally (see Figure 4). The movements suggested to the Committee of Inquiry that the failure was not a typical slip circle failure, but involved a shortening of the fill.

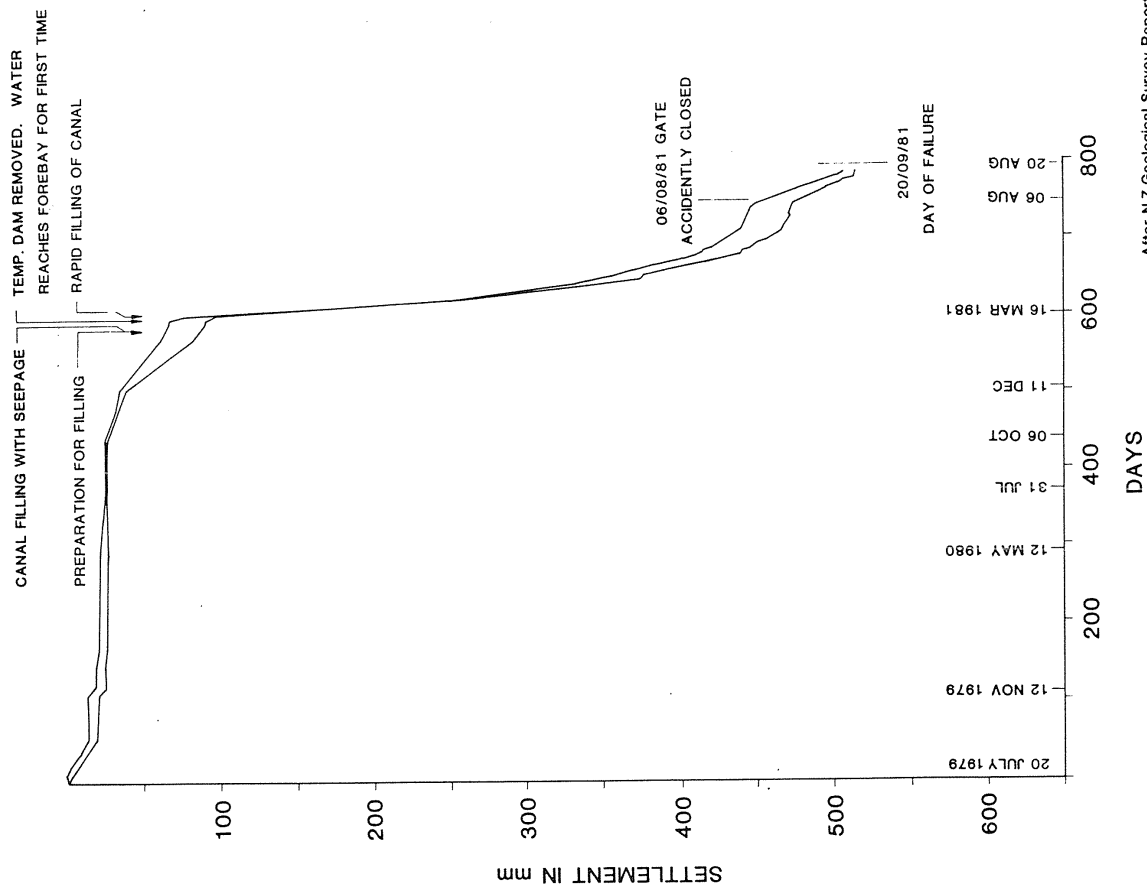
FIGURE 6 RATE OF SETTLEMENT OF INTAKE (FOREBAY) STRUCTURE

"tomos"). The effect of canal filling was demonstrated unequivocally by the rate of settlement of the forebay structure (see Figure 6).

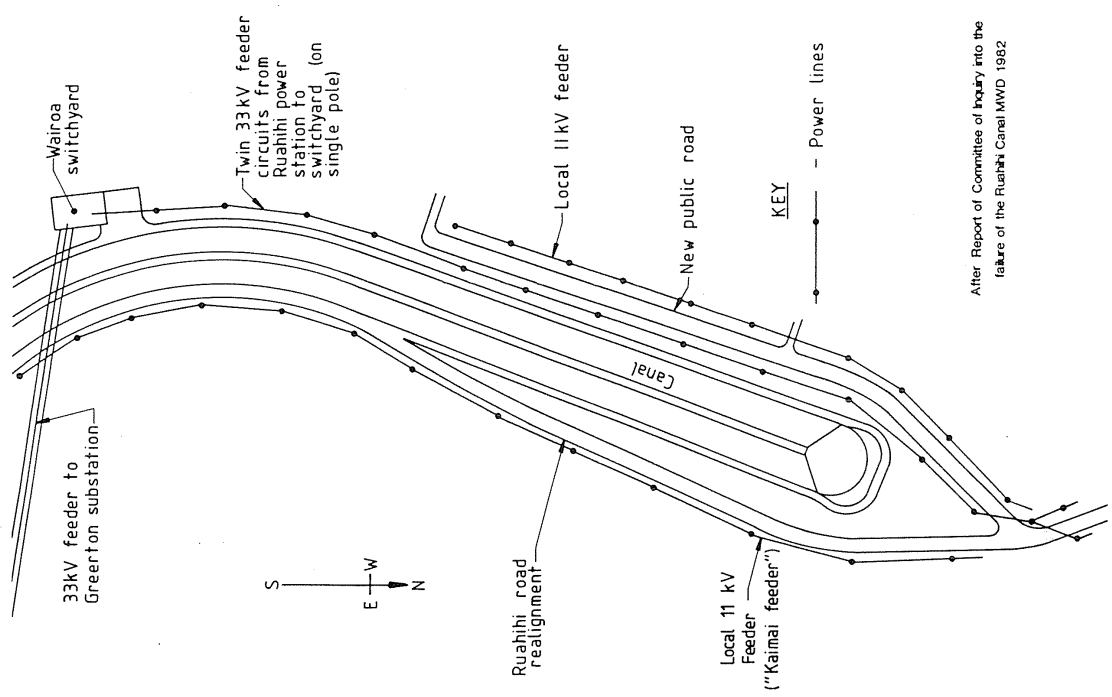
FIGURE 5 LOCATION OF POWER LINES IN FAILURE AREA

Faults on the local electrical system defined the time of the event. A local 11 KV power line which ran alongside the eastern bank of the canal lost power at 1.52 pm. Shortly afterwards an electrical trip at the Ruahihi Power Station, possibly caused by the loss of a 33 KV line along the western side of the canal, put the station out of operation. The tripping operated the relief valve which discharged water into the river (it was learnt subsequently that the penstock in use at the time had been partly drained before the turbine shut down). At 2.20 pm all generation in the TJGC system failed as the 33 KV line that crossed the canal was cut by collapsing canal banks (see Figure 5).
