Good grounds for the future

24-26 March 2021 • Dunedin • New Zealand

Innovation Under Pressure – Ohau Point Slope Stabilisation

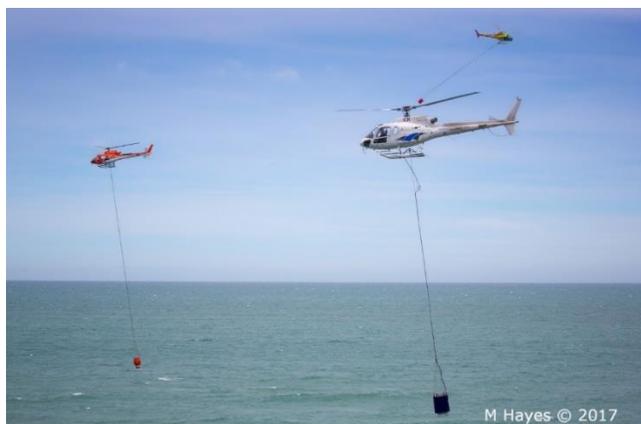
Figure 1: Kaikoura heli-sludging operations

Heli-sludging was quickly identified as the most appropriate primary means of treating the slopes while the ground shaking activity subsided; this would also allow time to consider more direct, permanent treatment options. Heli-sludging involves the use of helicopters fitted with firefighting 'monsoon' buckets dropping around 1000 liters of water at a time directly onto the slope. In the case of Kaikoura, the buckets were filled from the ocean and water washed onto the slopes in a targeted manner. Geotech engineers monitored the sludging operations directing the helicopter pilots to target areas.

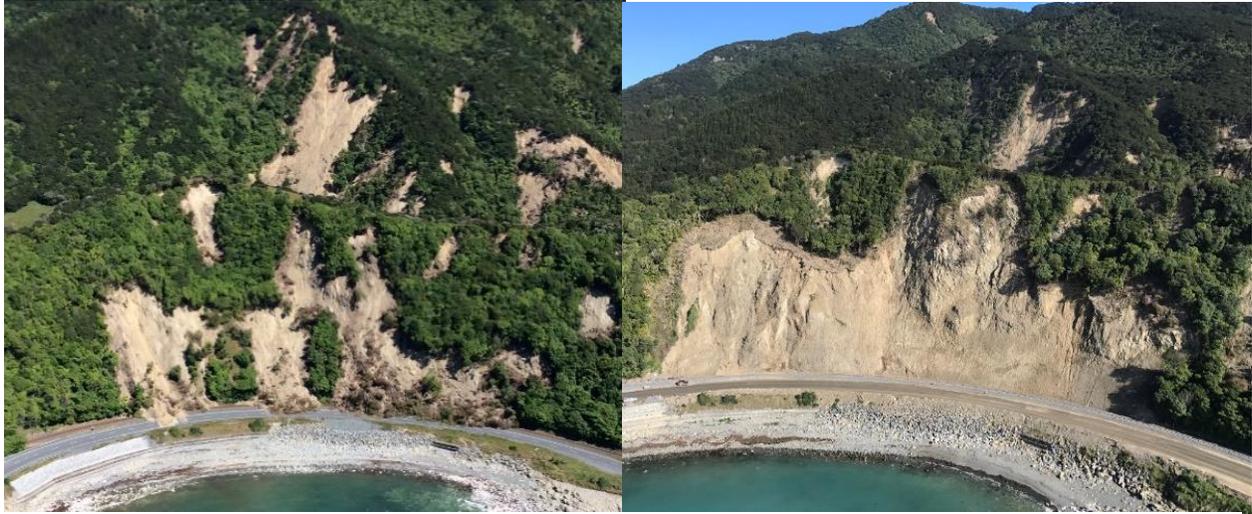
Figure 2: Before and after extensive heli-sluicing (and some earthworks) on Slip 3 North

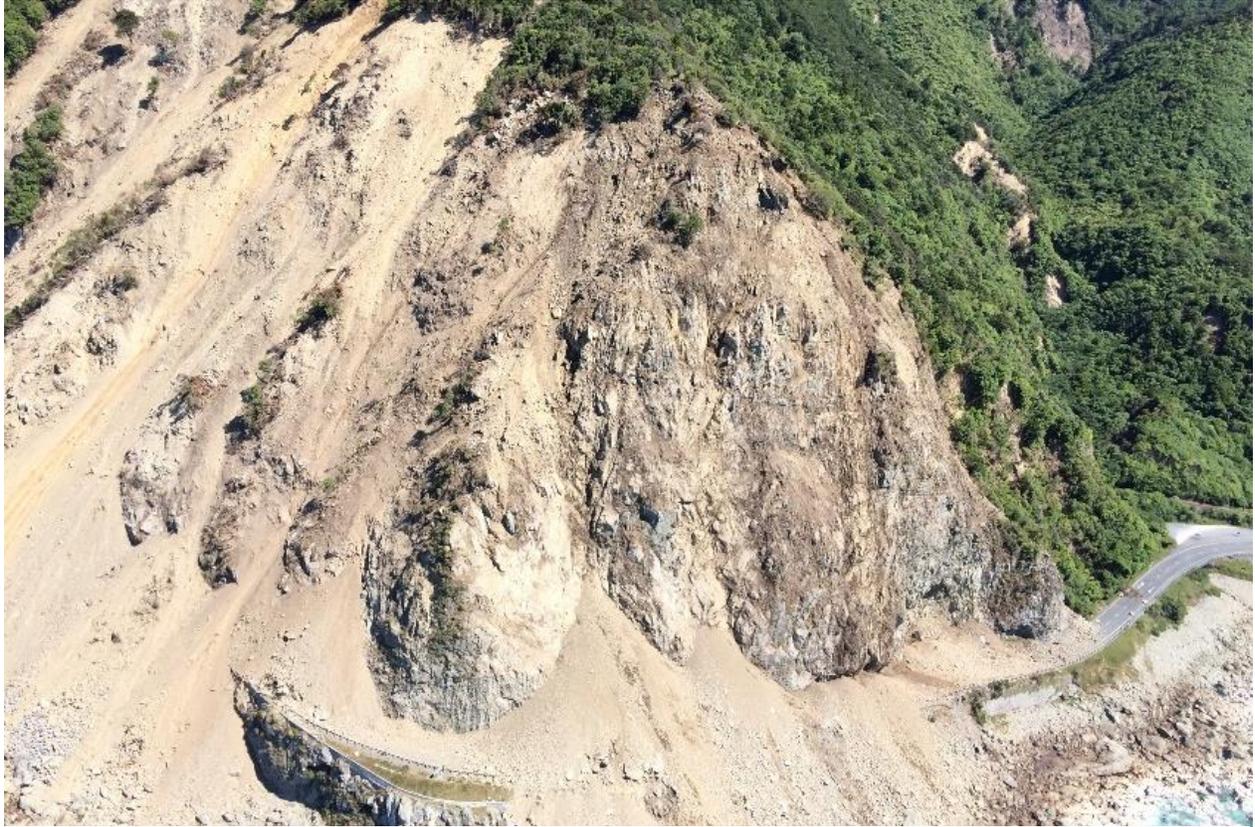
Figure 3: Ohau Point, December 2016 (photo courtesy Opus)

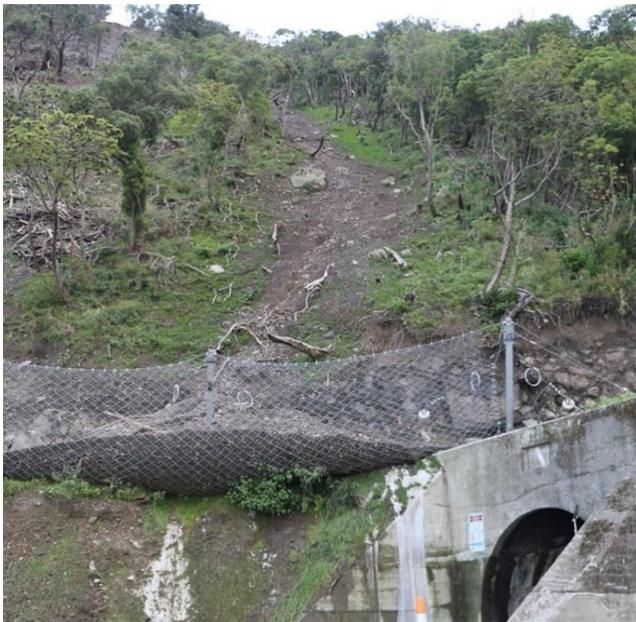
Figure 4: Rockfall barrier adjacent Raramai Tunnels

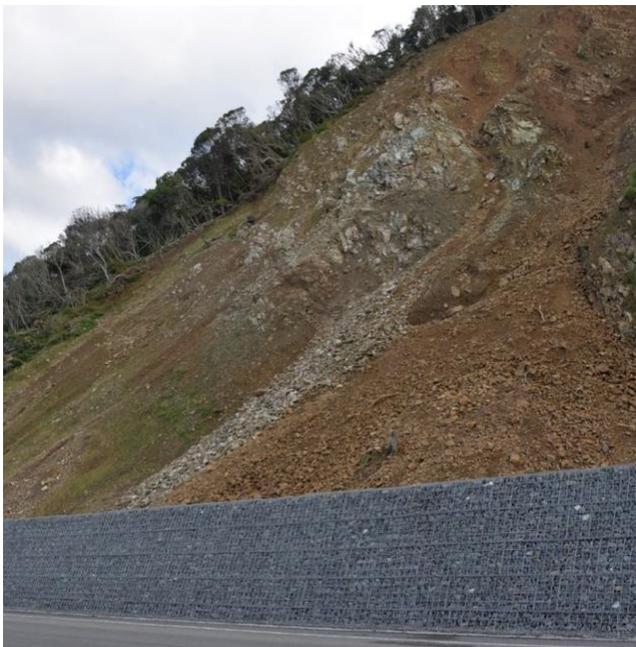
Figure 5: Rockfall/debris flow bund at Mangamaunu

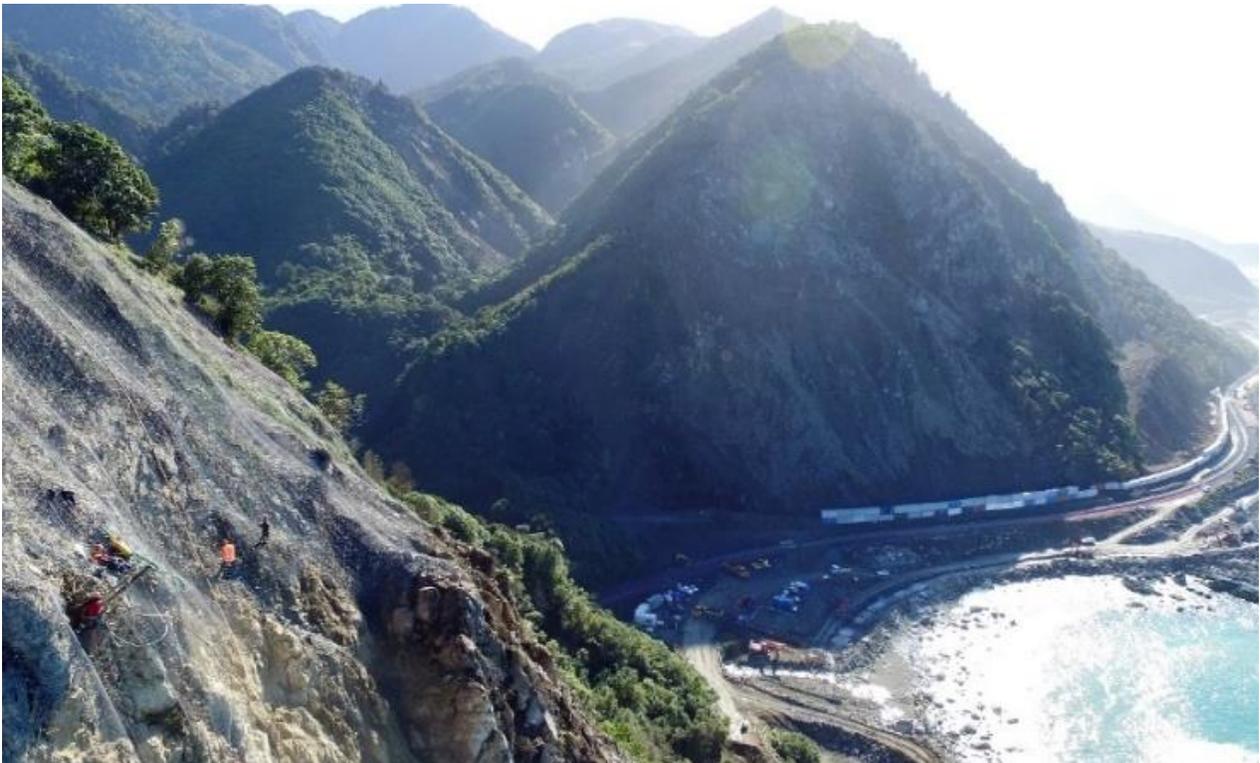
Figure 6: Installing the drape on Ohau Point

After careful consideration including material availability and overall programme, the client accepted a ring net drape option to be installed as an addition to the existing permanent pinned mesh solution. Sequencing involved installing the drape system immediately and in its entirety, with tensioned wire ropes across the bottom of the drape creating a closed system allowing access to the beach platform below. Then the pinned mesh solution would be constructed. The drape's design included perimeter anchors connected with wire rope, a primary ring net drape over the full 5,600 m², followed by a secondary high tensile mesh drape over the top of the ring net. Lastly, wire ropes were installed across the base of the system and tensioned.

While in many situations the original high tensile mesh could be installed to act as a drape and no further work would be required, the size of potential rock failures behind the mesh would risk compromising the system. The ring net was chosen to protect against more significant potential failures, and the high tensile secondary mesh installed to contain the smaller material. A 6-on-1 ring net was chosen as it maintains its width when lifted (doesn't choke in the middle) – which is critical when installation is via helicopter. The ring net was installed first as it conforms to the slope better than the high tensile mesh. At the completion of the drape, the pattern bolts of the original design were installed directly through the drape with all components (ring net and high tensile mesh) now forming part of the permanent system.

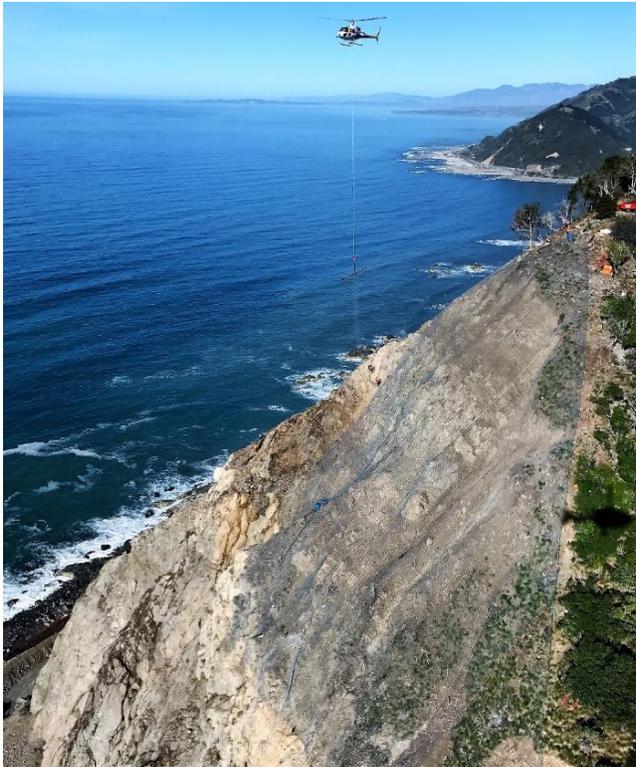
Figure 7: Installing the drape on Ohau Point

For the redesign of Ohau Point, considerable challenges needed to be overcome. The design (by GSI) and review process were completed within one week, and perimeter anchor installation began immediately following. Sourcing of the 6-on-1 ring net resulted in a worldwide search, and eventually, the global supply was exhausted. Suppliers were found in North America and Western Europe, and due to the significant pressure from Government, the ring net was flown into New Zealand on specially chartered aircraft. The ring net installation began three weeks after the start of the perimeter anchor installation.
