Good grounds for the future

Findings from the design and construction monitoring of an earthworks treatment at Flagstaff Hill, Dunedin

N. Taghipouran, I.G. Walsh & J.R. Grindley

WSP, Dunedin

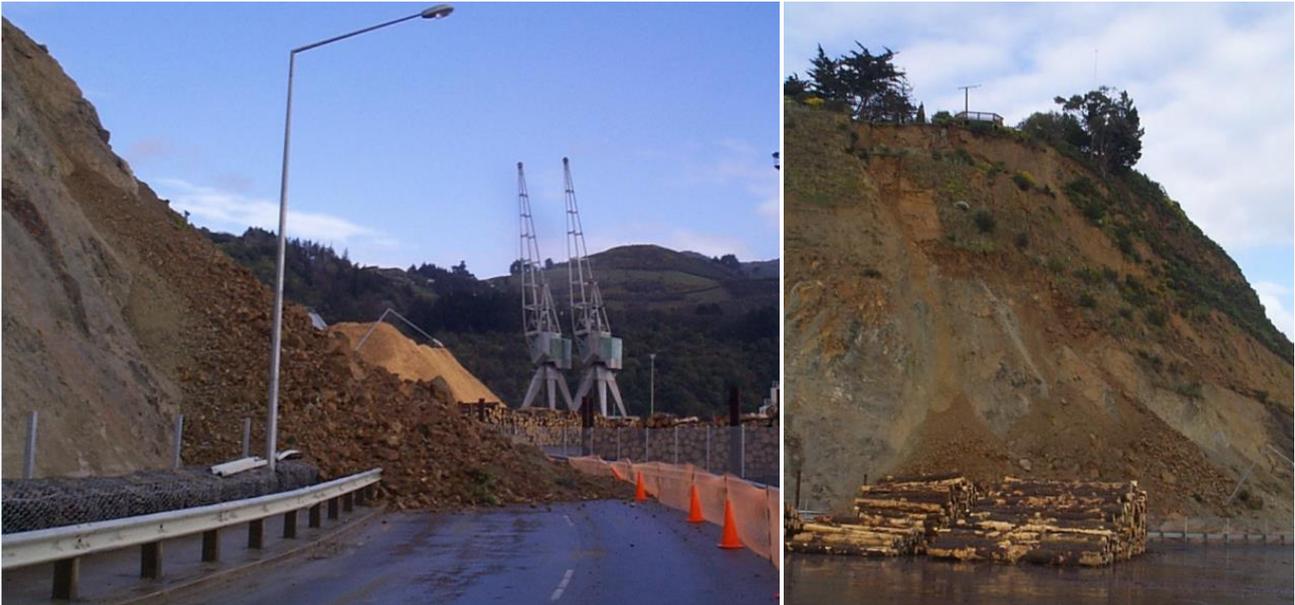
Practical completion of the reclamation work was achieved in December 1995, however ongoing and minor instability of the slope experienced from 1996 through to 1999 led to concern being established on the long-term stability of the hill. In September 1999, a significant slip on the excavated slope occurred following a heavy rainfall event. Run out from this slip crossed the Beach Street, with rock debris reaching the logging facility as shown on Figure 2 below.

Figure 2: Photographs of the site following 1999 event

In 2000, Opus International Consultants Limited (now WSP) undertook the geotechnical and geological investigations and developed a long-term solution to improve the stability of the cut batters that had been created during the reclamation borrow operation. The physical remedial work was staged to initially address mitigation of the most unstable western portion of the slope (referred to as Stage 1 works). A factor in this staging decision was the limited availability of spoil disposal sites at the time and their insufficient capacity to accommodate the total volume expected to be generated by the full remediation programme. The design included construction of benches within the upper section of the slope to allow for practical construction access from above together with the establishment of landscaping vegetation in this area-

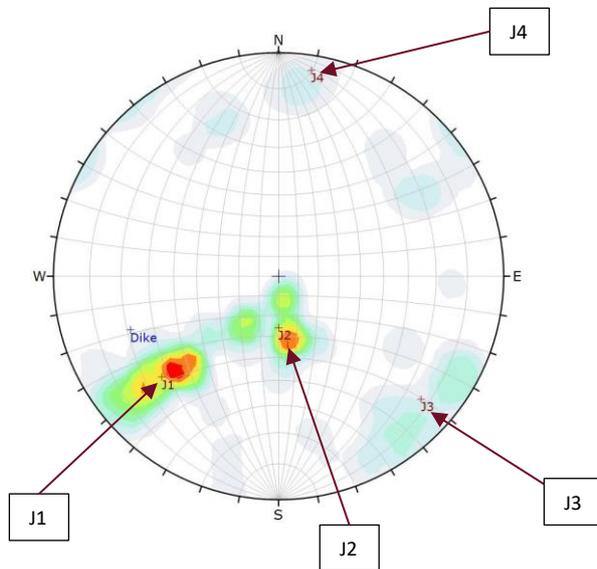
The Dolerite rock mass exhibited two persistent discontinuities (J1 and J2) as well two less persistent but regular discontinuities (J3 and J4). As such, instability was defined by the structural control and assessed by kinematic stability. The assessment focused on more persistent joints as well as a mapped dike, as these had the potential to result in larger scale failures. A summary of the discontinuities and structural trends is presented on Figure 4.

Figure 4: Stereonet showing the joint sets

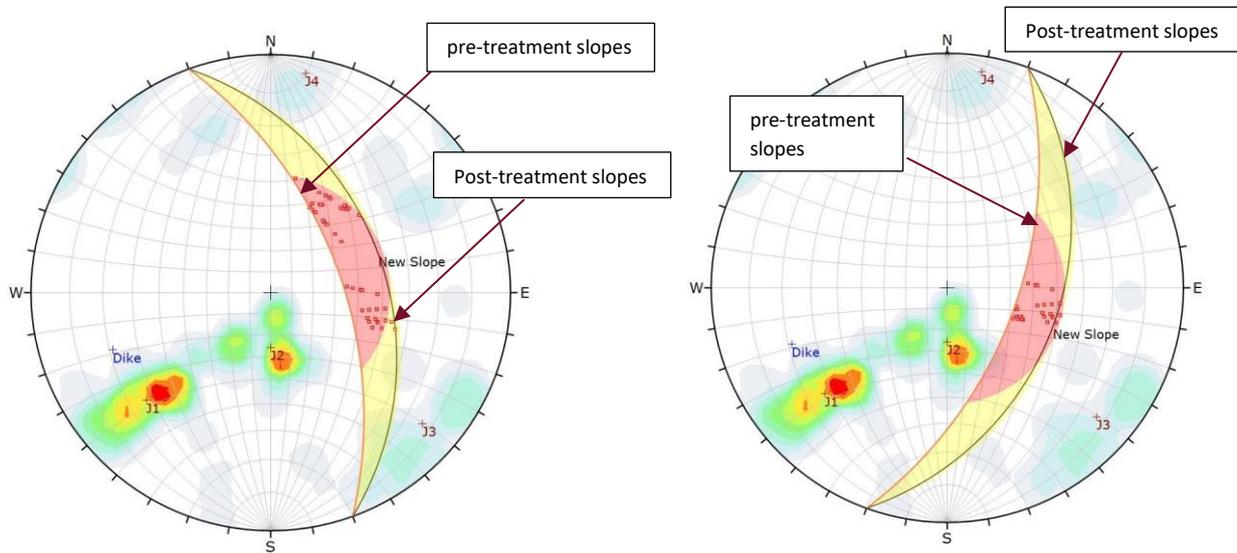
Summary plots showing potential wedge failures for Stage 2 is presented on Figure 5. This shows both the north-eastern and south-eastern sections of the slope face with the old and newly cut slope face.

Figure 4: Potential wedge failures in Stage 2, the north-eastern (left) and south-eastern sections (right) of the slope face

- The assessment showed that overall wedge failure limits the slope design. This is due to the combination of possible wedges given the slope orientation. As the slope transitions into north eastern facing slopes, wedge failure starts to become more prominent. There were a number of potential wedges and this limited the stable angle that these slopes can be cut. Toppling by comparison poses no problem along this section. The slopes are not steep enough to generate toppling failures.

The new proposed slopes were at 40 to 50 degrees and removed the potential failure mechanisms for large scale failures.

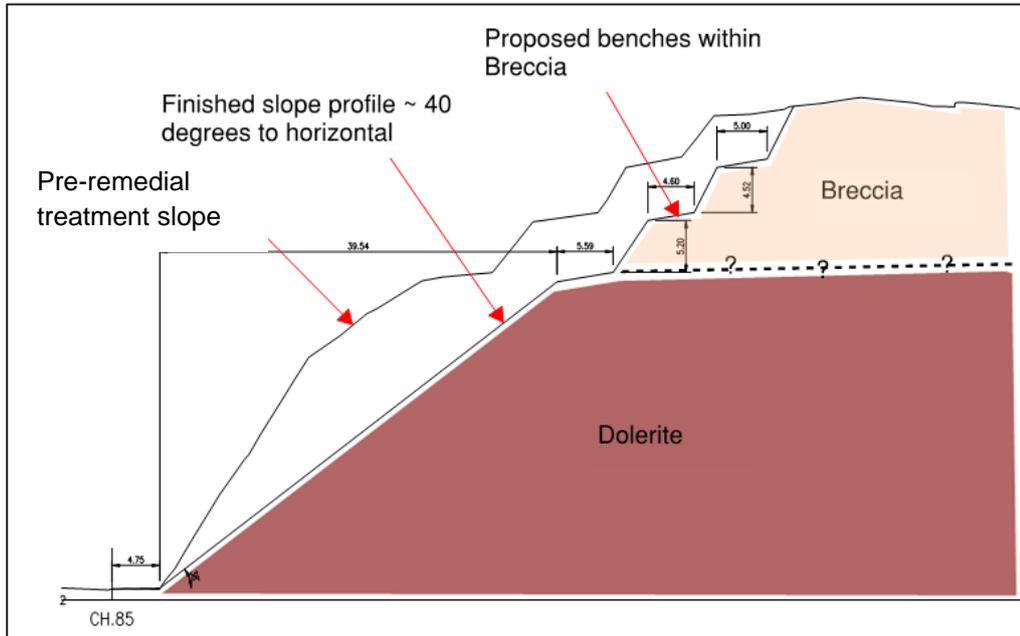
Figure 5: Indicative sketch of the proposed design solution

- Excavation of Dolerite in the lower section to form slope angles varying between 40 degrees to 50 degrees along slope to improve the kinematic stability and reduce the likelihood of wedge failure.

- Formation of approximately 5m wide benches at approximately 5m height intervals within the Breccia in the upper section of the slope to contain any localised shallow-seated instability and fretting of this material. The adoption of benches in the upper slope also facilitated revegetation objectives
- Installation of an appropriate rockfall catch fence at the base of the slope to manage isolated small-scale failures.

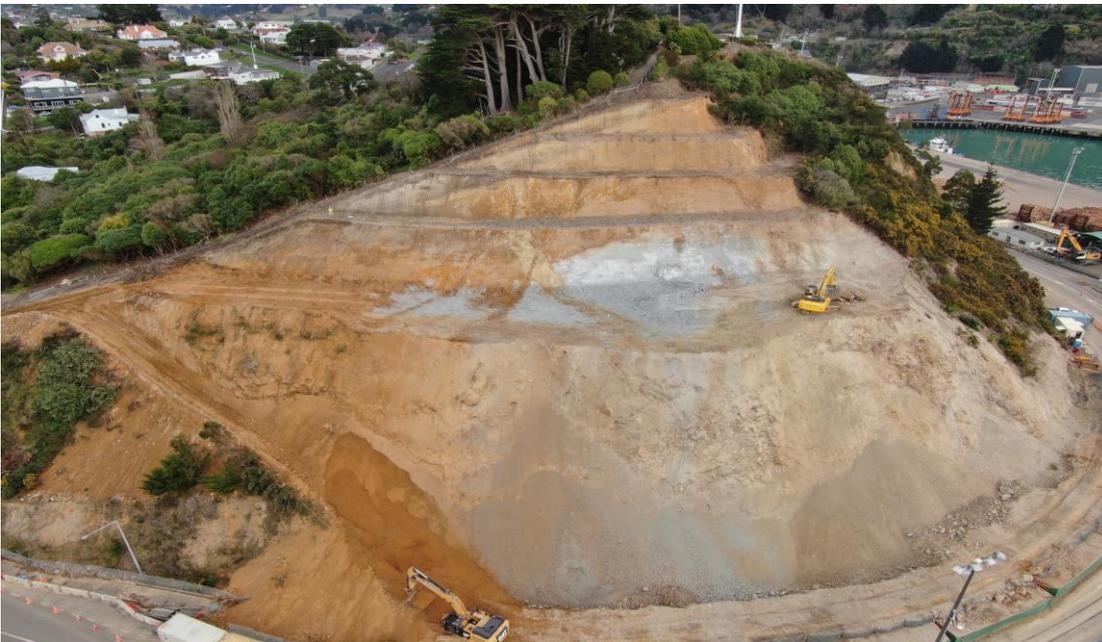
Figure 7: View of the site during construction

The methodology for bulk excavation included the use of excavators to form a track to the top of the excavation area. The site was then cleared of vegetation to allow for drone survey to confirm excavation quantities. Two excavators worked in tandem to bring the material from the top to the bottom. Once the stockpile of fill at the bottom of the slope was of sufficient size, one excavator moved to the opposite end of the face to continue excavation and the second excavator moved to the stockpile area.

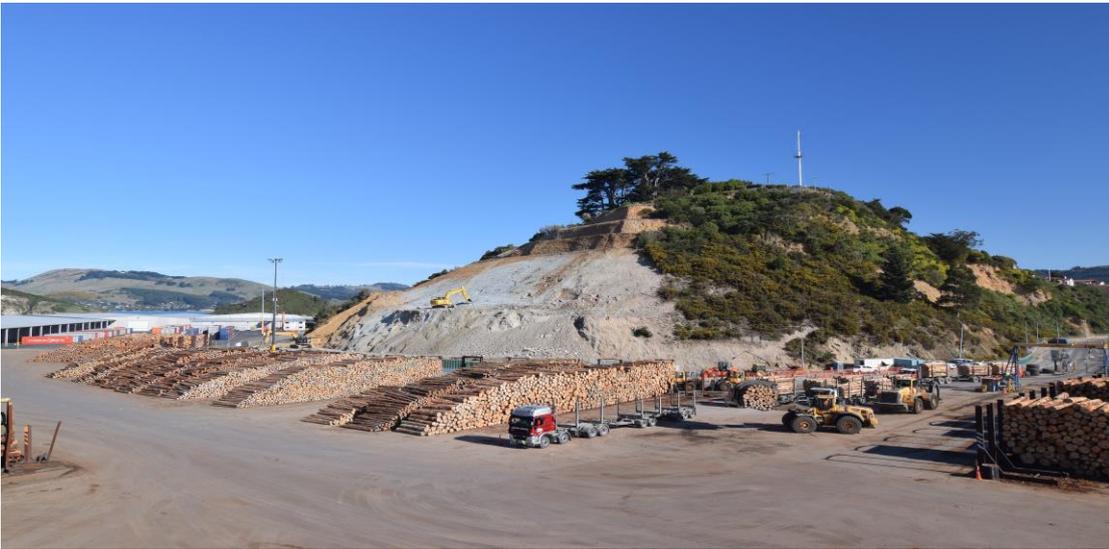
Geotechnical observations were made during the construction phase, including regular drone photography. The condition and strength of rock was generally consistent with the geological mapping findings during stage 1 and design expectations.

Figure 8: View of the site and logging facility during construction

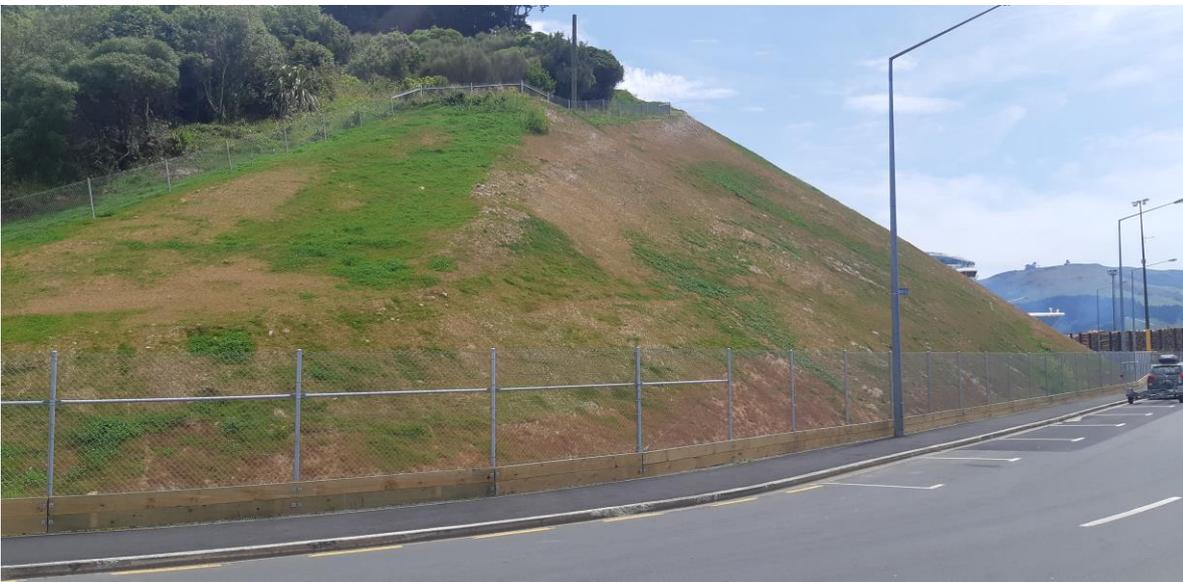
Figure 9: View of the finished site including the catch fence

Following construction of the earthworks measure, a non-rated chain link mesh rockfall barrier was constructed at the base of the slope. A view of the site following construction is shown on Figure 9.
