Good grounds for the future

24-26 March 2021 • Dunedin • New Zealand

Landslide Typology in the Eastern Bay of Plenty – Implications for Risk Management of Road Infrastructure

P. Martins, J. Griffiths

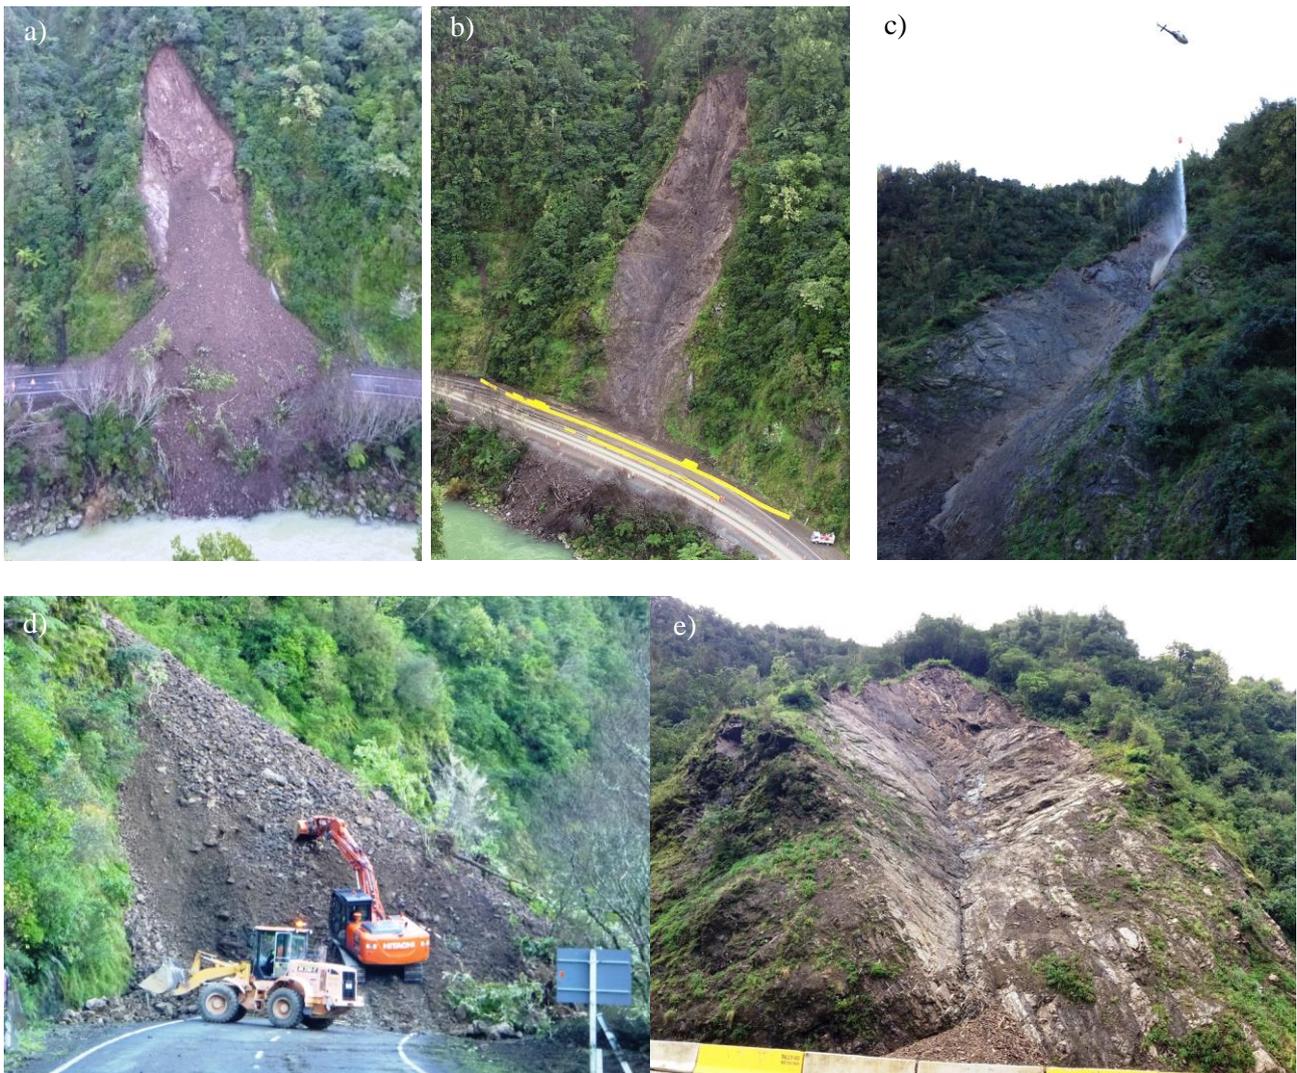
The initial failure occurred in the afternoon of 7 July 2017, releasing about 3000 m³ of rock debris. The failure progressed overnight between 7 and 8 July 2017, releasing approximately more 5000 m³ of debris. These failures were triggered by sustained rainfall in the 10-day period prior to the them, including two events in excess of 115mm/24h. The combined failures completely engulfed the highway (Figs 2a, 2d), leading to a full closure of seven days and one lane operation for approximately 14 days. Subsequent smaller failures (but larger than 100 m³) occurred during winter and spring 2017. The last known relatively large (> 100 m³) failure occurred on 24 June 2018. Smaller failures continue to occur on a regular basis.

The landslide can be classified as an active, retrogressive, multiple rock slide, with extremely rapid (> 5 m/s) rates of movement. This is a wedge failure, controlled by bedding (150/59 dip direction/dip) and a joint set (272/45), plus a tension crack on the back (222/75) (Figs 2b, 2e).

The failed rock mass consists of weak to moderately strong, slightly weathered, greywacke comprising 0.3-1.0 m thick sandstone beds interbedded with 0.1-0.3 m thick mudstone beds. Bedding and two main joint sets are steeply to very steeply inclined, closely to moderately widely spaced.

Figure 2: SH2 Son of Midway rock slide. (a) first failure on 7-8 July 2017; (b) general view of the landslide after removal of the debris; (c) helicopter sluicing following the initial failure; (d) road level view of the first failure on 7-8 July 2017; (e) road level view of the wedge failure.

- **Initial “make-safe” stage:** helicopter and UAV visual monitoring, helicopter sluicing of loose debris still sitting on the slope (Fig 1c), light localised blasting of relatively large unstable blocks still attached to the slope, hand scaling of smaller blocks.
- **Short-term solution:**
 - **First stage:** UAV and road-level visual monitoring, terrestrial laser scanner monitoring, installation of temporary concrete barriers, use of spotters, single lane operation under good weather and daylight only, pre-emptive closure of the highway under severe weather warnings.
 - **Second stage:** installation of a temporary rockfall fence, construction of a temporary lane on the rock slide debris (i.e. realignment of the road away from the landslide face), two lane operation.
- **Long term solution:** currently being developed.

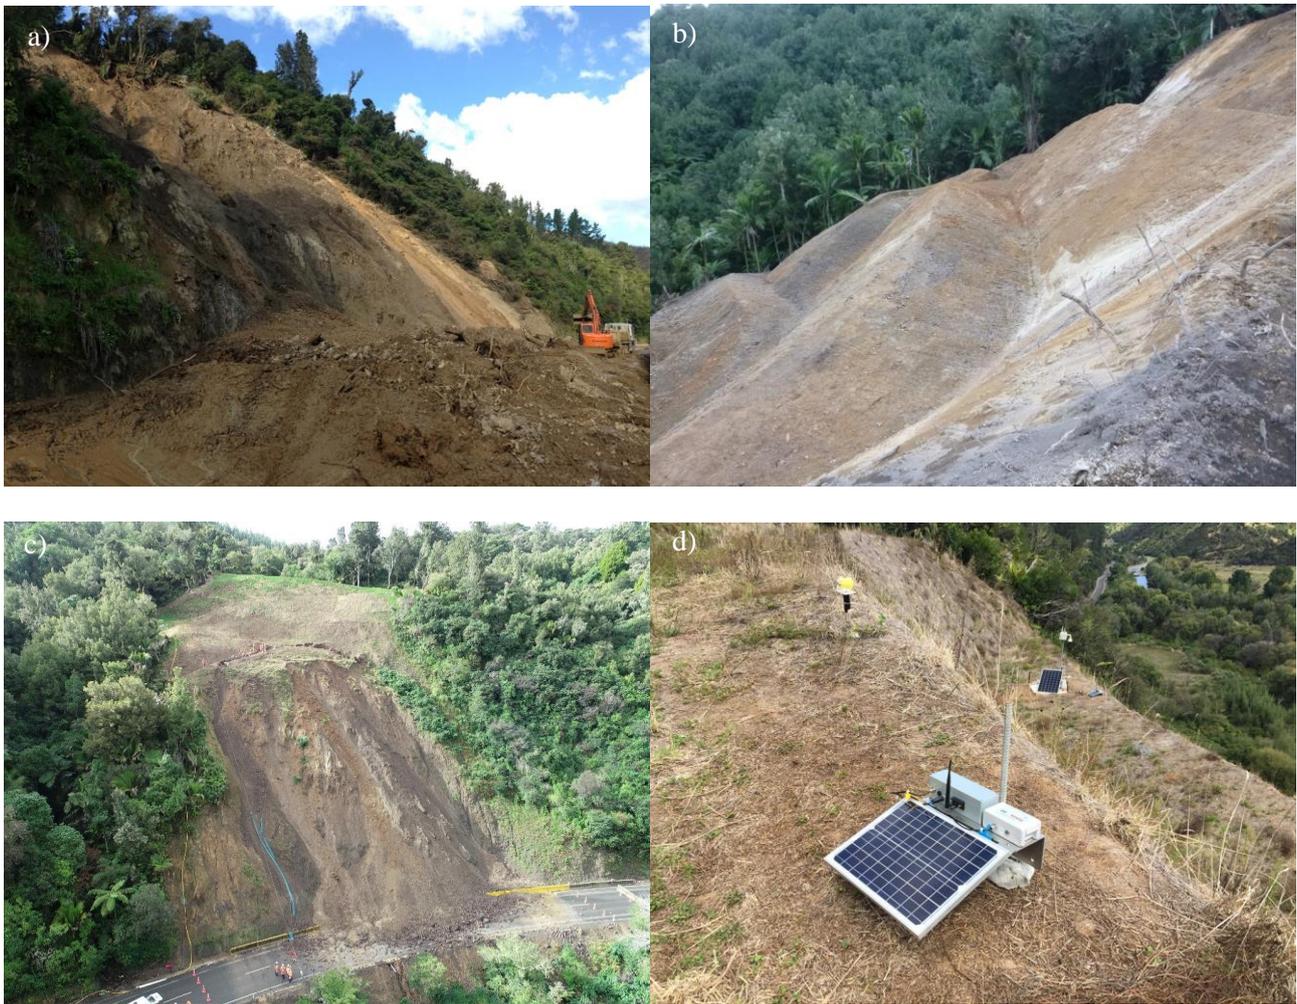
The initial failure occurred on 8 August 2016 and was relatively small, releasing about 100 m³ of debris. Following ex-tropical cyclone Debbie on 6 April 2017, when more than 200mm of rainfall were recorded for a 48-hour period, a much larger failure occurred releasing approximately 2000 m³ of debris. A further failure occurred on 14 April 2017, following ex-tropical cyclone Cook. These two failures entirely blocked the highway (Fig 3a), leading to full closure of the road for a number of weeks while remedial works were undertaken (further discussed in section 2.2.2).

The 2017 failures were of translational mode and involved mostly the pyroclastic cover sliding on top of the underlying rock. Subsequent smaller failures (but larger than 100 m³) occurred during winter 2018, this time involving rock from the lower parts of the slope.

On 5 July 2019 another failure occurred, this time mobilising the lower two-thirds of the slope, entirely through rock (Fig 3c). A 1m headscarp was formed, extending nearly across the full width of the slope. Whilst the failure mobilised a large volume of material, the amount of debris that dropped onto the road was relatively small (a few hundred cubic meters). This failure was largely translational, but had a minor rotational component, with the head of the landslide slightly tilting back.

As a summary of the events so far, the landslide can be classified as an active, enlarging, successive shallow rotational/translational rock/debris slide, with very slow (16 mm/year - 1.6 m/year) to extremely rapid (> 5 m/s) rate of movement.

Figure 3: SH2 Twin Faces landslide. (a) failure on 6 April 2017 following ex-tropical cyclone Debbie; (b) reprofiling of the top (pyroclastic cover) following the 2017 failures; (c) 5 July 2019 failure through rock, involving the lower two-thirds of the slope; (d) telemetered and conventional monitoring system installed on the slope following the 2019 failure.

- **“Make-safe” stage (2017):** helicopter and road level visual monitoring, helicopter sluicing, clean-up with long reach excavator from the base.
- **Engineered solution (2017):** top-down slope reprofiling of the top of the slope through the failed section in pyroclastic materials.

- **“Make-safe” stage (2019):** UAV and road-level visual monitoring, conventional survey monitoring, light localised blasting, installation of temporary concrete barriers, use of spotters, single lane operation under good weather and daylight only, pre-emptive closure of the highway under severe weather warnings.
- **Long term solution:** telemetered slope monitoring system with near-real time alerts (Fig 4d), rockfall attenuator (currently being built).

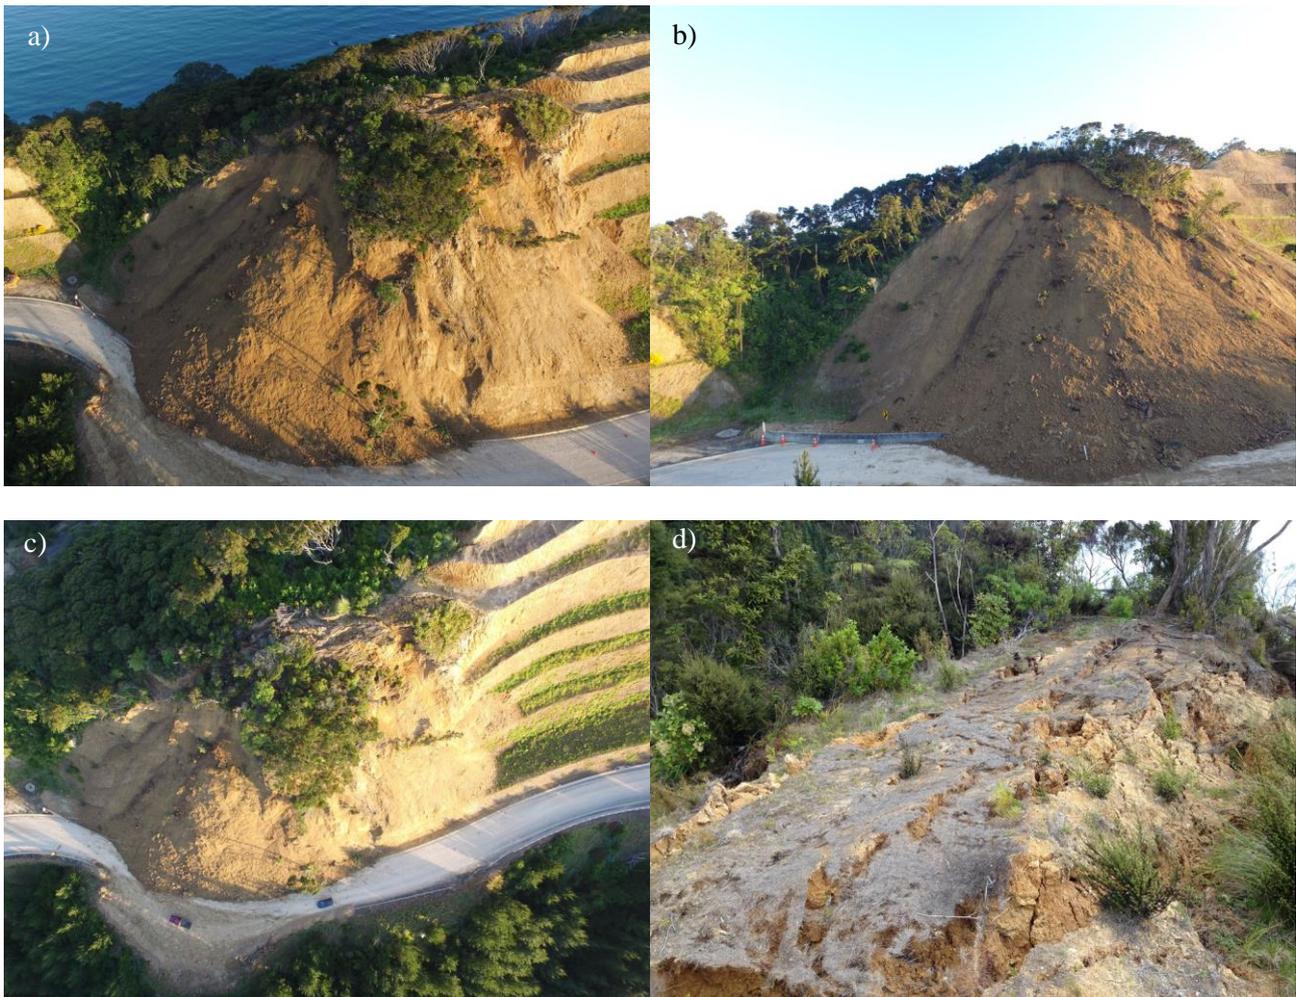
Initial small (< 100 m³) failures started to occur in the week commencing 14 September 2015. These failures continued to happen for the following two weeks, until a large failure occurred in the early hours of 2 October 2015. The trigger to these failures was a three-week period of sustained rainfall, including three events in excess of 60mm/24h. This large failure released around 1000m³ of debris, completely engulfing the road (Figs 4a–4c). The failed material continued to move for the following days, leading to nearly one week of full and/or partial closure of the road. Smaller failures continue to occur since then, leading to occasional partial closures of the road.

Figure 4: SH35 Maraenui rock slide. (a) oblique view of the site following the main failure; (b) front view of the landslide; (c) top view of the landslide – note the pronounced tension cracking at the head of the landslide; (d) detail of tension cracking at the head of the landslide.

The failed rock mass consists of weak to moderately strong, highly to moderately weathered greywacke, comprising thinly bedded mudstone and localised moderately thin beds of sandstone. Bedding and one main joint set are very steeply inclined to subvertical, very closely to extremely closely spaced. Additional randomly oriented, closely spaced discontinuities also occur. The failure is of translational mode, with the nearly homogeneous failed material sliding on top of less weathered greywacke, likely controlled by relict structure.

The landslide can be classified as an active, retrogressive, multiple rock slide, with very slow (16 mm/year - 1.6 m/year) to rapid 1.8 m/h – 3 m/min) rate of movement.

- **Make-safe” stage:** UAV and road-level visual monitoring, installation of temporary concrete barriers, use of spotters, single lane operation under good weather and daylight only.
- **Long term solution:** the design for reprofiling the slip was completed in early 2016 but, given that no further large failures occurred, it was decided not to implement it. Concrete barriers remain in place, with visual inspections carried out yearly.

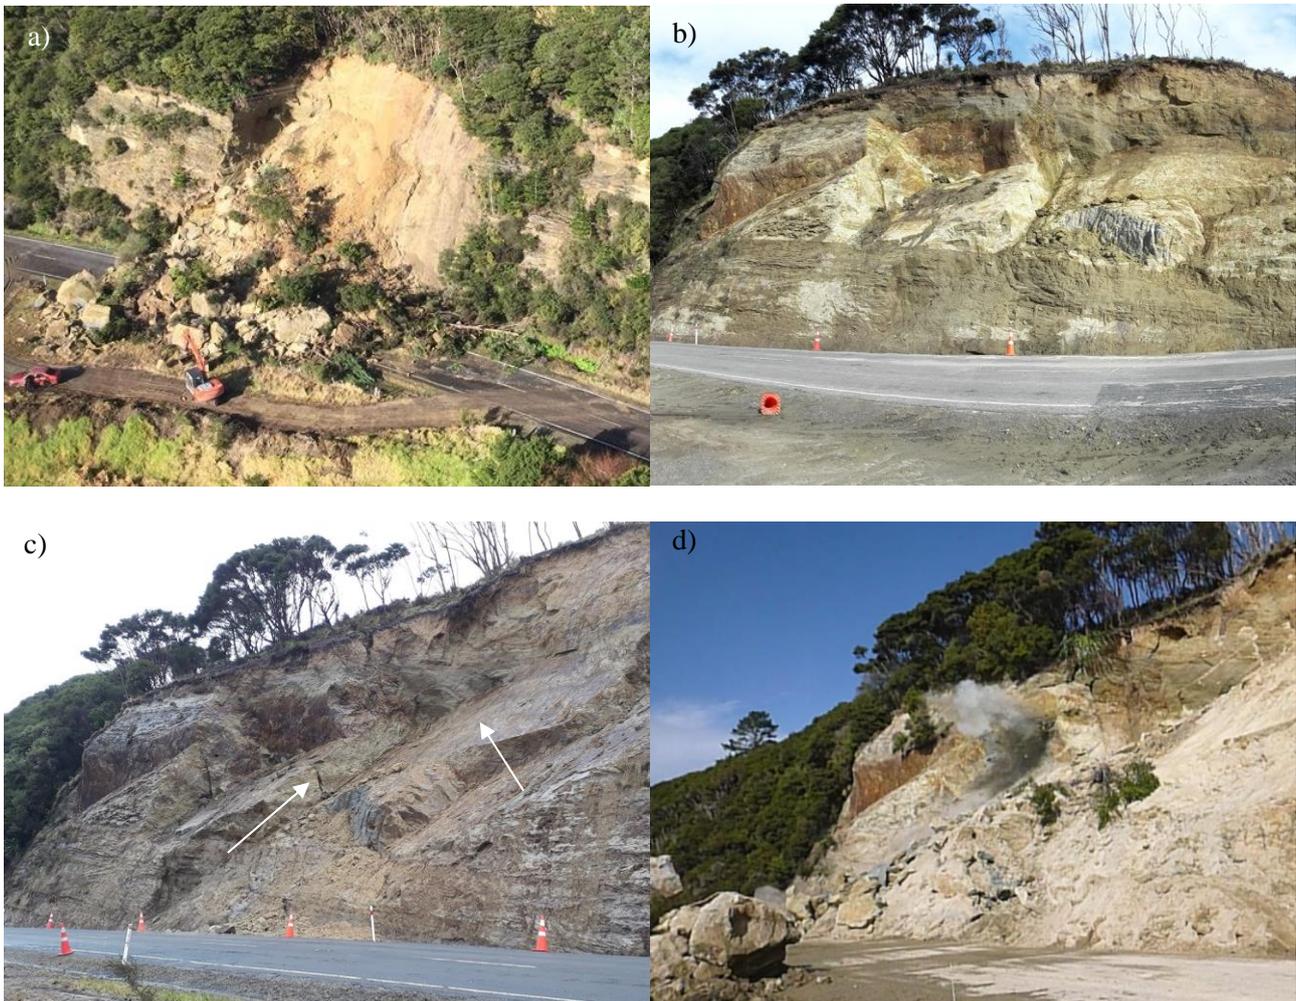
The Runaway rock slide is located on SH35 along the coast between Ōpōtiki and Cape Runaway, at Route Position 106/9.02, close to the boundary between the Bay of Plenty and Gisborne regions. The main failure occurred on 24 July 2018, extending through the whole height (approx. 20 m) of the cliff adjacent to the highway (Fig. 5a). The failure was triggered by heavy rainfall in the previous 24 hours, associated with sustained rainfall over the previous two weeks. The failure released approximately 1000 m³ of rock debris, completely blocking the road. A secondary, smaller (< 20 m³) failure occurred on 7 August 2018. No significant failures are known to have occurred since then.

The landslide can be classified as a dormant, retrogressive, multiple rock slide, with extremely rapid (> 5 m/s) rate of movement. The failure was of planar type, controlled by a joint set dipping approximately 45 degrees towards the road and a subvertical joint set acting as tension cracks (Fig. 5c).

The failed rock mass consists of weak to moderately strong, slightly weathered, massive, light yellow sandstone and thinly bedded, light brown mudstone. Bedding is generally sub horizontal, and there are two systematic joint sets: one steeply inclined and very widely spaced, and one subvertical and widely spaced (Fig 5b).

Figure 5: SH35 Runaway rock slide. (a) oblique view of the site following the main failure; (b) site after clean-up completed; note the light brown mudstone at the base of the slip and the light yellow sandstone at the top; (c) discontinuity sets controlling the planar failure; (d) light blasting applied as part of the “make safe” stage.

- **“Make-safe” stage:** helicopter and road level visual monitoring, implementation of local detour route, localised light blasting of relatively large unstable blocks still attached to the slope (Fig. 5d), hand scaling of smaller blocks.
- **Long term solution:** implementation of catch ditch at the base and conventional survey monitoring.

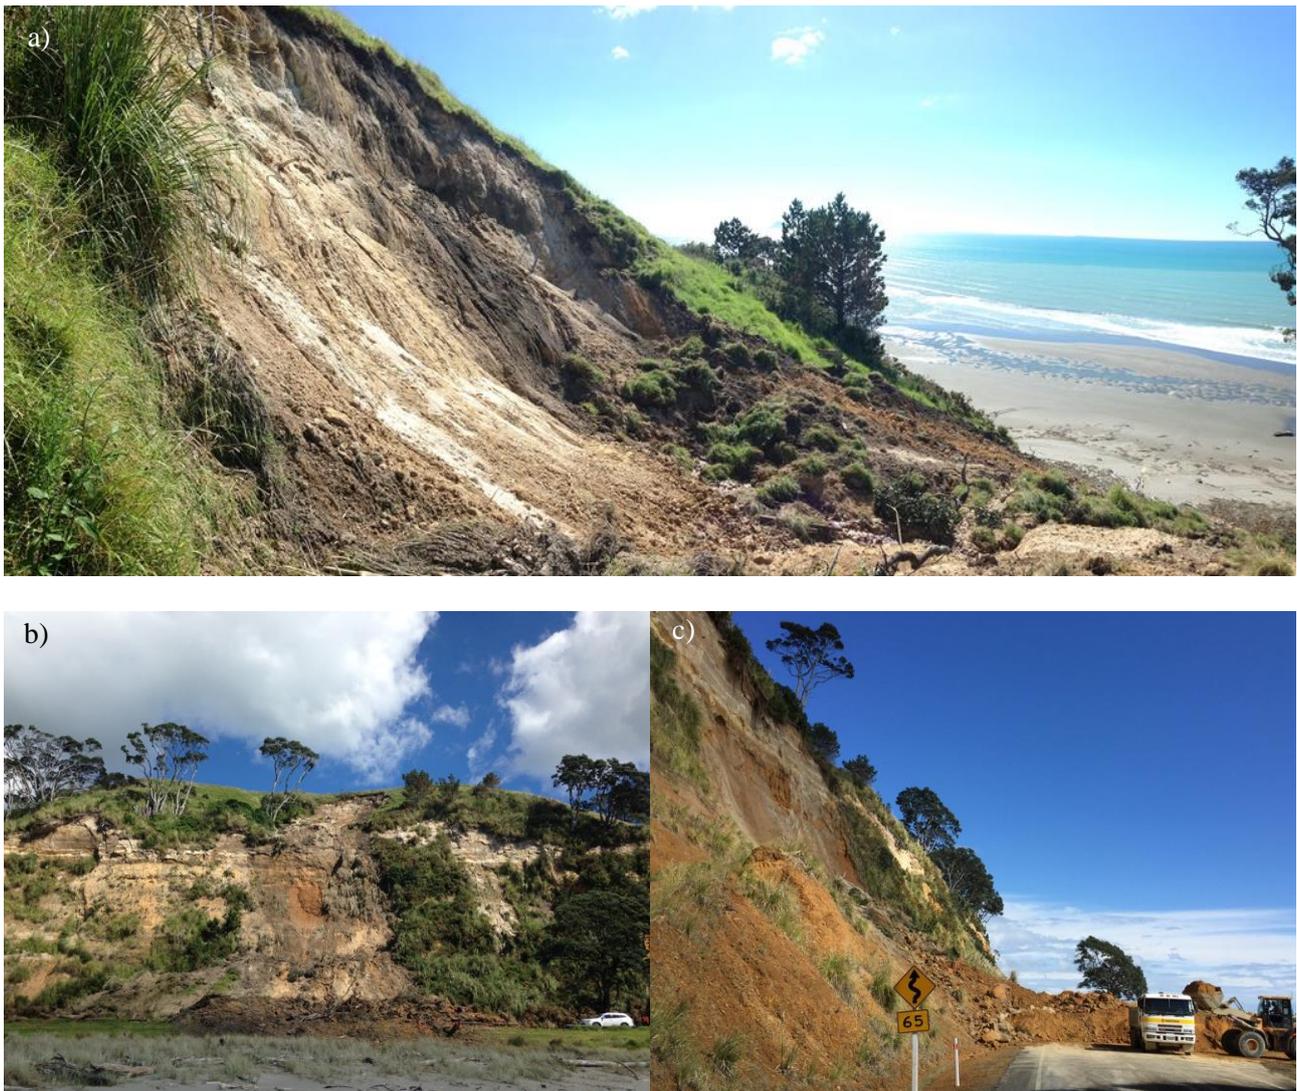
The Waiotahi earth slide is located on SH2, about 8km west of Ōpōtiki, at Route Position 294/2.35. This section of SH2 was built as an embankment through the dune field, at the toe of the coastal cliffs (Fig. 6b). The cliffs are up to 70m high and are formed of pumice-rich, interbedded alluvial and marine sediments of early to middle Pleistocene age. These cliffs have a recurrent history of failures of various sizes.

On 3 March 2018 the top third of the cliff failed, releasing 200-400 m³ of soil and closing the road (Fig. 6a). A second failure occurred on 3 September 2018, this time involving the lower half of the cliff (Fig. 6c). This second failure released 3000-5000 m³ of, completely engulfing the road. The material mobilised in the 2018 failures consist mainly of fine to coarse pumiceous sand with some fines and minor boulders, cobbles and gravel. No further failures are known to have occurred since September 2018.

The landslide can be classified as a dormant, retrogressive, multiple shallow rotational earth slide, with very rapid (3 m/min - 5 m/s) to extremely rapid (> 5 m/s) rate of movement.

Figure 6: SH2 Waiotahi earth slide. (a) March 2018 failure, view from the top; (b) March 2018 failure, general site view; (c) September 2018 failure.

Following the 2018 failures, the site was inspected from above and from road level. Because of no visual evidence of impending further failures or loose material on the cliff, it was assessed that it was safe for the clean-up crews to start working as soon as weather improved.

Once the failed material was cleared from the road it was confirmed that the existing toe buttress was not damaged. At this point the risk to road users at the Waiotahi landslide was assessed as similar to that of other sections of the road at the toe of the wider cliff. Consequently, no additional measures were taken other than adding the site to the register of sites that are subject to annual geotechnical inspections.
