## Management of geotechnical risks for some tunnels in the Wellington Region

David Stewart

Opus International Consultants, Wellington, New Zealand

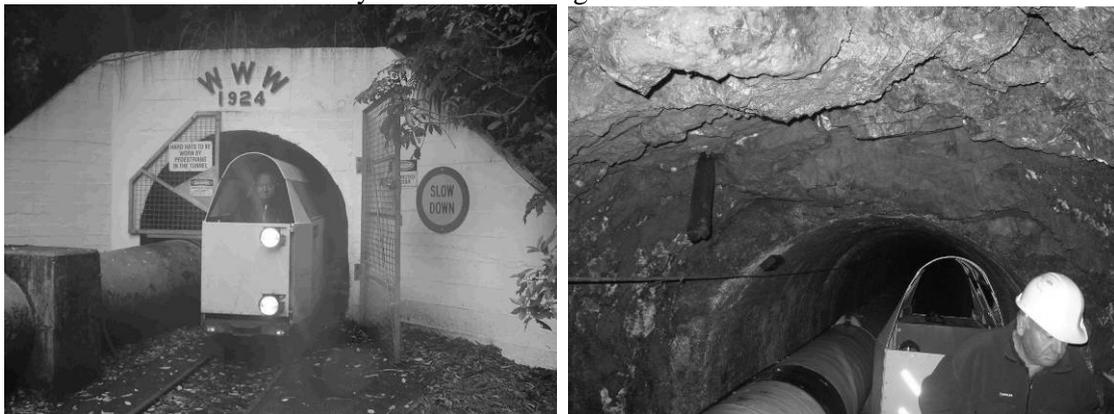
Figure 2: Orongorongo Tunnel, showing (a) railway jigger and water pipeline at portal, and (b) bedrock section of tunnel in foreground with concrete lined section beyond

The tunnel is constructed through Greywacke bedrock, which is typically closely to extremely closely fractured sandstone and siltstone, with block sizes normally less than 300 mm. Sheared seams and thin faults/crushed zones cross the tunnel at intervals with localised minor rock falls common at these points. In many sections the rock surrounding the tunnel is dilated with slight block separation (ie. is 'drummy' when tapped with hammer). Sites of rock falls occurring since the previous inspection are noted during the inspections in consultation with the jigger operator.

- Hardhats and steel cap boots are mandatory for all persons entering the tunnel
- Speed restrictions and vigilance by the jigger operator to ensure that any rock fall debris on the railway line does not cause derailment.
- Localised scaling and/or shotcreting of the most unstable sections. Recent inspections have concluded that such measures are not essential to date due to the relatively low level of rock fall risk. However, rock bolting and shotcreting was carried out in 1996 in a section with adversely oriented widely spaced joints; this took place (during works to slightly widen sections of the tunnel) in order to mitigate the risk of falls of large blocks from the roof.
- Additional inspections are recommended after large earthquakes or if a large volume of rock fall occurs i.e. greater than 1m<sup>3</sup>.

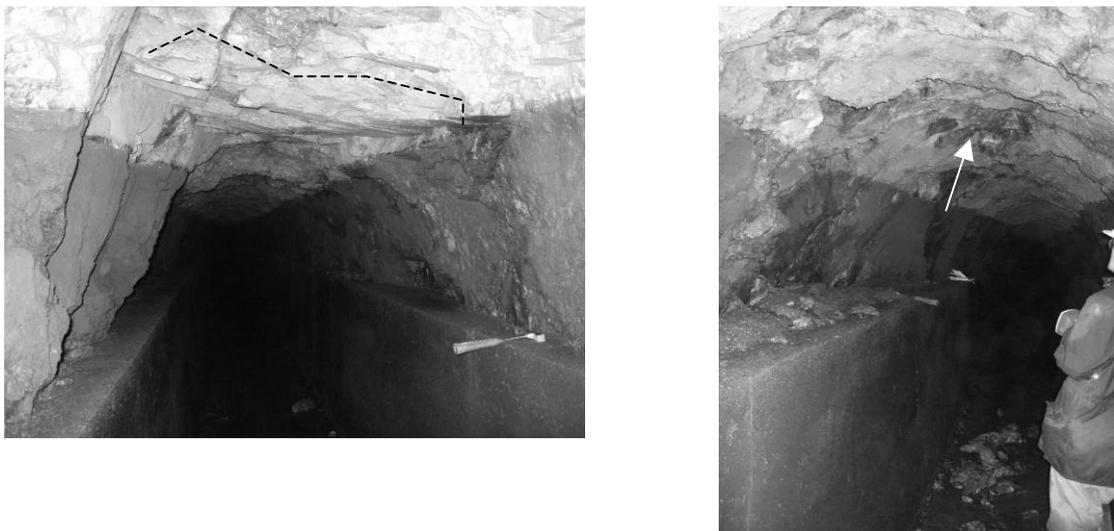
Figure 3: Kaitoke Tunnels showing sections of rock block separation (a) low angle 0.3m thick separated slab crossing roof (dashed line) and (b) site of minor slabbing at the roof (arrowed) with debris on floor

The rock mass comprises typically closely fractured unweathered strong Wellington Greywacke (similar to that in the Orongorongo Tunnel). Block sizes are typically <0.3 m. Sections of slightly dilated ('drummy') rock mass are present along the tunnels; in the most recent (2007) inspection two sites of specific instability were noted – a separated 0.3 m thick slab crossing the roof (Figure 3a) and a small (0.3 m<sup>3</sup>) rock fall (Figure 3b).

Failures of greater than 1-2 m<sup>3</sup> are considered to have a significant effect on the capacity of the tunnel. As the tunnel supplies 45% of the Wellington Region's water, this loss in capacity can be significant. Therefore, indications of likely rock falls of this size are considered to require remedial work (scaling/removal or support by rock bolting) to mitigate the risk of collapses which may affect the tunnel capacity. The latest (2007) assessment recommended allowance for immediate remedial work during the next inspection shutdown at one or both of the sites shown in Figure 3, to be implemented if the inspection indicates conditions have deteriorated; as both sites have the potential for rock fall volumes of greater than 1m<sup>3</sup>.

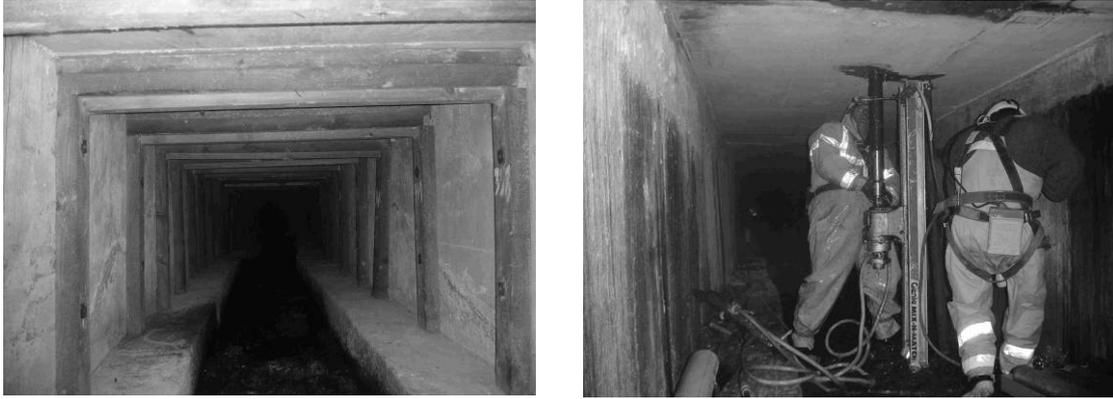
This tunnel carries the Carey's Gully Stream under the Wellington City Council's (WCC) Southern Landfill (Figure 4). The tunnel was constructed in the mid 1990's to replace a collapsed circular culvert which had been laid prior to landfilling. The tunnel was excavated 530 m through highly fractured greywacke bedrock, and is fully lined with a rectangular (1.8m wide by 1.6 m high) cross section, with a 250 mm diam. leachate pipe running down the side (Figure 5). Soon after construction, checks revealed sections of substandard concrete lining (very thin concrete) and voids between the roof lining and surrounding greywacke bedrock. At the worst (160m long) section adjoining the downstream portal, the roof was reconstructed with concrete in 1999. Throughout the remaining 370 m of the 1990's tunnel, timber supports were installed at 1100 mm centres (Figure 5a) to support the tunnel roof.

**Figure 5: Carey's Gully Stream tunnel - (a) rectangular profile showing timber supports, and (b) 2005 drilling investigations in unsupported section near portal**

Drilling investigations carried out in 2005 (Figure 5b) involved 21 cored holes (50 and 80 mm diameter) through the concrete lining (13 in the roof and 8 in the walls) which enabled:

Investigation findings indicated that the wall lining was largely adequate (>150 mm thick concrete), however the roof lining was 'thin and unreinforced' in a number of sections. The concrete quality was found to be satisfactory. Roof cavity heights were indicated to be generally small (<0.8 m).

Structural assessment of rock fall debris loadings on the roof lining indicated that where the concrete roof lining is less than about 100 mm thick the unreinforced lining is inadequate to support debris loadings from potential roof rock falls. In addition, the timber supports installed in 1999 were a 'stopgap' option and were assessed to be inadequate to support potential rock fall debris loads on the roof lining; also the life of the timber supports is not sufficient.

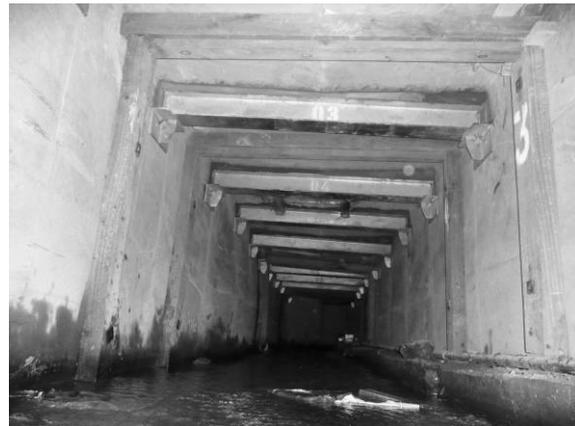
**Figure 6: Carey's Gully Stream Tunnel - Risk management solution involved removal of the timber supports (visible in walls and roof) and installation of steel beams supported on steel brackets bolted into the upper wall (see numbered steel beam)**

The final solution, developed in conjunction with WCC, involved installation of replaceable galvanised steel roof beams supported on brackets attached with stainless steel bolts to the concrete wall lining. This option is significantly cheaper than the other options, is sufficiently robust to maintain the tunnel integrity under possible loadings from rock fall debris on the roof lining, maintains full access to the leachate pipe within the tunnel and also maintains the same hydraulic capacity as the existing tunnel. Proof drilling at close intervals was carried out in 2007 to verify the lining thicknesses assumed in the design. The retrofit work was carried out between February and April 2008 (Figure 6).
