## Correlations between liquefaction induced damage and former river channels in Kaiapoi

L M Wotherspoon, M J Pender, R P Orense  
Civil & Environmental Engineering, The University of Auckland, NZ.  
[l.wotherspoon@auckland.ac.nz](mailto:l.wotherspoon@auckland.ac.nz) (Corresponding author)

The town of Kaiapoi, 17 km north of the city of Christchurch, suffered significant liquefaction induced damage during the Canterbury earthquake sequence. Severe lateral spreading and large volumes of ejecta were present throughout the town and surrounding region after multiple earthquakes in this sequence. This region has also seen significant changes to the paths of rivers since European settlement in the 1850's, and as a result there are many areas within the town and surrounding area that were, until recently, channels of the Waimakariri River. Using historical data, the reclaimed channels were identified, which were shown to have a strong correlation with the areas of severe liquefaction damage following these earthquakes. Examples of damage in these areas are presented and related to the relatively recent changes to the river channels in the region. The significant damage to the infrastruc

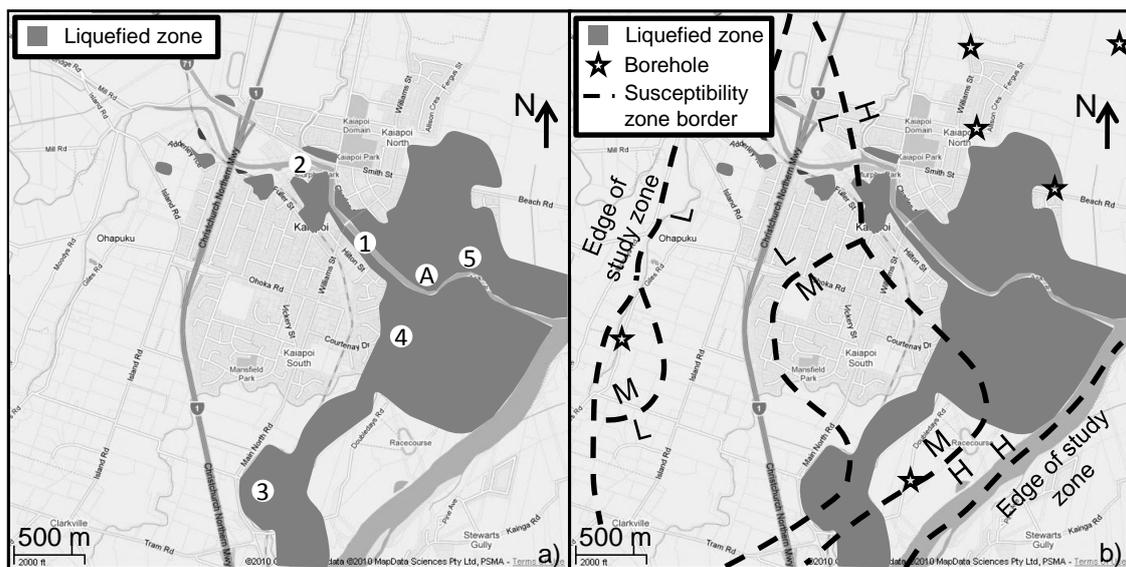
In this section we focus on specific areas in and around Kaiapoi and the correlation between damage as a result of the Darfield event and the position of old river channels. Further discussion of this relationship is provided in Wotherspoon et al. (2012). This region is reasonably flat, with the largest slopes in the area resulting from stopbank construction and land reclamation along the Kaiapoi and Waimakariri Rivers. Using data from aerial photographs (NZAM, 2010) and ground reconnaissance, the areas that experienced liquefaction in this area following the 4<sup>th</sup> September 2010 Darfield earthquake are shown shaded in Figure 2. Looking at the areas near the town, the most extensive liquefaction damage occurred on the north side and at the eastern edge. Less severe but still significant liquefaction induced damage was evident following the 22<sup>nd</sup> February 2011 Christchurch earthquake, the 13<sup>th</sup> June 2011 events, and the 23 December 2011 earthquake. A reduced area within the shaded zones in Figure 2 was affected by each of these events, and locations that suffered from repeated significant liquefaction damage are outlined in the following sections. The majority of this affected area has been deemed uneconomical to repair due to the poor soil conditions and classified as red zone, with much of this region formed of old and reclaimed river channels.

Comparison between the liquefied zones and liquefaction susceptibility zones from the 2001 study (Christensen, 2001) in Figure 2b indicates that much of the area that experienced liquefaction had been mapped as highly susceptible zones. The only regions that are mismatched is the area of extensive liquefaction south east of town that cuts through medium and low susceptibility zones, which is described in further detail in Section 3.2.2.

**Figure 2: Kaiapoi a) liquefied zone following the Darfield earthquake and locations of interest; b) site investigation and 2001 liquefaction susceptibility zones**

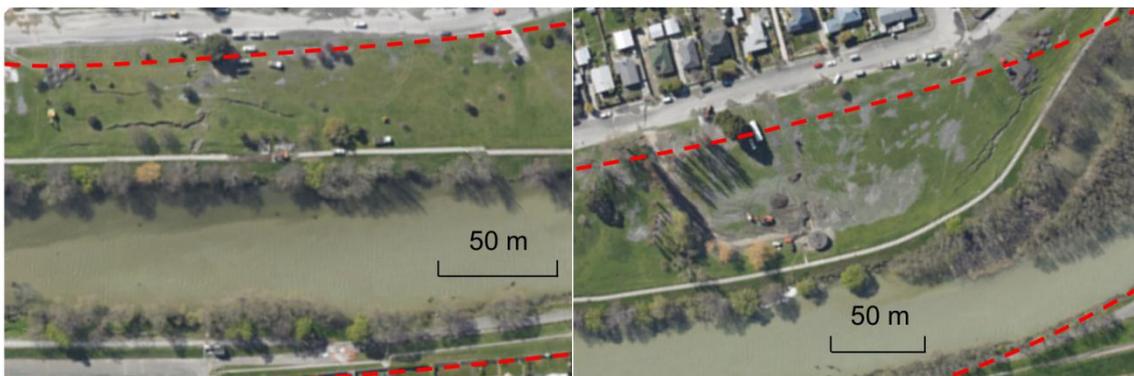
Kaiapoi River, at position 1 in Figure 2a, originally spanned the distance between the roads on both sides of the river when it was the north branch of the Waimakariri River. This width has been halved as a result of progressive land reclamation that began in 1907 with dredging of the river, as highlighted in Figure 3, where the red dashed lines indicate the location of the river banks prior to reclamation (Wood, 1993). These areas are now parks, with stopbanks built up along both sides. This area suffered extensive liquefaction and large lateral spread fissuring parallel to the riverbanks. Up to 3 m of total permanent lateral displacement was recorded in this area following the Darfield earthquake (Robinson et al., 2011), damaging stopbanks, bridges and structures along the river banks (Figure 3a). Some of these fissures were up to a metre wide, and two metres deep. Behind this area, further from the river, large volumes of ejecta were evident, resulting in settlement of structures and damage to roading and services.

Further spreading movements were identified in this reclaimed area following the Christchurch earthquake.

**Figure 3: Liquefaction damage along the Kaiapoi River following the Darfield earthquake and location of old river banks.**

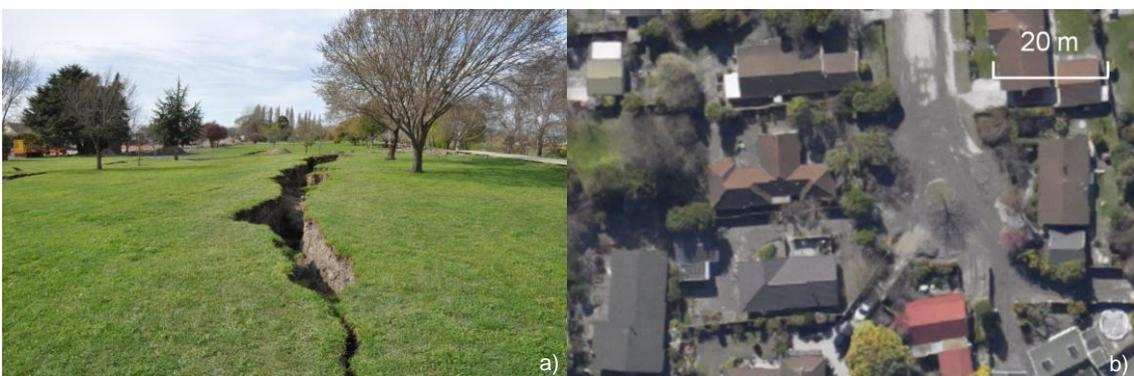
**Figure 4: Liquefaction damage following the Darfield earthquake a) lateral spreading along the Kaiapoi River; b) widespread ejecta in eastern Kaiapoi.**

This region experienced some of the most severe liquefaction damage, with ejecta up to 400 mm thick and settlement of houses in the area following the Darfield earthquake (Figure 4b). Services and roadways were damaged due to ground movement throughout. Adjacent to the river lateral spreading was evident, with large ejecta volumes in the low lying areas. Severe liquefaction damage was again evident following the Christchurch earthquake, with minor-moderate damage apparent after both the June and December events.

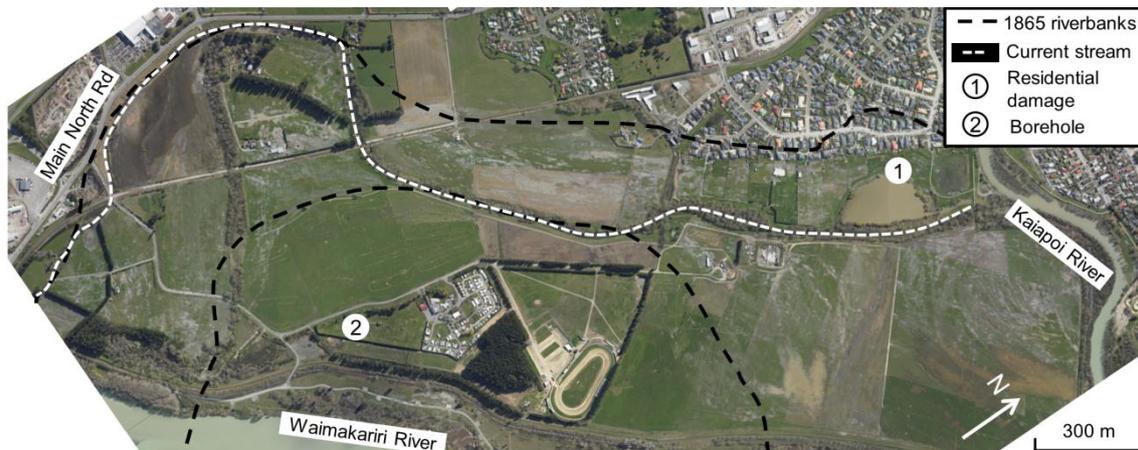
An aerial view of the eastern edge of Kaiapoi south of the Kaiapoi River following the Darfield earthquake is presented in Figure 6, with the boundary of the old southern channel of the Waimakariri River between the years 1865-1880 shown by the dashed black line (Ward & Reeves, 1865, Cass, 1864, Logan, 1998). What is immediately obvious is that the regions of liquefaction damage demonstrate a close correlation to the position of the old river channel. Large volumes of ejected sand and ground cracking are evident in the fields east of Kaiapoi, while heading south, the liquefaction damage follows a more confined path along the former river channel. One of the exploratory boreholes from the 2001 liquefaction study was at position 2 in Figure 6 and in Figure 2b, clearly outside the path of the old river channel and in an area where no liquefaction was evident at the surface. Knowledge of the location of the old river channel would likely have influenced the definition of the various liquefaction susceptibility zones outlined in Figure 2b. Five distinct episodes of liquefaction were evident in the structure

of a sand boil that was trenched in this region, clearly exhibiting the high liquefaction susceptibility of these loose deposits (Green et al. 2012).

**Figure 6: Liquefaction damage following the Darfield earthquake and location of old river channel in South-Eastern Kaiapoi**

On the eastern side of Kaiapoi, the old channel passes underneath the present day Courtenay Drive area shown by position 1 in Figure 6, the site of widespread damage to residential properties as a result of liquefaction and extensive lateral spreading following the Darfield earthquake. This was evident along the eastern side of Courtenay Drive for a distance of approximately 700 m. Up to 500 mm of ejected sand covered much of the roads and properties in this area following the event. Large lateral spread fissures between 0.5 and 1.5 m wide ran through residential areas parallel to the banks of the old river channel, with many of these filled with ejecta. This spreading resulted in permanent displacements of the ground of between 1.3 and 2.8 m towards Courtenay Stream, the present day small water course that follows the approximate path of the old river channel. The characteristics of the lateral spreading in this area were different to those observed elsewhere in Kaiapoi, with the majority of large fissures developing 120 – 200 m from the banks of Courtenay Stream in a block-like movement, instead of the larger cracks close to the free face (Robinson et al., 2011). At the free face there were only a few small cracks evident. The residential one and two storey structures in this area, especially on the eastern side of Courtenay Drive, were severely damaged due to these large movements as indicated in Figure 7. Structural damage was a result of tilting, differential settlement, loss of foundation support, and cracking of foundation slabs (Allen et al., 2010). Further lateral spreading occurred in this area during the Christchurch and December earthquakes.

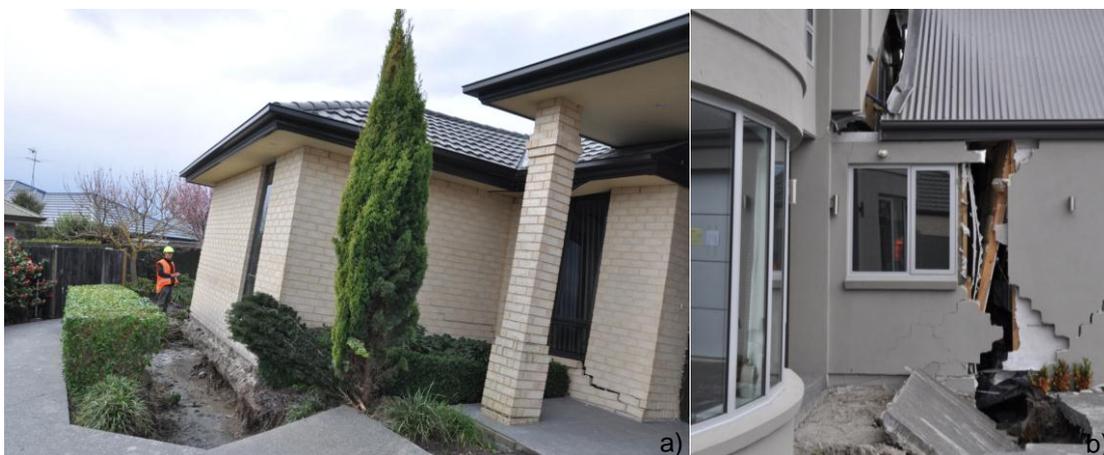
**Figure 7: Lateral spreading induced damage in South-Eastern Kaiapoi following the Darfield earthquake**
