Good grounds for the future

24-26 March 2021 • Dunedin • New Zealand

Ground damage caused by Typhoon “Hagibis” in Central and Eastern Japan

R.P. Orense

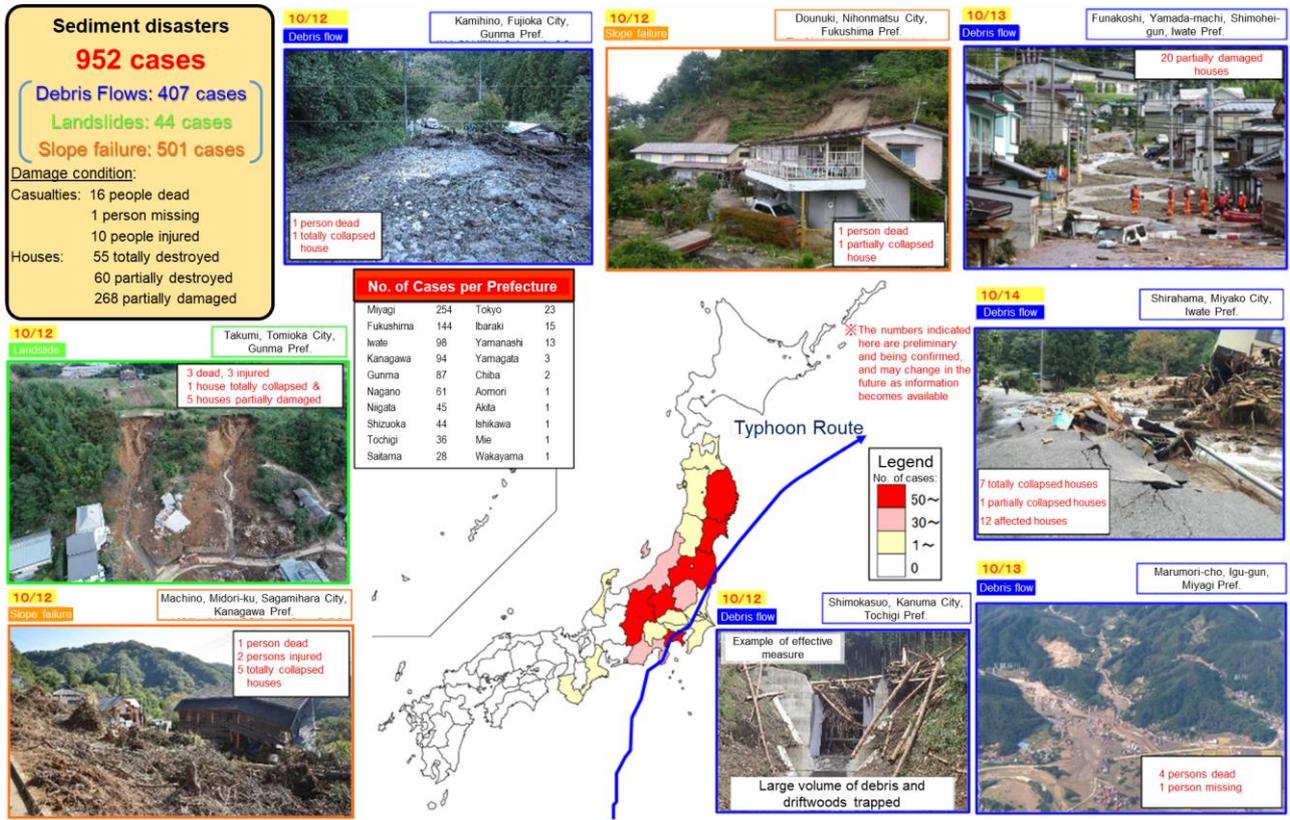
Examples of sediment disasters that occurred following the passage of typhoon Hagibis and their distributions throughout the affected regions in Japan are illustrated in Figure 2. Many of these disasters occurred in the mountainous areas located along the path of the typhoon. At least 16 people were killed and 115 residential houses were destroyed, either completely or partially, as a result of these mass movements. Following the events, researchers conducted in-depth investigations on some of the slope failures and landslides that occurred through site inspections and aerial surveys, supplemented by field testing, and various causative factors, such as rainfall intensity, topography and geology were identified. Many of the cases involved “classic” rainfall-induced failure mechanism (i.e., rainfall infiltration leads to an increase in positive pore water pressure and/or elimination of suction in the soil, leading to a reduction in shear strength and when equilibrium can no longer be sustained in the slope, failure is mobilised along a slip surface).

Figure 2: Sediment disasters, including debris flow, landslides and slope failures, due to passage of Typhoon Hagibis (modified from www.mlit.go.jp/river/sabo/jirei/r1dosha/r1typhoon19191224jiten.pdf)

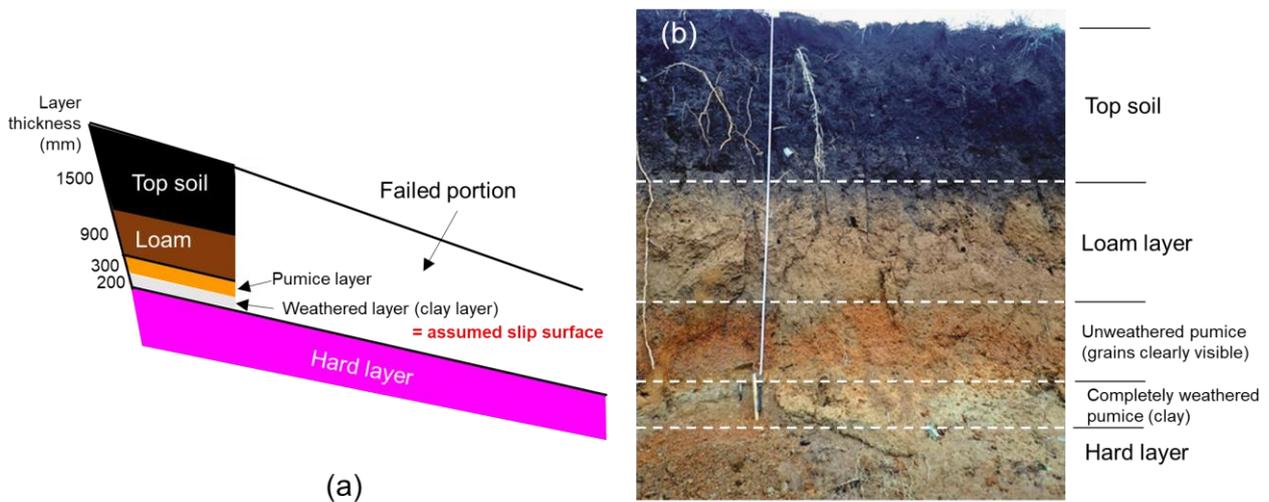
However, there were some cases where the mechanism involved was not straight-forward. According to existing guidelines, an evacuation advisory needs to be specified by the prefectural authorities for residential areas near slopes if the slope gradients are in excess of 30° (i.e., areas designated as sediment disaster alert area). Now, some slopes in Gunma and Tochigi Prefectures with inclinations as low as 20° failed, but because they were not designated as sediment disaster alert area, no warning advisory was issued. For example, in Takumi, Tomioka City where a landslide killed three people, it was found that a 20 cm thick whitish layer was horizontally distributed for about 20 m in length at a depth of 3 m from the ground surface (see Figure 3). It turned out that the whitish layer was a clay layer in which pumice, associated with the eruption of Mt. Asama, has weathered for tens of thousands of years. The layer, which was impermeable,

was overlain by highly permeable topsoil while below was a hard sedimentary layer. As a result, the infiltrating water from the typhoon was concentrated on the clay layer, which suddenly failed together with the upper layer, causing a sediment disaster. These clay layers are formed by complex natural conditions, such as the type of pumice and the condition of groundwater. Although the distribution of pumice from volcanoes is known to some extent, it is difficult to predict where the weathered clay layers are located.

Figure 3: Landslide in a pumiceous layer in Takumi, Tomioka City: (a) schematic of slope profile; (b) cross-section of stratified layers, showing the location of weathered pumice layer where slide appeared to have been mobilised (modified from www.jiban.or.jp/file/saigai/houkoku/goto_20191218.pdf)

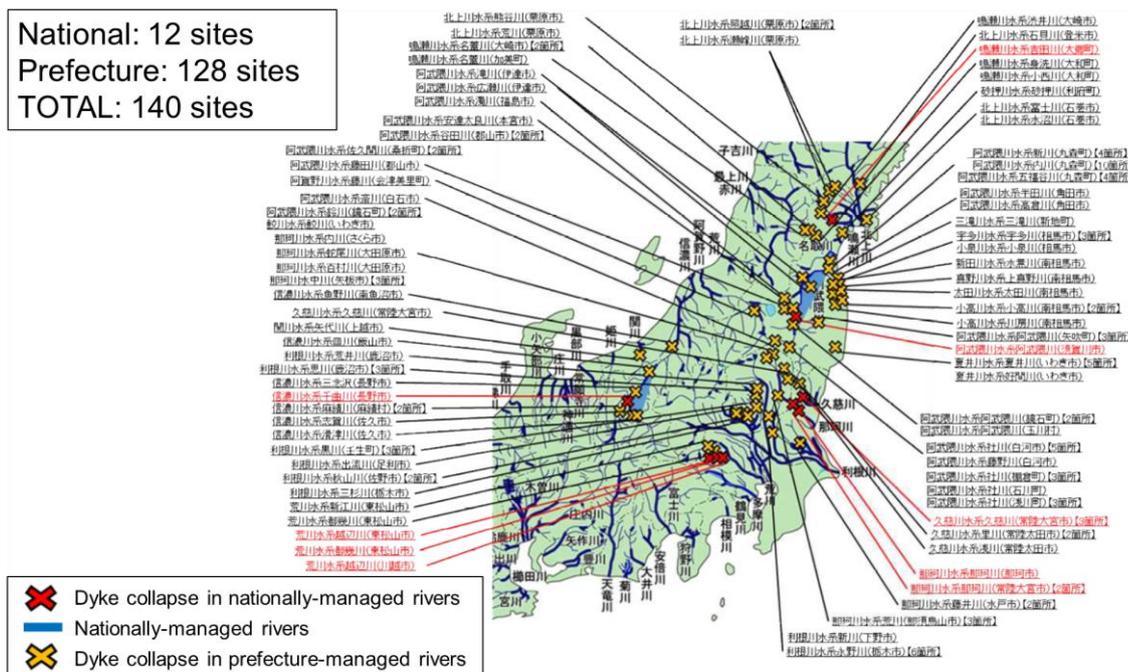
One of the features of Typhoon Hagibis is that many river dykes in central and northeastern Japan were breached and the turbulent floodwaters engulfed people and villages. Per the damage reports, river dykes failed at around 140 sites along 71 rivers in seven prefectures, primarily due to the large volume of rain that fell over a wide area due to the intense strength of the typhoon. Figure 4 illustrates the distribution of these breached river dykes. Among these, 12 sections failed in nationally-managed rivers (i.e., administered by MLIT) while 128 sections collapsed in prefecture-managed rivers. As of 08/11/2019, reinforcement works have been completed in all collapsed dykes in nationally-managed rivers while temporary river dykes have been completely set-up in all prefecture-managed dykes.

Figure 4: Locations of failed dykes (modified from www.mlit.go.jp/policy/shingikai/content/001317859.pdf)

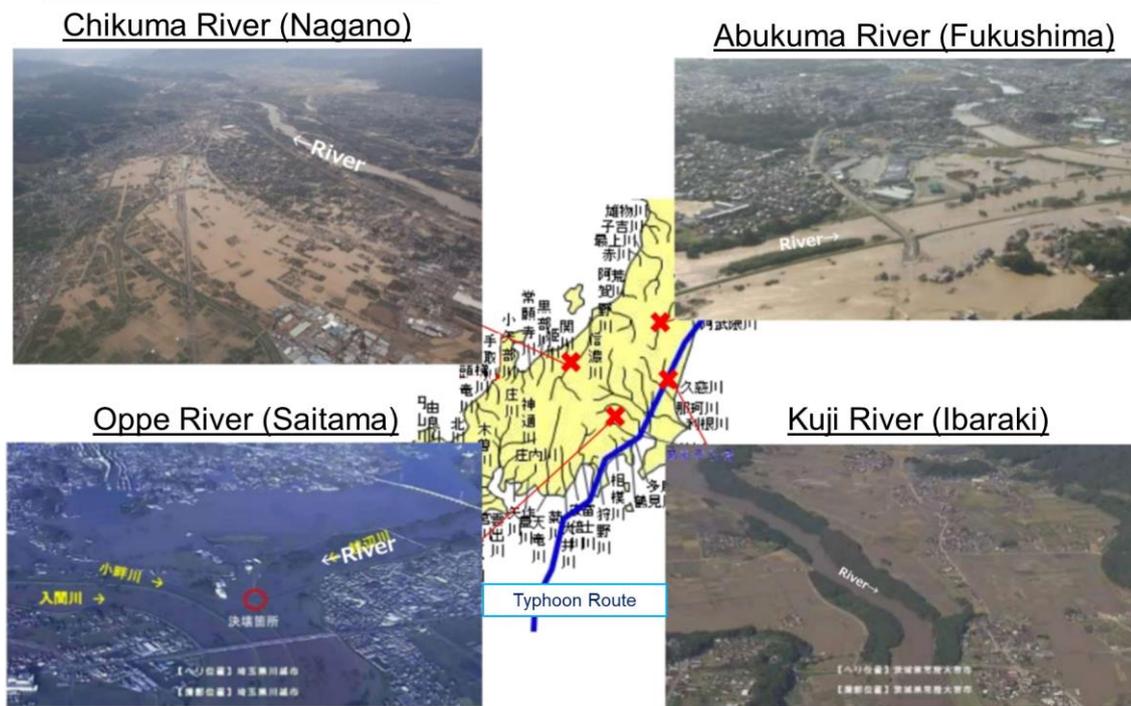
Some examples of the breached river dykes are illustrated in Figure 5. One of the most widely reported dyke breaches occurred along Chikuma River in Hobo, Nagano City. It was reported that the breach occurred over a 70 m-section of the dyke in the early morning of 13 October, killing 2 residents and flooding many houses and fields. The rushing floodwater, which reached the second floor of nearby residential houses, inundated as far as the National Highway Route 18, which was about 100 m away from the river bank. Almost the entire area along the Abukuma River, which meanders through a number of cities in the largely agricultural Fukushima Prefecture, was flooded after the typhoon moved north along the river's stream, dumping huge amounts of rain that caused the dykes to break in at least 14 places. In Kawagoe, Saitama Prefecture, the Oppe River embankment failed in the wee hours of 13 October near a point where the main and branch streams merged, submerging the area and temporarily isolating a nursing home. Subsequent investigations revealed that workers evacuated during the height of the heavy rain and left two pump stations discharging water from tributaries into the main river. In Hitachiomiya, Ibaraki Prefecture, a flood alert was issued at around 5:20 am on 13 October for areas along the Kuji River, whose dyke burst at three locations.

Figure 5: Examples of breached dykes (modified from mlit.go.jp/policy/shingikai/content/001317859.pdf)

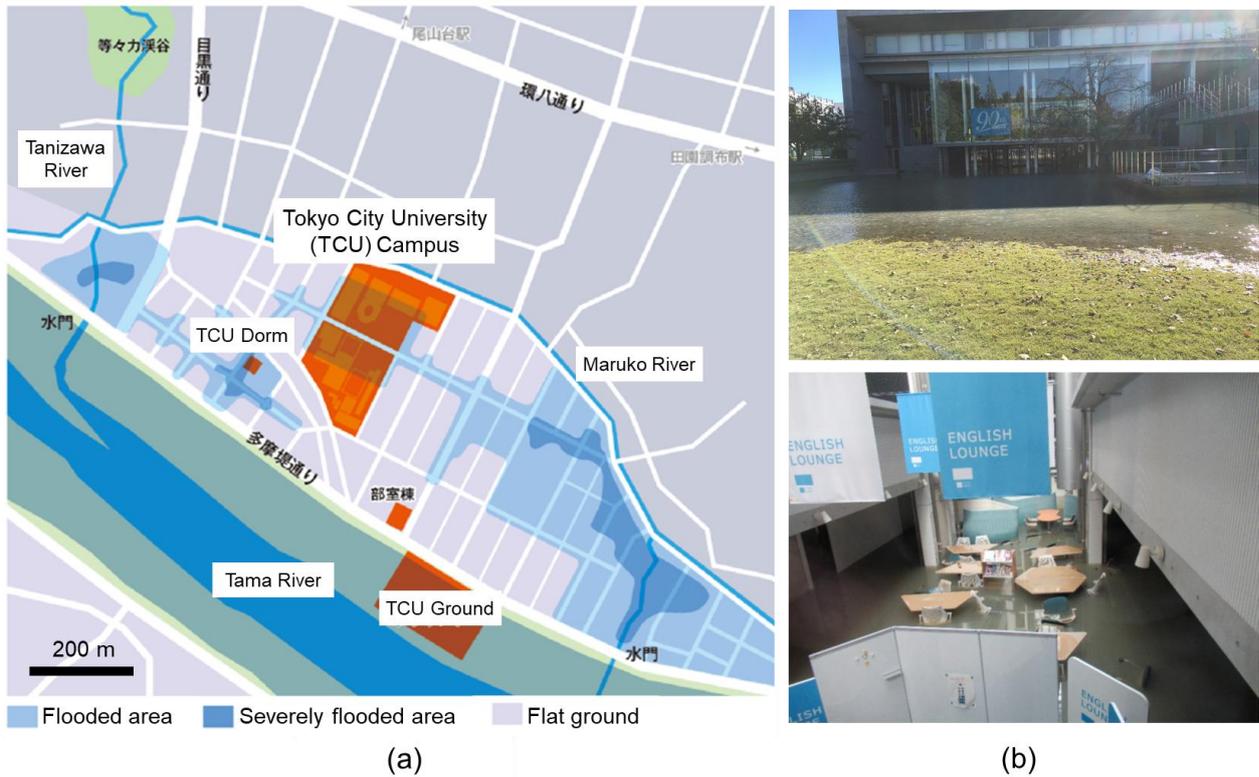
The author experienced the impact of flooding when his dormitory, located adjacent to Tokyo's Tama River, was inundated by >1.3m high flood water. The nearby campus of Tokyo City University (TCU) was also submerged, not by breaching of the Tama River, but by inland flooding which was induced by the overflowing of two tributaries (Tanizawa River and Maruko River) running nearby (see Figure 6(a)). As a result, many university buildings were flooded up to the first floor, while buildings with basement floors, such as the library basement floor and some research areas, were filled with floodwater (see Figure 6(b)). About 83,000 books in the library basement were destroyed. The author then joined the university's Department of Urban Engineering Reconnaissance Team to investigate the damage caused by the inundation of the inland waters and collect valuable information necessary for implementing effective countermeasures.

Figure 6: Extent of flooding adjacent to TCU campus (modified from univ-journal.jp/column/201929656/); and (b) photos of submerged university buildings within the campus.

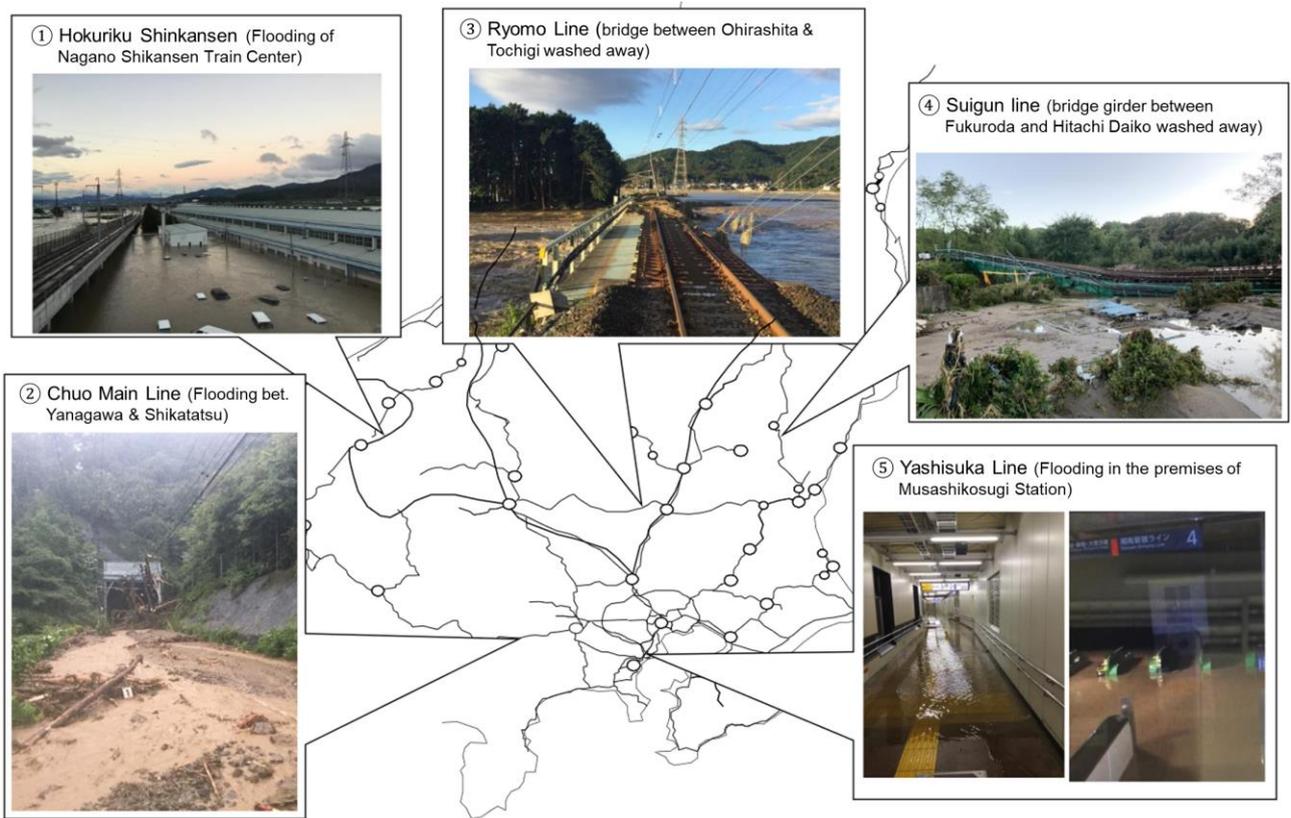
Train services were severely disrupted due to severe flooding and ground damage. The Central Japan Railway Co. cancelled their high-speed Tokaido shinkansen train services from 12-13 October. Various railway facilities of East Japan Railway Co. (JR East) were affected by the typhoon as a result of flooding and sediment disasters. Some of these damages to railway infrastructures are depicted in Figure 7. Ten Hokuriku bullet trains (consisting of 120 cars) were submerged when the Abukuma River overflowed and inundated the train depot located near the bank of the river. As a result, the inundated trains were scrapped with the damage worth US\$300M. A railway bridge of the Ueda Dentetsu Railway Company, which crossed the Chikuma River, collapsed into the water below. Local small railways also encountered damage, particularly to railway tracks, and suspended operations across several routes.

Figure 7: Damage to JR-East facilities (modified from www.jreast.co.jp/press/2019/20191013_ho01.pdf)
