Good grounds for the future

Responses to three 2017 landslide events affecting road networks in the lower North Island of New Zealand

D.L. Stewart

Principal Geotechnical Engineer/WSP, Wellington.

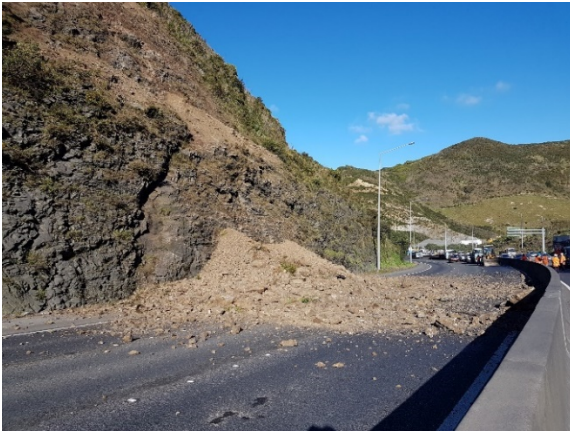
The route for State Highway 1 (SH1) out of Wellington passes through Ngauranga Gorge (Figure 1). This highway is on a steep grade, with three lanes of traffic each way below steep rock cuttings up to 50 m high. Rockfalls and slips are relatively infrequent, however they can be very disruptive when they do occur, due to the high traffic volumes affected (80,000 vehicles per day). On 11 July 2017, a rockfall event occurred just after 12 noon affecting the downhill lanes of Wellington bound traffic (Figure 2). The event occurred in relatively fine weather. The debris landing on the road fortunately did not cause a serious accident, presumably as smaller precursor events gave warning for cars to slow and then stop before the bulk of the debris fell.

Figure 2: Debris from the 11 July 2017 Ngauranga Gorge rockfall crossed all three southbound lanes with some blocks hopping the central barrier. Full road closure in place at time of photo (taken at 1.20pm).

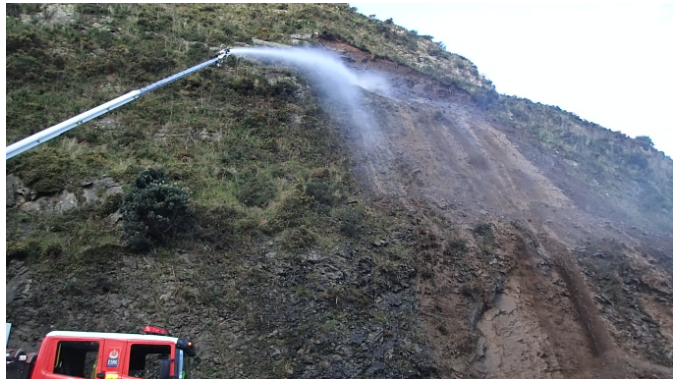
Figure 3: Sluicing of loose debris from the face was initially attempted using a fire hose, followed by helicopter with monsoon bucket. A check of the face was then carried out using abseil staff. Photo taken at

In order to address the residual risks of further falling blocks, a number of approaches were considered and attempted with varying success. The first approach involved mobilising a fire engine and sluicing the upper face with a high-pressure hose (Figure 3). However, the water pressure was insufficient to reach the source area due to its height and high winds. A platform of debris was then constructed to attempt to reach the source area with a very long reach excavator. The reach of the excavator also proved to be inadequate. The approach that provided greatest success was using a helicopter with monsoon bucket to sluice loose material

from the upper face. Following clearing of large amounts of debris off the face in this way, the slope was inspected by experienced abseil based staff, removing remaining loose rocks by hand (scaling).

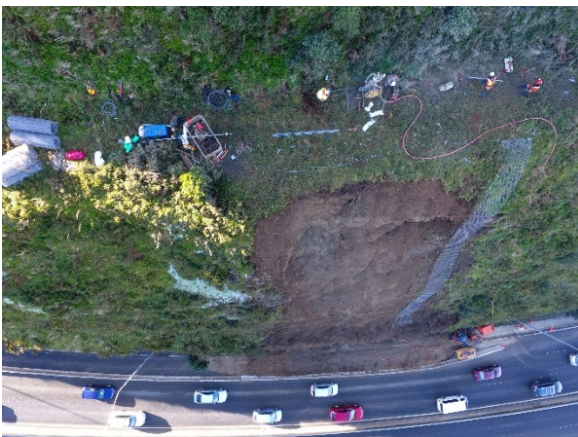
Figure 4: The solution to enable full reopening of the highway involved drilling of ground anchors at the upper bench with draped mesh placed over the exposed slip face and slope below.

In order to open two south bound lanes, a bed of gravel was placed on the outer lane to cushion the energy of any falling rocks, with a concrete barrier placed between this and the traffic lanes. To open all south bound lanes, removal of some loose rock overhangs were undertaken by the abseil crew by hand scaling (and the use of low energy explosives), and a layer of steel mesh was draped across the slope to control any residual blocks that may become loosened and fall. The mesh was hung from steel cables attached to steel anchors drilled and grouted into a bench immediately above the site (Figure 4). The equipment was mobilised to the upper bench site using a helicopter.

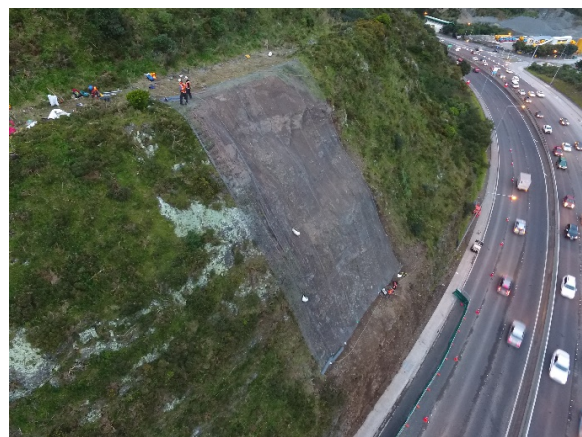
Figure 5: Abseilers completing draped mesh installation at SH1 Ngauranga Gorge rockfall

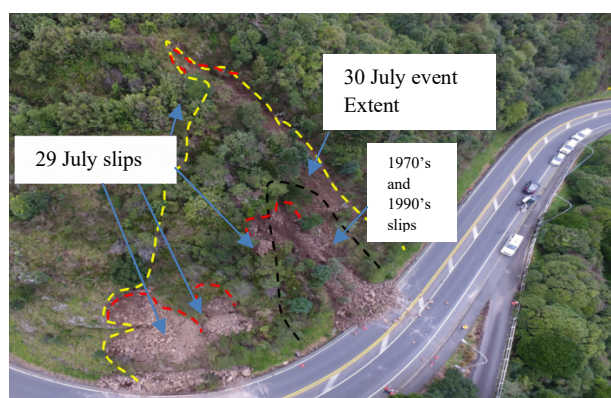
GNS geologists also attended the site on the 29th (and 30th) July and carried out a ground inspection of the slope, drone inspections and laser scanning of the slip area. These suggested the possibility of a larger failure developing (Figure 6). Opus geotechnical staff arrived early on the morning of 30th July, to discover that a much larger failure had indeed occurred. Comparison by GNS of a laser scan with Council LiDAR data indicated a landslide volume of about 1,300 m³. A bedrock failure of this size is a relatively rare event in the Wellington region, being controlled by moderately steep persistent rock defects (joints/shears). The failure had occurred in a greywacke slope cut in the 1970's for a corner easing realignment (Figure 7). In addition to risk to the road, a Transpower pylon is located at the top of the slope immediately above the landslide (Figure 7).

Figure 6: Drone image from 29 July 2017 after the initial slips on Ngaio Gorge Road, with the extent of the 30 July landslide indicated. Photographic evidence of previous bedrock landslides of smaller size at this site in the 1970's and 1990's indicates a

precedent for reasonable size bedrock failures here (albeit not of the size that occurred in 2017). GNS image.

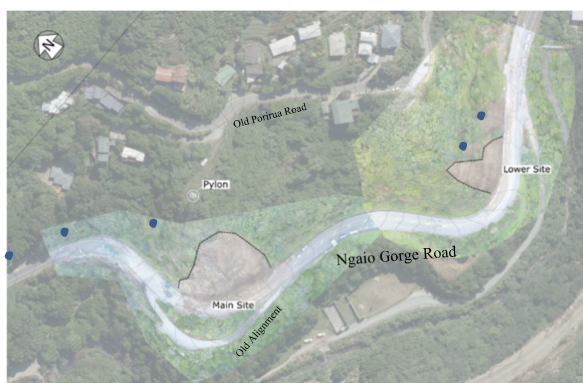
Figure 7: Location plan of the slips occurring in July 2017 along Ngaio Gorge Road, including the two main rockfall sites and a number of smaller slips (blue dots). The map is built up from drone derived imagery taken in late 2017 after site clean-up, superimposed over older Council aerials.

In addition to the main landslide, a number of other smaller nearby slip events occurred through late 2017 (Figure 7) which underlined the continuing safety and resilience risks of the cut slopes at the wider site area. On 18 August 2017 two rock blocks fell from steep slopes at the lower site, 150 m down the road from the main site (Figures 7 and 13). This resulted in a ‘near miss’, captured on dashcams from two cars, with videos supplied to news websites. For the hyperlink for the Ngaio dashcam videos refer Stuff (2017b) in the References.

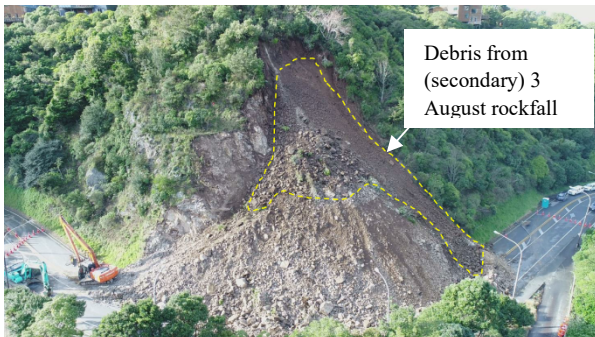
Figure 8: Ngaio Gorge rock slide site nearing end of earthworks to trim the over-steepened upper scarps remaining after the main failure. Drone photo taken on 3 August immediately following a 150 m³ rockslide event, which was mitigated by real-time survey monitoring.

Remedial works initially involved removal of the over-steepened, loose scarps at the top of the landslide using large excavators (Figure 8), operated by highly experienced operators with extensive quarry experience. The risk to the excavators was further managed by installation of survey targets by abseillers around the perimeter of the landslide headscarp which were then monitored by surveyors in real-time to check for adverse movements. Locations for targets were chosen by an engineering geologist who was highly experienced in rock slope assessments. Accelerating movement was detected on one target during earthworks, which provided warning to allow an excavator high on the slope to safely move away prior to an approximately 150 m³ rockfall event (Figure 8). Helicopter sluicing was used to remove loose debris that was out of reach of the excavator.

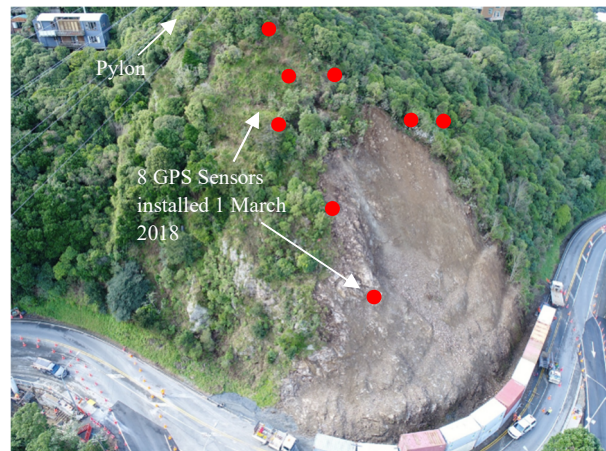
Figure 9: Site after slope trimming, debris removal, and container wall installation. Opus drone image 15 August 2017 just prior to reopening of two lanes of traffic

Once all debris was removed, a shipping container wall was installed on the downhill lane to contain any future rockfalls at the site (Figure 9). Two weeks after reopening the road to two lanes, a 200m³ rockfall event from the head of the landslide was halted by the shipping containers (Figures 10 and 11), with no effect on traffic. To allow construction and public traffic to bypass the site, the fortuitous position of the old road alignment (Figures 6 and 7) was reinstated as a single lane road.

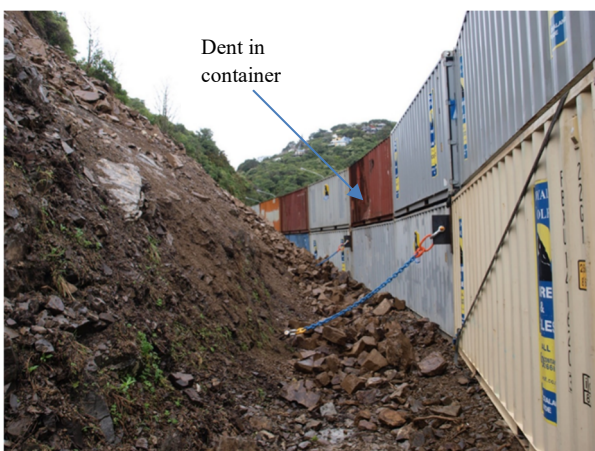
Figure 10: Anchored shipping containers installed in mid August 2017 allowed re-opening of two lanes of traffic; these stopped debris from the 1 Sept 2017 (200 m³) rockfall models developed from drone imagery before and after the 200m³ rockfall event on 1 September 2017

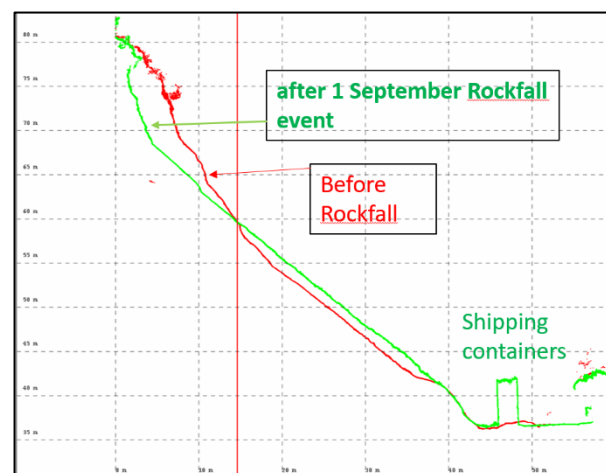
Figure 11: Comparison of slope profiles from 3D

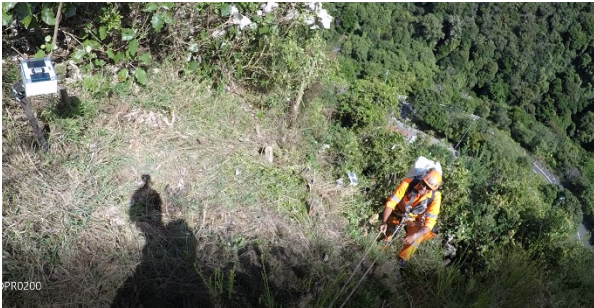
Figure 12: Abseillers installed GPS sensors (left) around the two main slip sites in a trial to allow future movement trends to be picked up much more quickly than from conventional surveying

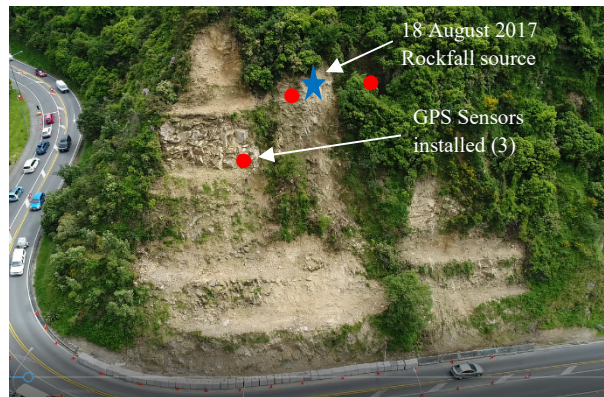
Figure 13: Lower Ngaio Gorge Slip site following late August 2017 slope remedial works.

While the main landslide site is protected by containers, the other sites were not well protected, hence a detailed assessment of other slip sites was carried out by experienced abseil contractors and geotechnical staff. Abseil based inspections and loose rock removal occurred at these sites during planned three day road closures in late September 2017 and again in February 2018.

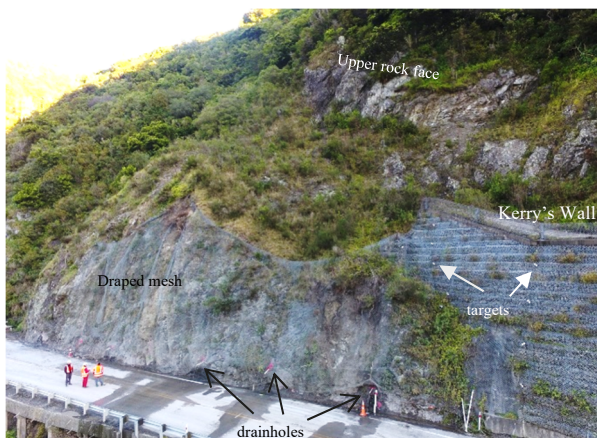
Kerry’s Wall is a 10m high gabion faced wall (Figure 14), constructed in 1998 to buttress part of the slope immediately above SH3 after a number of moderate to large sized landslide events at this location in the 1990s. Following a period of relative stability, deformation of the wall was noted in 2012. Subsequent deformation monitoring of the wall and slope above by Beca (part of the NOC team with contractor Higgins) in February 2017 identified a significant displacement over a period which included the November 2016 Kaikoura Earthquake. NZTA’s Structures Consultant for the area, Opus (now WSP), then carried out an assessment of the wall deformation in order to assess remedial options for the wall. A key part of the puzzle involved locating 1990’s reports and wall construction information, which fortunately was able to be sourced through NZTA and long-time Higgins and consultant staff involved in the construction. This enabled corroboration, between 1990’s documents, construction photos and staff involved, to determine the “as-built” state of the wall and slope. The second part of the puzzle involved trying to determine the extent and

Figure 14: Kerry's Wall at right with survey targets visible on the wall. A laser scanner set up at road level surveyed the wall and upper rock face. Wet patches on the road are from deep drainholes drilled into the lower rock slope in June 2017. Drone photo 29 June 2017.

At the time of the NZTA's decision to close the gorge to all staff, when significant accelerating movement trends were identified, a programme of drainhole drilling was underway in an attempt to lower water pressures in the slopes at Kerry's wall (Figure 14). At that stage proposals had been developed to carry out comprehensive slope monitoring and subsurface investigations at the site, to better define the rate and spatial extent of movement. These proposals included remote monitoring techniques such as slope movement scanners and real-time instrumentation. The aim was to gather near real-time data in an attempt to establish patterns of movement, in order to see whether changes in slope movement behaviour could be assessed ahead of potential or actual failures. If confidence in the cause and effect relationship could be achieved then the risk for access to the site could be managed. This would be in staged way: firstly for contractors carrying out investigations, secondly for carrying out remedial works and ultimately for reopening to the public if sufficient confidence in the slope performance could be established. While our data relates to the period up to July 2017, NZTA indicated ongoing issues at Kerry's Wall since then, as well as significant slope

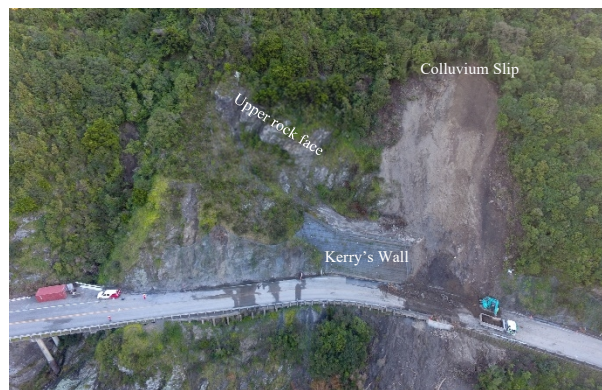
On 24 April 2017 two almost simultaneous moderate to large landslide events about 2km apart occurred in the gorge, during a relatively dry period. One of the events occurred immediately adjacent to Kerry's Wall with debris falling onto the shelf on top of the wall. The characteristics of this failure in colluvium soils appeared to be unrelated to the movement of Kerry's Wall which was believed to be related to movement in the greywacke bedrock (Figures 14 and 15). Ongoing monitoring by Beca through to May 2017 indicated sporadic movement trends of the wall and rock face above, followed by accelerating movement to early July. During this period, enlargement of the colluvium slip also occurred with two further moderate to large slips occurring in May and June 2017, engulfing a rebuilt rockfall attenuator fence and the road itself adjacent to Kerry's Wall (Figure 15).

Figure 15: Location of Kerry's Wall and monitored rock outcrop, with excavation in progress to clear debris from 24 June colluvium slip event immediately to the west of the wall (Drone photo 29 June 2017)
