# Static failure mechanisms in sensitive volcanic soils in the Tauranga Region, New Zealand

## ABSTRACT

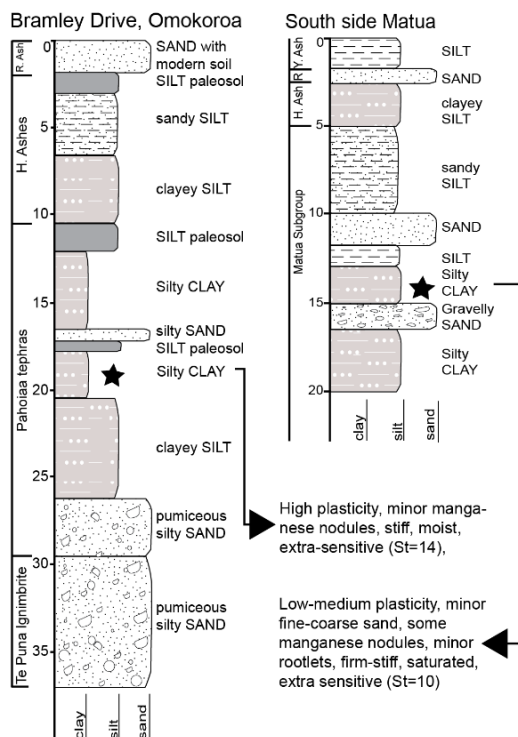
Fig 1. Stratigraphic profiles of Bramley Drive and Matua.

(Briggs 1996). Overlying the Matua Subgroup are younger airfall tephra sequences (Briggs 1996, Lowe *et al.* 2001). Stratigraphic profiles and soil sample descriptions at each site are outlined in Fig 1.

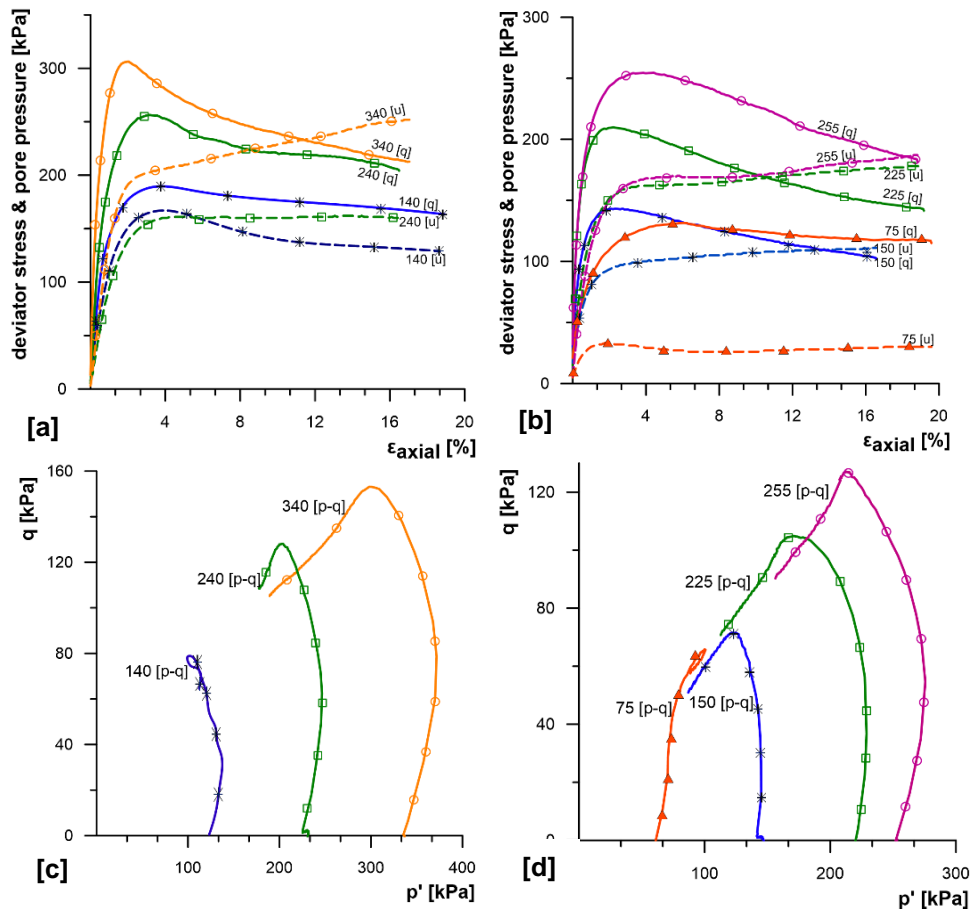
Fig 2. [a-b]. Deviator stress and pore pressure vs axial strain, and [c-d]  $p'$ - $q'$  stress path plots for Omokoroa (left) and Matua materials (right).

Triaxial results for M1 and OM1 samples are presented in Table 2, and a-d. At greater confining stresses, peak deviator stress, curvature of peak, and degree of strain softening increases for both M1 and OM1. Tests where pore pressure rises after peak stress correlate with a contractive, left trending curve along the CSL (critical state line) (c, d), while tests where pore pressure drops following peak stress correlate with curves that touch the CSL and trend slightly to the right. All samples failed along either one sliding plane by shear, or as a wedge, where two sliding planes occur at roughly perpendicular angles. Only M1a failed by barrel deformation with very minor shear zones observed. High effective friction and variable effective cohesion values are in the range of previous publications (Keam 2008, Wyatt 2009, Cunningham 2012). Effective friction angles and cohesion for samples stayed mostly consistent between peak and residual states, albeit minor reductions i.e. little to no friction and cohesion softening occurred.
