Landform Development of the Central Coastal Bay of Plenty Region: An Integrated Study

J H Rae

Network Control Planner, Transfield Services (New Zealand) Ltd.

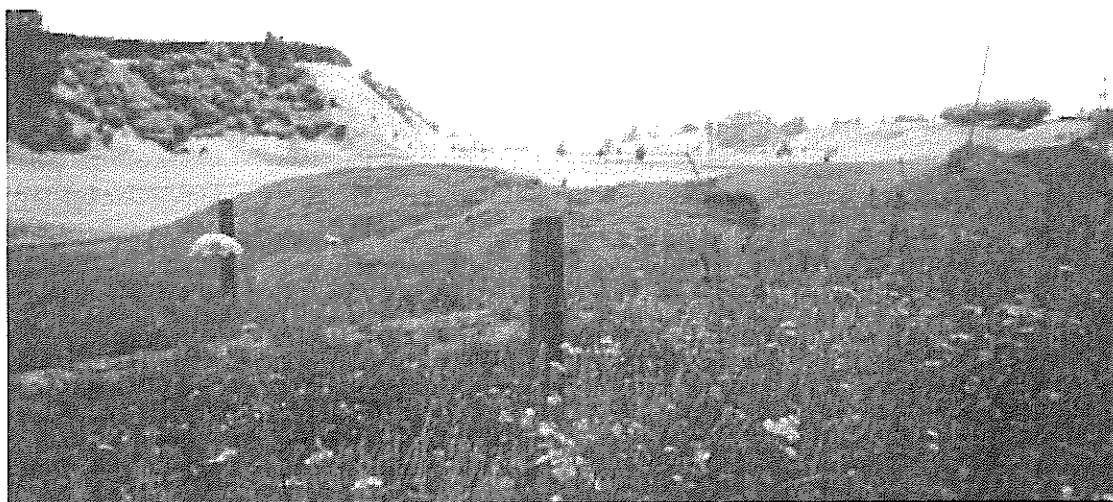
Figure 2. Rotoehu Valley Morphology.

The western side of the study area marks the termination of the Kaharoa Plateau and is characterised by lowland plains and broad alluvial valleys with low hills to the south. Figure 2. shows the Rotoehu valley which is typically bounded by a terrace of volcanic materials and infilled by gentling sloping alluvial fans (0-5°). The terraces are described as flat topped with moderately steep (26-35°), convex profile slopes. The Matahina Ignimbrite is absent from the western half of the study area, and stratigraphy is dominated by the non-welded Rotoiti Eruptives (e.g. Matahi Scoria, Rotoehu Tephra Rotoiti Ignimbrite, and reworked unit). The Rotoiti Ignimbrite is widespread, formed of several thick units, and provides a major geomorphic control. The ignimbrite overlies and mimics a gently dipping surface formed from older ignimbrites. The upper surface of this unit is truncated, showing evidence for post depositional erosion and stream channels are frequently infilled with reworked Rotoiti sourced pyroclastic materials.

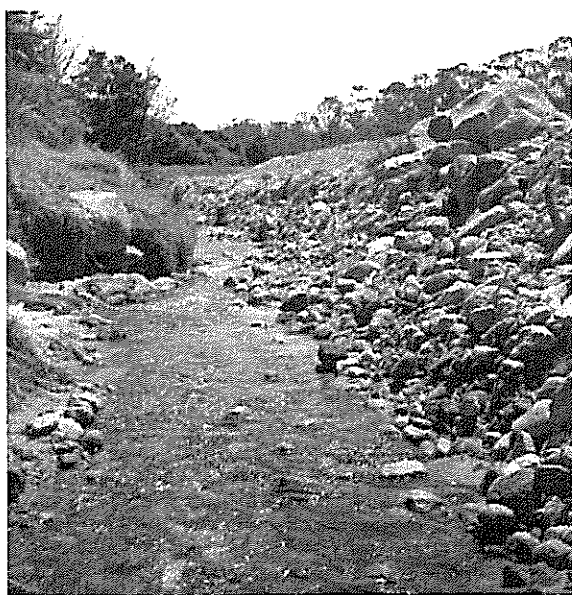
Figure 3. Reworked Volcaniclastic Deposits

Debris flows initiate in the headlands of local streams and exhibit run out distances of 2-3 km. Dispersal occurs as flows reach the cliff base and form wide depositional lobes. Such flows damage engineering structures (culverts, drains) and create a hazard to local roading systems (i.e. SH 2). These minor events occur frequently i.e. several times a year (based on field observations). Deposits described in the field suggest that the study area has in the past seen numerous erosional and mass movement events and been inherently unstable, particularly within zones defined by steep slopes and unconsolidated deposits. As Figure 3. shows, many stream beds, poorly sorted, poorly graded deposits are found, formed from reworked, welded ignimbrite and rhyolite lavas (e.g. upper Mimiha Rd, NZMS 260 V15 346 616). Debris deposits are also evident in geological history. Thick (2-6 m) layers are found within marine sands, where streams have now incised into the Matata cliffs (e.g. western Herepuru Rd, NZMS 260 V15 374 626). Paleo-flows form deposits similar to recent debris flow deposits, with coarse ignimbrite boulders and cobbles, dispersed with a fine sand and silt matrix. Recent failures (i.e. recent slips at Pikowai) also highlight this instability.

[Debris Alongside SH2, Ohinekoao]

[Relict Debris Flow Upper Mimiha Road (NZMS 260 V15 346 616)]
