Design and Construction of a Large Cut Slope in Sensitive Volcanic Ash Soils

Abstract: The PJK Expressways Project includes approximately eight kilometres of new roads, seven bridges and more than 1 million m³ of earthworks. This paper describes the design and construction of one of the larger cut slopes in the project, the J3 Cut. This cut is up to about 20 m high and involves excavation of approximately 50,000 m³.

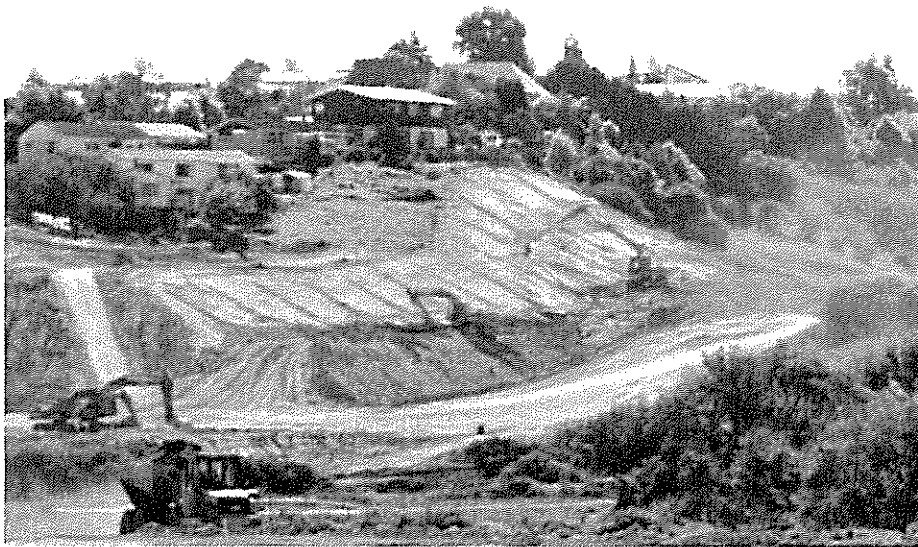
This paper describes the design and construction of the J3 Cut. The location of the cut is shown on Figure 1. This cut is up to about 20 m high and involves excavation of approximately 50,000 m³. A general overview of the cut during construction is shown in Figure 2.

Figure 2. Overview of J3 Cut

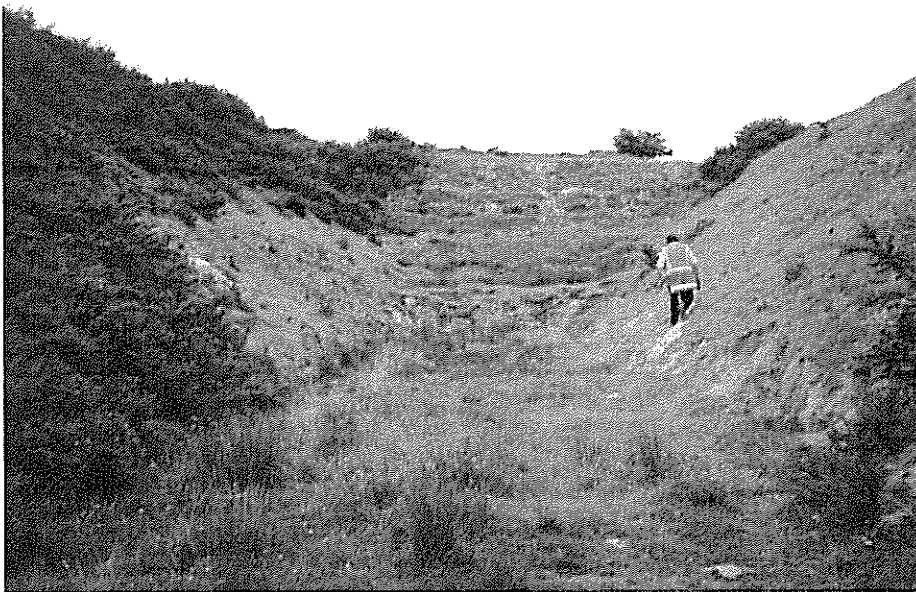
The trial excavation comprised a 1H:1V end slope up to 9.5 m high and 1.5H:1V side slopes up to 12 m high (Figure 3). Aside from erosion of some of the less cohesive materials exposed in the cut slopes in the first winter, there was no sign of instability in the trial cut.

Figure 3. Trial Excavation

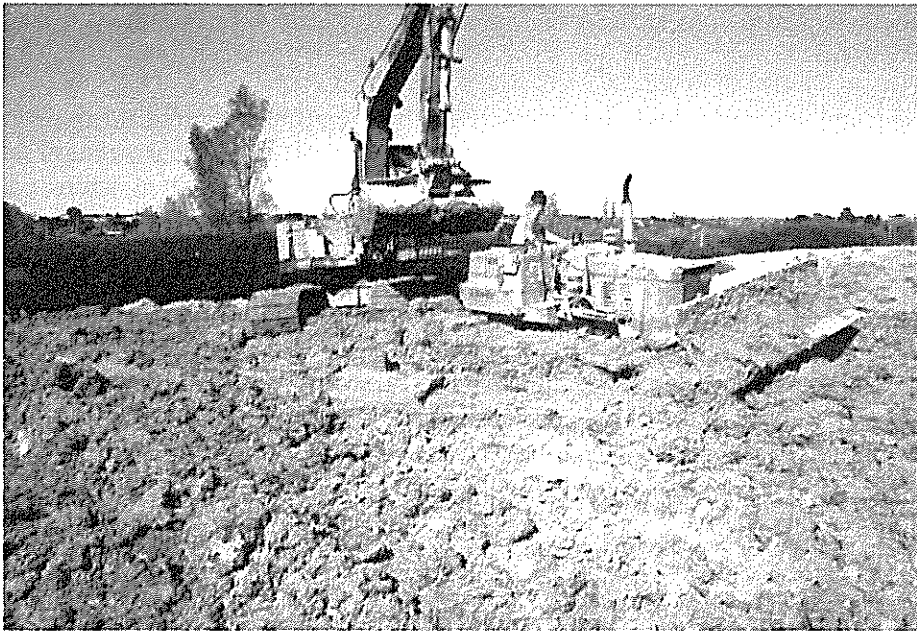
Hauling and placement in the embankment became significantly more difficult when the more sensitive soils at and below the Hamilton Ash layer were reached in the excavation (Figure 4). Testing

indicated that a Pilcon vane strength of about 80 kPa was required to provide passage for trafficking of haul equipment.

Figure 4. Swamp Track Dozer Stuck in Sensitive Ash Fill

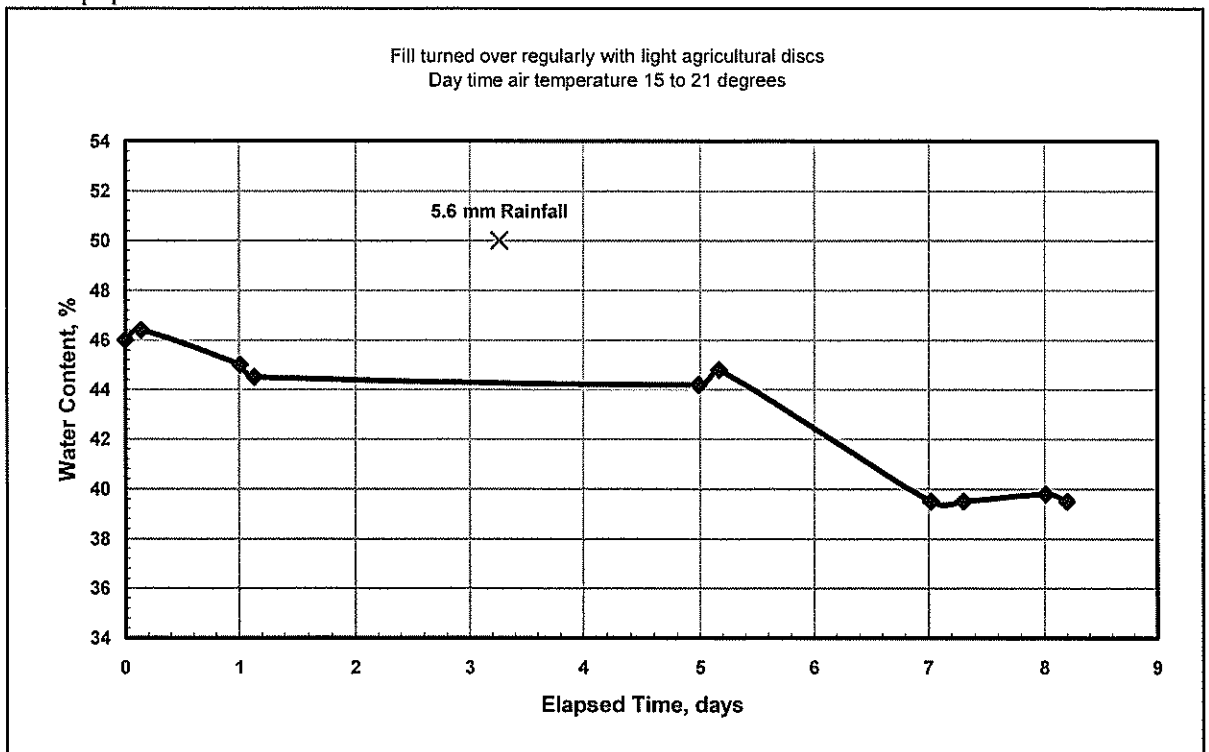
As part of the Route J trial fill, an experiment was carried out to assess drying of the soil using light agricultural discs. The equipment repeatedly became bogged down during the trial. A water content reduction of about 6% was achieved in eight days (Figure 5).

Figure 5. Results of Field Drying Trial

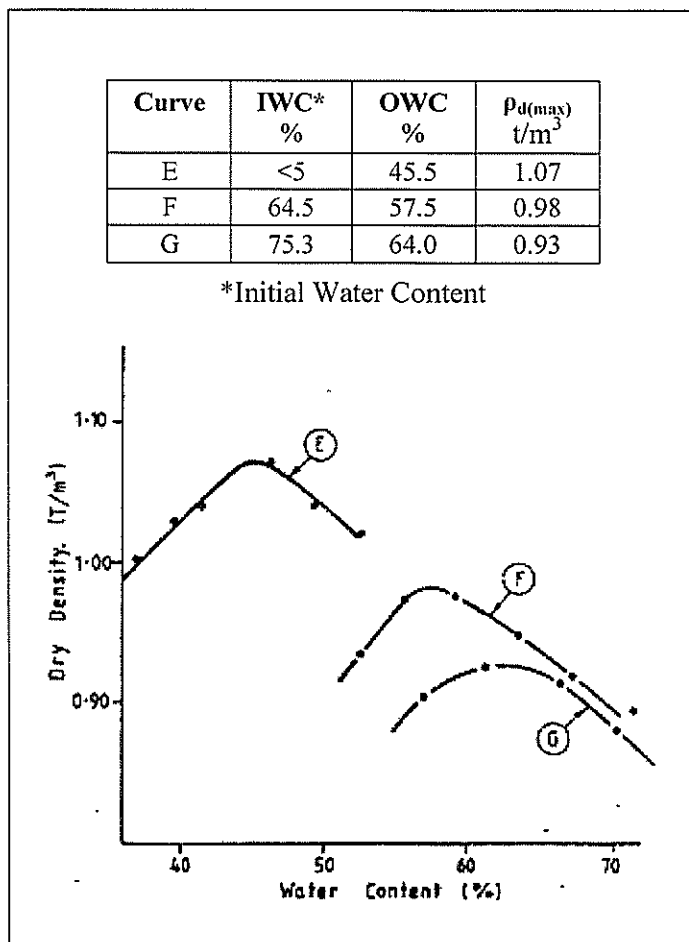
Compaction tests indicate local ash soils are often sensitive to the moisture history of the sample. Samples from similar soils prepared by drying back from the natural moisture content give significantly different results than if they are wetted up from oven dried samples, as shown in Figure 7. Because of this, it can be difficult to control compaction using the standard moisture versus density laboratory test.

Figure 7. Compaction Curves at Different Initial Water Contents (after Parton & Olsen, 1980)

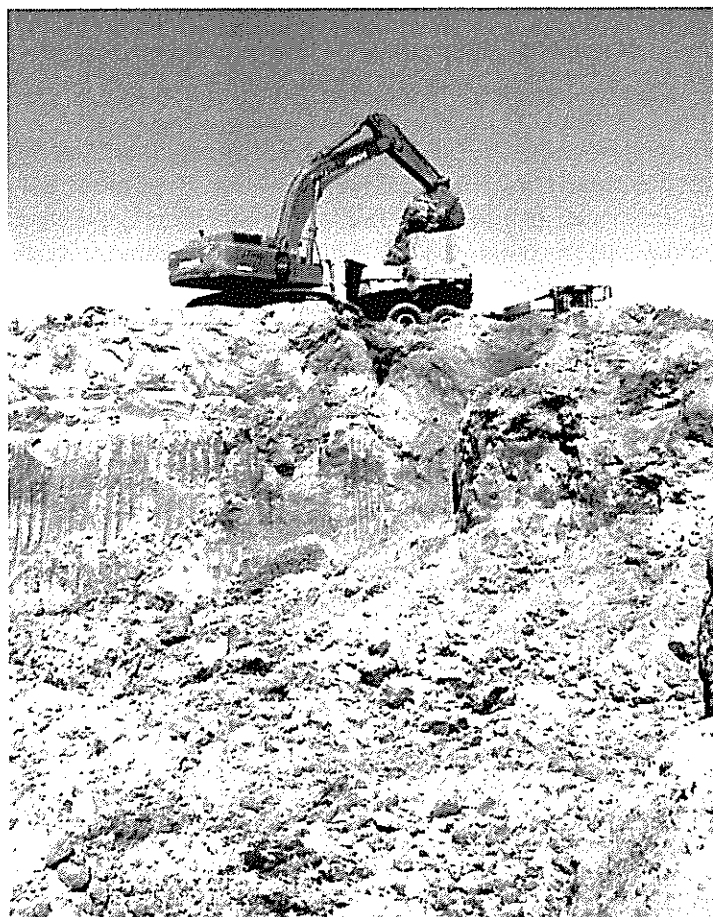
The J3 excavation extends well below the original ground water table and encountered soils that were too soft or slippery for standard earthworks equipment. Within the Route J trial excavation a long reach excavator was used to reduce the requirement for construction traffic because of the trafficability problems. The full scale construction also made use of a long reach excavator to dig most of the sensitive soils in a single large lift, working from a bench in the upper more friable soils (Figure 8). Most of the soil excavated was used in non-structural applications, such as stability berms for the embankments in the interchange area.

Figure 8. Single Large Excavation Lift
