GEOTECHNICS ON THE VOLCANIC EDGE

**TAURANGA, MARCH 2003
NEW ZEALAND GEOTECHNICAL SOCIETY SYMPOSIUM**

Proceedings of Technical Groups Vol. 30
Issue 1 (GM) 2003
ISSN 0111-9532

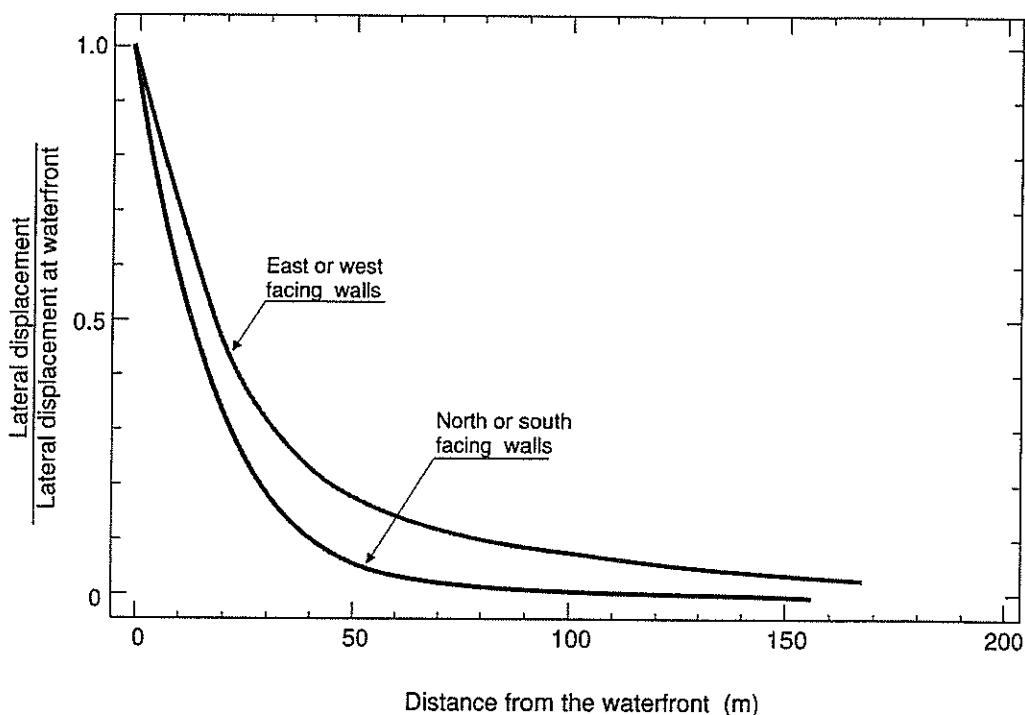
Figure 13. Comparison of Normalized Displacement Patterns in Liquefied Deposits Retained by the Quaywalls Facing Different Directions.

Taking the average curves of attenuation shown in Fig.11 and 12, the lateral displacement at any point normalised to that at the waterfront is shown in Fig.13. It can be seen in Fig.13 that the attenuation is more pronounced for the soil deposit retained by the north- or south-facing caisson walls as compared to the ground behind the walls facing the east or west direction.

The reason for the rapid attenuation in the former case is simply the larger movements of the quaywalls which were caused by a greater acceleration in the north-south direction during the Kobe earthquake. As discussed above, the ground movements in the backland retained by the east- or west-facing walls appear to have been caused primarily by the liquefaction of the soil deposit. For this reason, it would be legitimate to choose the attenuation curve pertaining to the east- or west-facing walls for practical purposes where estimate of lateral displacements is needed given the quaywall movements less than 2.0m with a ground shaking of the order of 200-300gal.

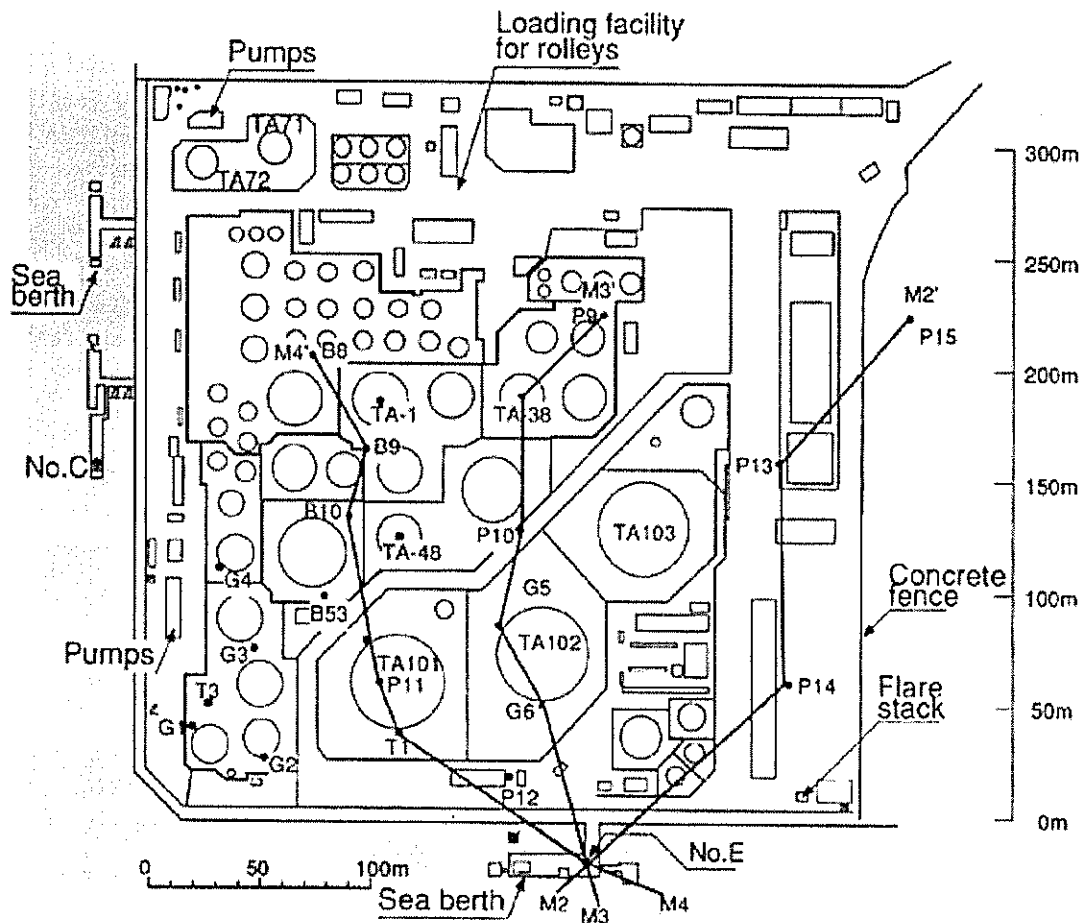
Figure 21. Map of the LPG Tank Location.

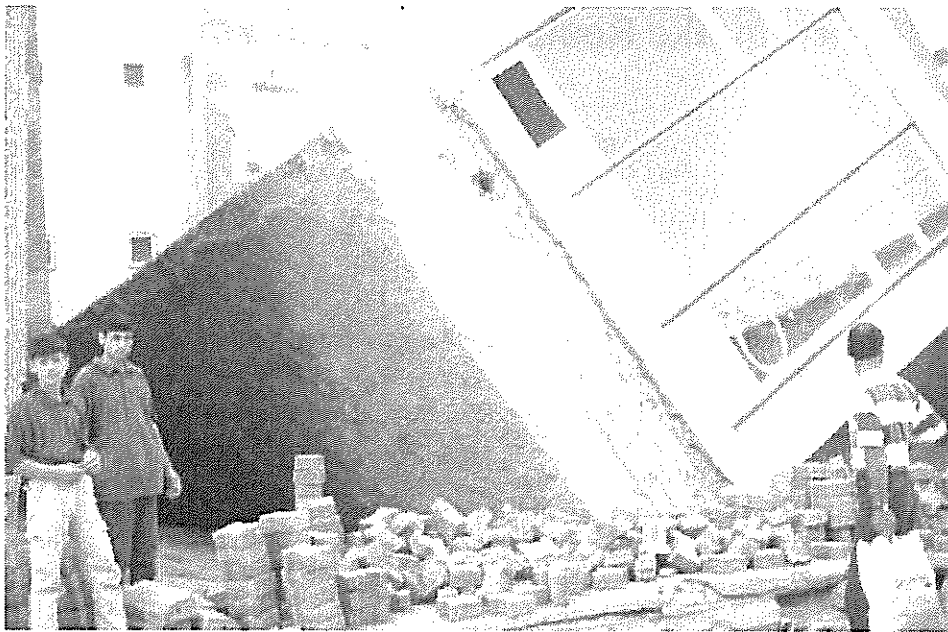
Figure 1. Overturned Building in Adapazzari

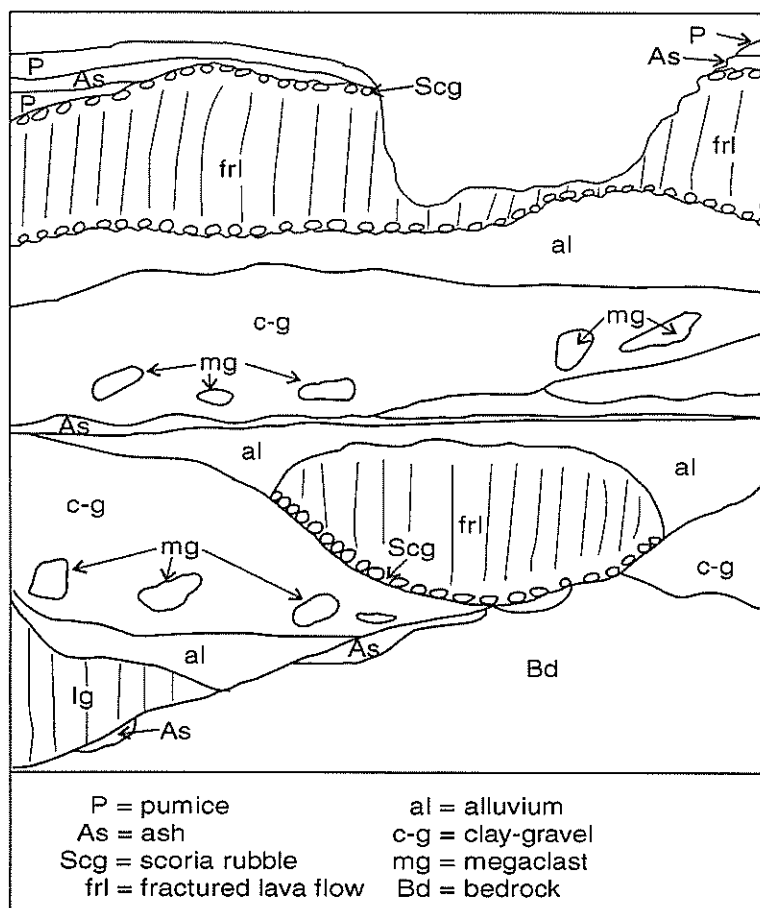
Figure 5. Two – Dimensional Model (cross-section) Through Ring-Plain Deposits of an Andesite Volcano, Such as Tongariro. The Fractured Lava Flows are Approximately 30 m Thick. This Model is Taken from the Vicinity of Wanganui, Te Whaiu and Otamangakau Dam Sites.

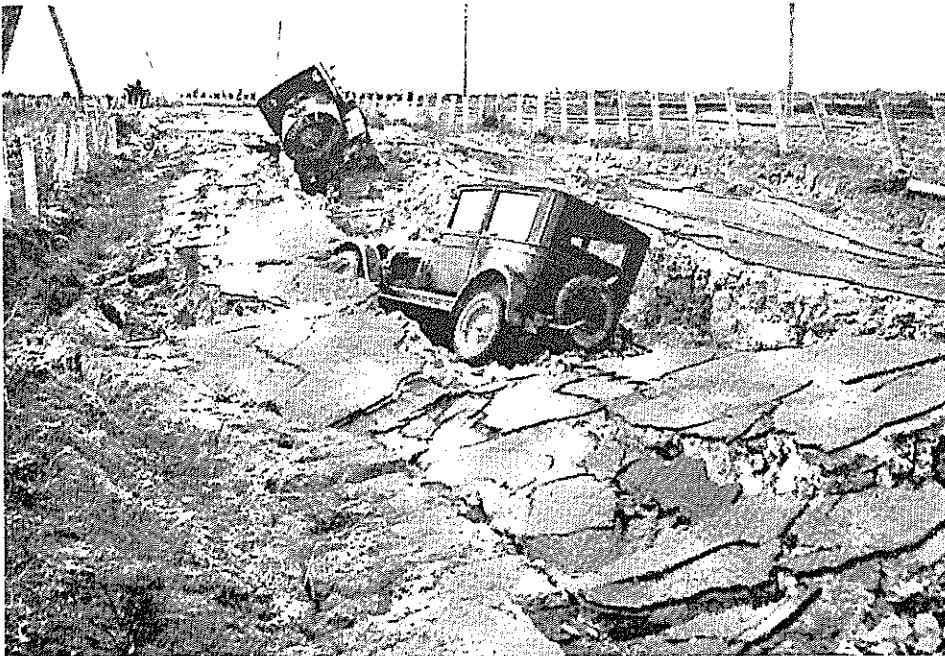
Figure 2. Lateral Spreading of Road Embankment in Napier Earthquake, 1931

Lateral spreading of ground has the potential to cause a greater magnitude of ground damage and consequential damage to lifelines. This could occur where liquefied ground can displace towards free surfaces such as river or stream banks and the shorelines. Any embankments (including bridge approaches) built on liquefiable ground are also likely to undergo lateral spreading. Severe damage to a road embankment due to liquefaction related lateral spreading during the 1931 Napier Earthquake is shown on Figure 2.

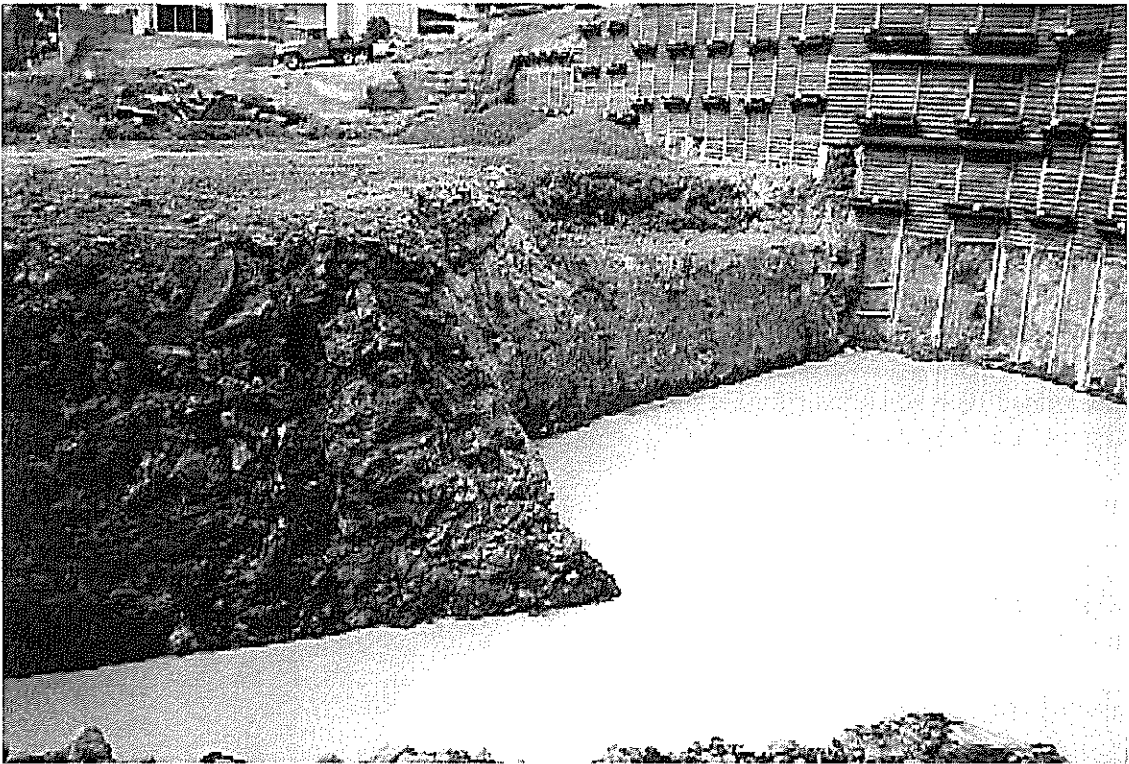
Figure 2. Fractured basalt
