8th Young Geotechnical Professionals Conference

Proceedings of the 8th New Zealand - Australia Young Geotechnical Professionals Conference

Copthorne Hotel, Wellington, November 5th - 8th 2008

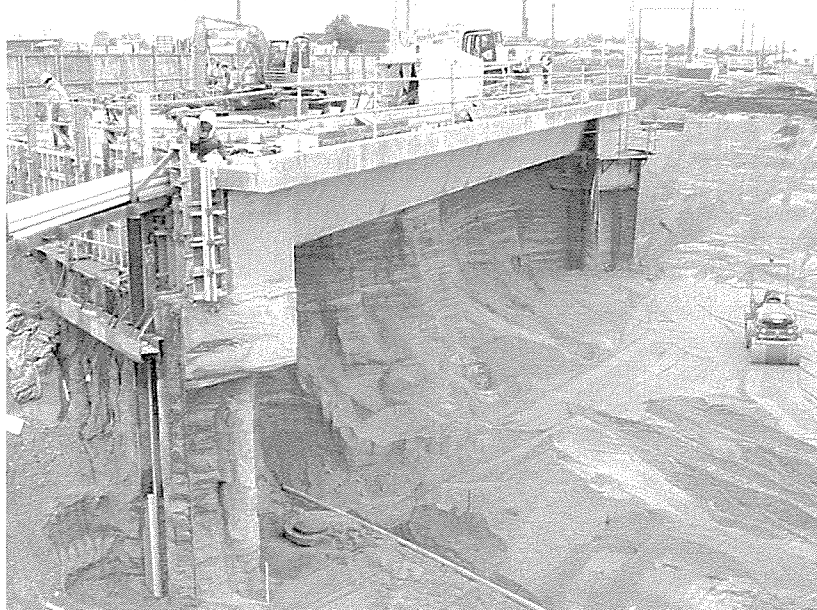
Figure 2: Showing the interbedded sands and silts of the Hinuera Formation

The Hinuera Formation was deposited in the late Pleistocene Epoch. It is up to 90m thick and comprises of cross-bedded pumiceous sands, silts, and gravels (Figure 2), interbedded with peat. The Hinuera Formation is the result of deposition of typically volcanic deposits from the Taupo Volcanic Zone by a braided ancestral Waikato River.

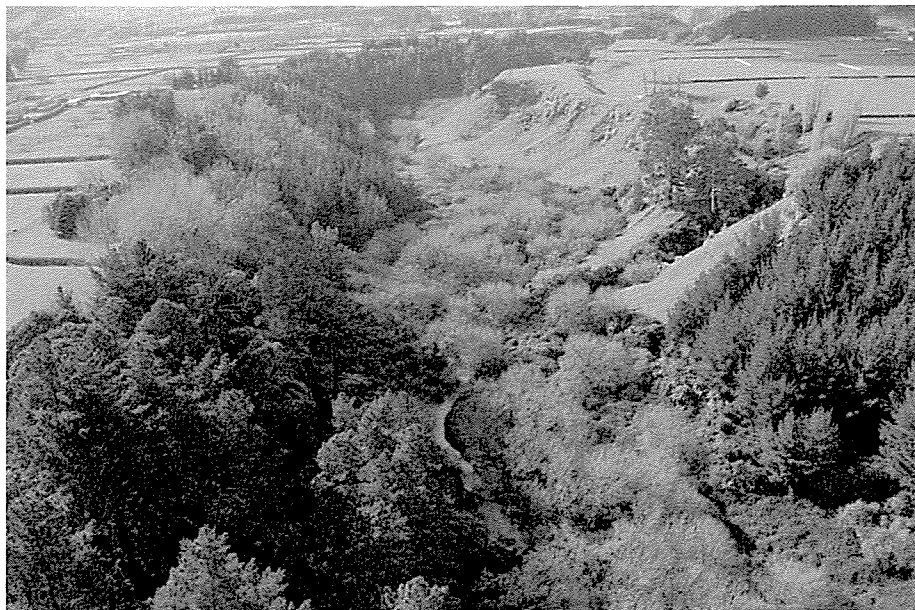
Figure 3: Cambridge Bypass proposed crossing of Karapiro Gully Stream

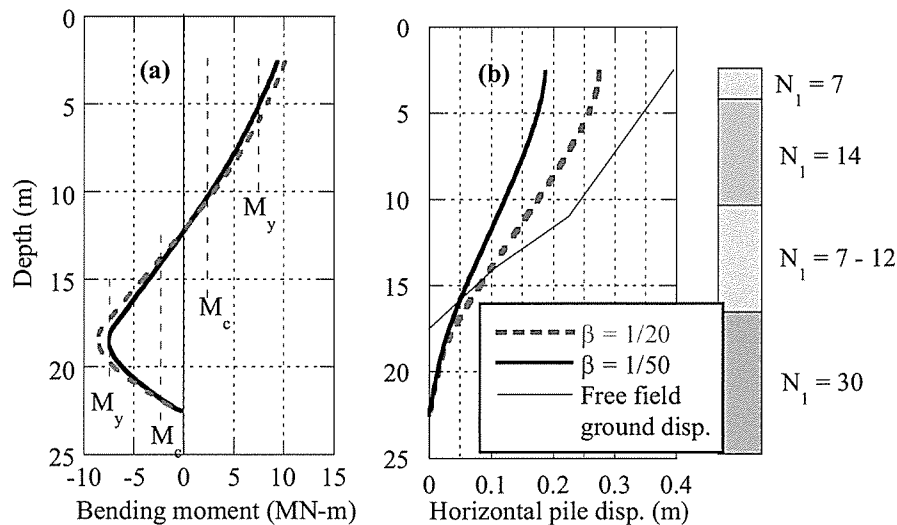
Figure 2: Variation of pile response due to liquefied layer soil stiffness; (a) pile bending moment, (b) pile displacement

Figure 2 shows that for both cases the maximum bending moments occur at the pile head and at the interface between the liquefied and non-liquefied soil layers. With regard to the pile displacements the $\beta = 1/50$ case demonstrates stiffer pile behaviour, where relatively stiff pile resists the movement of the surrounding ground. For the $\beta = 1/20$ case the liquefied soil is softer, the pile shows more flexible behaviour and the pile displacement and bending moment is higher than the $\beta = 1/50$ case.

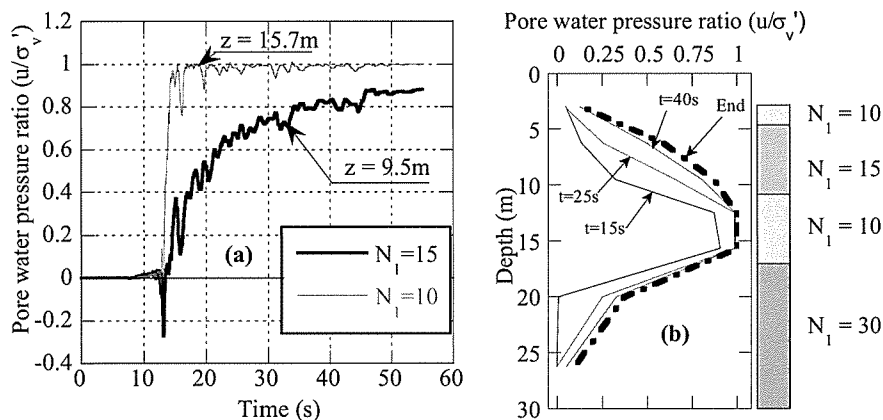
Figure 3: Excess pore water pressures in the free field; (a) time histories showing the development of pore pressure and eventual liquefaction at different depths, (b) distribution of excess pore water pressure ratio throughout the depth of the profile at different times

First we will examine the computed ground response in the free field, which is not affected by the presence of the pile foundation. Figure 3a shows computed time histories of excess pore water pressure at two different depths throughout the soil profile in the free field. Here $z = 9.5$ m and $z = 15.7$ m depths correspond to the top parts of the second layer ($N_1=15$) and the third layer ($N_1=10$) respectively.

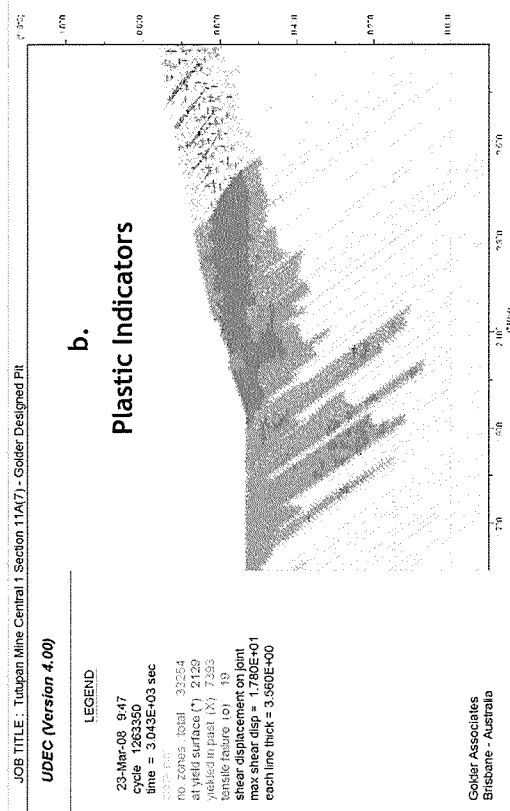
Figure 4: Example of failure in a. low wall, b. high wall

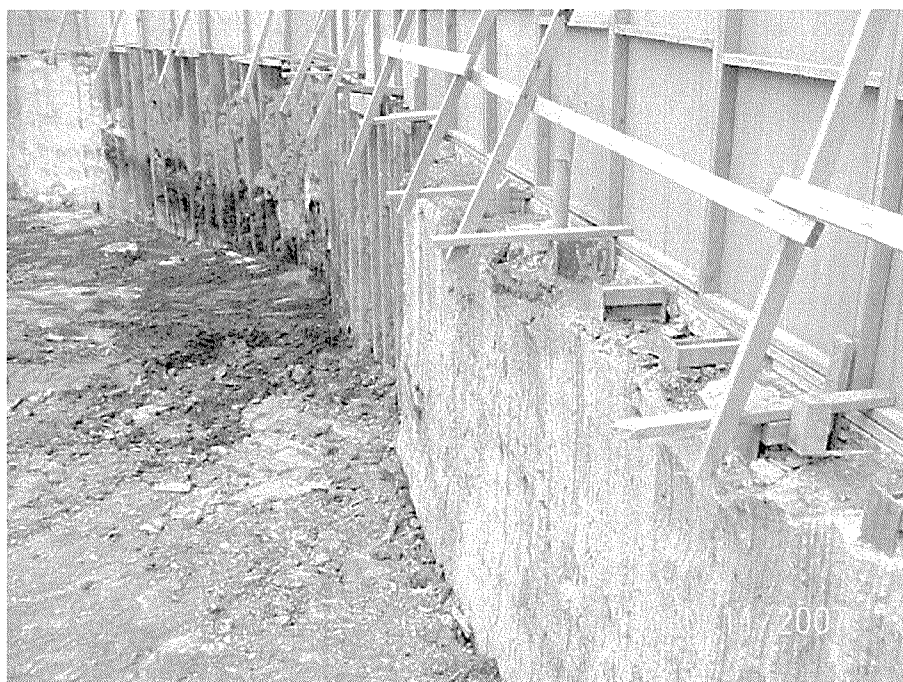
Figure 4: Sheet pile and CSM wall at Fanshawe Street, Auckland

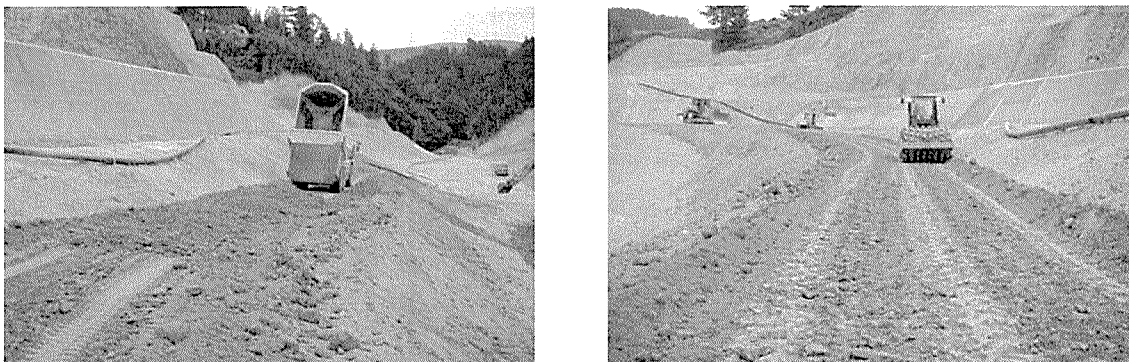
Figure 4: Low permeability compacted clay soil installation

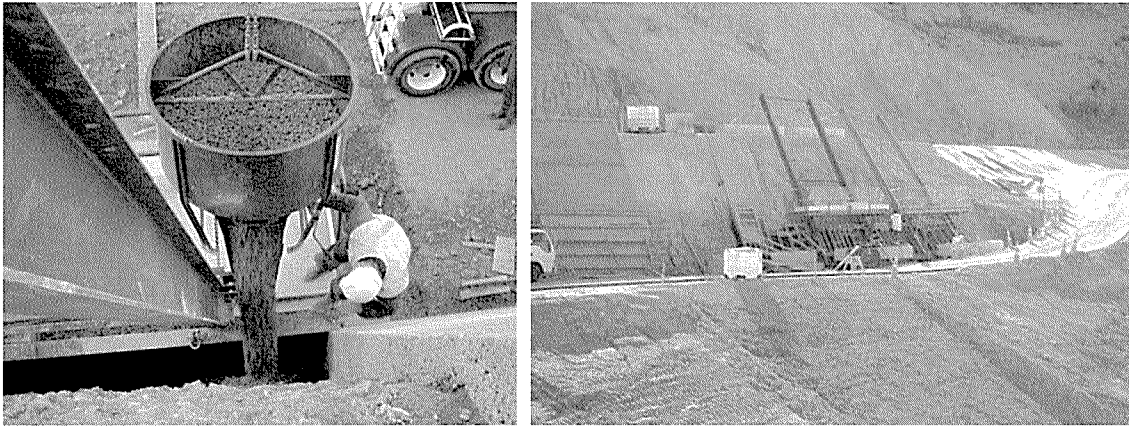
Figure 5: “No fines” concrete installation

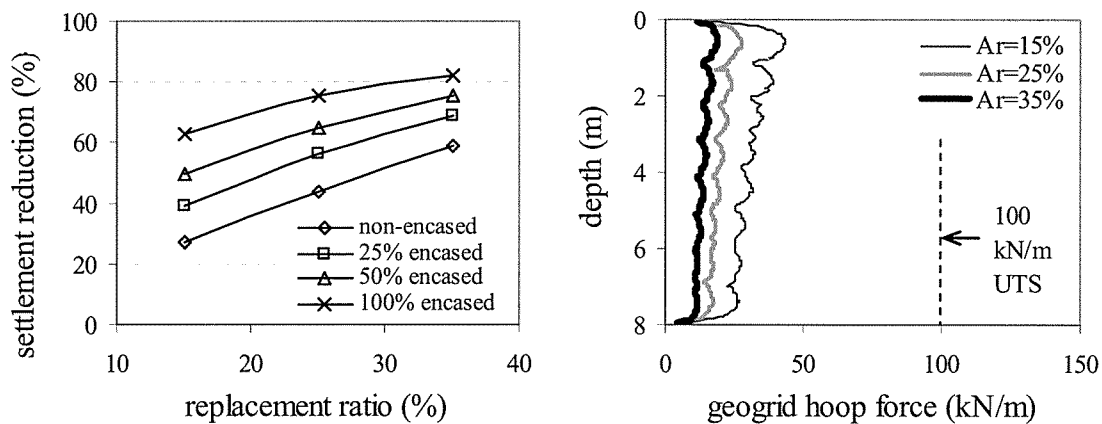
Figure 4: Results of numerical modelling for encased stone columns installed in CIS

The properties of Secugrid® (produced by Naue GmbH) were used for the geogrid tensile elements in the numerical model. A Secugrid® material of medium stiffness and strength (ultimate tensile strength, UTS, of 100kN/m at a strain of about 6%) was adopted. Columns with 25%, 50% and 100% encasement were modelled and the behaviour compared to non-encased columns in Figure 4. The hoop forces within the geogrid for fully encased columns at different replacement ratios are also presented in Figure 4. Results of the full-scale study indicated similar reductions in vertical strain with increased encased length to small-scale tests.

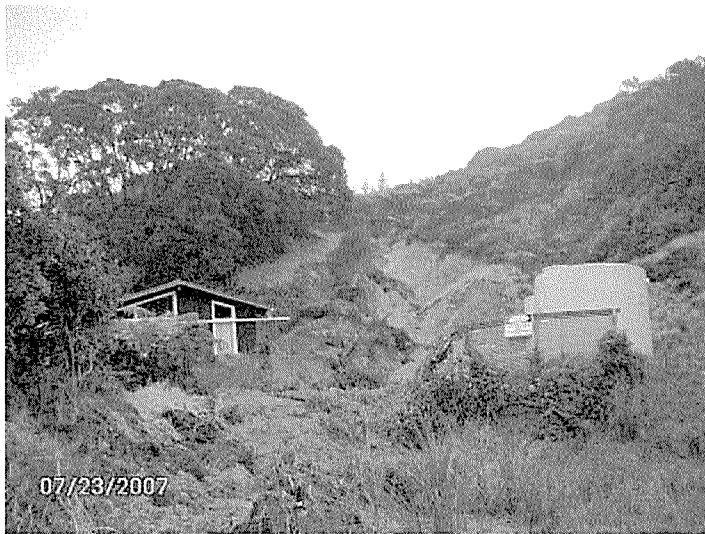
Figure 4: Looking west at headscarp of landslide

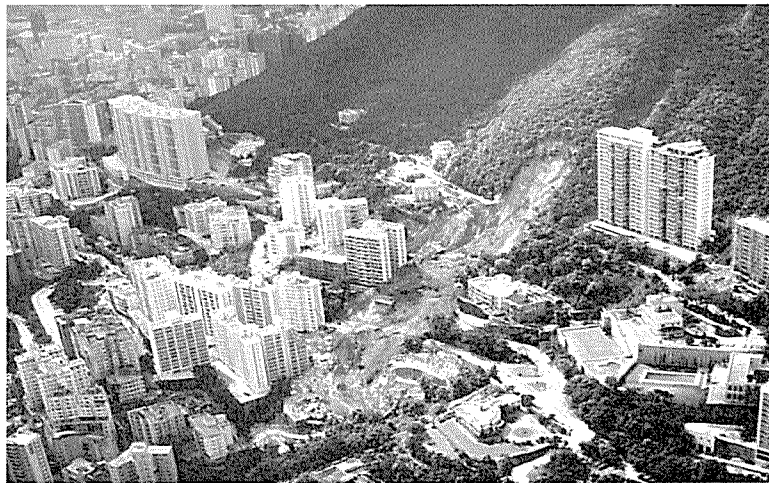
Figure 2: Po Shan Road Landslide, 18 June 1972. A four-storey building and a 15-storey apartment block were demolished during the landslide, resulting in 67 deaths

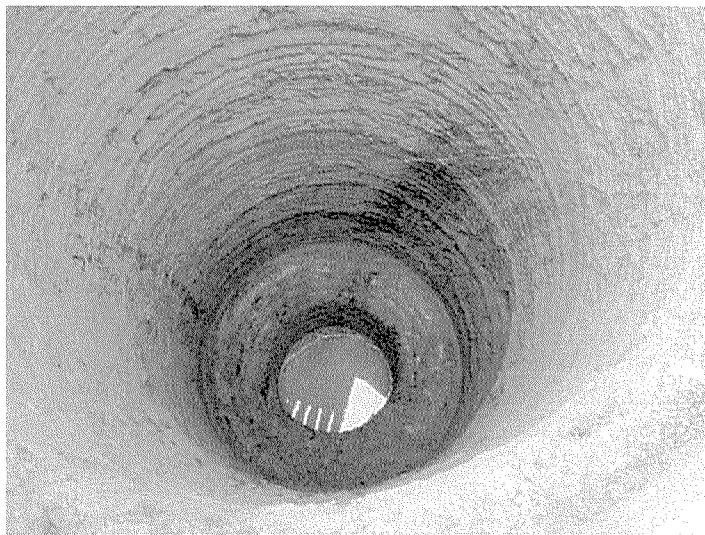
Figure 2: Typical view of a 7m deep, 2.4m diameter pile shaft taken during a site inspection

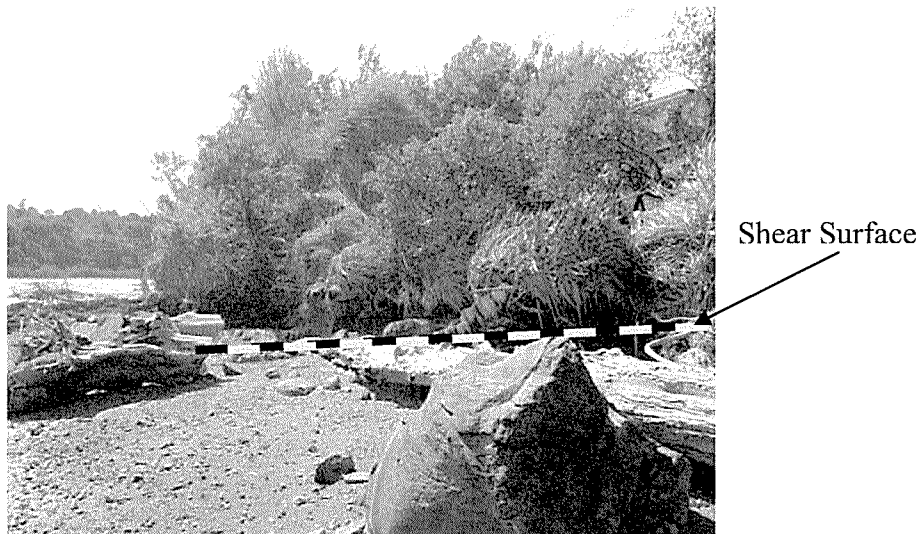
Figure 3: Residual soils sliding over mudstone as seen from shore platform

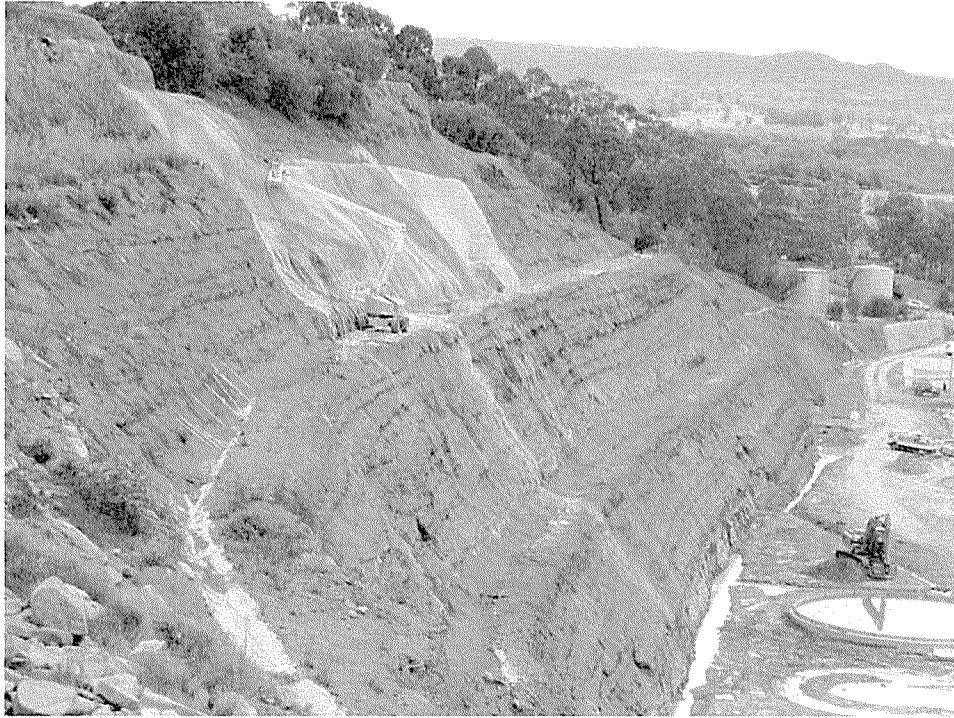
Figure 2: Stabilisation works in progress

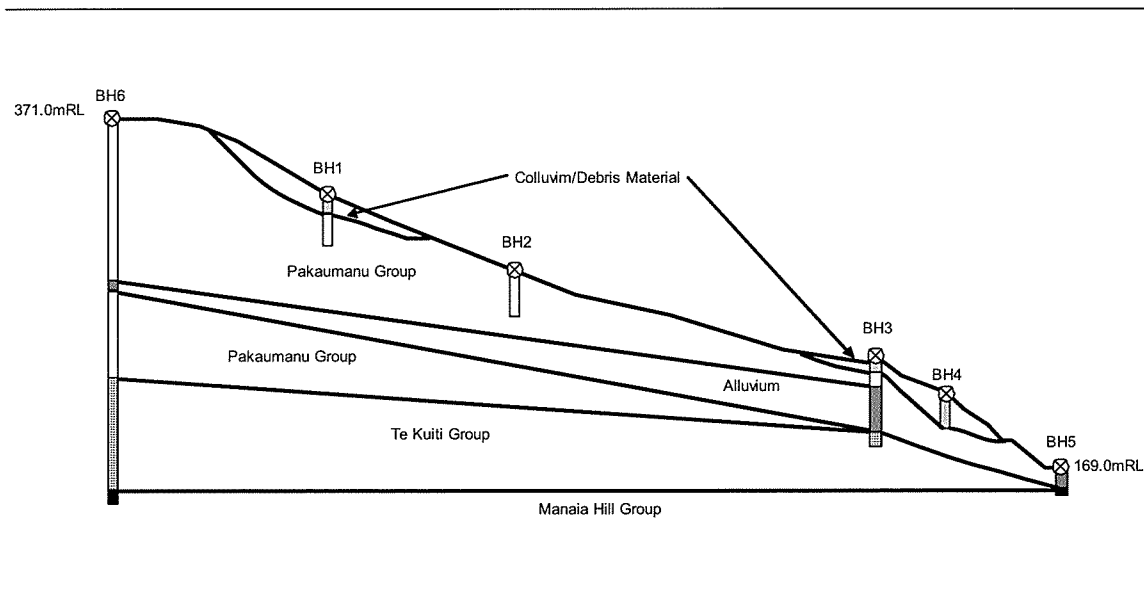
Figure 1: Subsurface stratigraphy

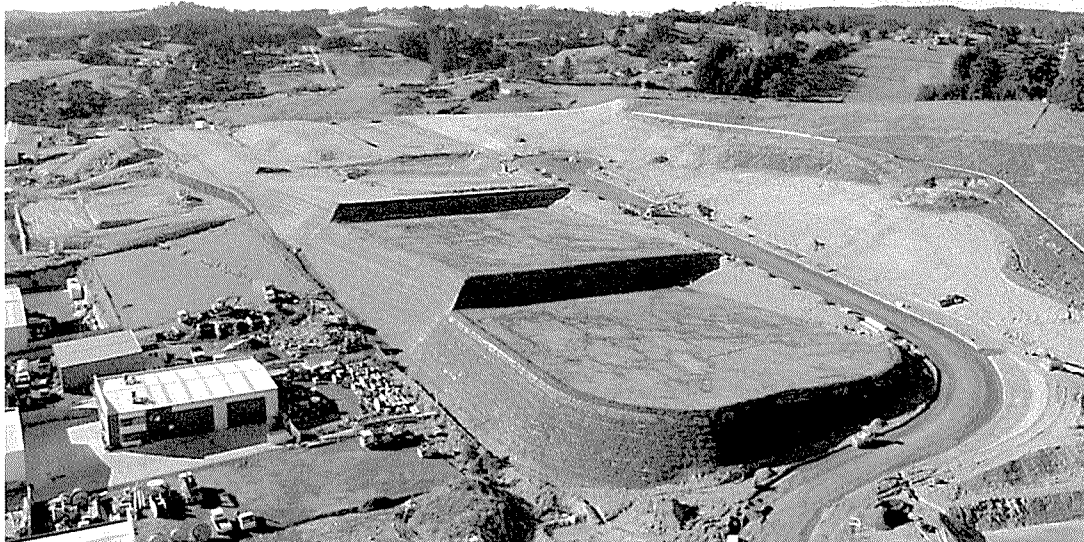
Figure 2: Reinforced Soil Slope during construction.

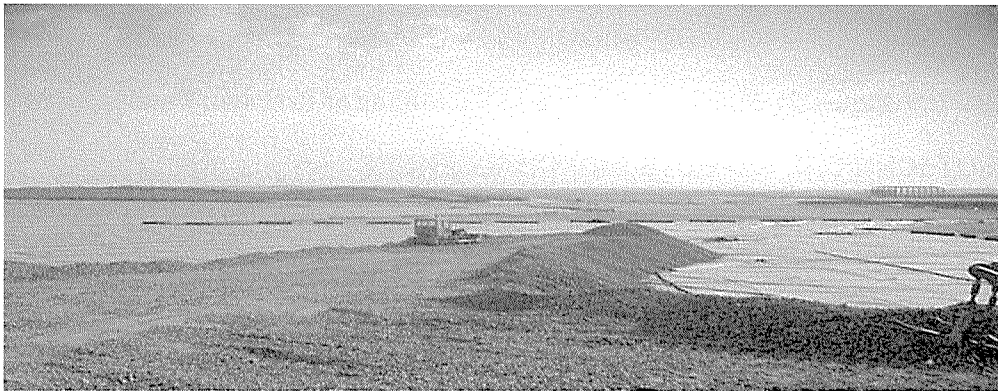
Figure 1: Heap Leach Pad
