# ANZ 2015 THE CHANGING FACE OF THE EARTH

Geomechanics & Human Influence  
22-25 February 2015, Wellington, New Zealand

**12th Australia New Zealand Conference on Geomechanics (ANZ 2015)**

**“The Changing Face of the Earth – Geomechanics & Human Influence”**

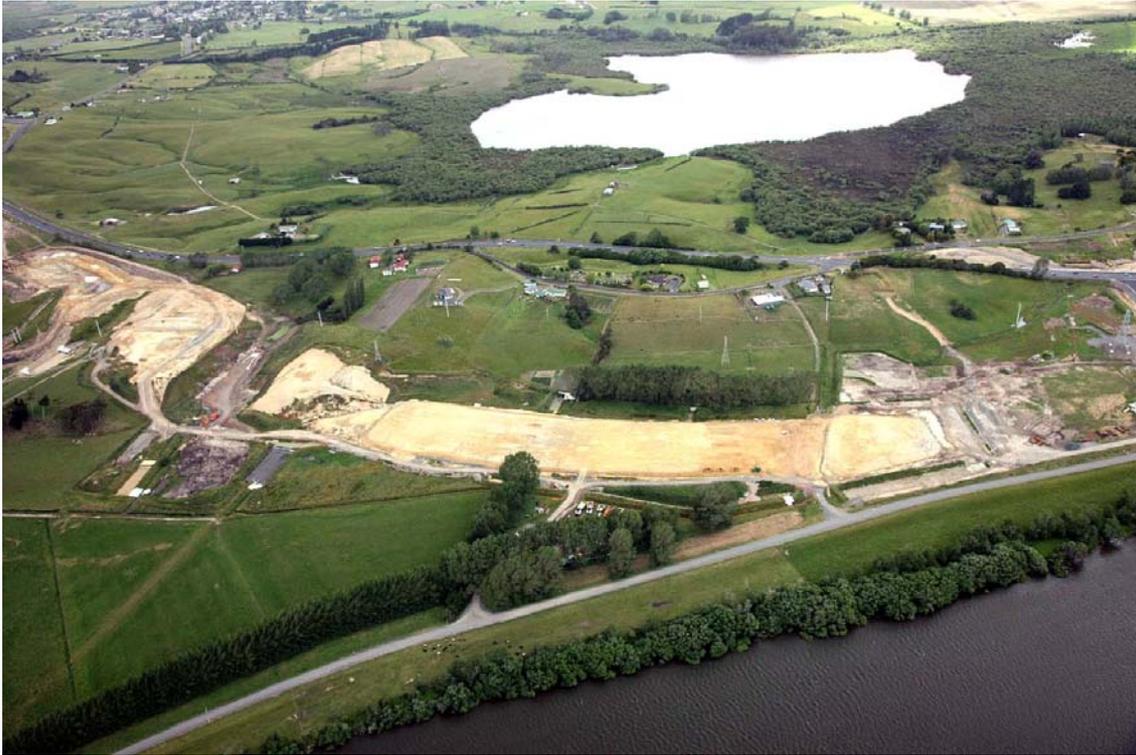
Figure 1. Aerial view of the earthworks in progress for the embankment on soft ground adjacent to the Waikato River

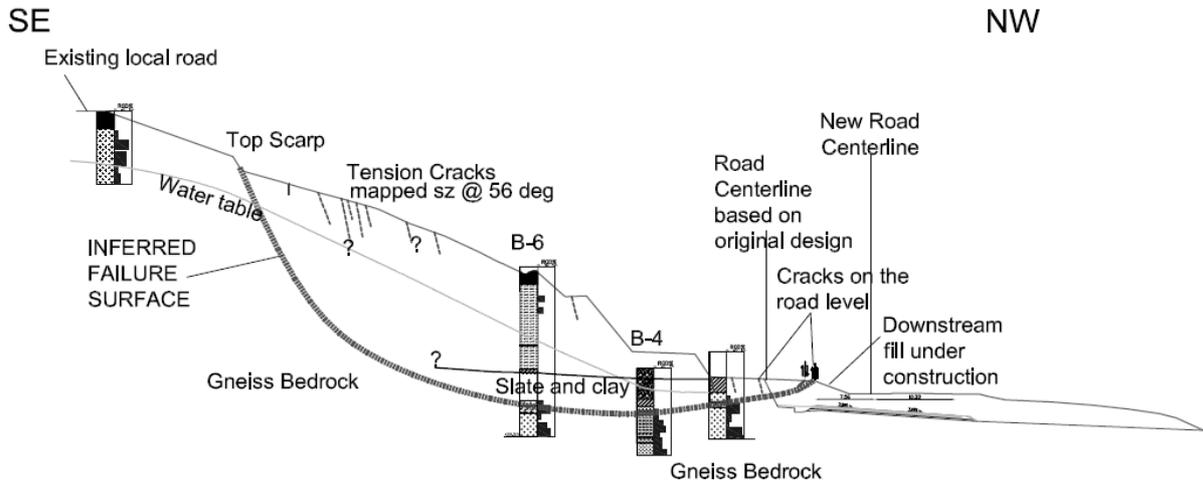
Figure 11. The mechanism of failure at Cut 19.

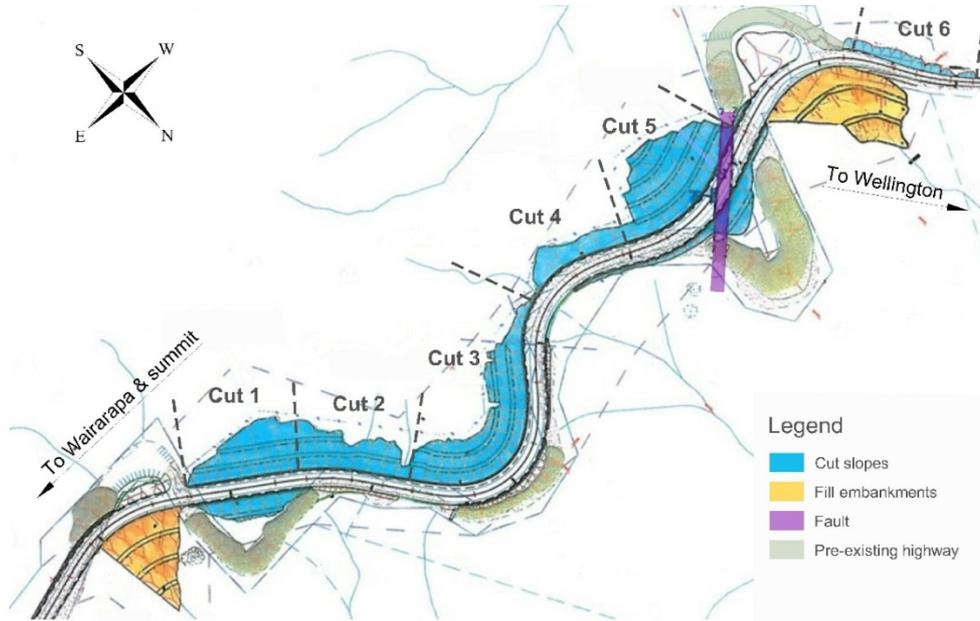
Figure 2. Layout of proposed Cuts (blue) and Fills (brown), showing the previous road line (grey)

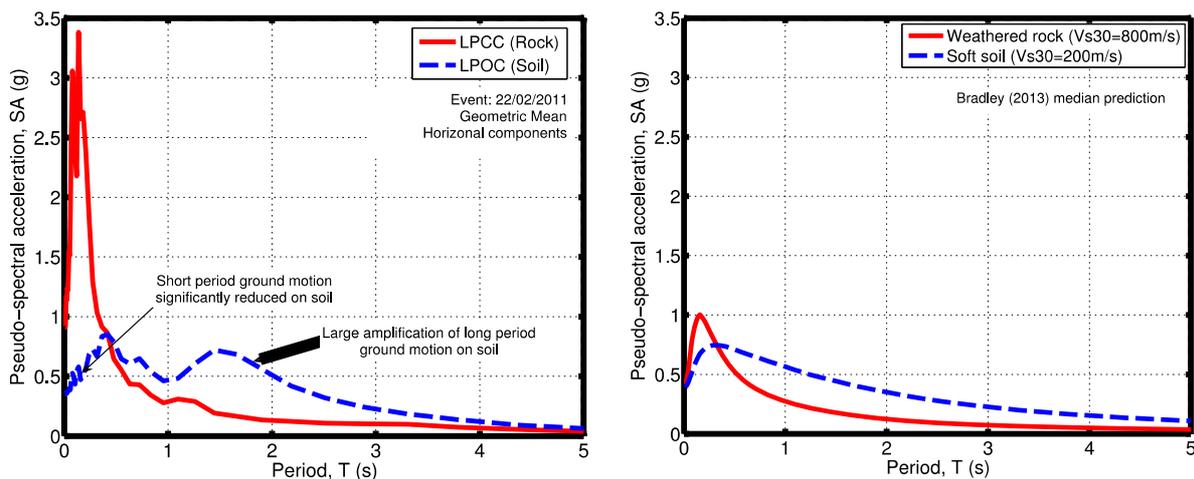
*Figure 3. Illustration of the consideration of nonlinear site effects in empirical ground motion prediction models: (a) observed horizontal response spectra at rock and soil sites in Lyttelton Port in the 22 February 2011 Christchurch earthquake (Bradley and Cubrinovski 2011); and (b) nonlinear site effects based on the Bradley (2013) GMPE median prediction.*

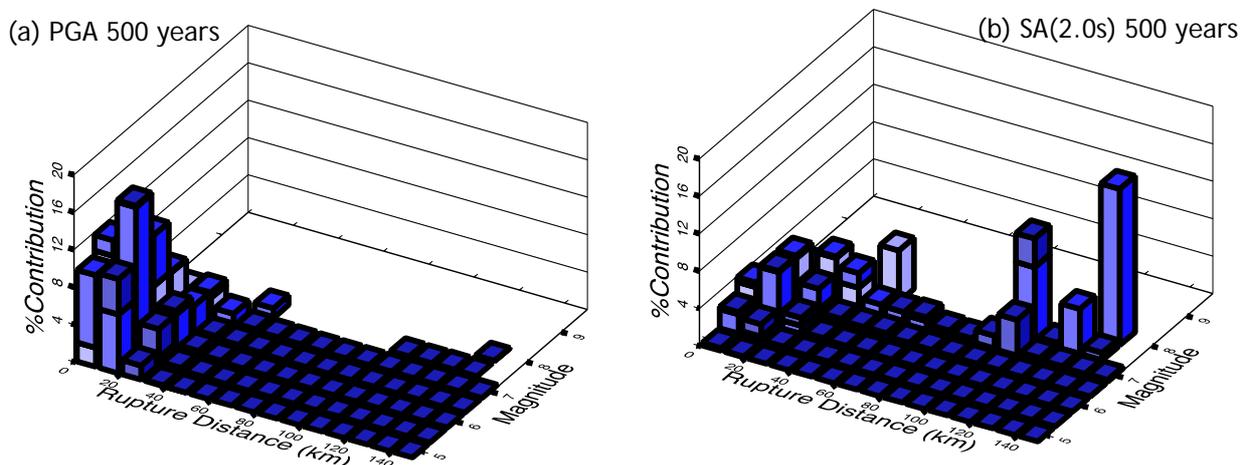
Figure 4. Seismic hazard deaggregation illustrating the dominant seismic sources contributing to the total seismic hazard: (a) Christchurch – PGA; and (b) Christchurch SA(2.0s).

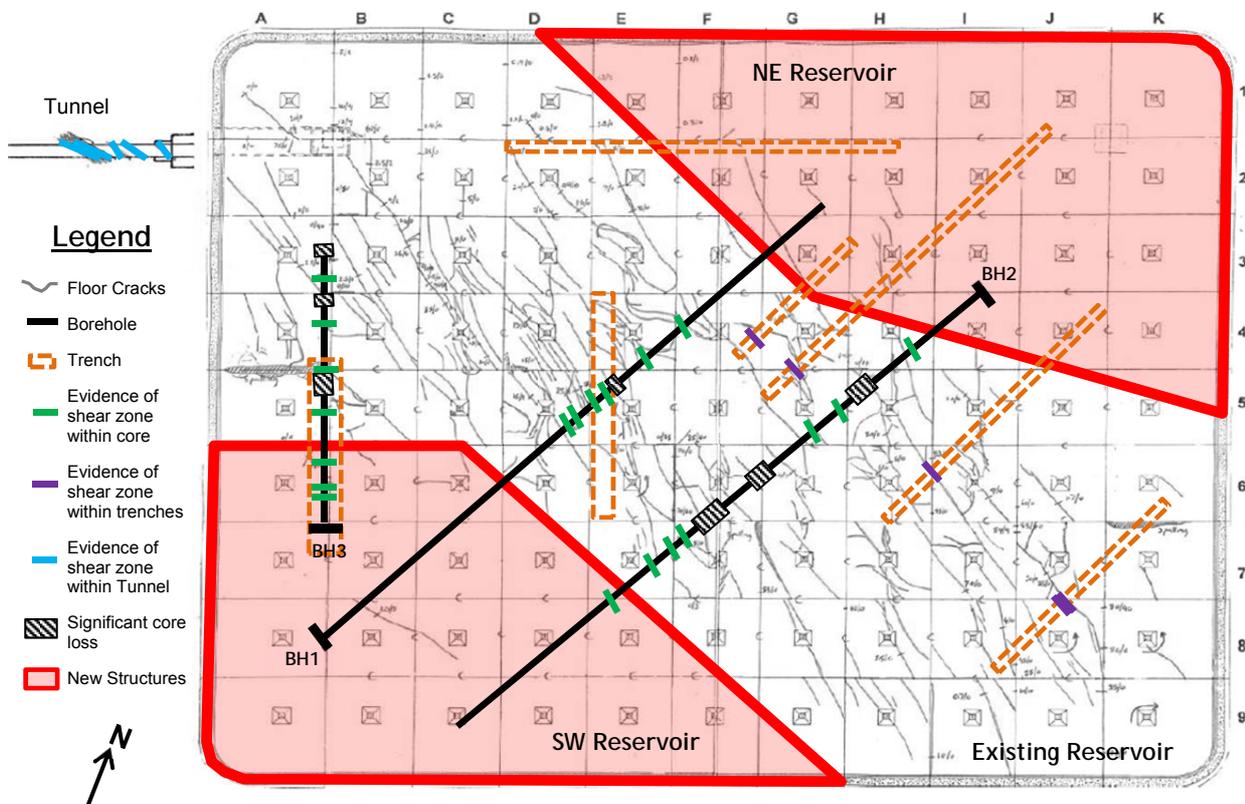
Figure 1. Plan showing: mapped cracking on the reservoir floor and in the tunnel, borehole and trench investigation locations and evidence of shearing, modified positions of reservoir walls

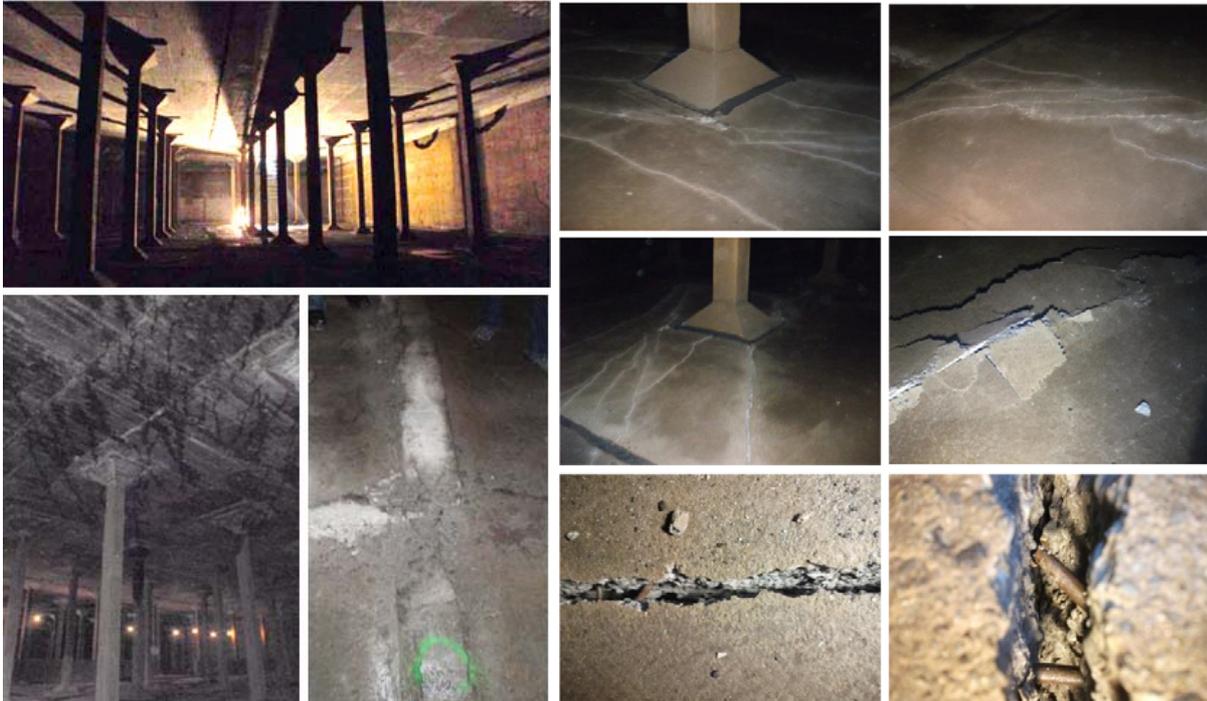
Figure 2. Photos showing structural damage to the reservoir roof and floor

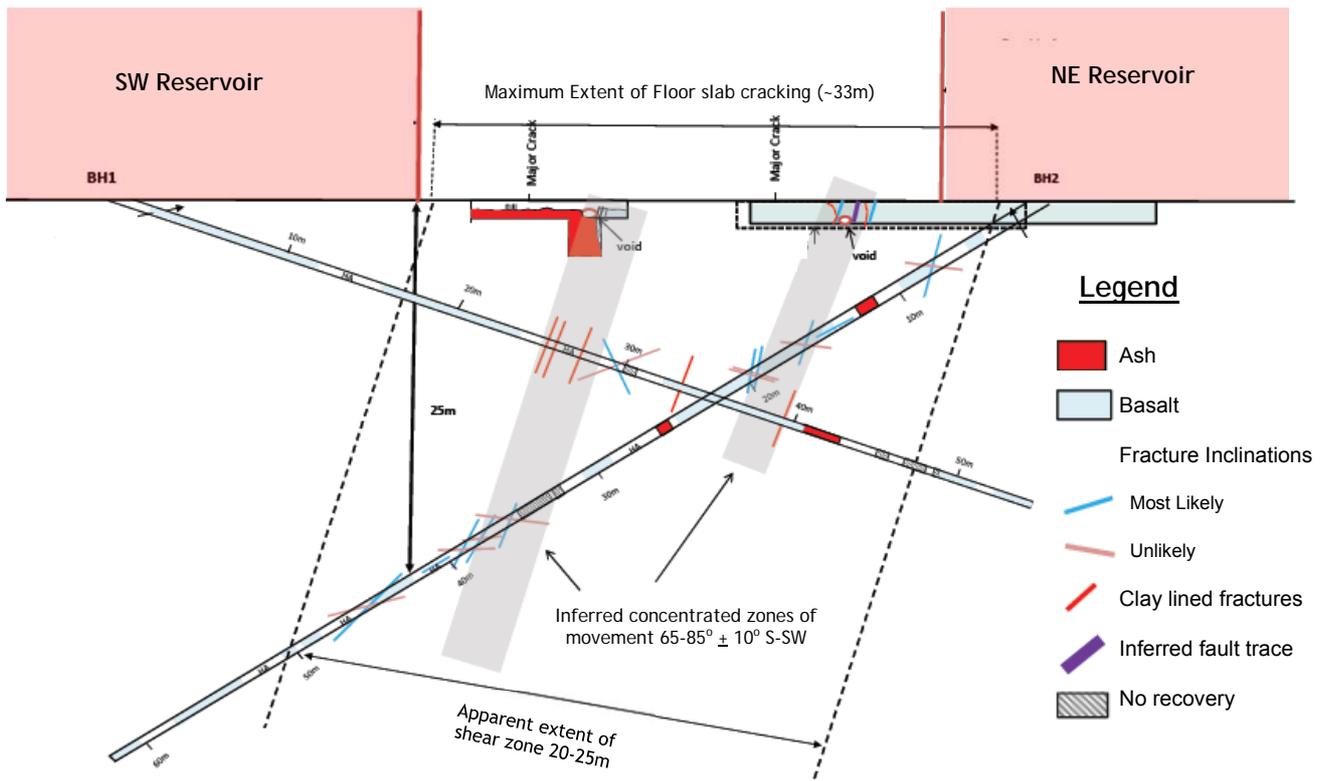
Figure 4. Interpreted cross-section of shear zone developed from subsurface investigations and surface mapping of structural damage.

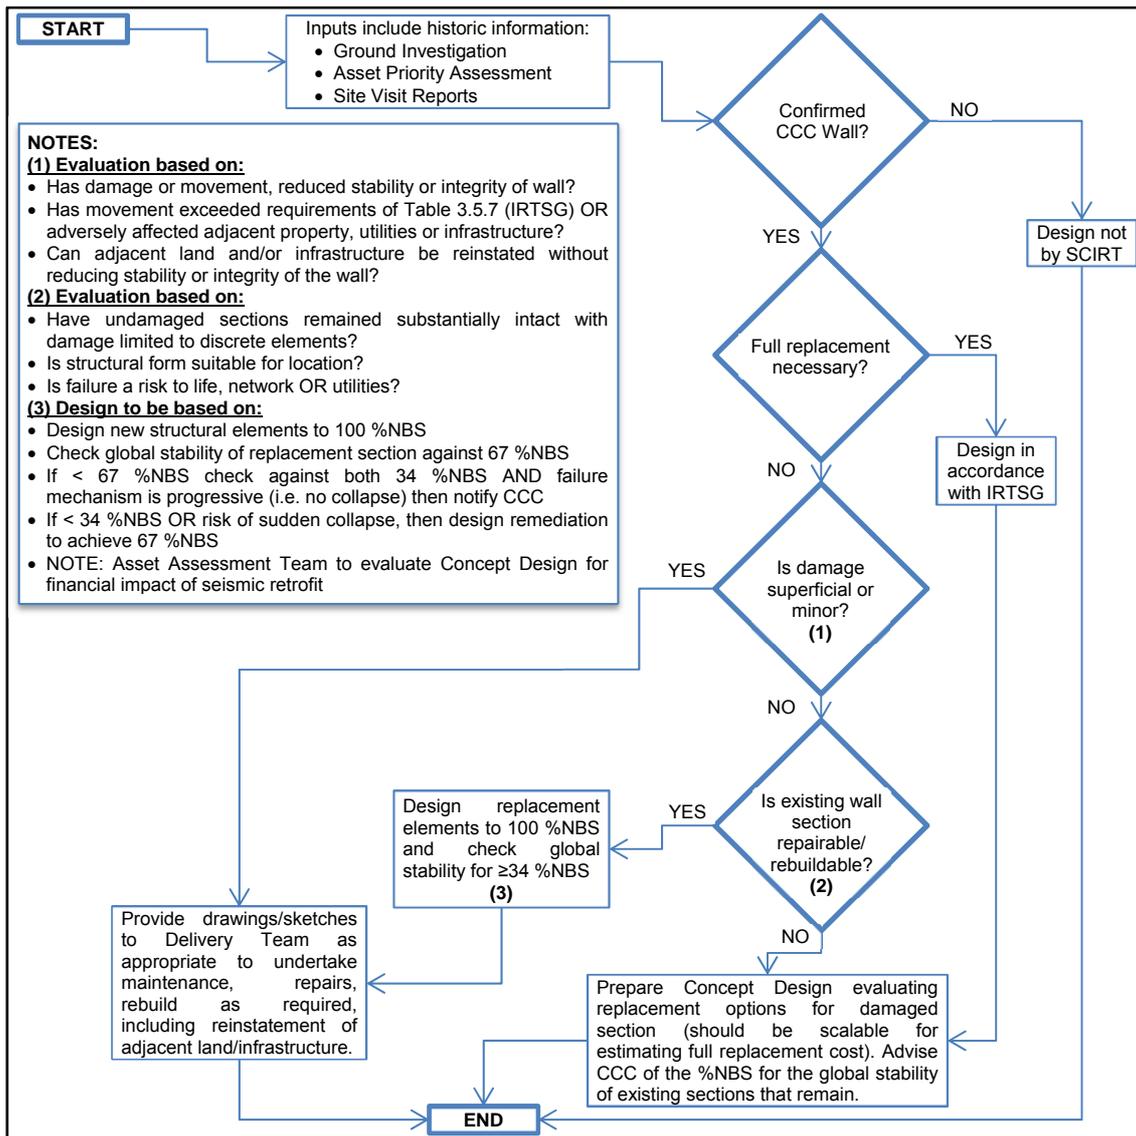
Figure 2. Design Guideline 015 - Retaining Wall Concept Design Option Generation

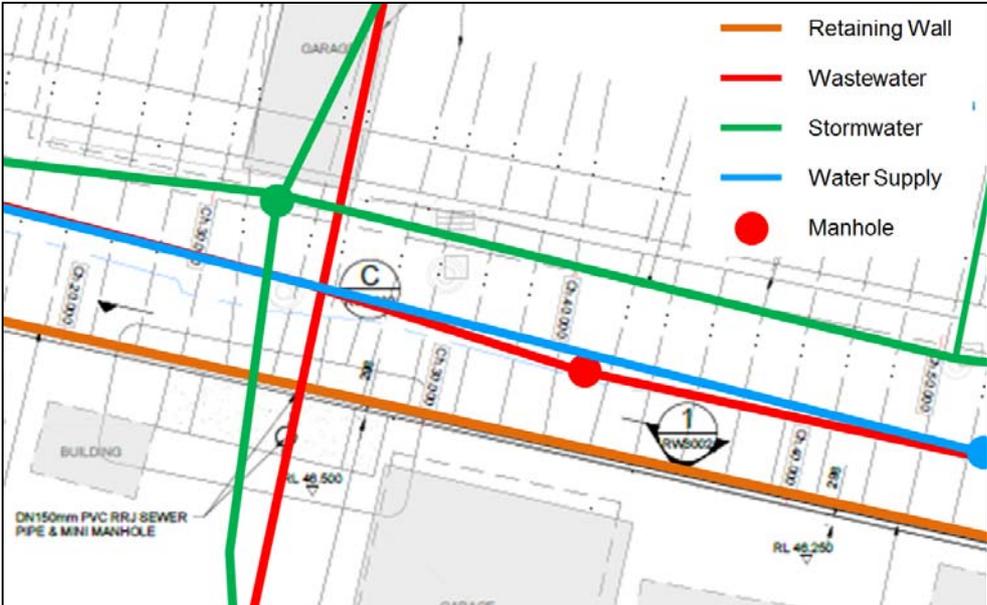
Figure 5. Buried Services adjacent to Cunningham Terrace Retaining Wall

Coordination between all the aspects of the project was important because there were a number of conflicts between assets. These can be seen in Figure 5. A number of anchors were installed at an angle to avoid manholes and sumps behind the wall and a few anchors are above the wastewater pipes at the west end of the site so as the required grade could be achieved. There had been a wastewater drop structure behind the wall to convey wastewater from Cunningham Terrace to the wastewater line below. This was replaced with a drop structure in front of the wall so it could be accessed if required and a manhole was added. To accommodate this a retaining wall panel was designed with a hole in it for the wastewater pipeline to pass through.

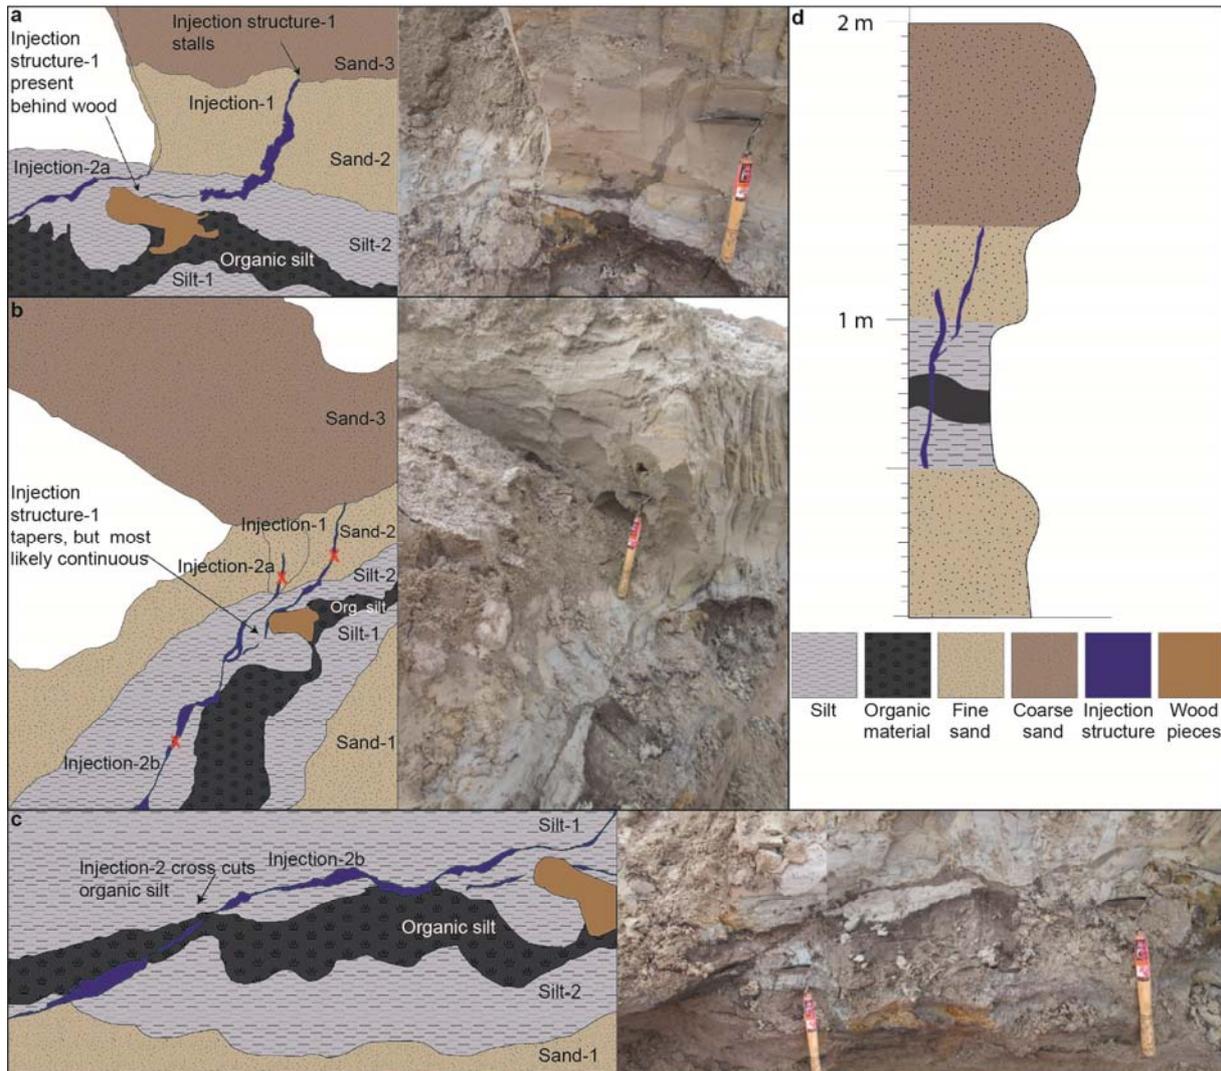
Figure 2. Injection structures for Site 15. (a) Injection-1 intrudes through Silt-1 and Sand-2; width: 0.03 m; vertical height: 0.30 m; horizontal length 0.48 m. (b) and (c) Injection-2 intrudes through Silt-1, Organic silt, Silt-2, and Sand-2; width: 0.01-0.02 m; vertical height: 0.10 m; horizontal length 1.20 m. Sample sites are indicated by the red X. (d) Stratigraphy at Site 15. Cutting tool is ~30 cm in length.

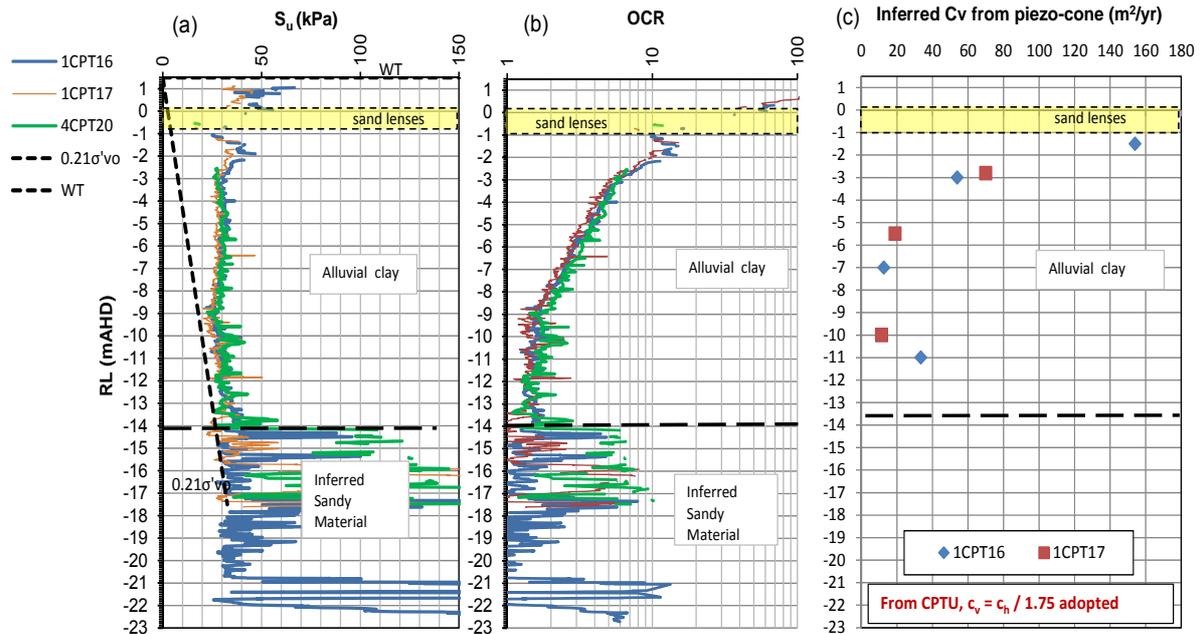
Figure 3. Typical profiles of (a) Piezocone inferred  $s_u$  vs. RL, (b) Piezocone inferred OCR vs. RL and (c) Inferred  $c_v$  vs Reduce Level (RL) at Nambucca Floodplain

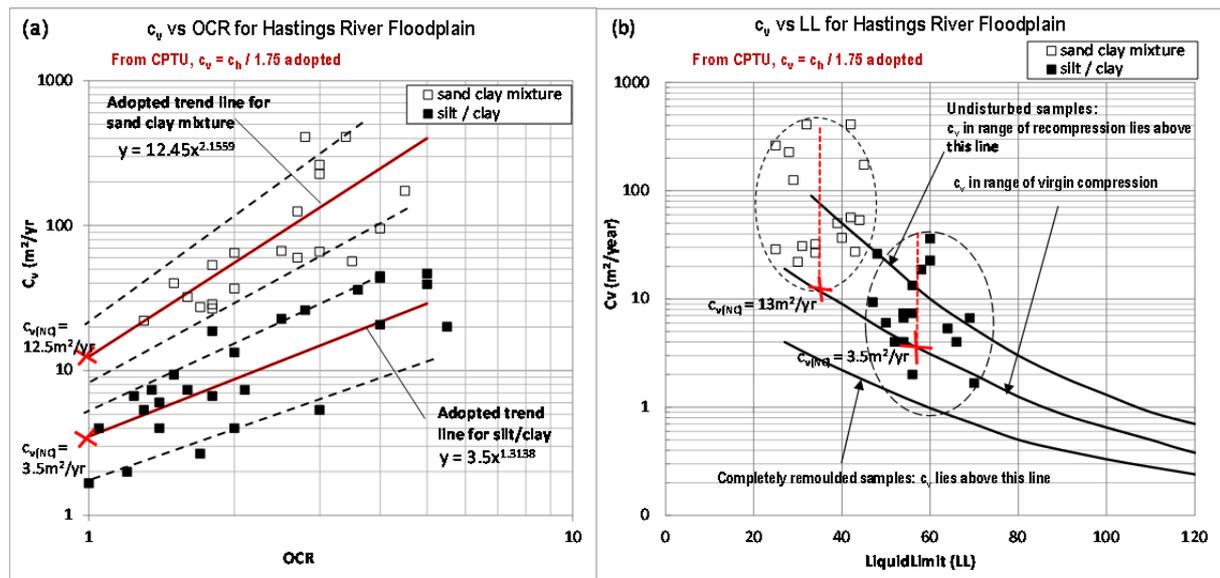
Figure 5. (a)  $c_v$  vs OCR, (a)  $c_v$  vs LL for silt/clay and sand clay mixture (Hastings River Floodplain)

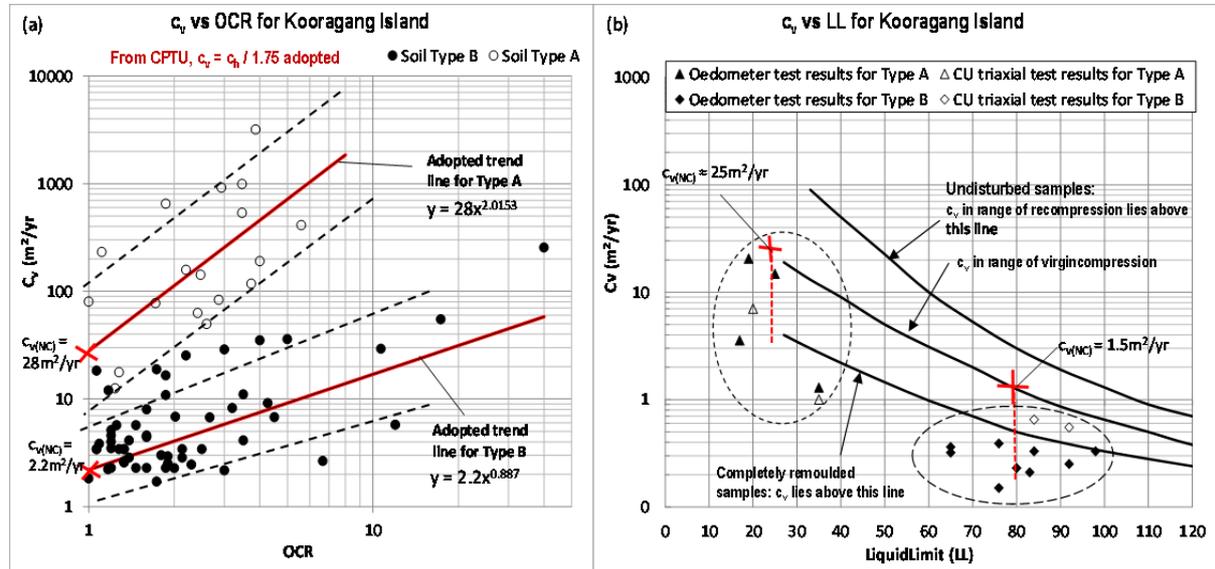
Figure 6. (a)  $c_v$  vs OCR, (a)  $c_v$  vs LL for Soil Types A and B at Kooragang Island

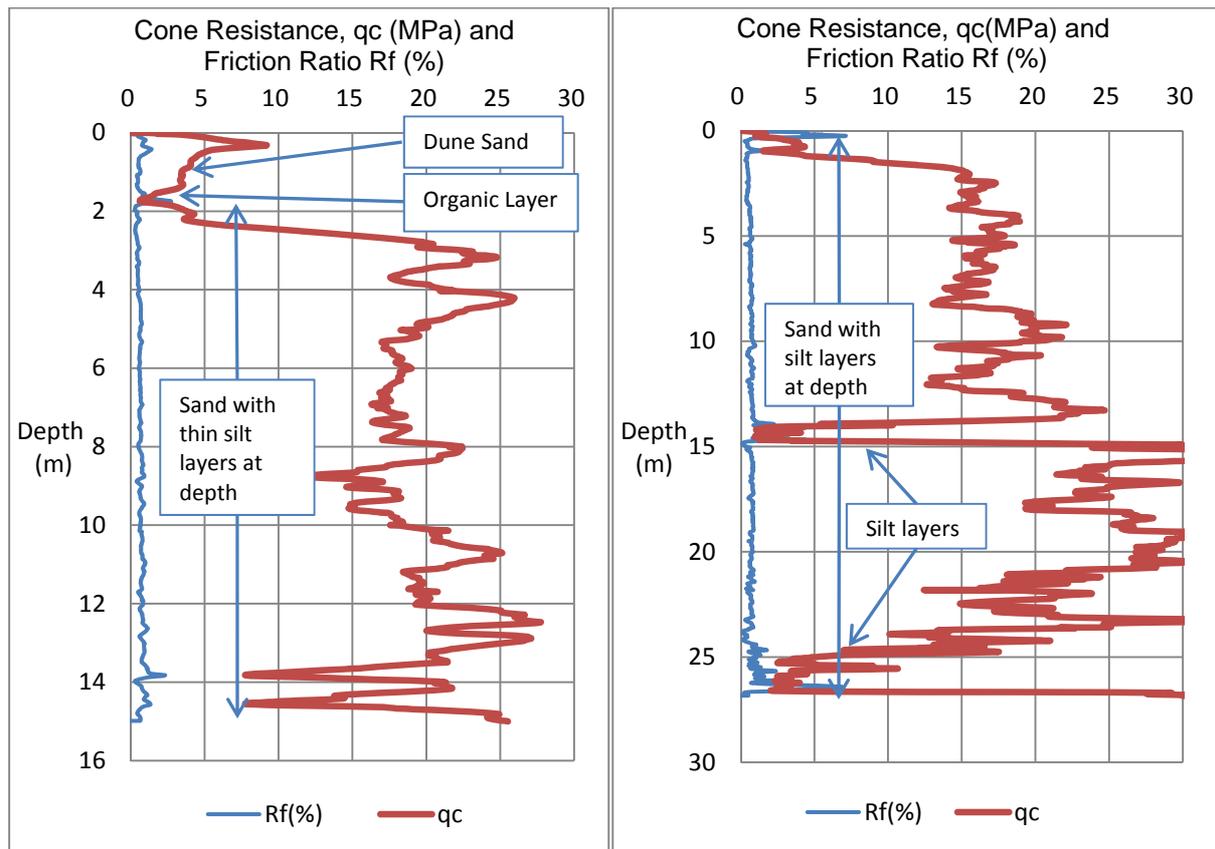
Figure 1. a) Typical CPT profile in an area of dune sand and b) typical CPT profile in a beach sand area

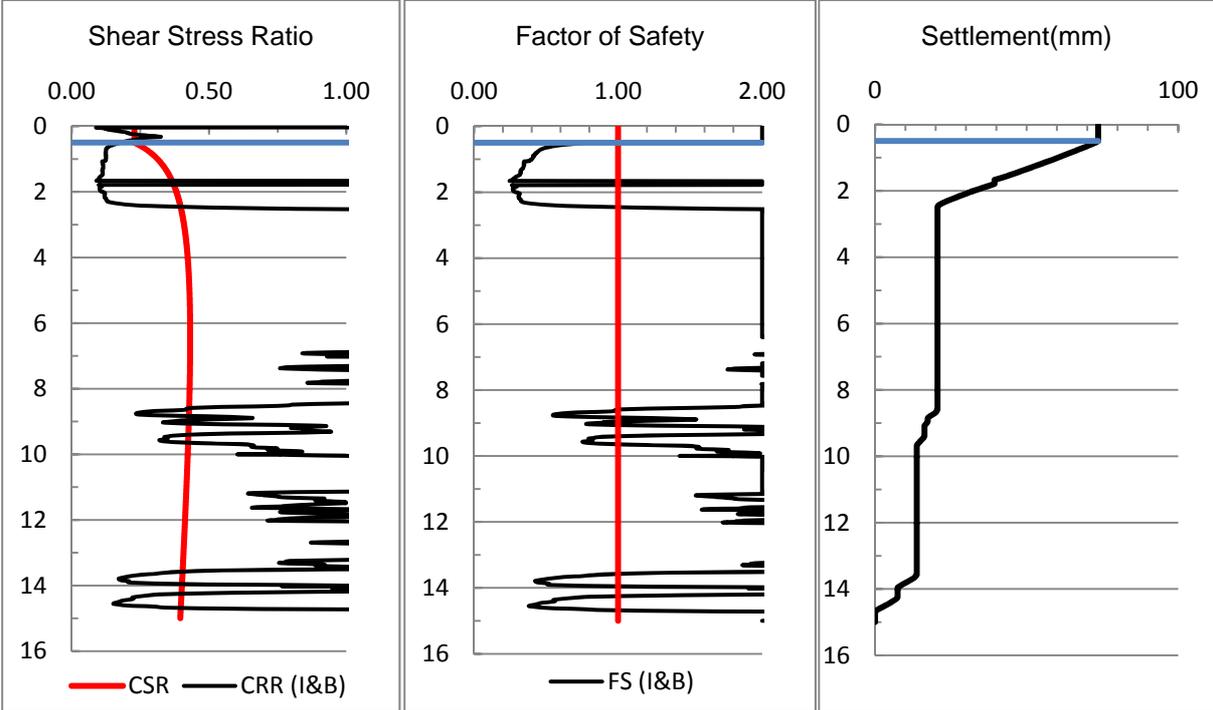
Figure 2a. Typical liquefaction profile within the **dune sand** for the ULS case, based on the Idriss and Boulanger method

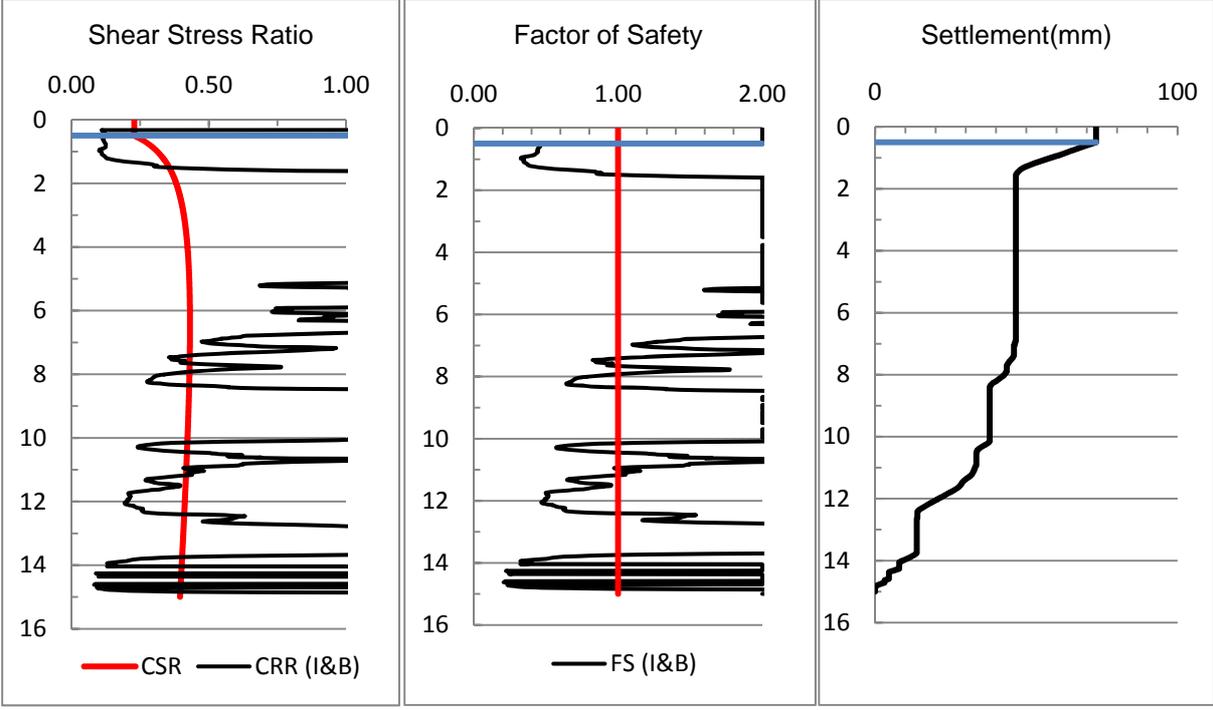
Figure 2b. Typical liquefaction profile within the **beach sand** for the ULS case, based on the Idriss and Boulanger method

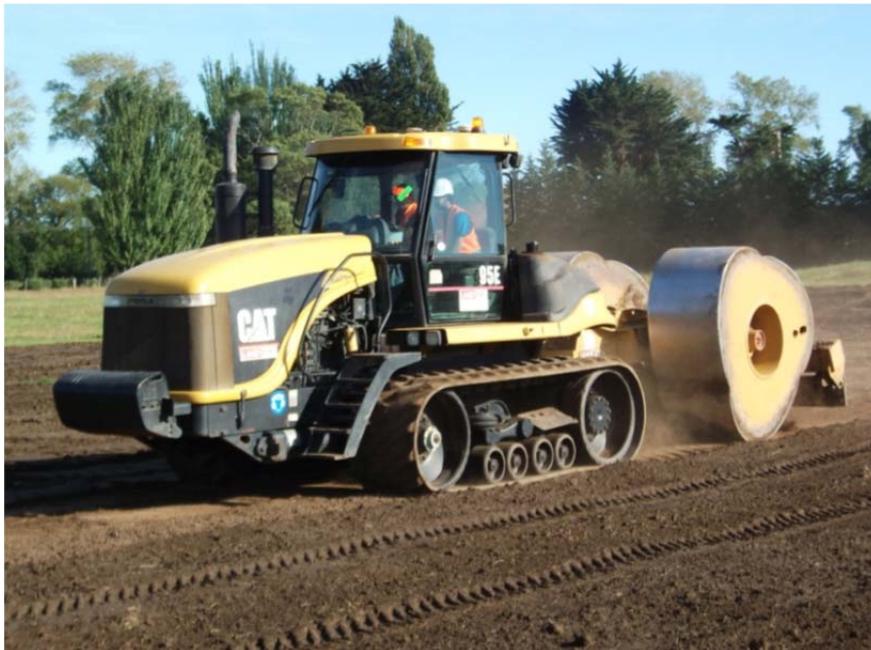
*Figure 3. Impact compactor working at the Prestons Subdivision*

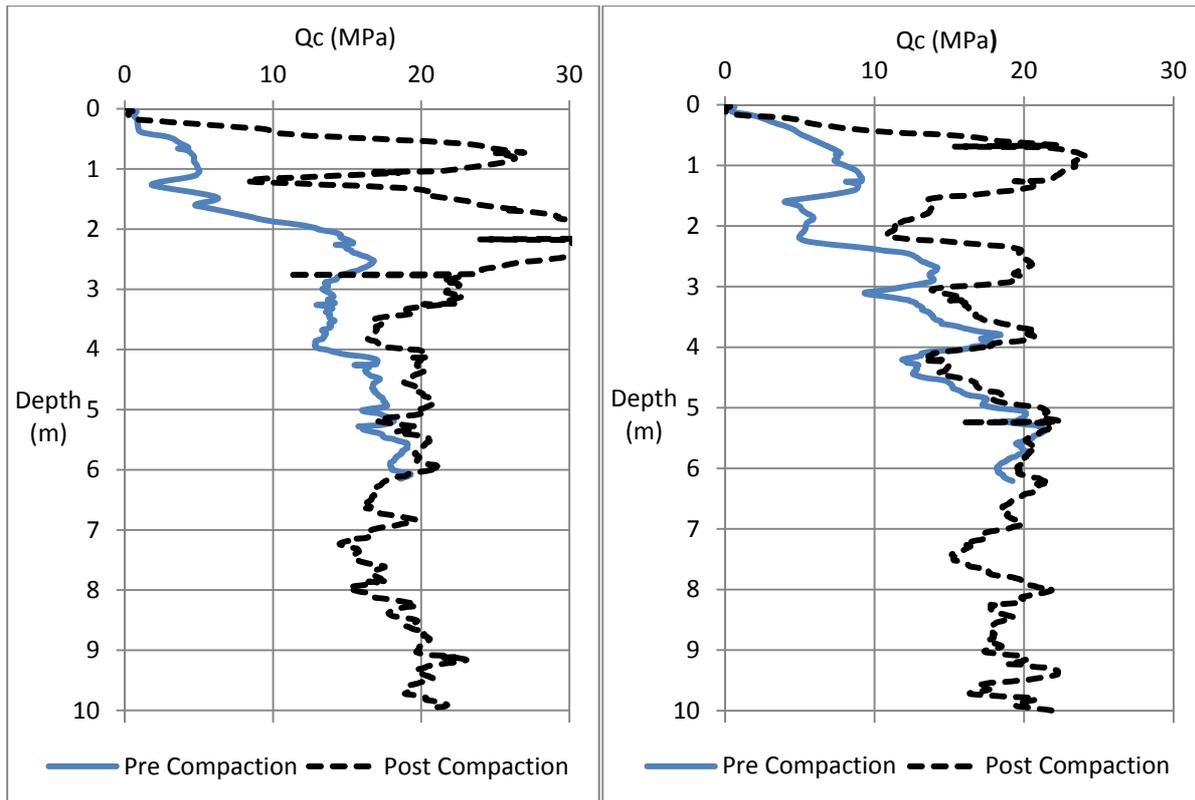
Figure 5. a) and b) Two CPT profile comparisons where impact compaction was undertaken

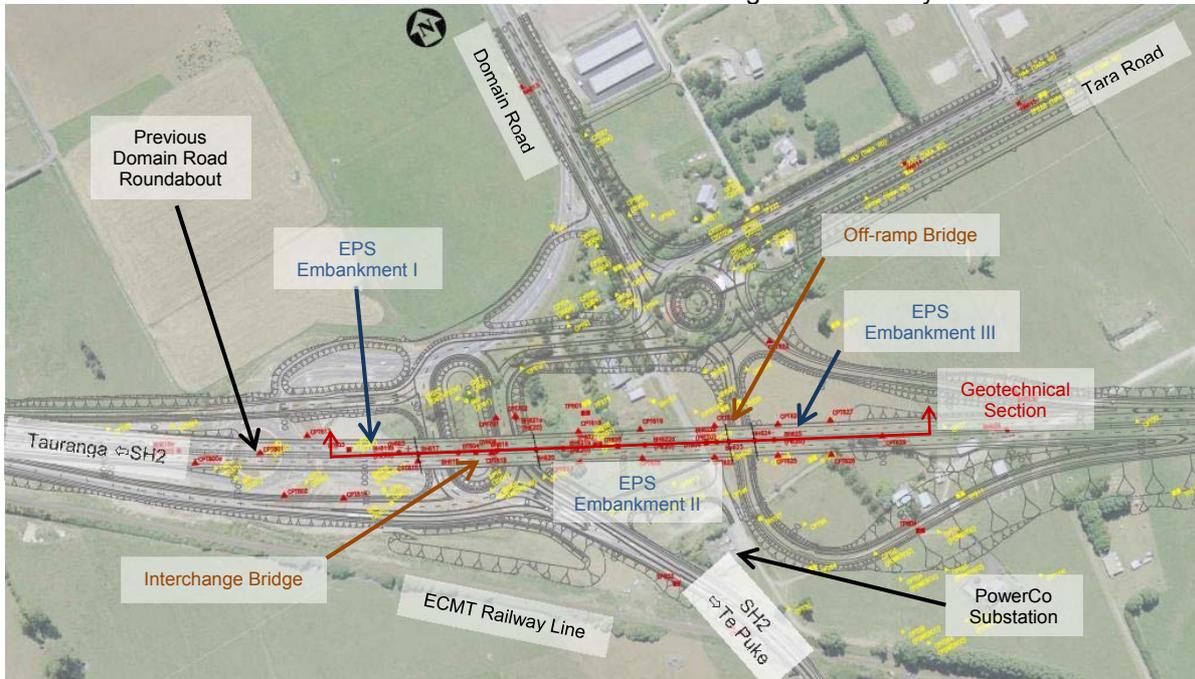
Figure 1. Site Plan Domain Road Interchange

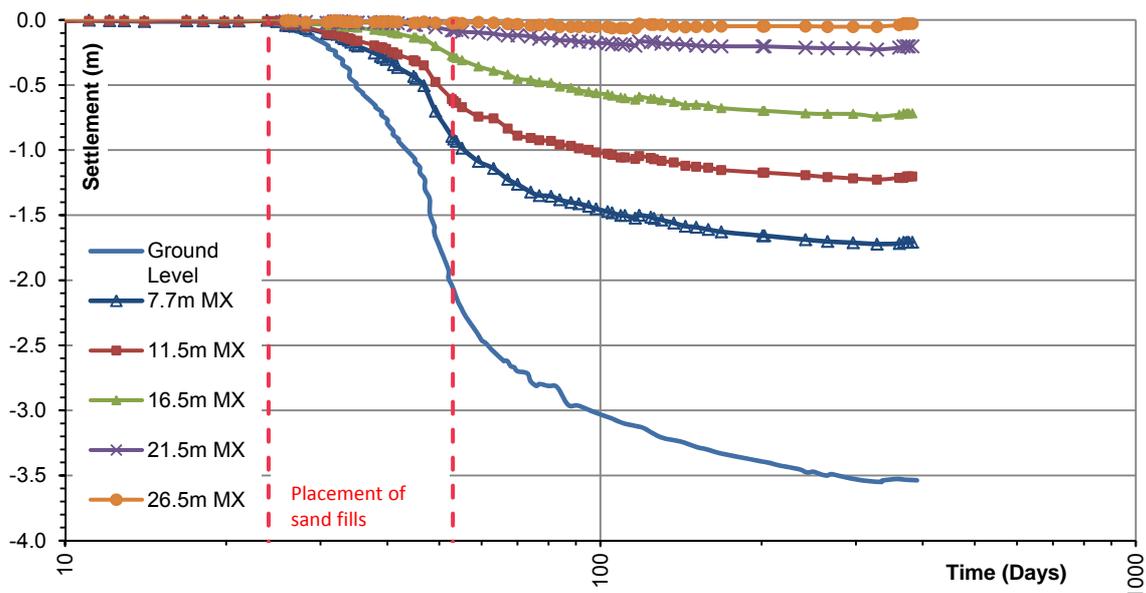
*Figure 3. Trial Embankment Settlement Monitoring*

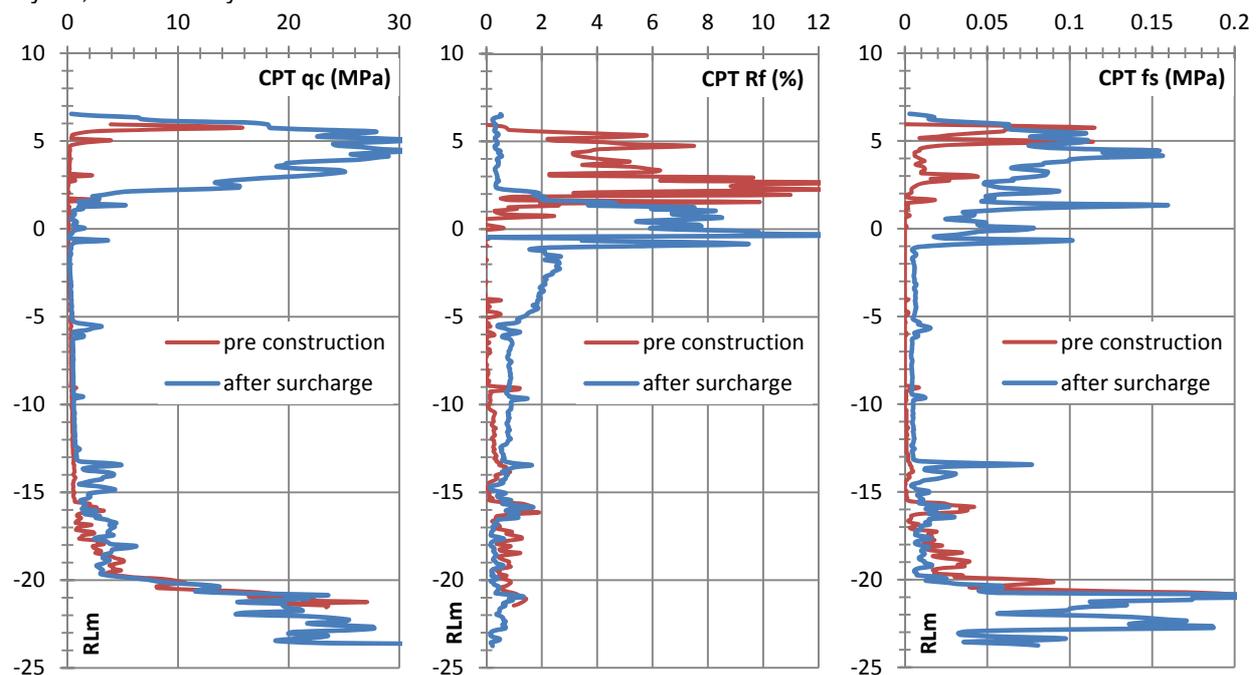
Figure 4. CPT Investigation Data prior and after Surcharging

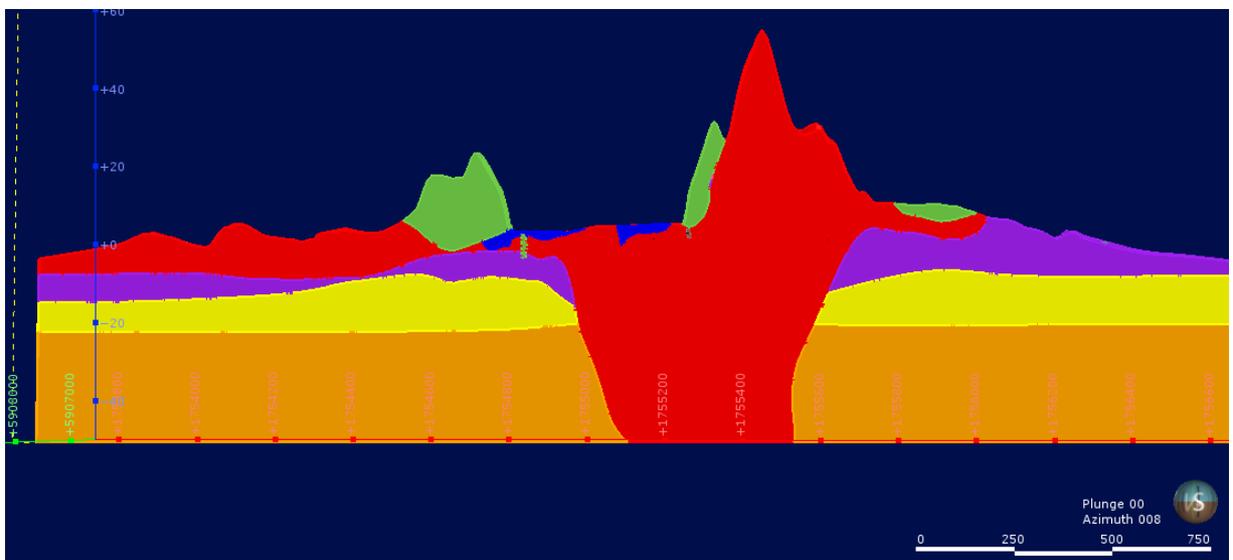
Figure 4. Leapfrog viewer output showing an example 2D cross-section through the geological model of the site and biosolids containment facility embankment. Colours represent different lithological units.

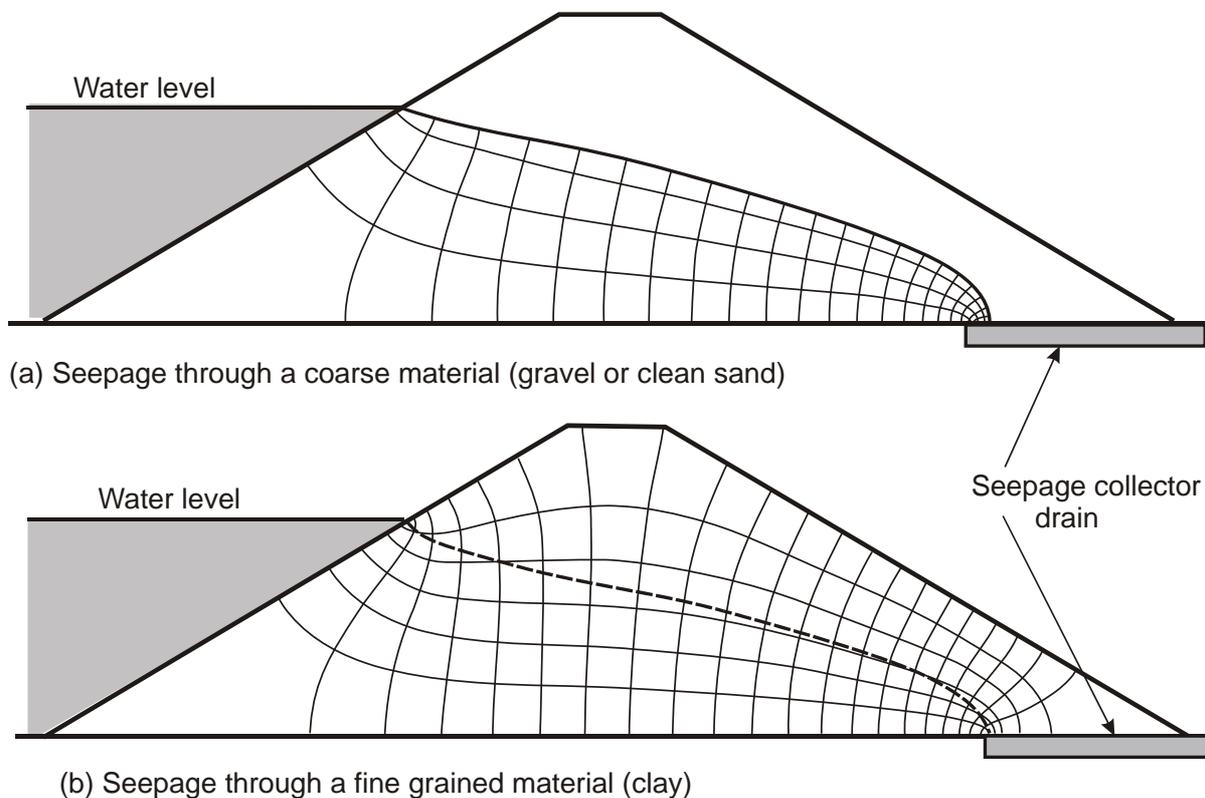
Figure 2. Flow nets in homogeneous embankments built of coarse and fine grained soils.

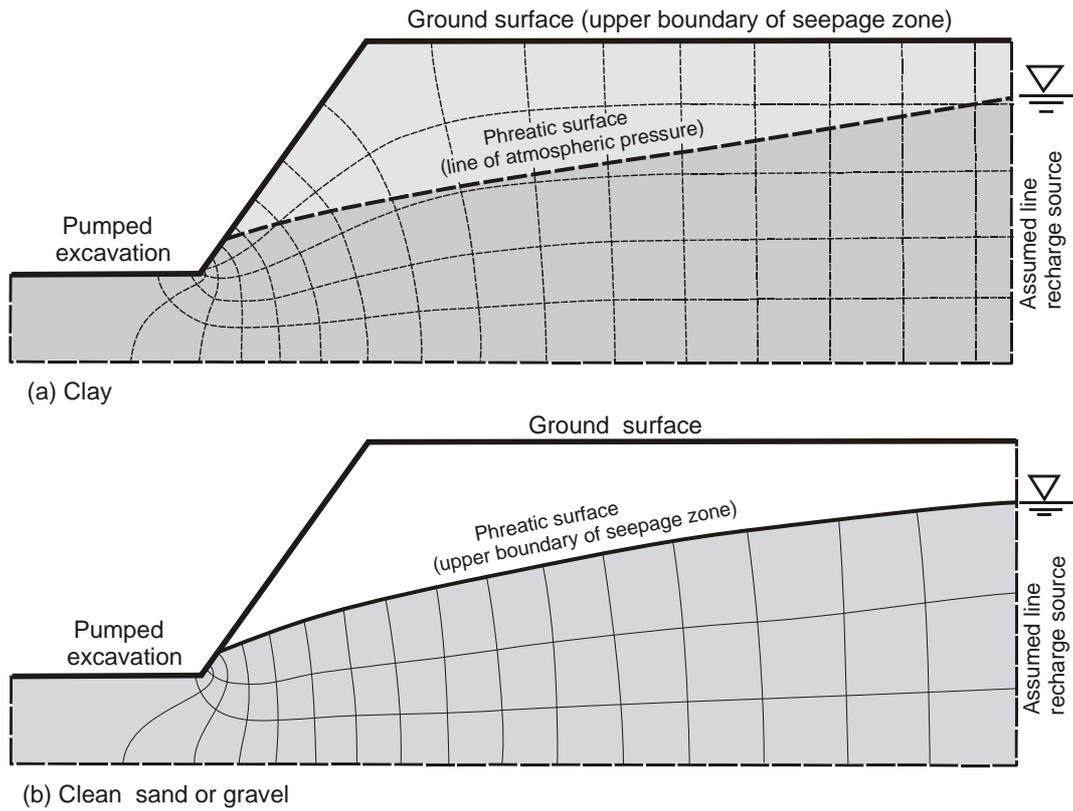
Figure 4. Seepage toward a pumped excavation in clay and in sand or gravel.

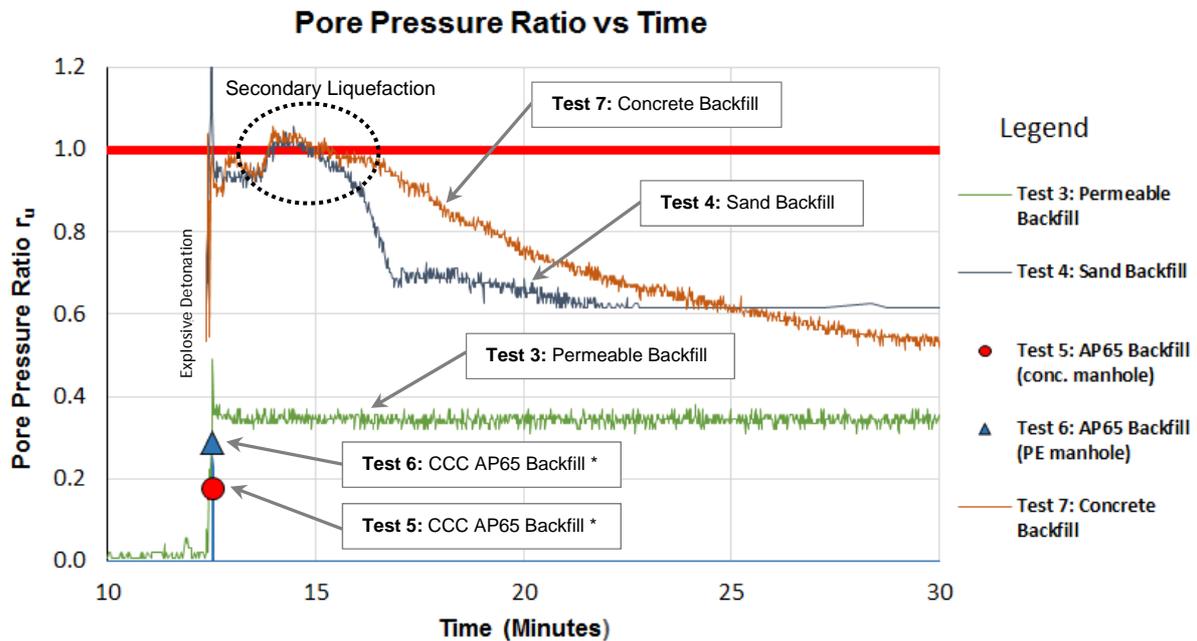
Figure 2. Pore Pressure Ratio for PPT installed beneath chambers
