# ANZ 2015 THE CHANGING FACE OF THE EARTH

Geomechanics & Human Influence  
22-25 February 2015, Wellington, New Zealand

**12th Australia New Zealand Conference on Geomechanics (ANZ 2015)**

**“The Changing Face of the Earth – Geomechanics & Human Influence”**

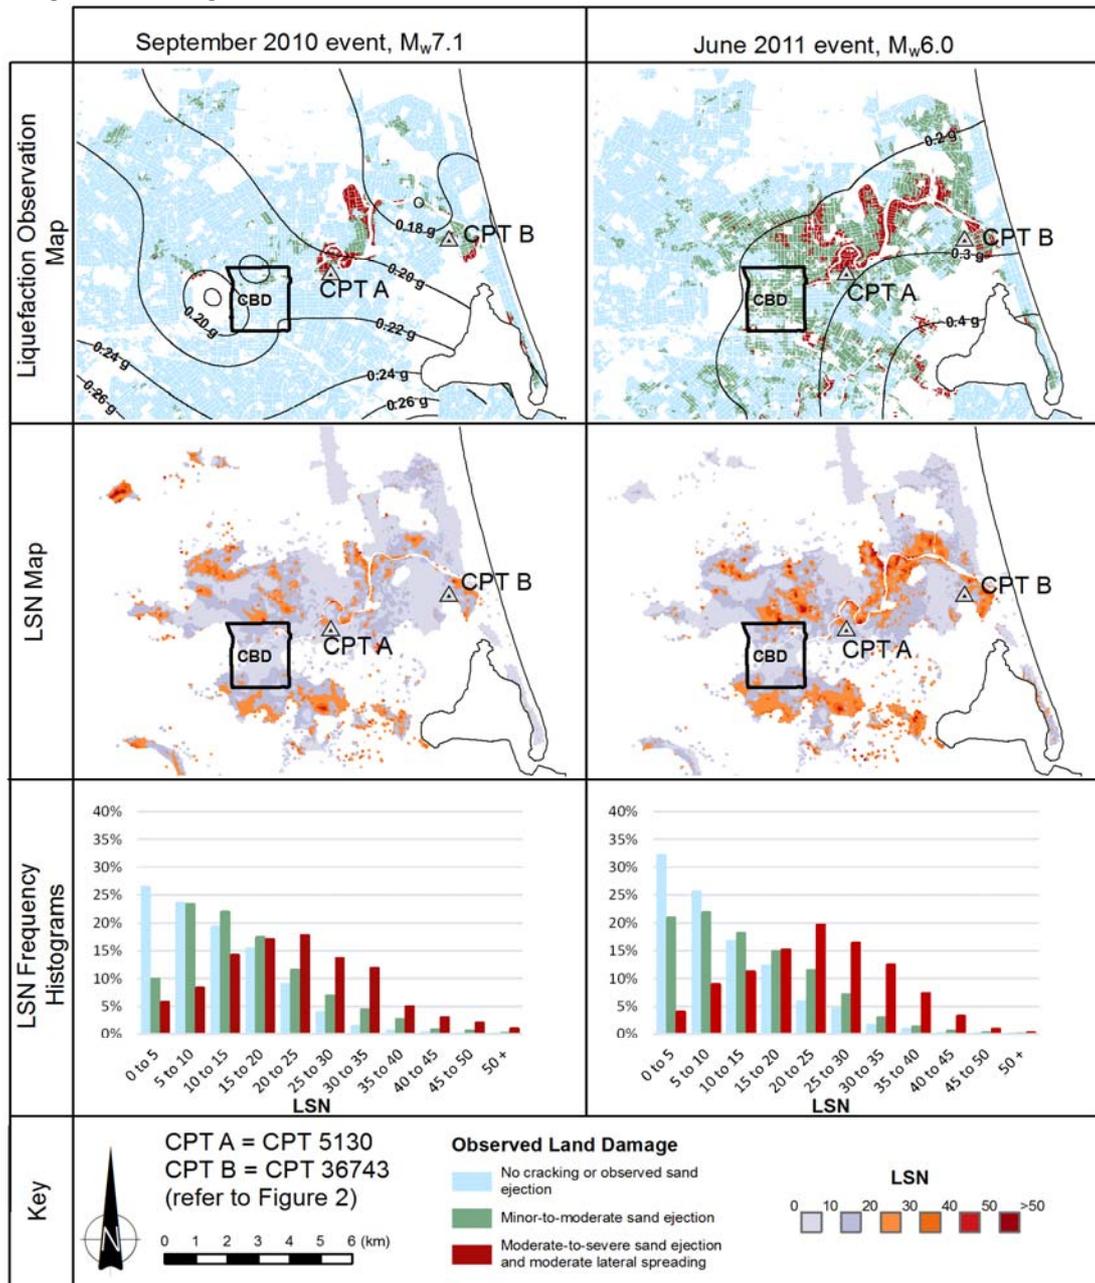
Figure 1. Comparison of September 2010 and June 2011 earthquake events. The top row shows the liquefaction severity observation maps with the Bradley and Hughes (2012) PGA contours overlaid. The middle row shows the calculated LSN over the top 10m for each CPT using the Boulanger and Idriss (2014) simplified liquefaction evaluation method with the pre CES median depth to groundwater model. The bottom row shows LSN frequency histograms for the observations of no liquefaction, minor-to-moderate liquefaction and moderate-to-severe liquefaction manifestation at the ground surface.

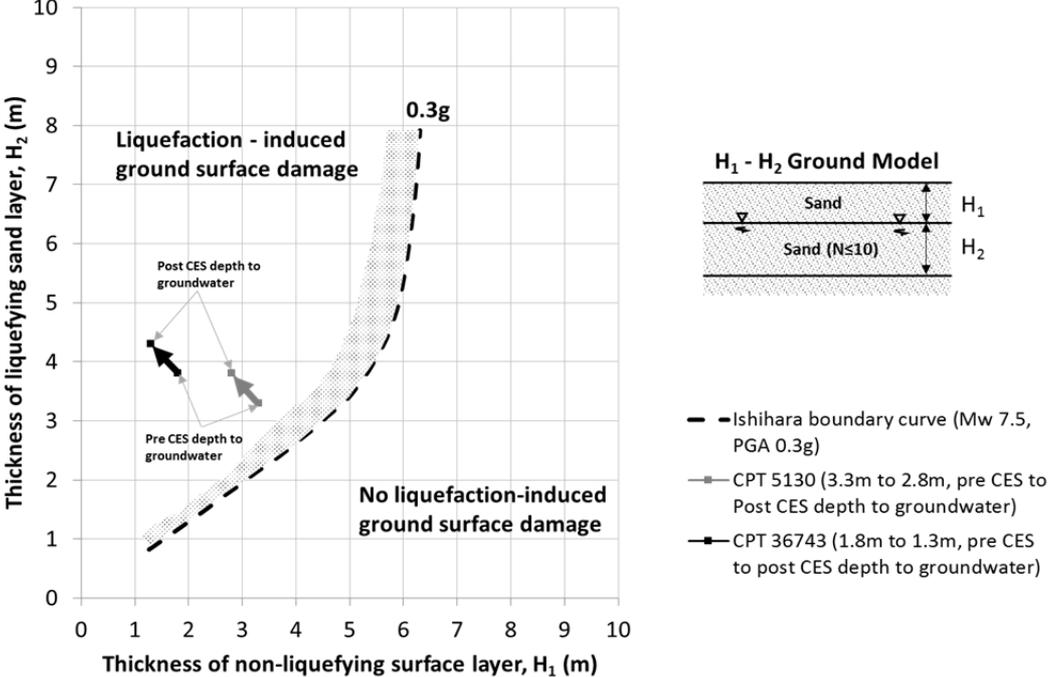
Figure 2. Ishihara (1985) boundary curve for  $M_w$  7.5, PGA 0.3g earthquake event (note the reference numbers used to identify the CPT correspond to the CGD reference numbers).

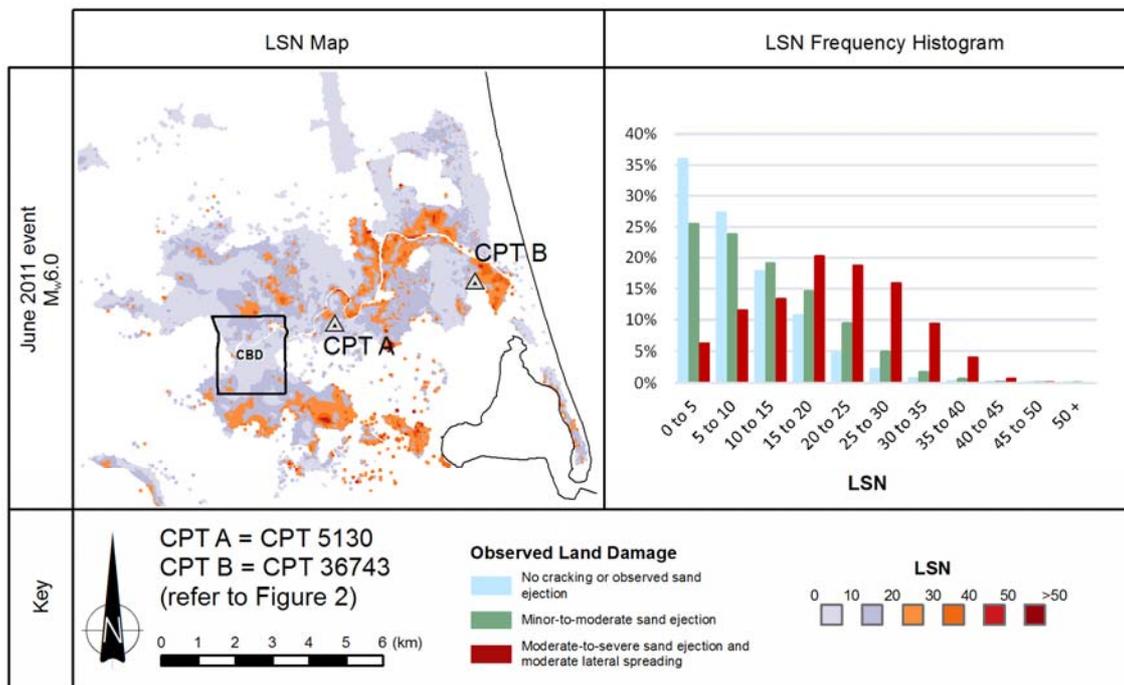
Figure 4. June 2011 earthquake event with adjusted depth to groundwater model. On the left side of the Figure is the LSN map over the top 10m for each CPT using the Boulanger and Idriss (2014) simplified liquefaction evaluation method. On the right side of the Figure is the LSN frequency histogram for the observations of no liquefaction, minor-to-moderate liquefaction and moderate-to-severe liquefaction manifestation at the ground surface.

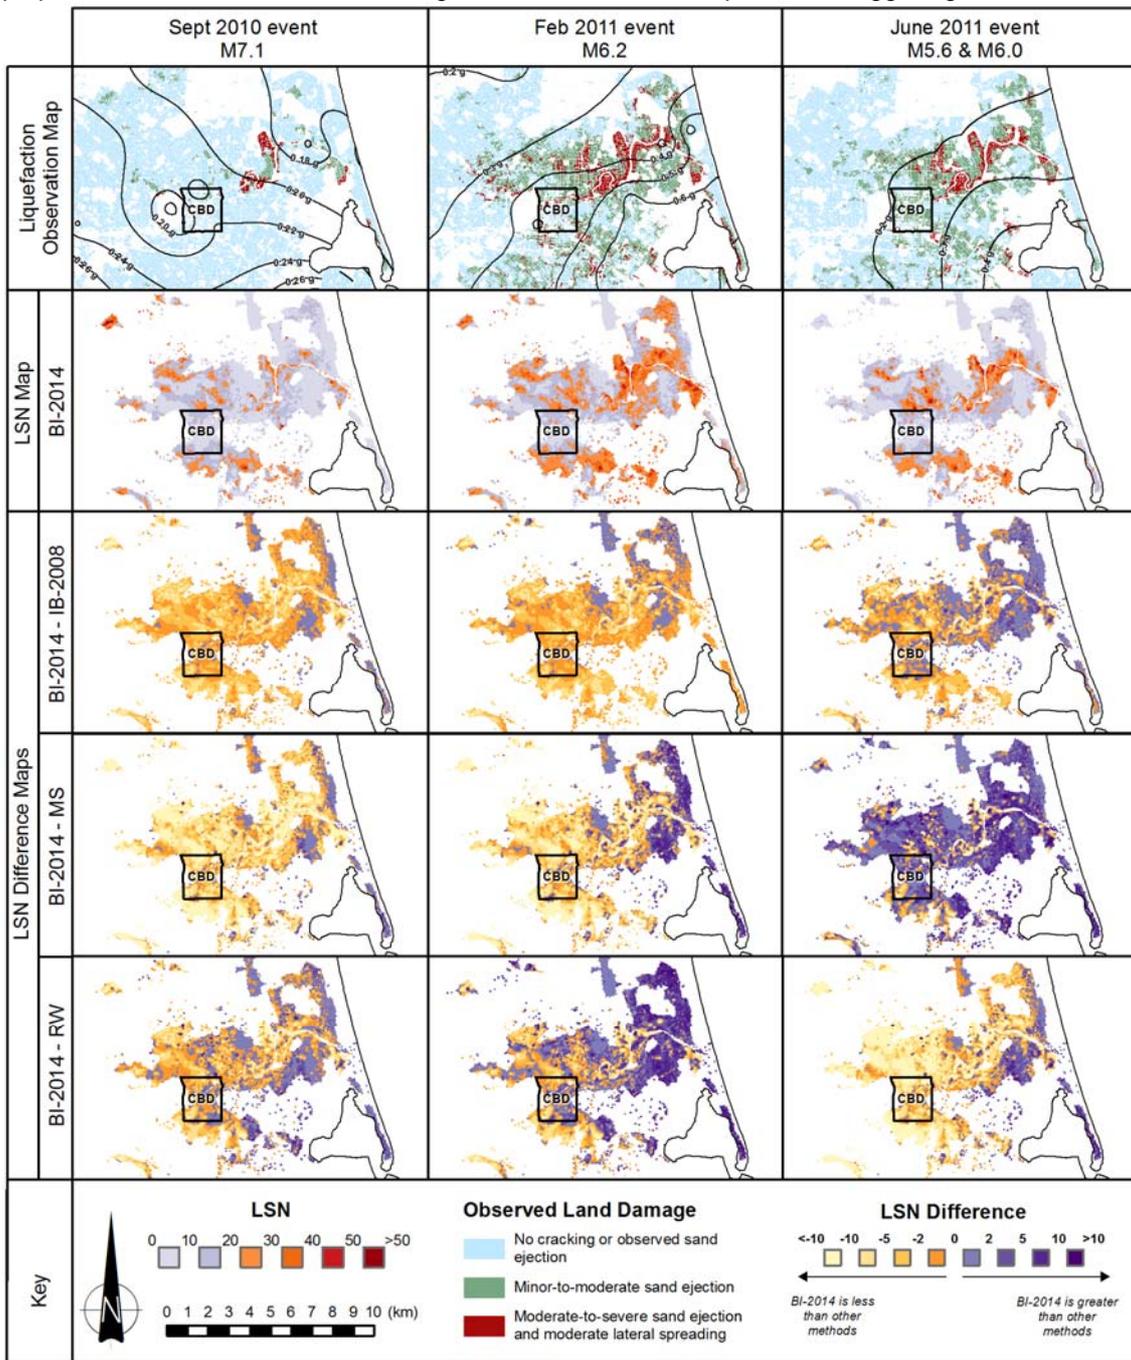
Figure 1. Map series of liquefaction severity observations and calculated LSN for each CPT using the BI-2014, IB-2008, MS and RW simplified liquefaction evaluation methods for the September 2010, February 2011 and June 2011 earthquake events. PGA contours (Bradley and Hughes 2012) are overlaid on the liquefaction severity observation maps. Difference maps are shown between BI-2014 and the other three methods (IB-2008, MS and RW) to accentuate the differences between the LSN maps. Positive values on the difference maps indicate areas where BI-2014 predicts higher values and negative values indicate areas where BI-2014 predicts lower values.

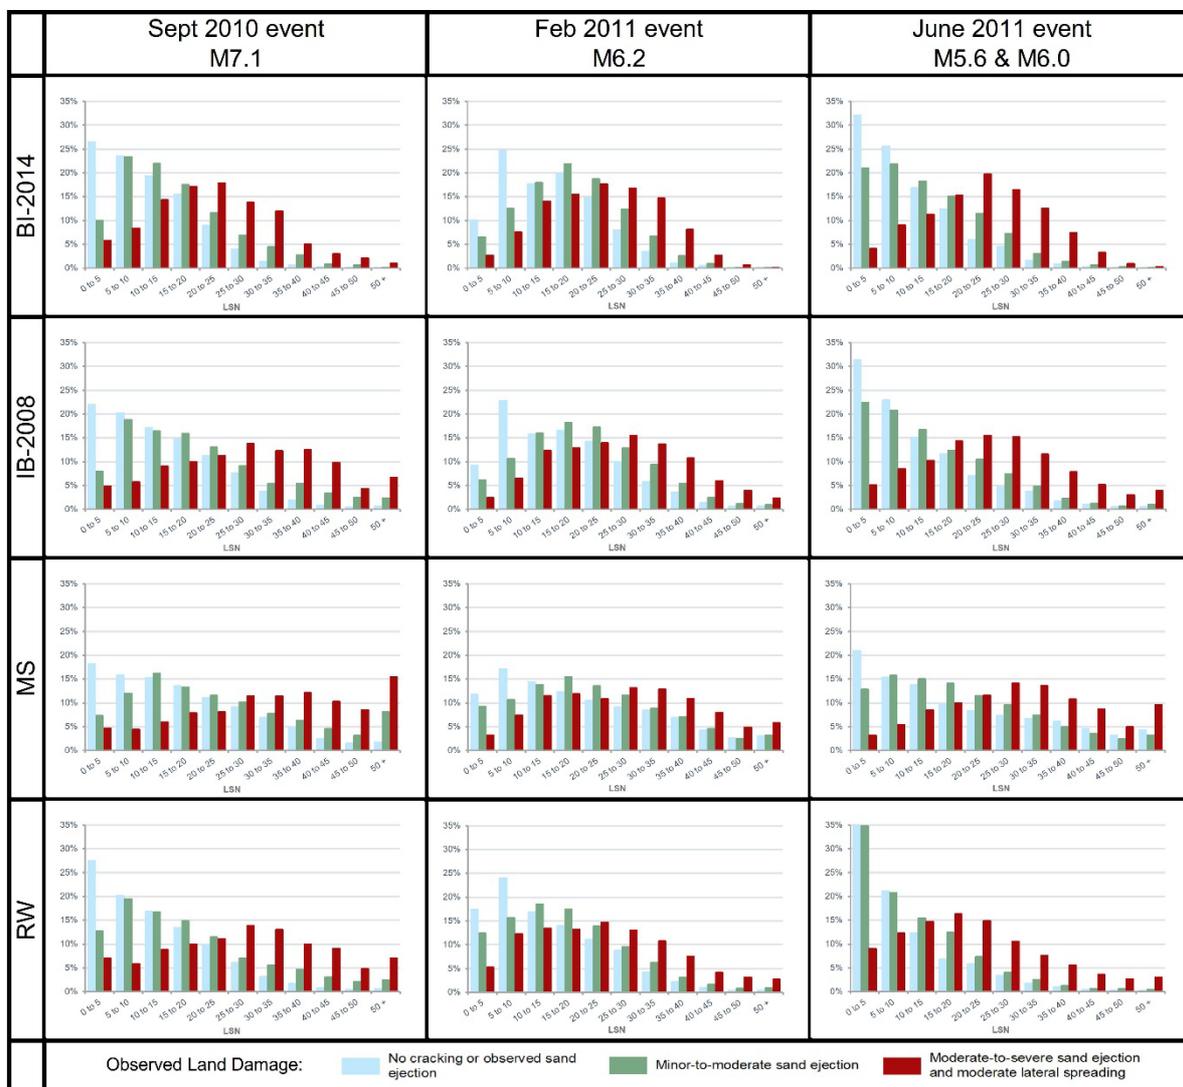
Figure 2. Frequency histograms of the calculated LSN values throughout Christchurch for the BI-2014, IB-2008, MS and RW simplified liquefaction triggering methods for the September 2010, February 2011 and June 2011 earthquake events, for observation categories of none-to-minor liquefaction damage, minor-to-moderate liquefaction damage and moderate-to-severe liquefaction damage based on the land damage maps in Figure 1. The horizontal axis represents LSN from 0 to 50+ in increments of 5, and the vertical axis represents frequency percentage from 0 to 35%.

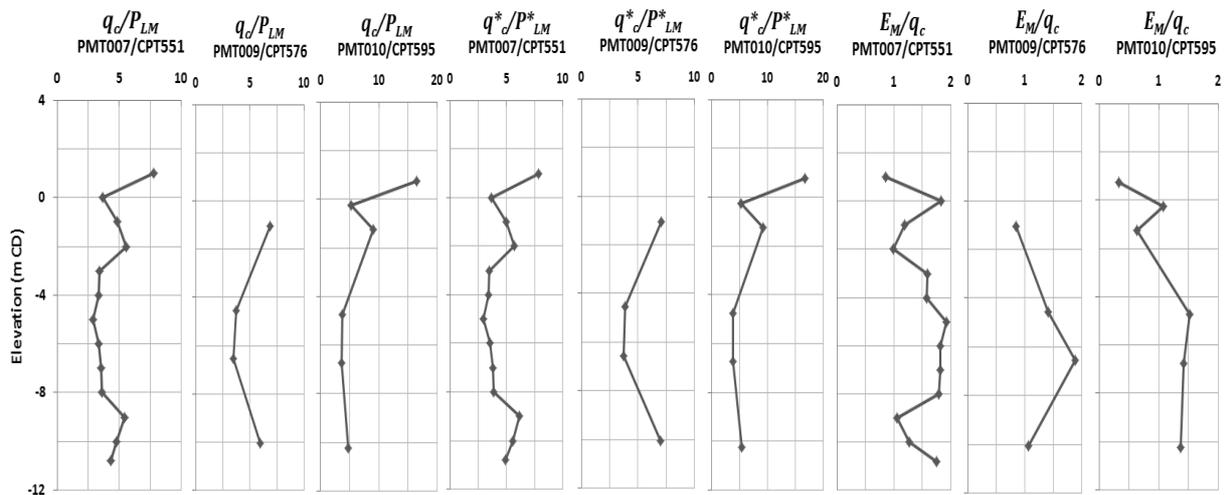
Figure 1.  $q_c/P_{LM}$ ,  $q_c^*/P_{LM}^*$  and  $E_M/q_c$  for Ras Laffan carbonate sand

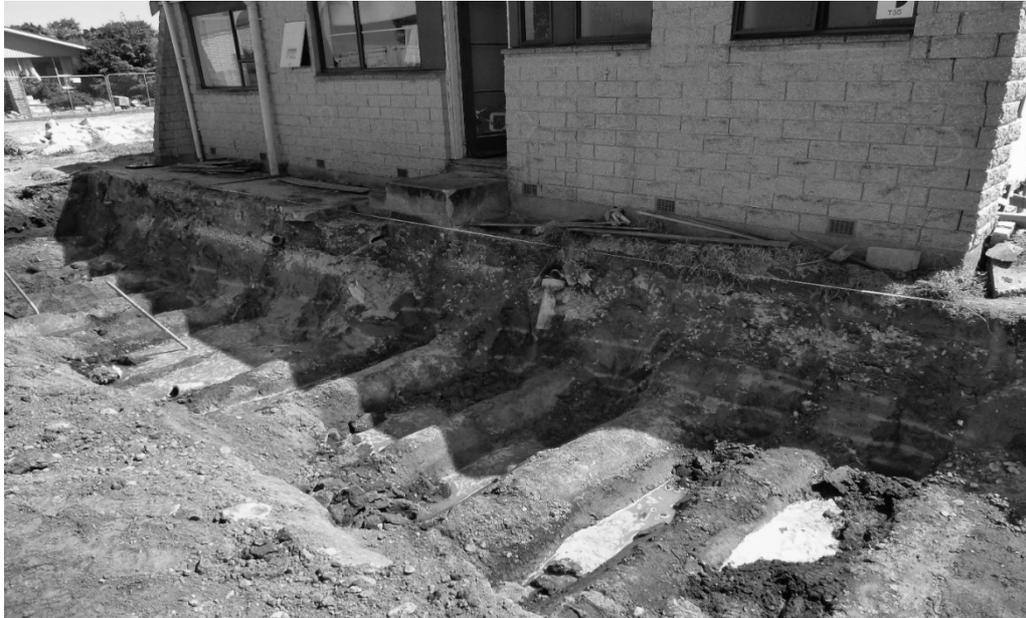
*Figure 2. Exposed HSM beams which were constructed beneath one of the houses at the ground improvement trial site. The HSM beams were exposed after the blast-induced liquefaction testing was completed*

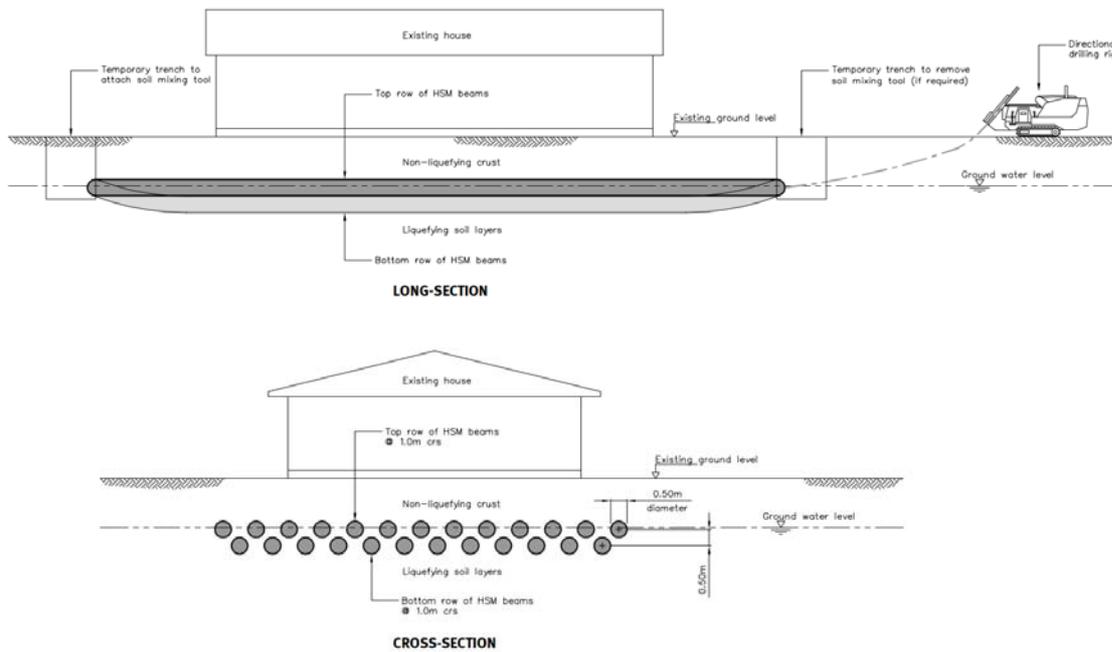
Figure 3. Long-section and cross-section showing the typical layout, configuration and vertical positioning in the ground of the HSM beams beneath an existing house

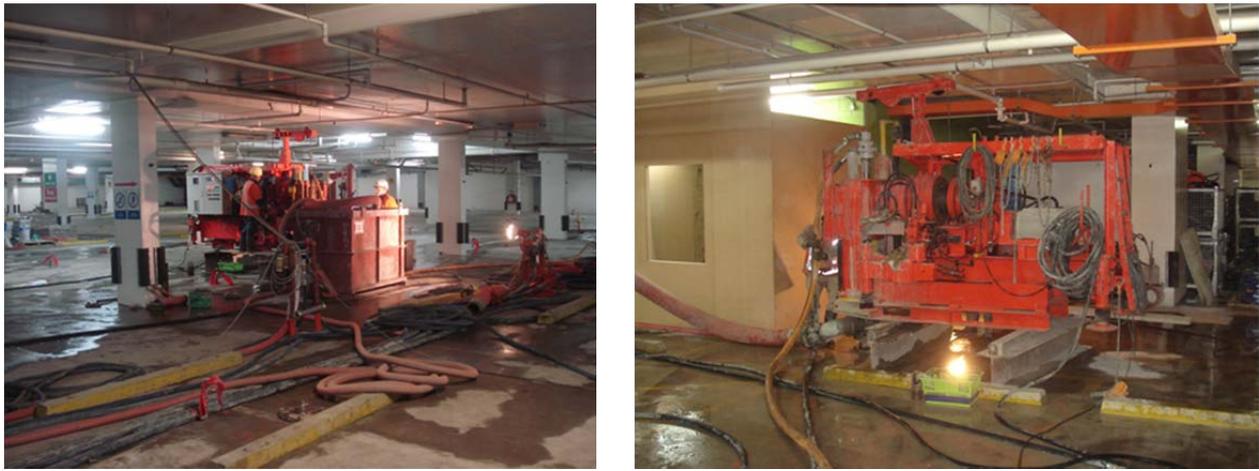
Figure 3. Installation of jet grouting columns in the Art Gallery basement

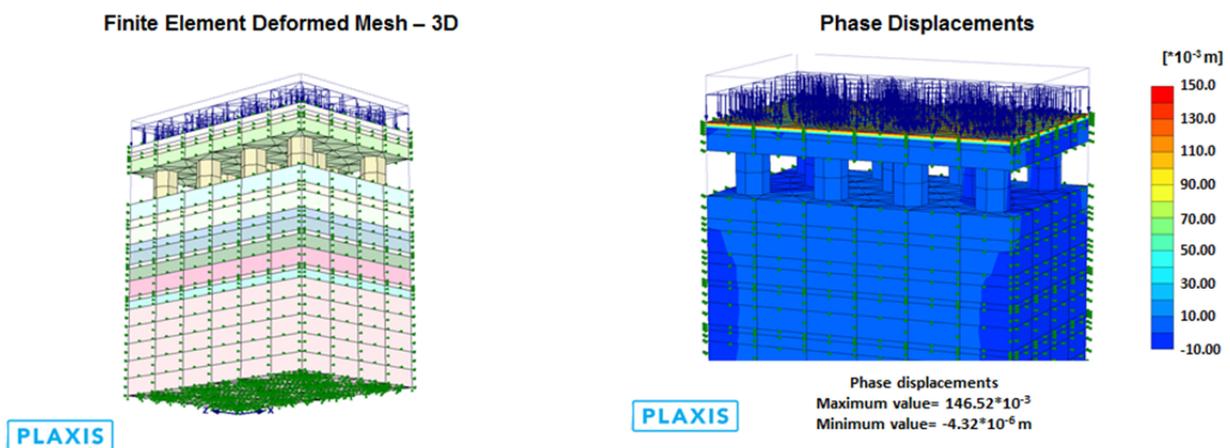
Figure 4. 3D model finite element mesh (left) and deformations after JOG and jet grouting columns (right).

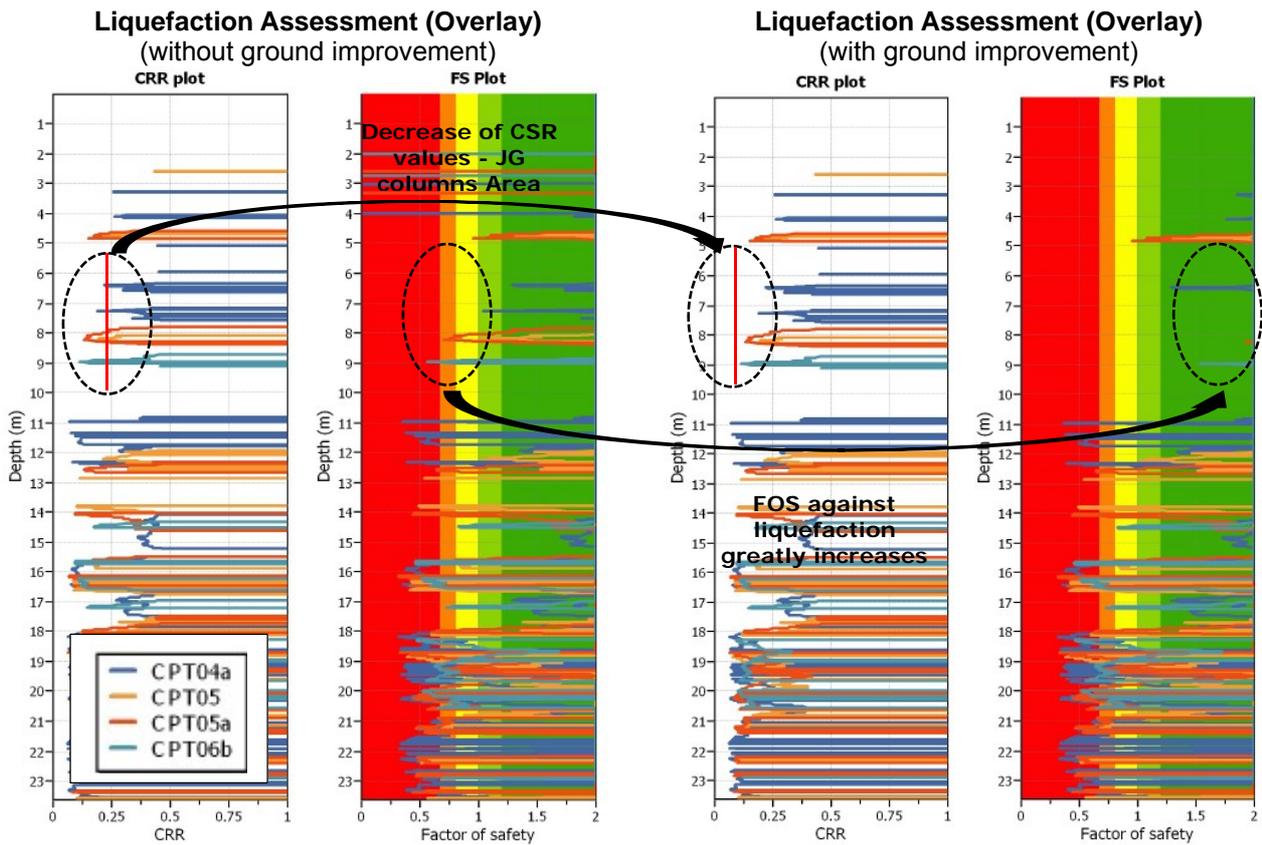
Figure 6. Liquefaction assessment overlay of CPT's 4a, 5, 5a and 6b.

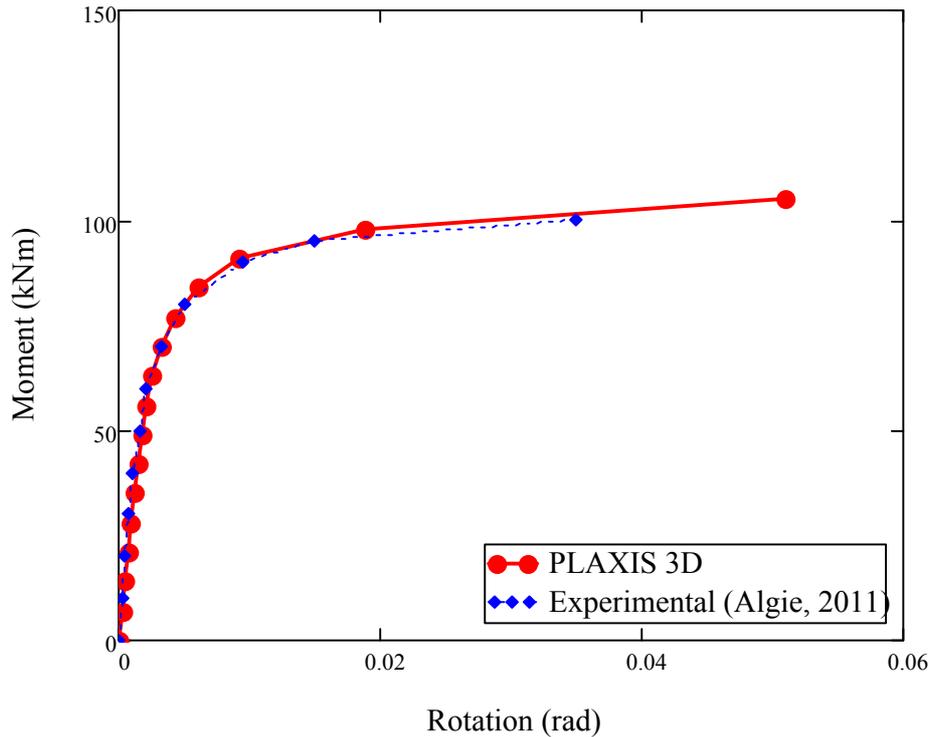
Figure 1. Comparison of moment-rotation curves from experimental results (Algie (2011)) and PLAXIS 3D analysis

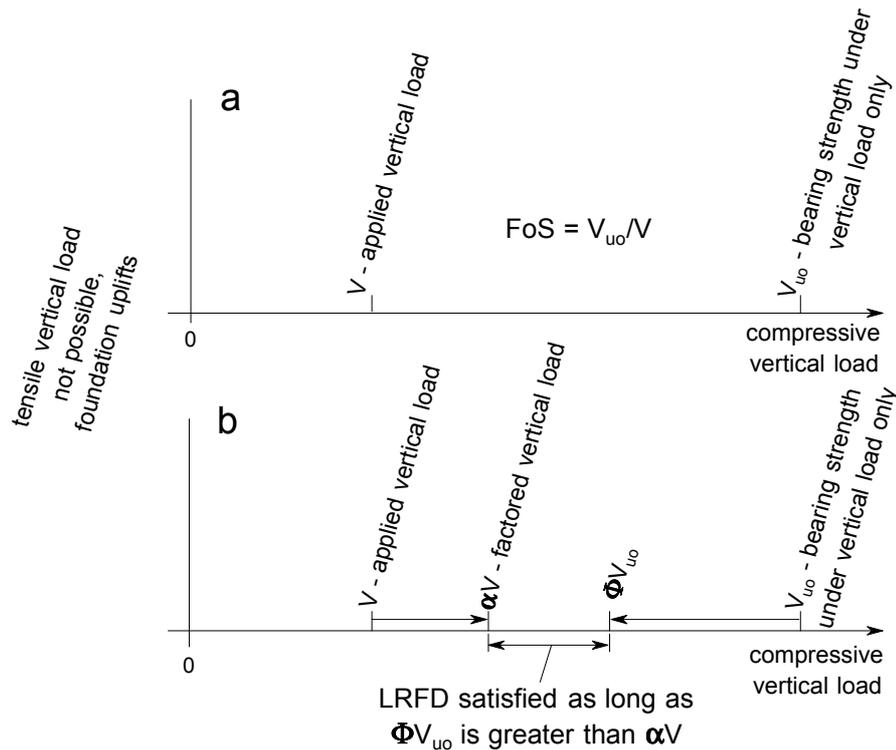
Figure 1. Estimating reserve of bearing strength for shallow foundations subject only to vertical load. (a) Total factor of safety approach; (b) Load and Resistance Factor Design method.

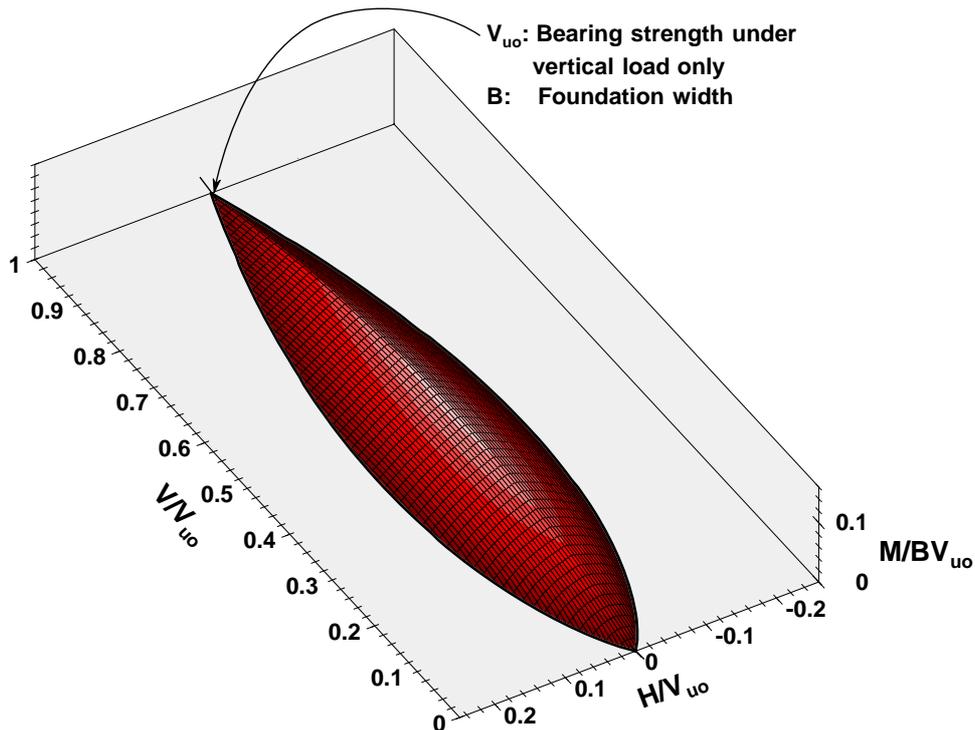
Figure 3. View of the upper half of the bearing strength surface for shallow foundations in cohesionless soils.

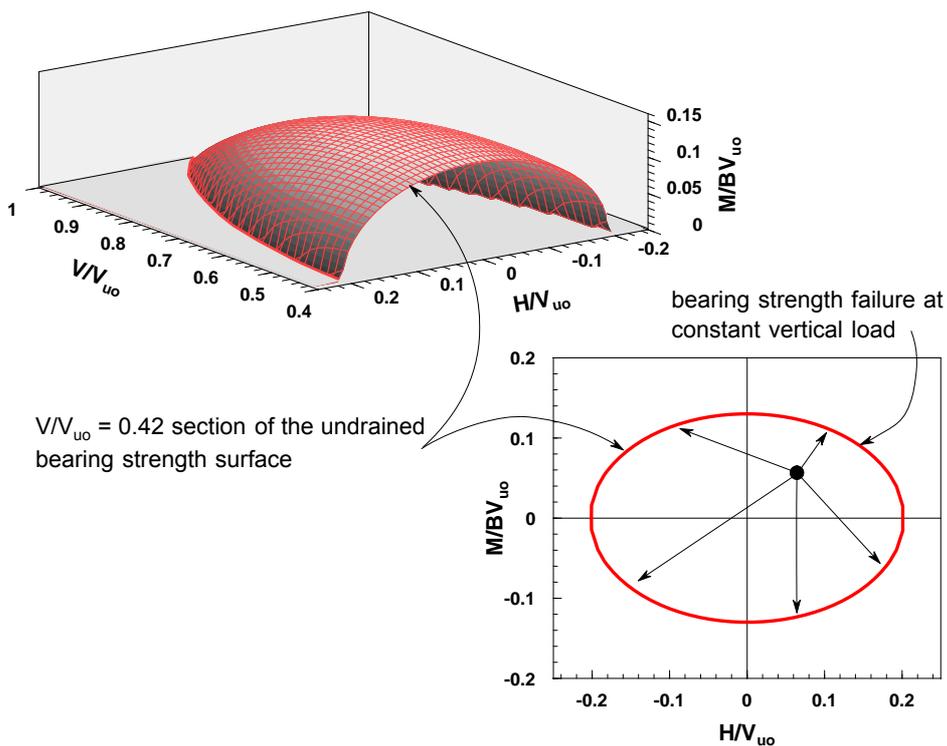
Figure 5. A constant vertical load section of the bearing strength surface illustrating that at constant vertical load there are a multitude of combinations of shear and moment that can induce bearing failure.

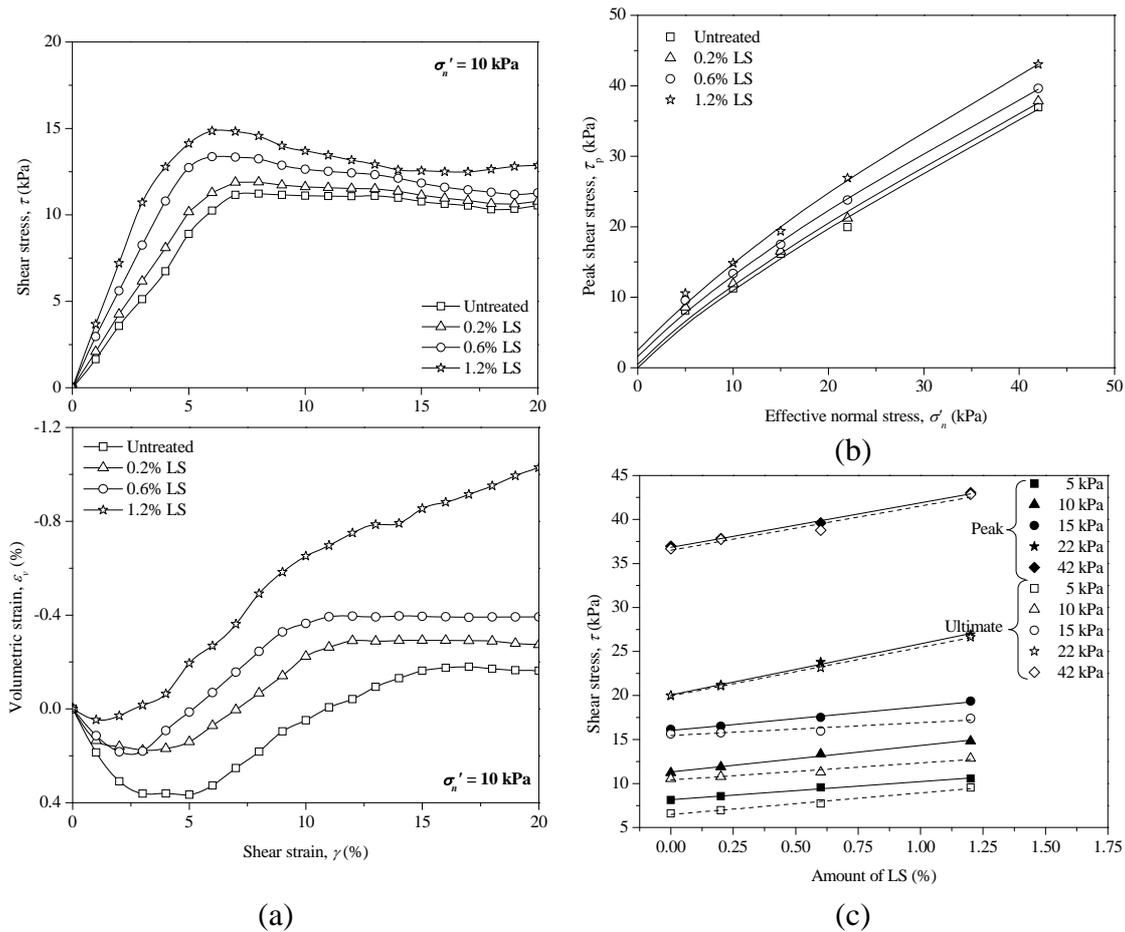
Figure 2. (a) Variations of shear stresses and volumetric strains of lignosulfonate treated and untreated silty sand with shear strain under effective normal stress of 10kPa (b) peak failure envelopes (c) Variation of peak and ultimate shear strengths with the amount of lignosulfonate (After Athukorala 2013)

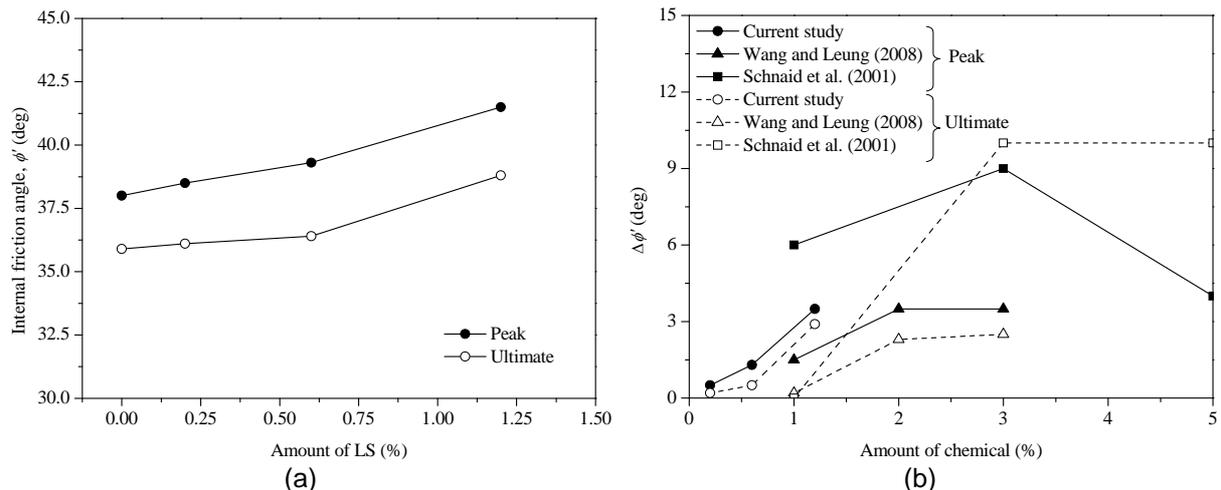
Figure 4. (a) The change of the internal friction angle of silty sand with the amount of lignosulfonate (b) Comparison of change in internal friction angle due to lignosulfonate and cement treatments at peak and ultimate states (After Athukorala 2013)

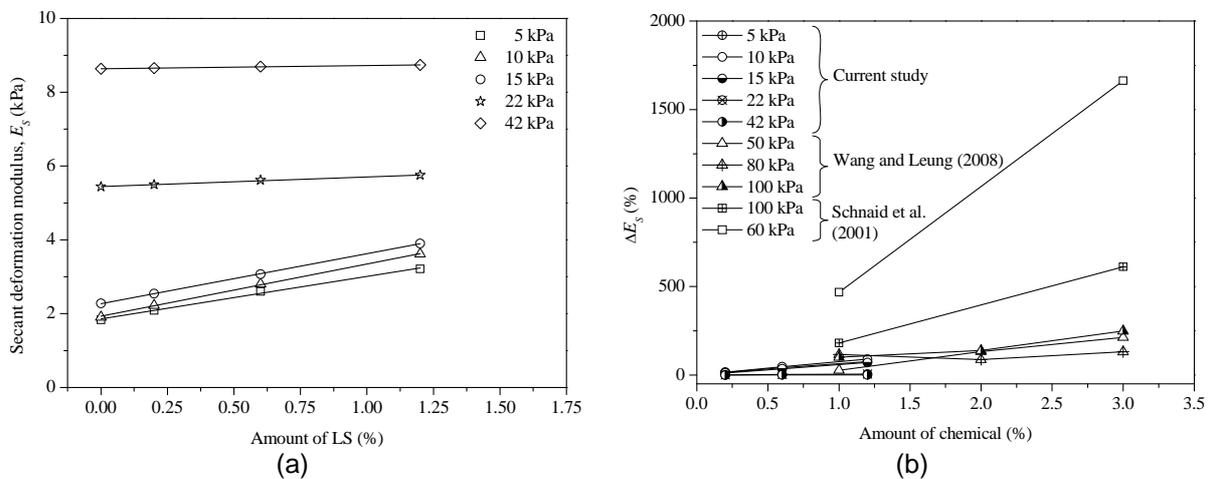
Figure 5. (a) Variation of secant deformation modulus with the amount of LS (b) Comparison of improvement in secant deformation modulus due to LS and cement treatments on sands (After Athukorala 2013)

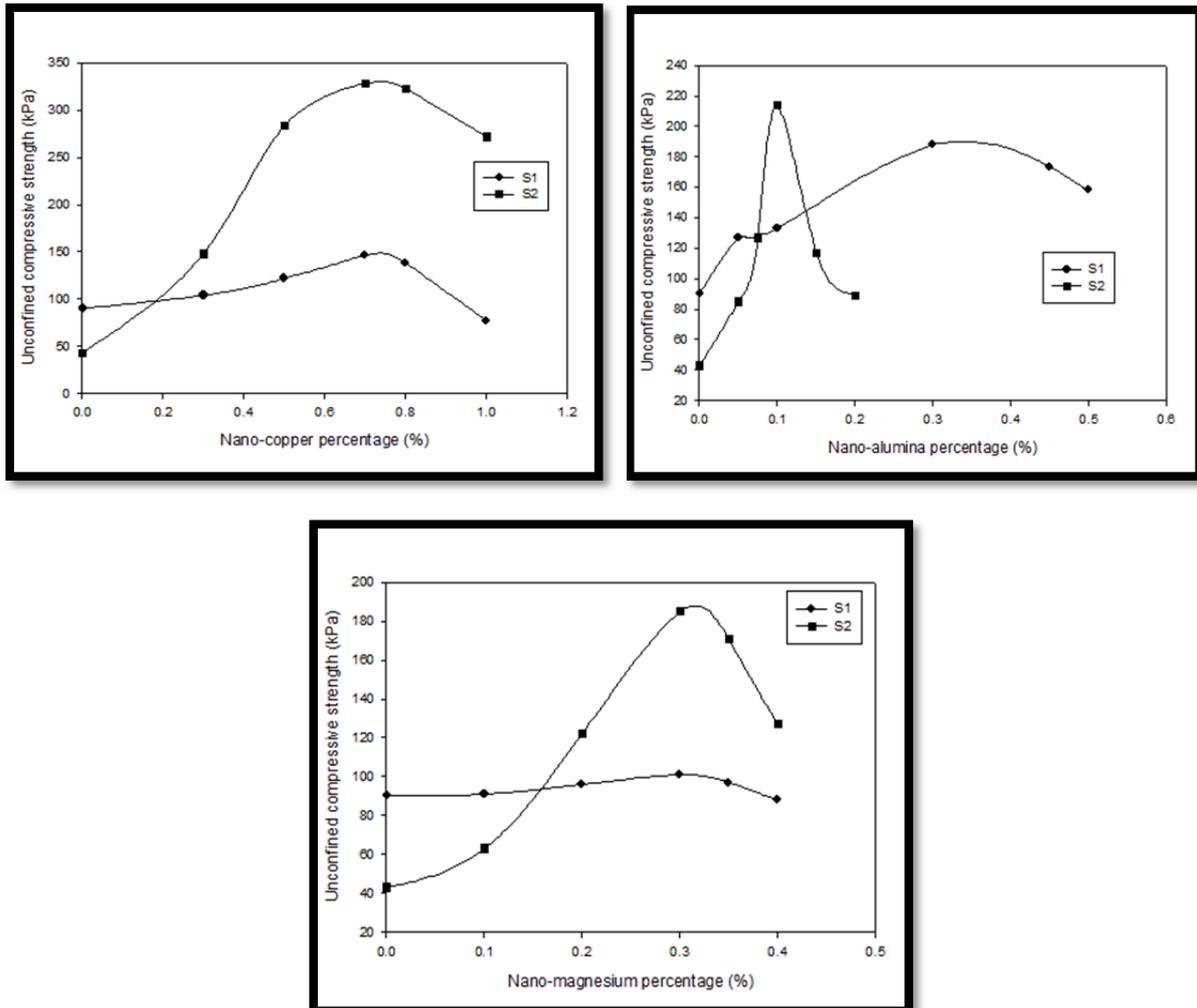
Figure 2. The effect of nanomaterials on the unconfined compressive strength, UCS

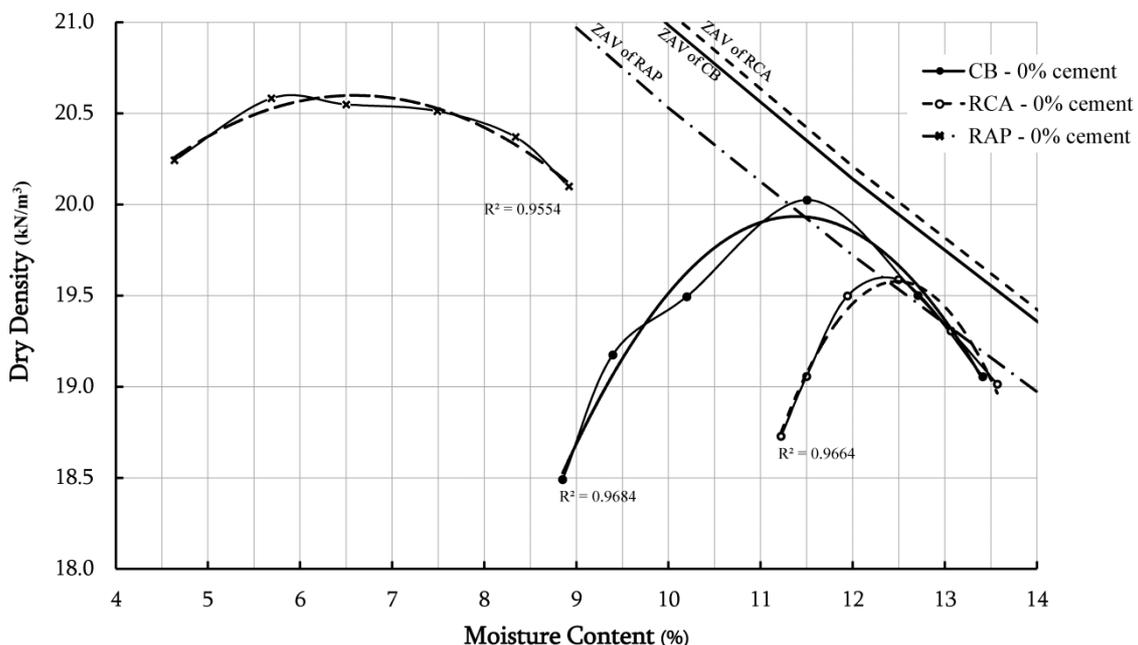
Figure 1. Compaction curves for untreated CB, RCA and RAP

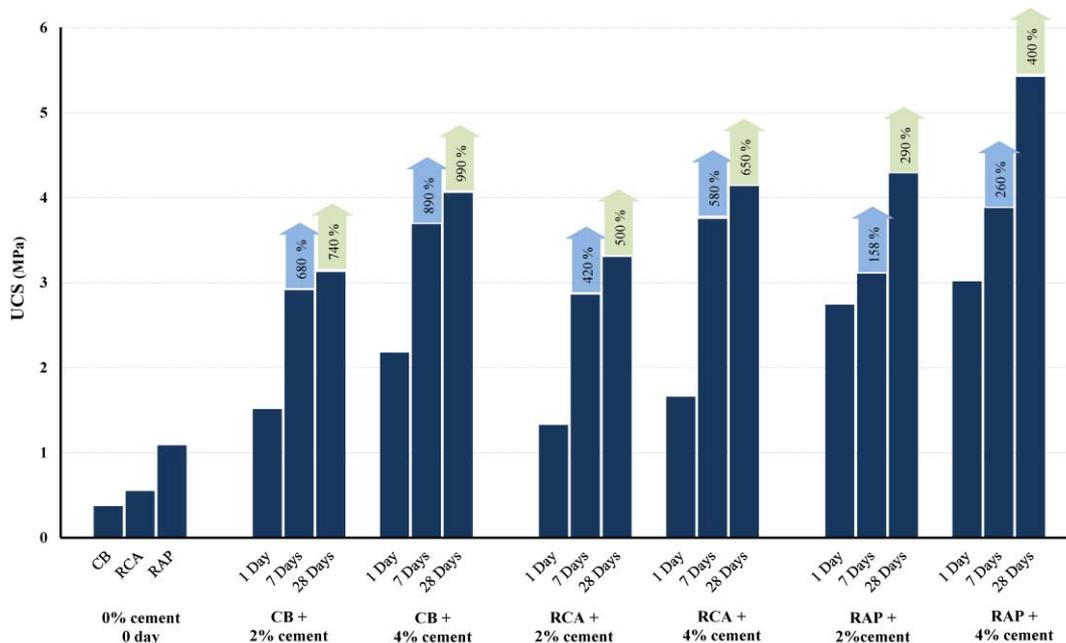
Figure 2. Development of UCS in C&D material with curing time

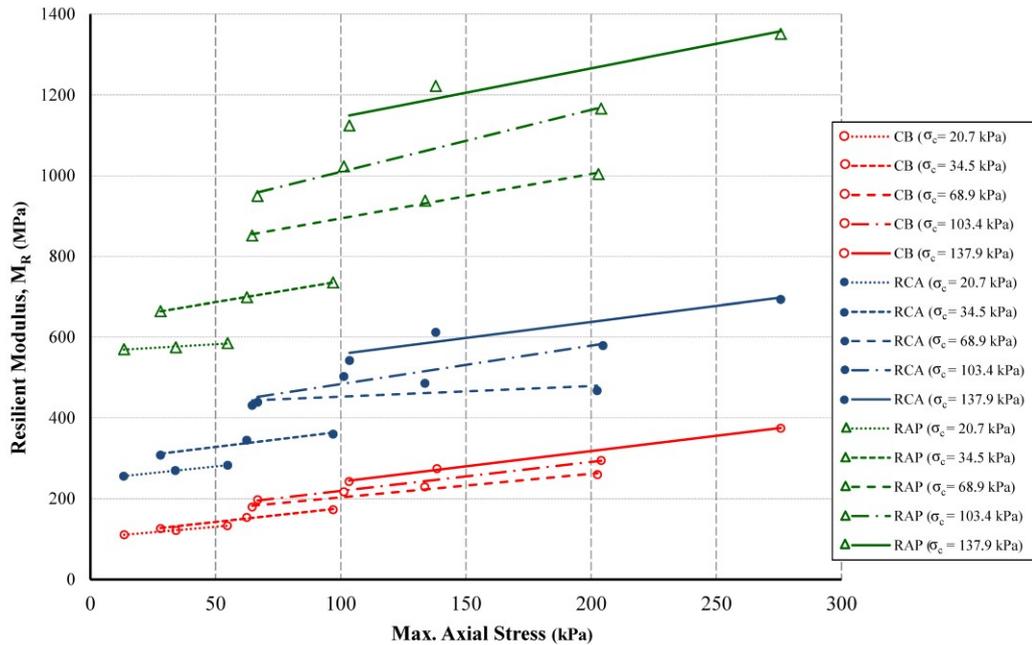
Figure 3. Resilient modulus results for untreated C&D material (Mohammadinia, et al., 2014)

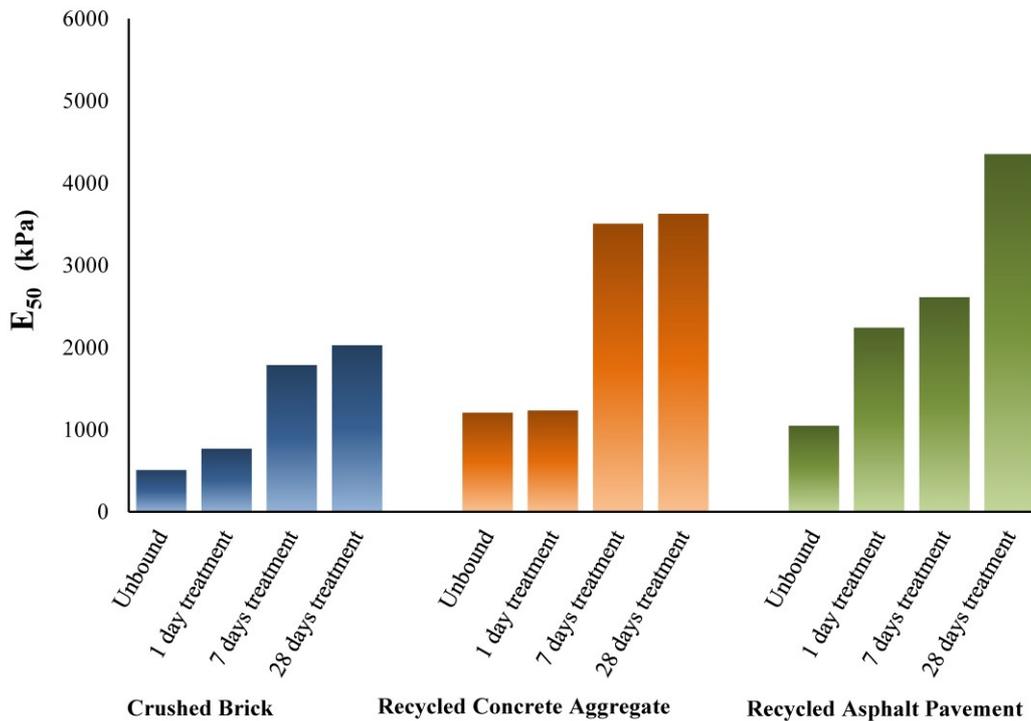
Figure 5. Secant modulus ( $E_{50}$ ) measured by strain on the top of the sample in C&D material stabilized with 4% cement due to curing time

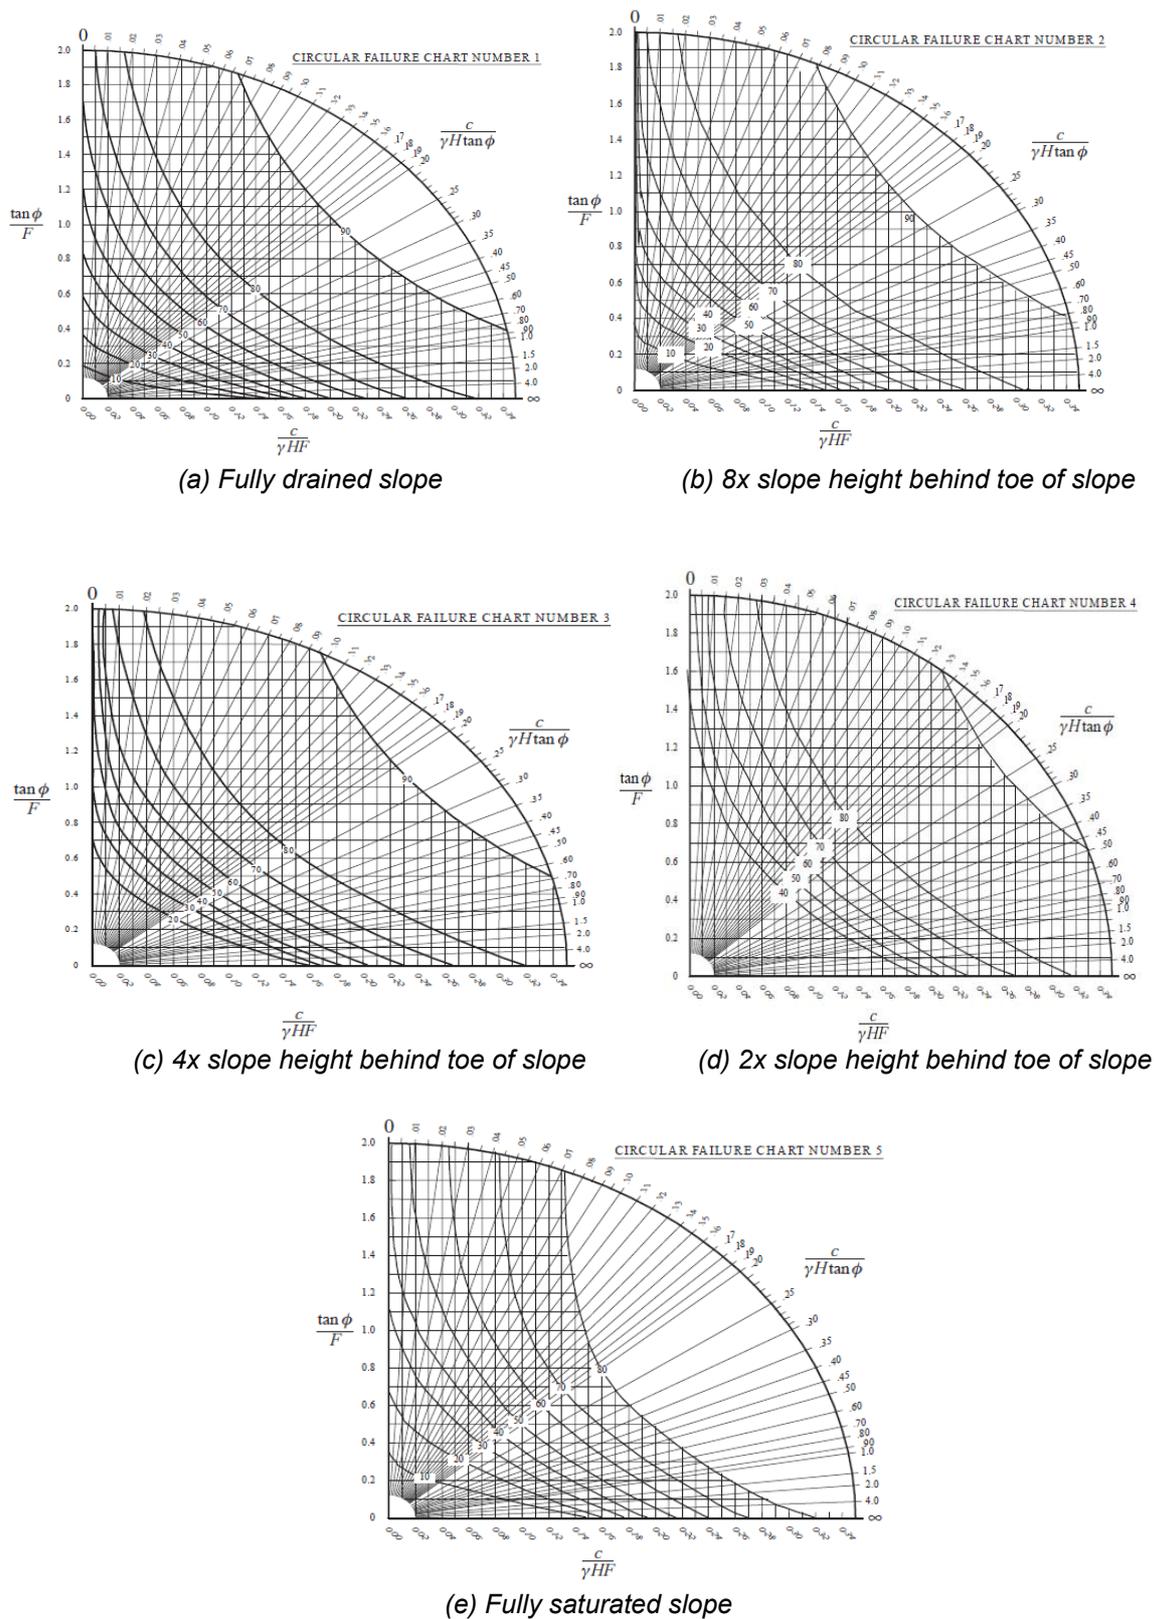
Figure 3. Chart solutions for corresponding level of water table adapted from Hoek and Bray (1981)

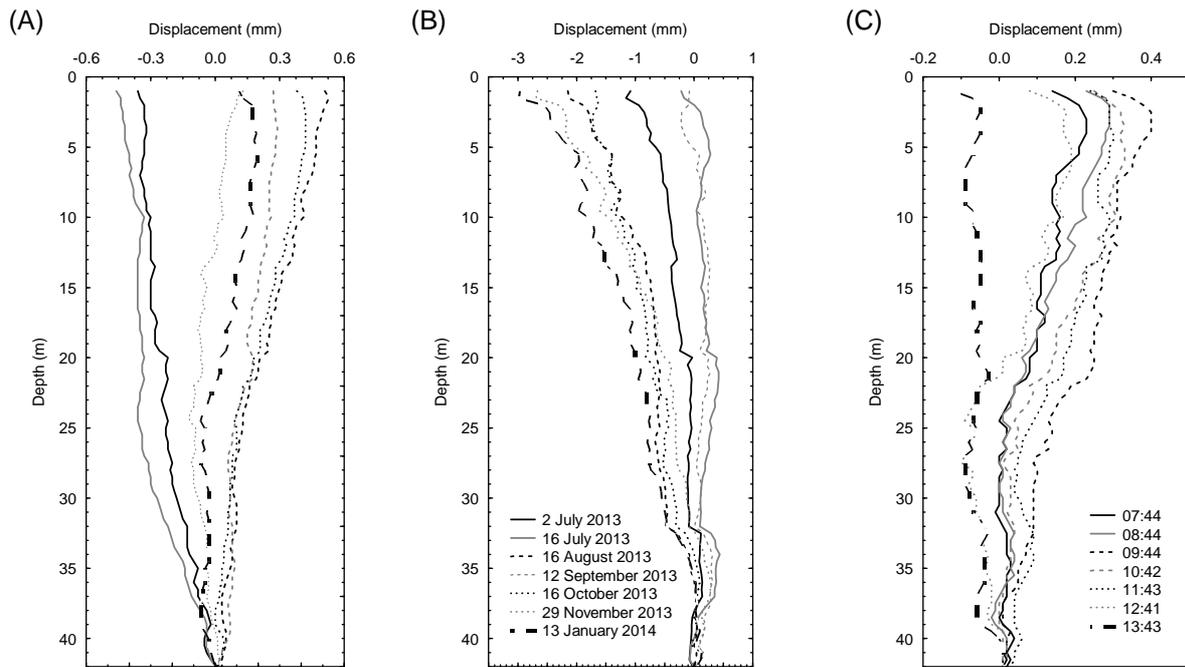
Figure 6. Cumulative plots of borehole inclinometer data from various dates (A and B), and different times on 22 October 2013 (C). The legend in (B) applies to both (A (A axis)) and (B (B axis)) plots.
