# ANZ 2015 THE CHANGING FACE OF THE EARTH

Geomechanics & Human Influence  
22-25 February 2015, Wellington, New Zealand

**12th Australia New Zealand Conference on Geomechanics (ANZ 2015)**

**“The Changing Face of the Earth – Geomechanics & Human Influence”**

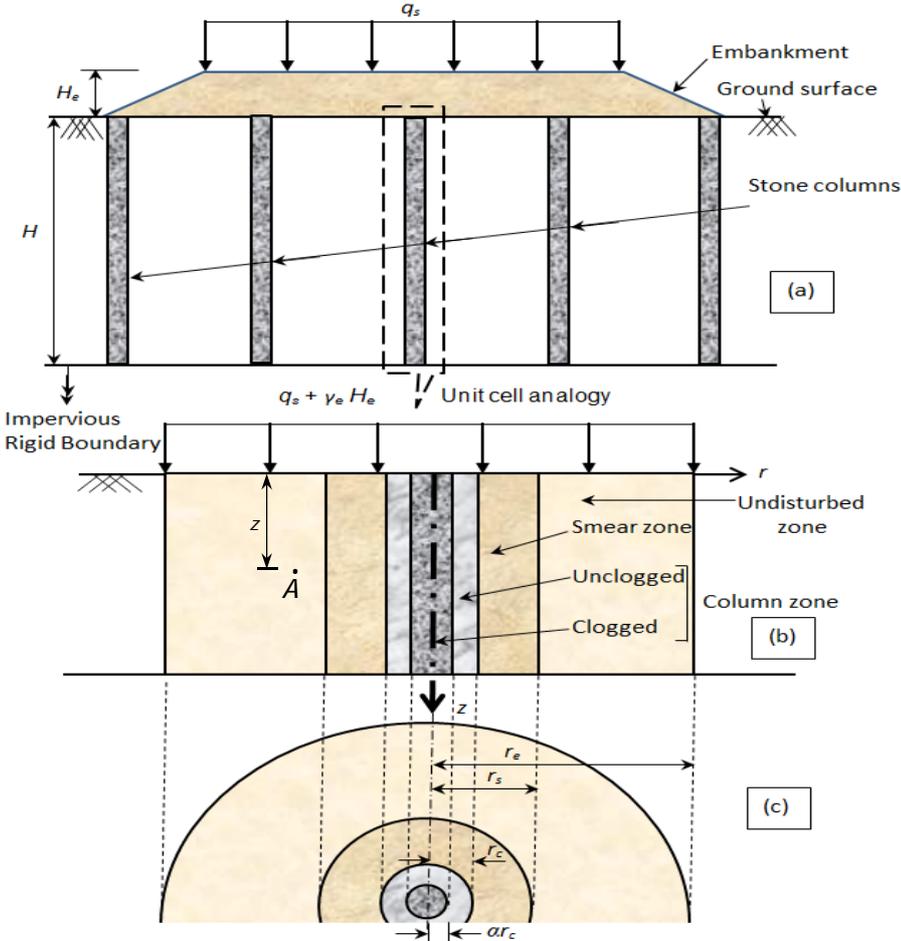
Figure 1. Soft clay reinforcement: (a) Embankment resting on stone column installed ground. (b) Unit cell analogy. (c) Cross section of unit cell.

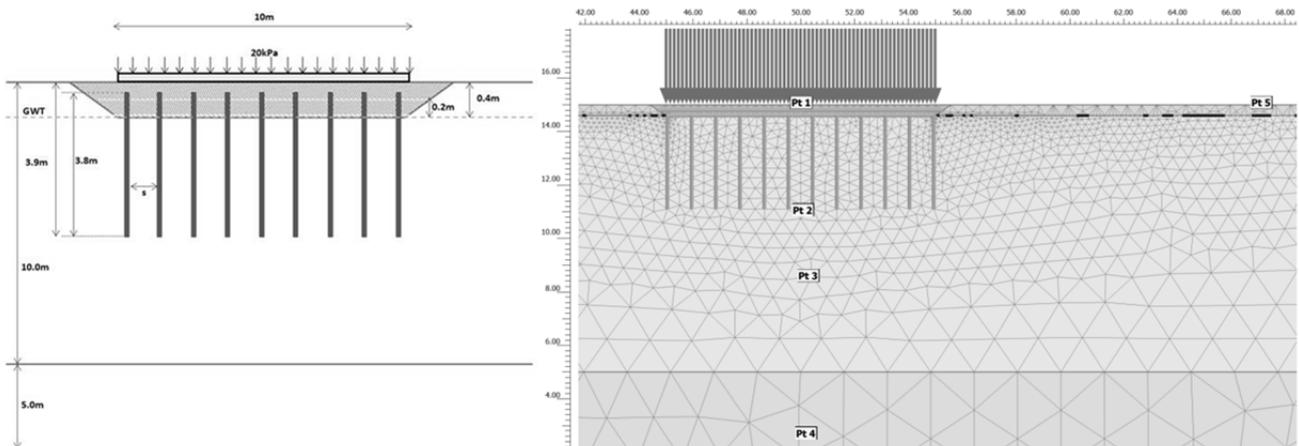
Figure 1. Schematic illustration of ground profile and finite element mesh used in Plaxis model

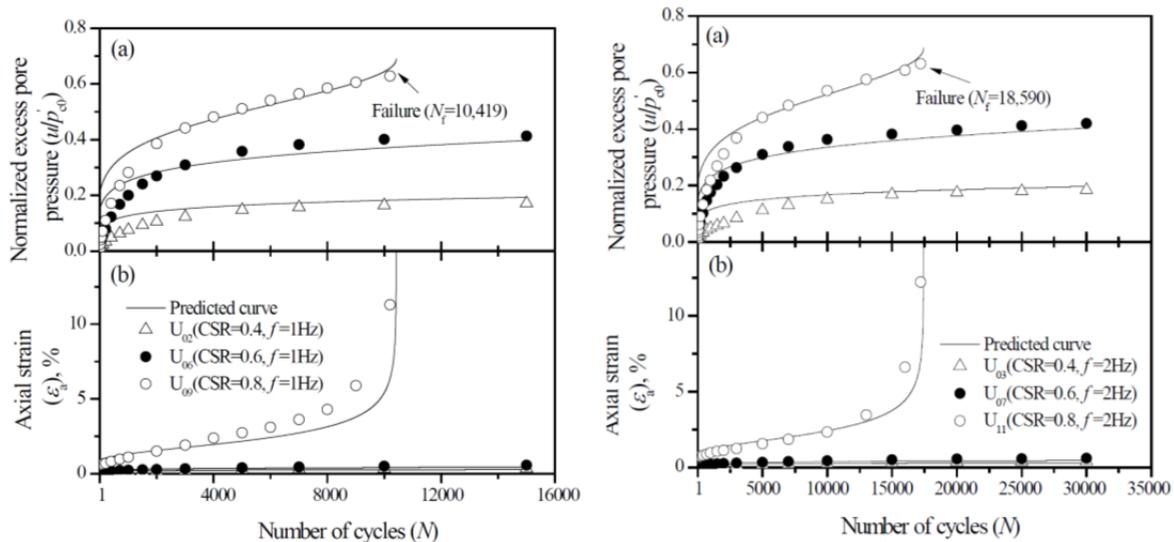
Figure 2. Predictions of excess pore pressures and axial strains: (a)  $f=1\text{Hz}$ , (b)  $f=2\text{Hz}$

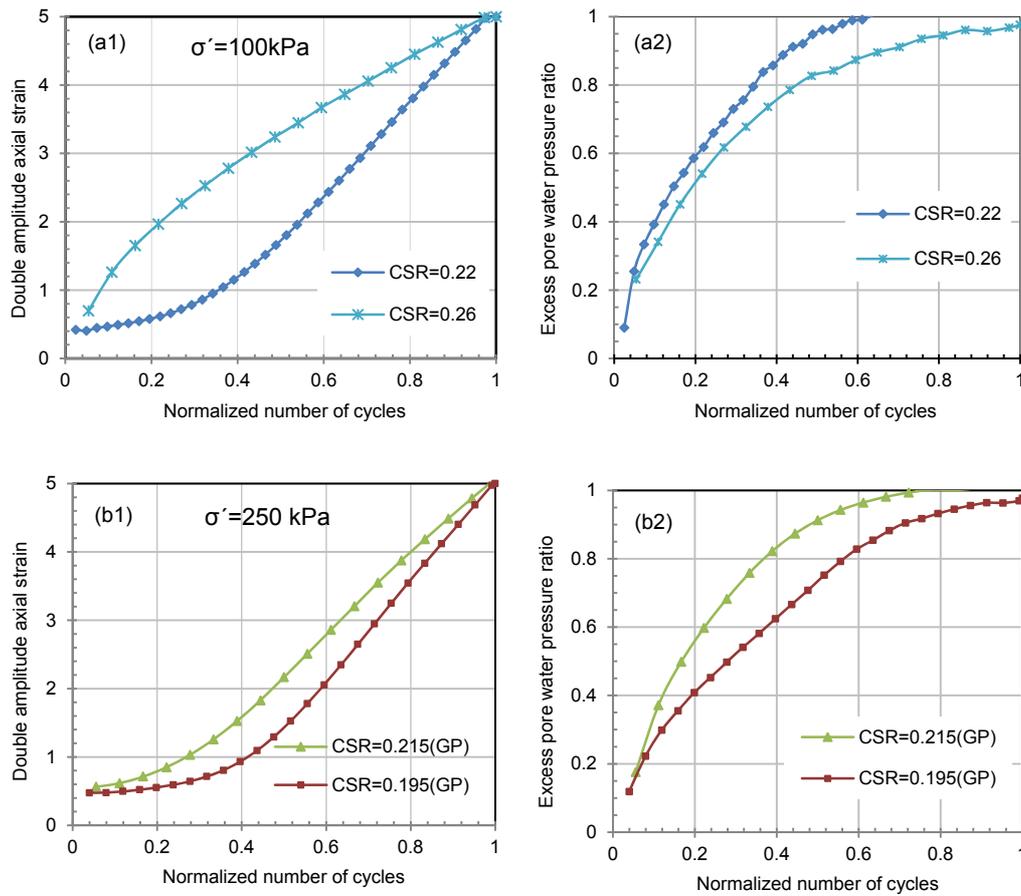
Figure 7. (a1, b1) Double amplitude axial strain  $\varepsilon_{DA}$  and (a2, b2) excess pore water pressure ratio, plots against normalized number of cycles  $N/N_{\varepsilon_{DA}=5\%}$  from cyclic undrained tests.

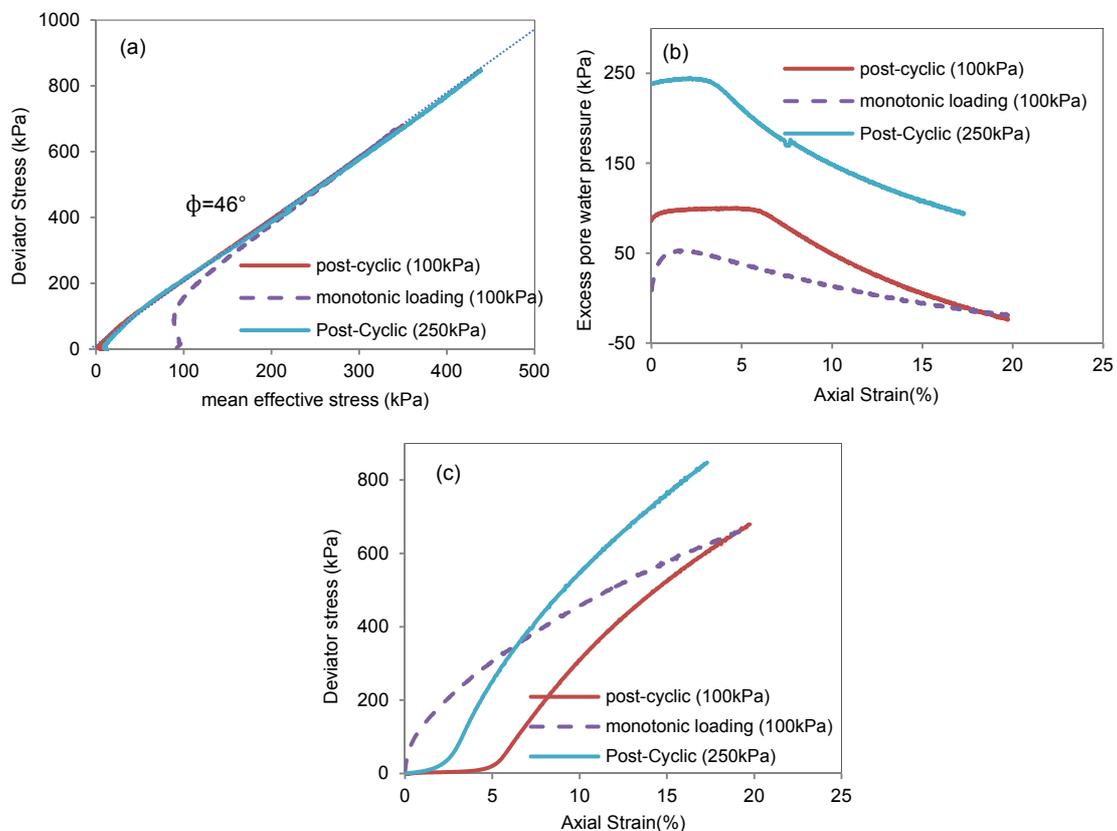
Figure 9. (a) Effective stress paths for static and post-cyclic monotonic loading; (b) pore pressure response during post-cyclic monotonic loading and monotonic loading; (c) stress-strain relation.

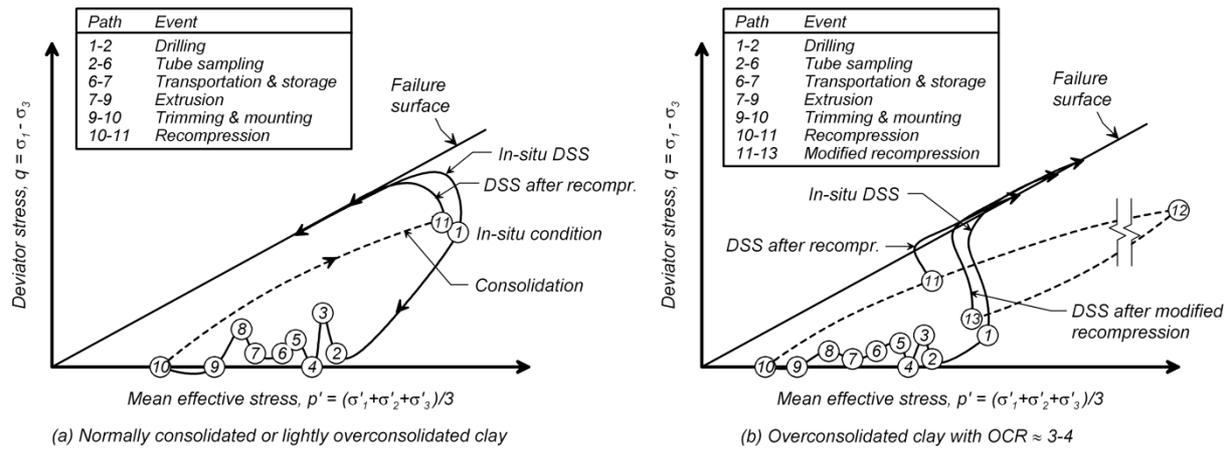
Figure 1. Schematic of stress paths during sampling and undrained monotonic DSS testing of NC and OC clay (modified and expanded after Ladd and DeGroot 2003; Dahl 2011).

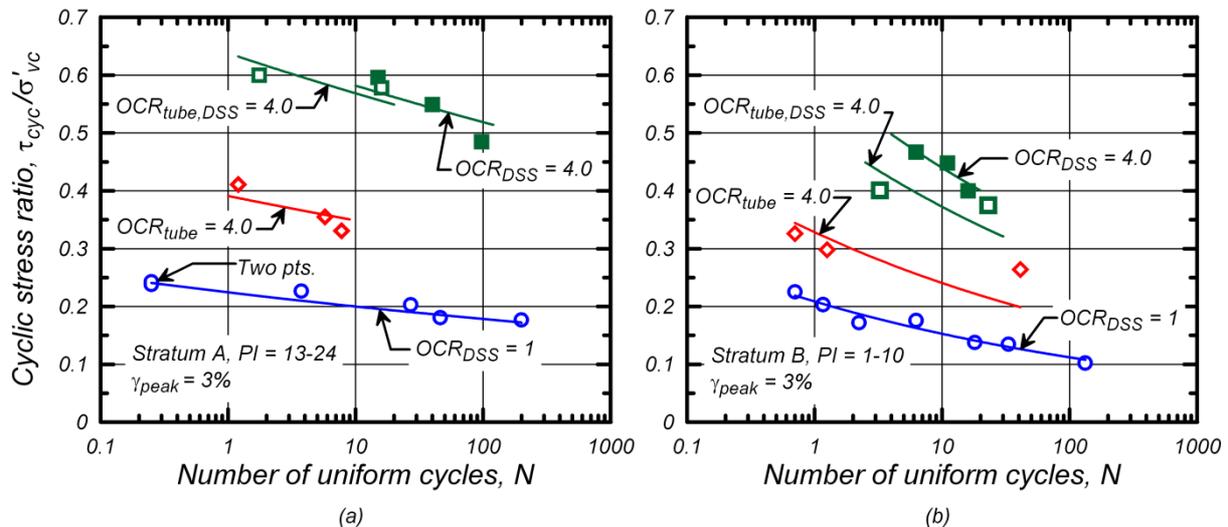
Figure 4. Cyclic stress ratio versus  $N$  to cause a peak shear strain of 3% on (a) Stratum A and (b) Stratum B specimens prepared using different specimen preparation histories.

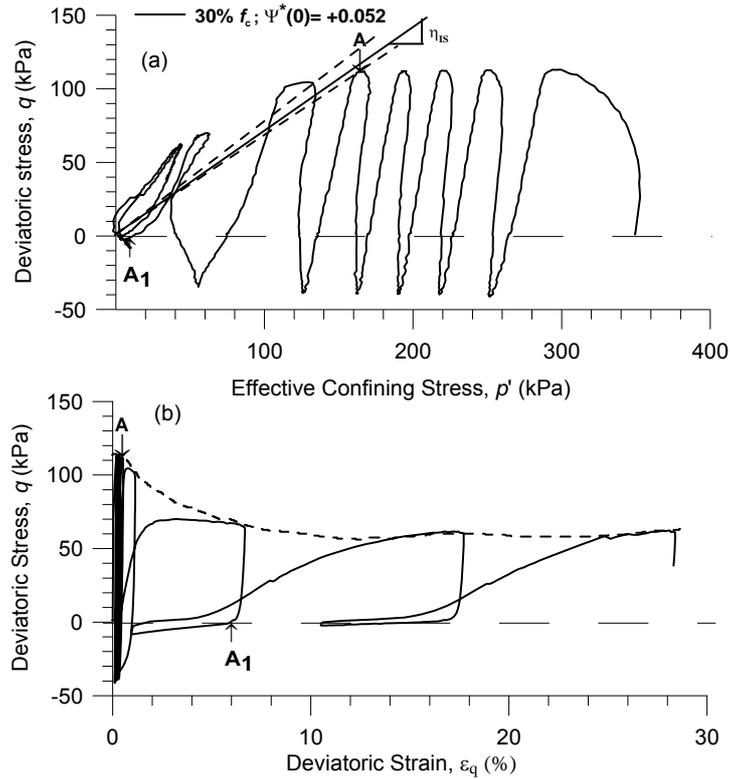
Figure 3. Instability triggered by under 2-way cyclic loading (a) ESP, (b)  $q$ - $\epsilon_q$  plot

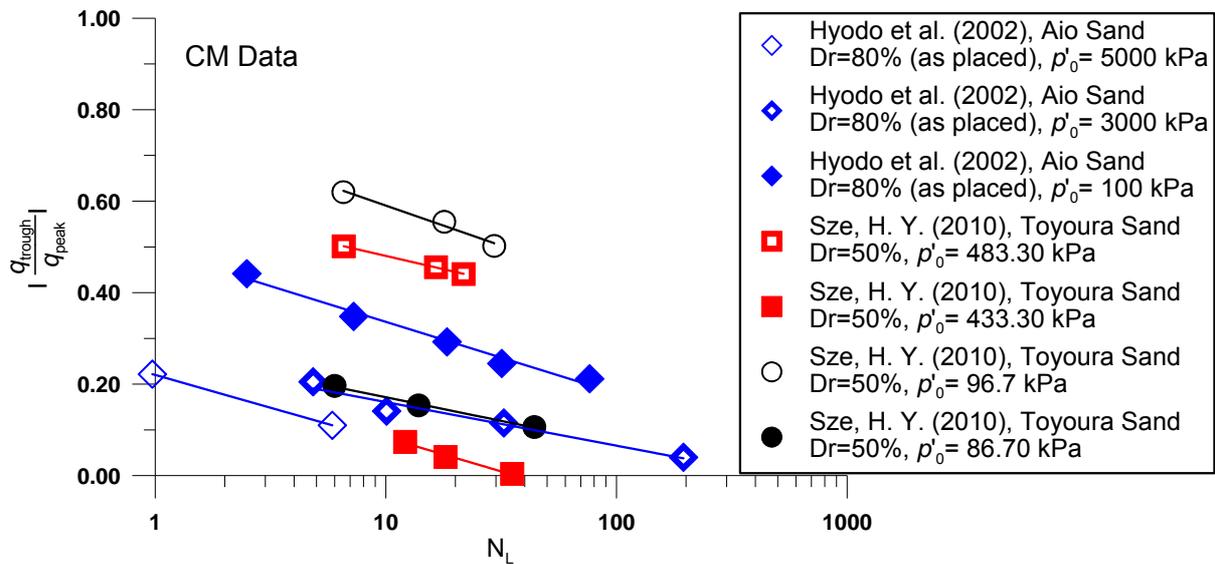
Figure 5. Analysis of CM data

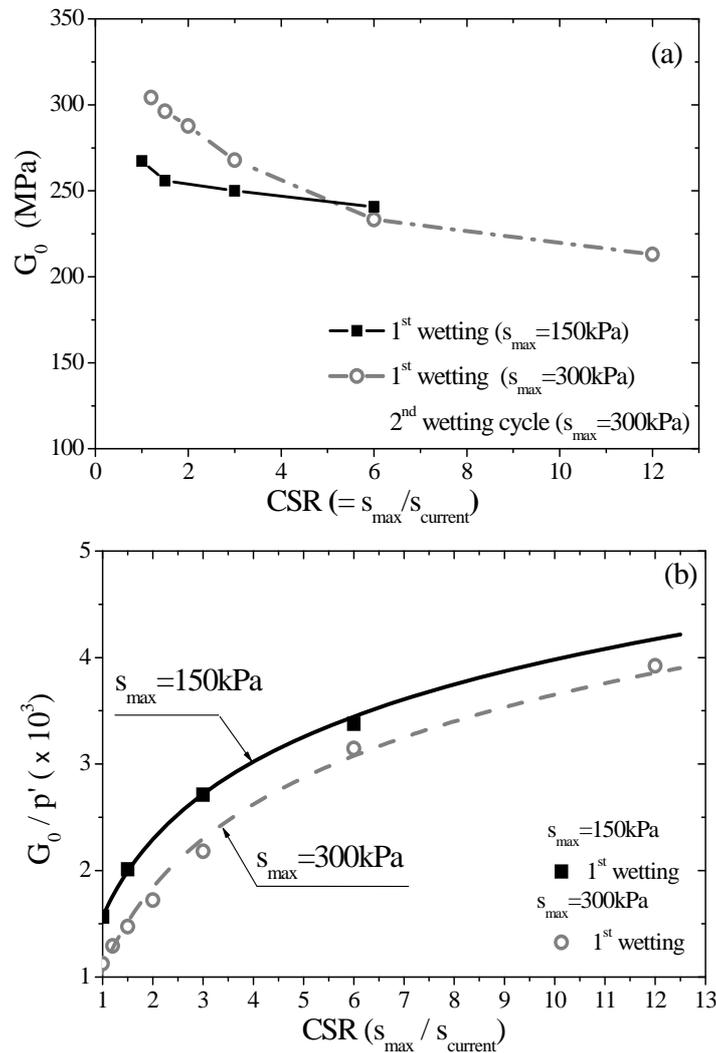
Figure 7. Variation of (a)  $G_0$  and (b) normalised  $G_0$  with current suction ratio (CSR) for the wetting paths of specimens with  $s_{max}$  of 150kPa and 300kPa.

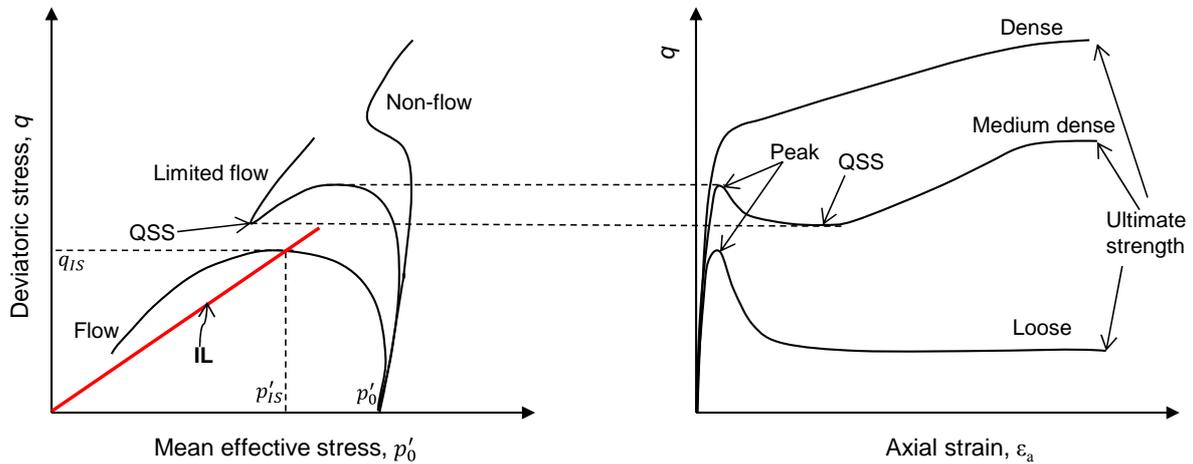
Figure 1. Typical undrained behaviour of sandy soil

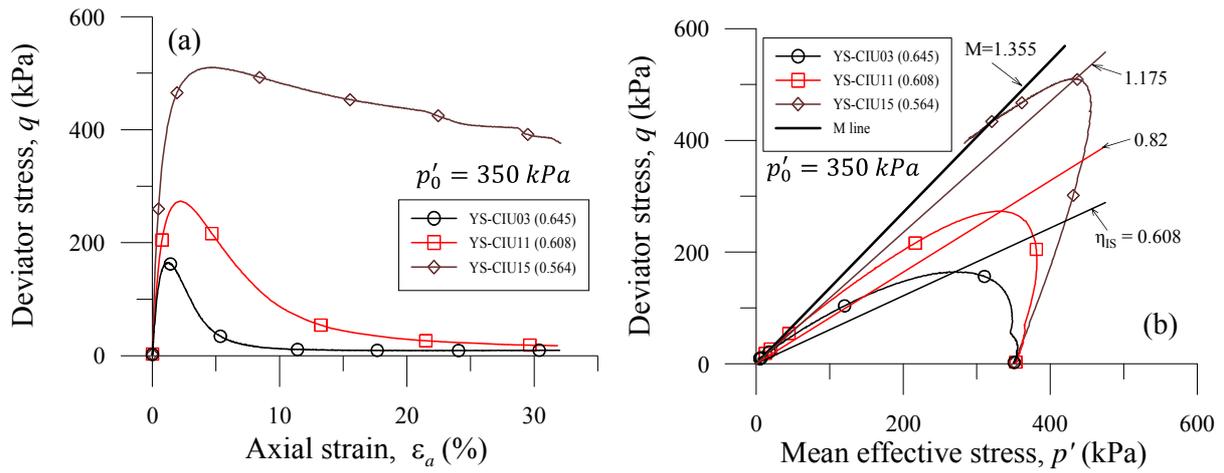
Figure 3. Undrained (a) stress-strain and (b) effective stress path for silty sand at  $p'_0 = 350$  kPa

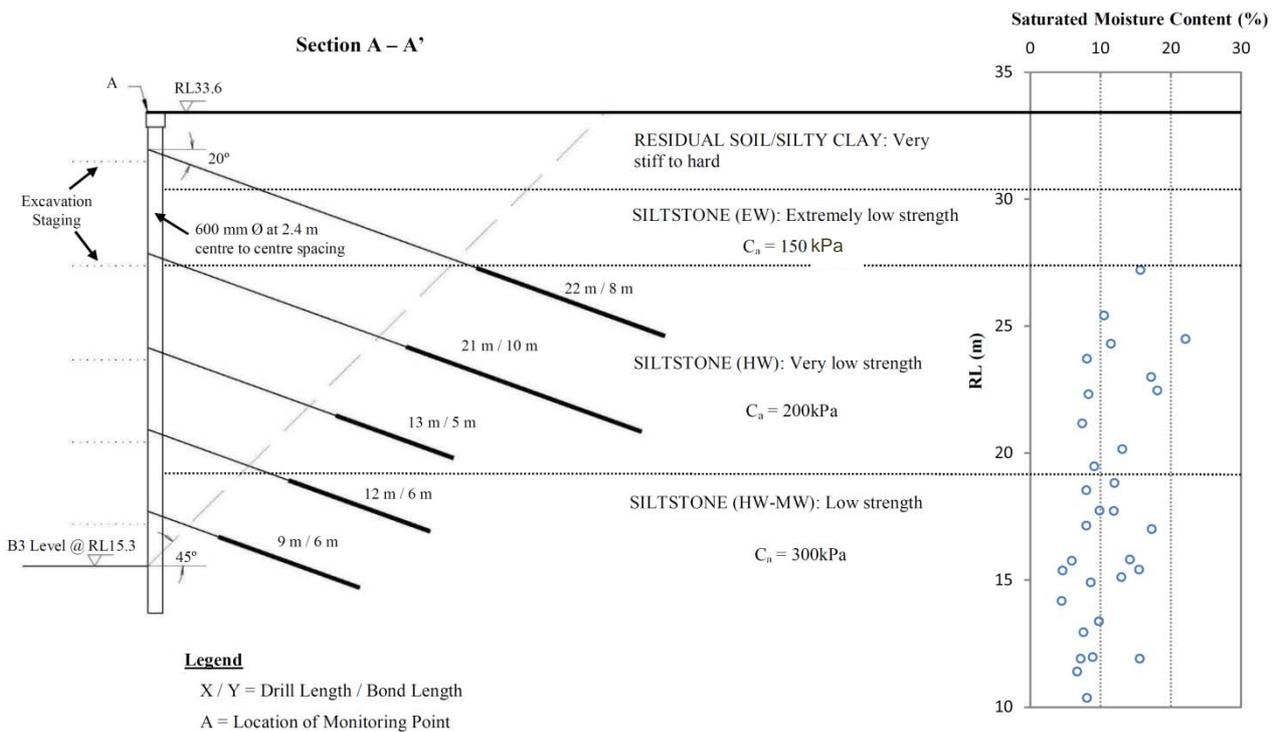
Figure 2. Ground Retention Details

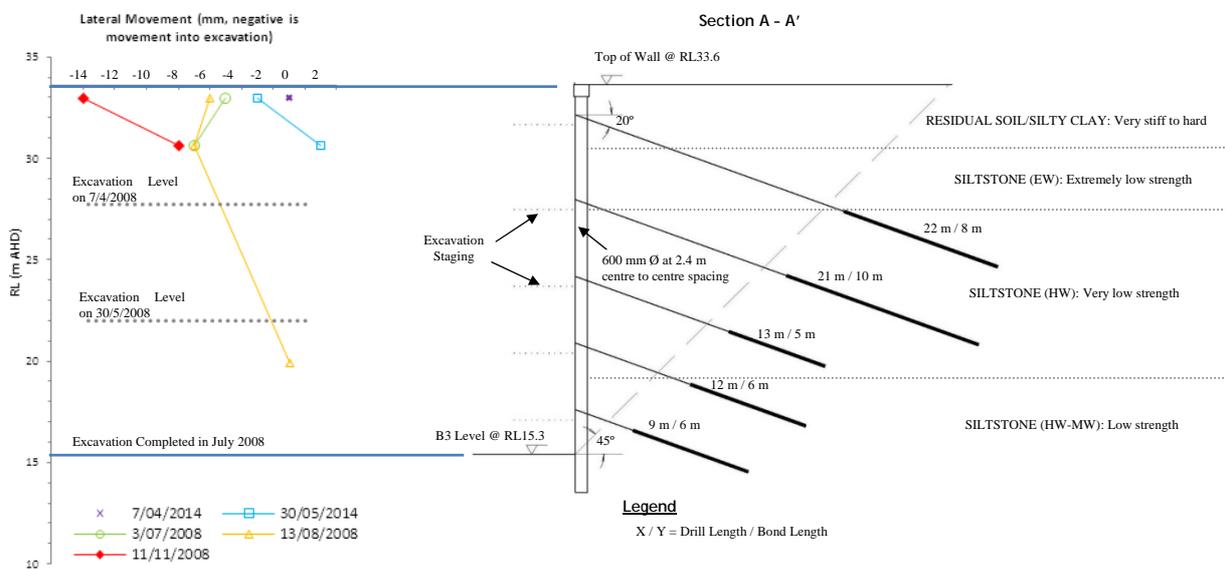
Figure 5. Retention Wall (Section A-A')
