Good grounds for the future

24-26 March 2021 • Dunedin • New Zealand

# A mining approach to a civil engineering problem – Sumner Road Re-opening, Christchurch, New Zealand

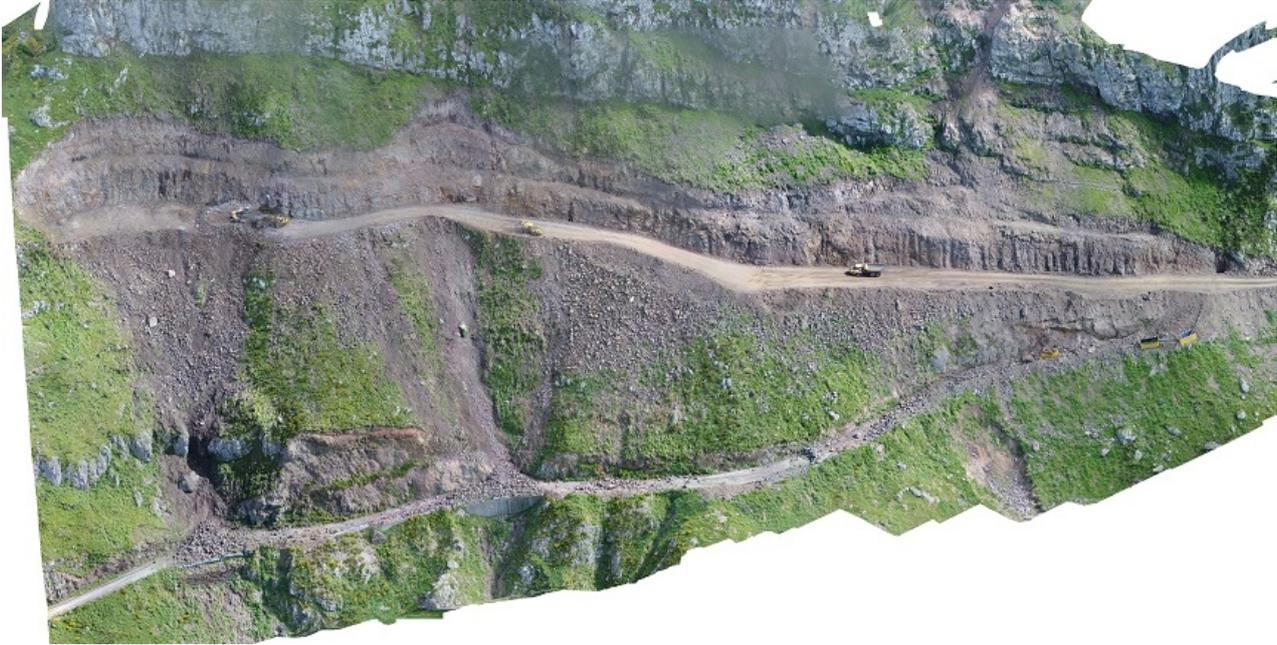
Figure 4: Oblique UAV image of the catch bench during construction

Excavation was staged both vertically and longitudinally. A “pioneering” bench was excavated near the top of the proposed cut using a tracked excavator to allow access for drilling equipment. The excavation was then lowered in a series of “flitches” by drill and blast techniques. Initially spoil was passed to a lower ramp level by 30 tonne excavators for removal by the ADT’s. Once the excavation reached suitable width and level, temporary ramps were developed to provide haul truck access to the working area for direct loading.

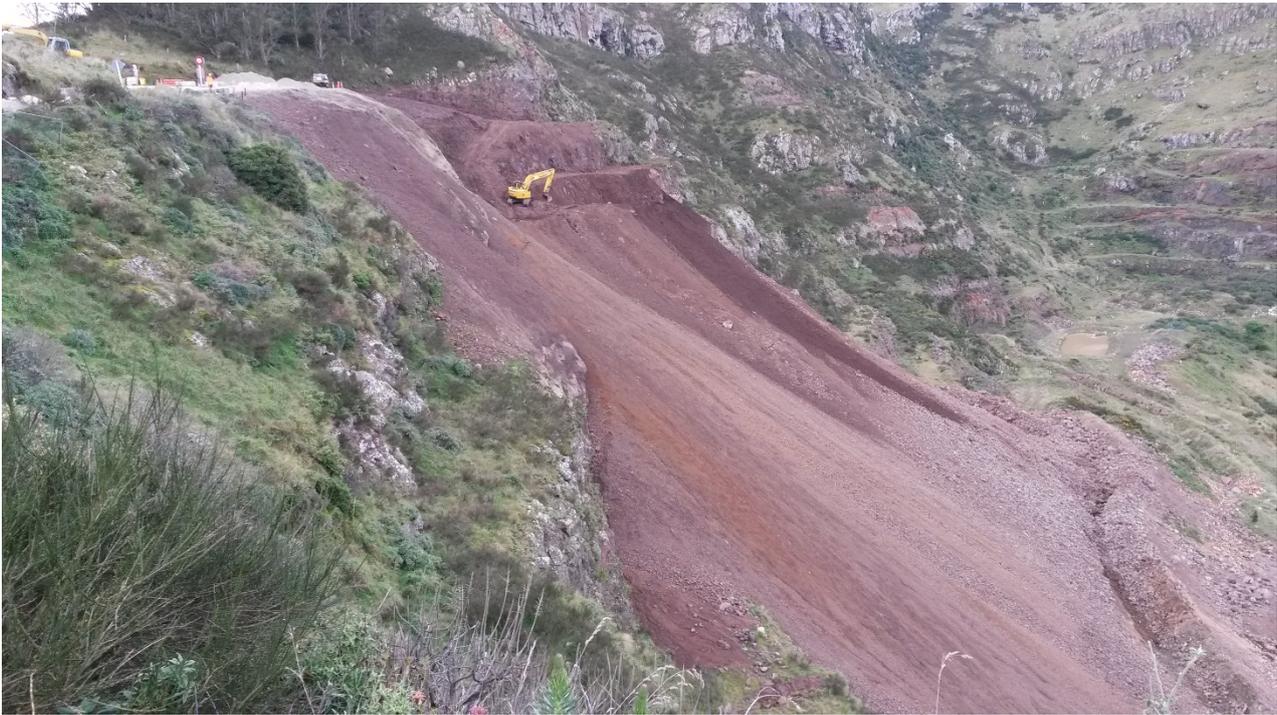
*Figure 6: Waste rock stockpile during re-profiling works. A temporary haul route to directly transport waste rock to the quarry would have traversed the steep slopes visible in the foreground.*

By using an end tipped methodology similar to a mine waste rock stockpile it was possible to avoid the construction of a dedicated haulage route from Sumner Road to the Gollans Bay quarry floor. Such a route would have required large and expensive retaining walls to achieve a workable gradient, with additional costs to either remove it on completion or provide ongoing maintenance following the approximately 11-month period of tipping and stockpile formation.

On completion of tipping, the spoil material was re-shaped from the top down using a 30-tonne excavator and 40 tonne dozer to provide a flat-topped landform approximately coincident with the pre-tipping RL 154 m quarry bench. Material in the central portion of the stockpile was left higher than RL 154 m as this would still be easily removable by accessing along the bench from the west. This bench provides the initial access for removing the stockpile via the existing lower quarry access road. Re-shaping involved dozing down of material above RL 154 m, and progressive clearance and recontouring of spoil material remaining on higher quarry benches.
