OMOKOROA POINT  
LAND STABILITY INVESTIGATION

REF: 4487/2  
MAY, 1980

PREPARED FOR:

Tauranga County Council,  
Private Bag,  
TAURANGA

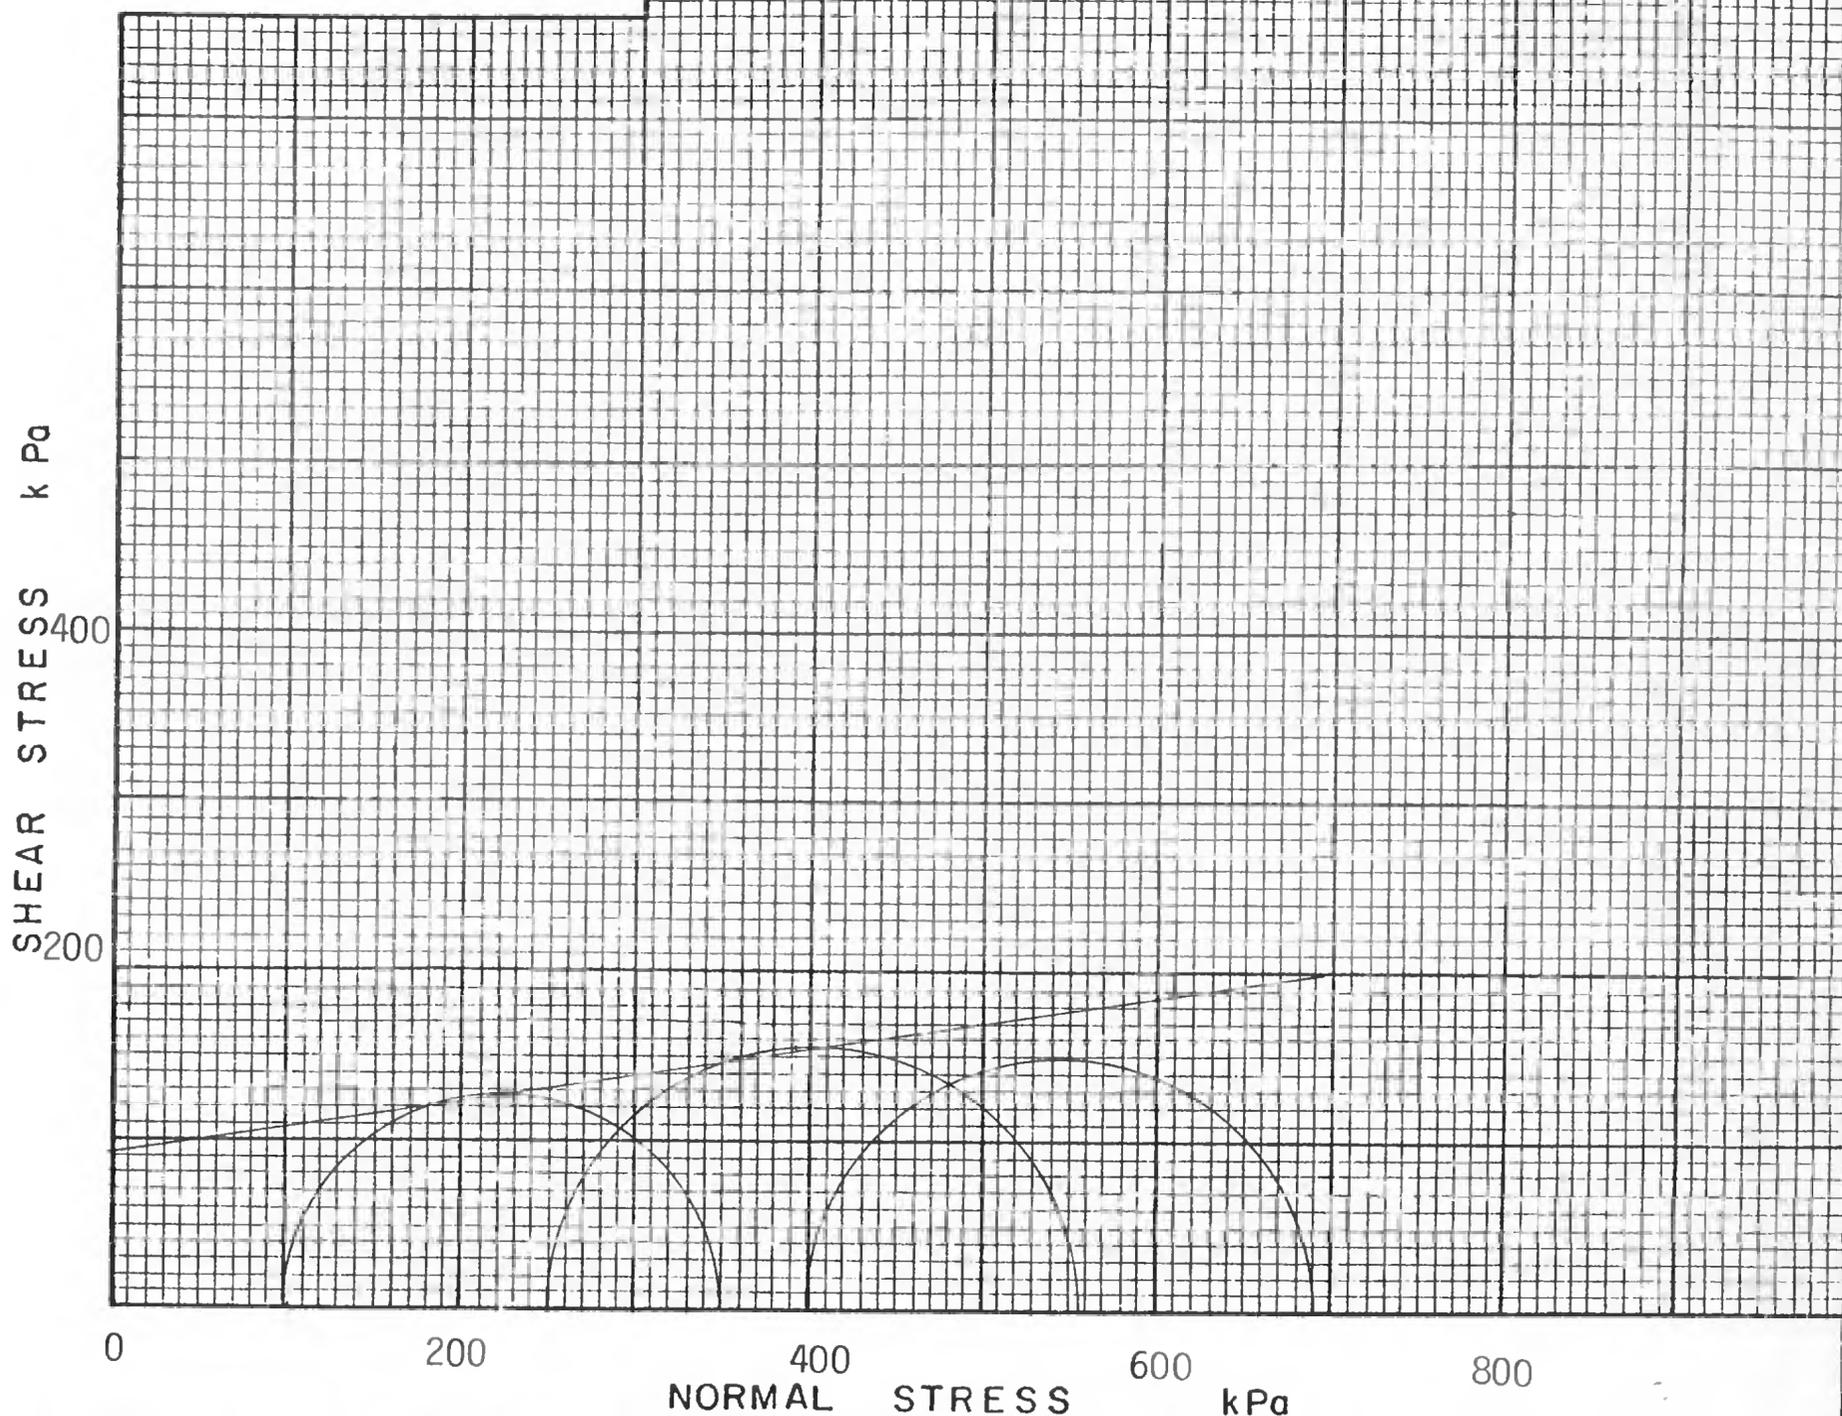
PLATE No. 1.

Soil test results are summarised on the borelogs and on plates 1 and 2, table 1 and figures 1 to 4.

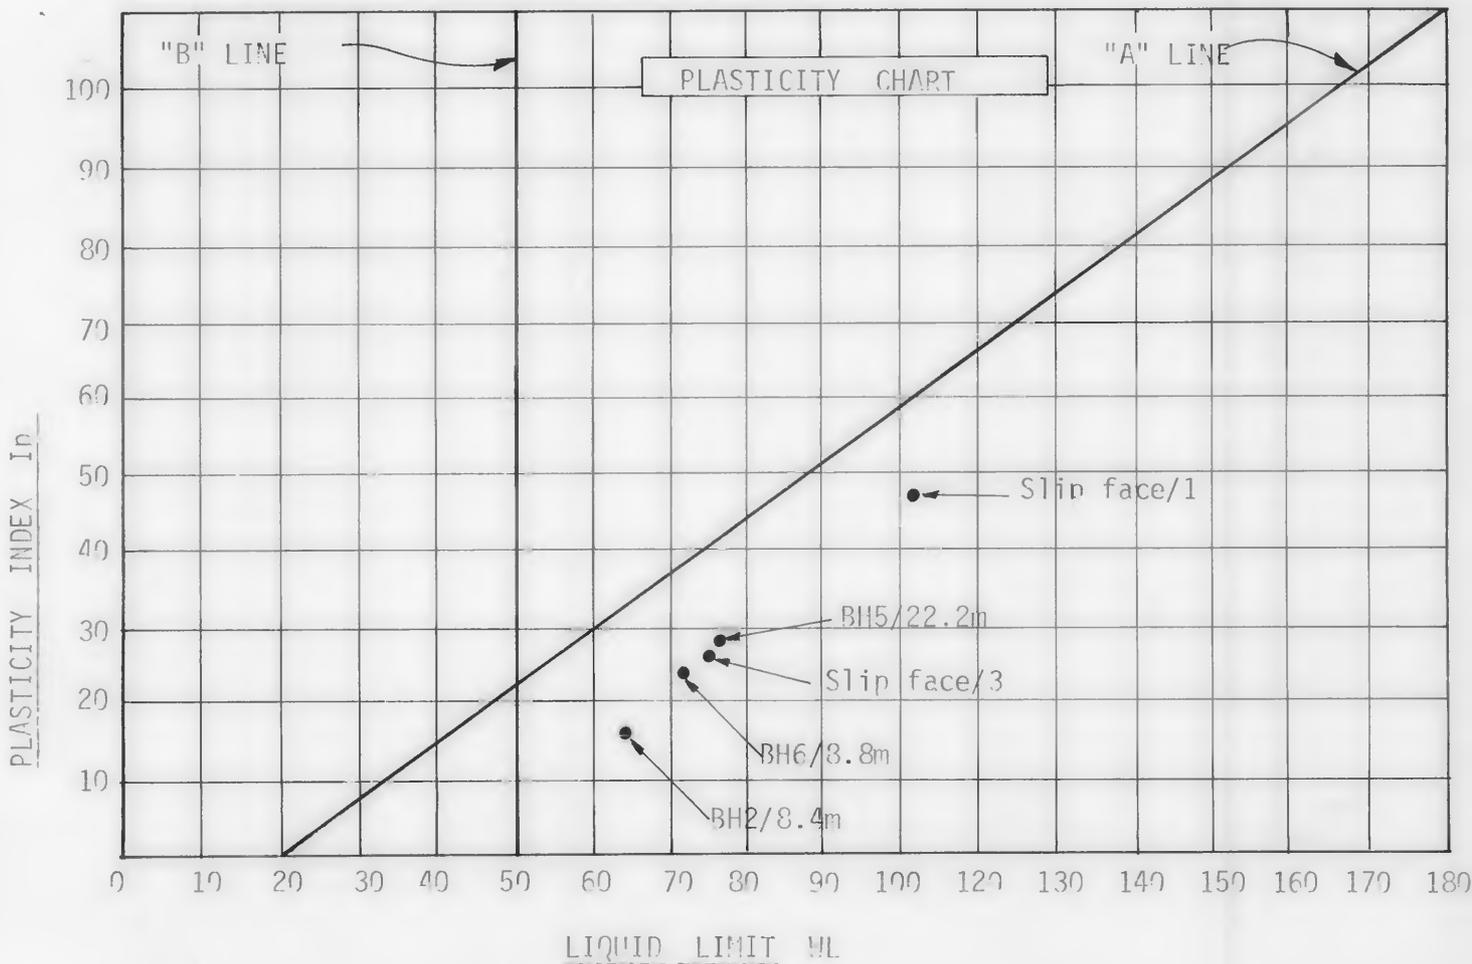
Fig. 1.

Natural water contents were often above the liquid limits. When plotted on the Casagrande Plasticity Chart for soil classification (refer fig.1) the samples all plotted well below, but parallel to the 'A' line, in the region of highly compressible inorganic silts (MH). Such soils can be expected to show high shrinkage characteristics and low dry strengths.

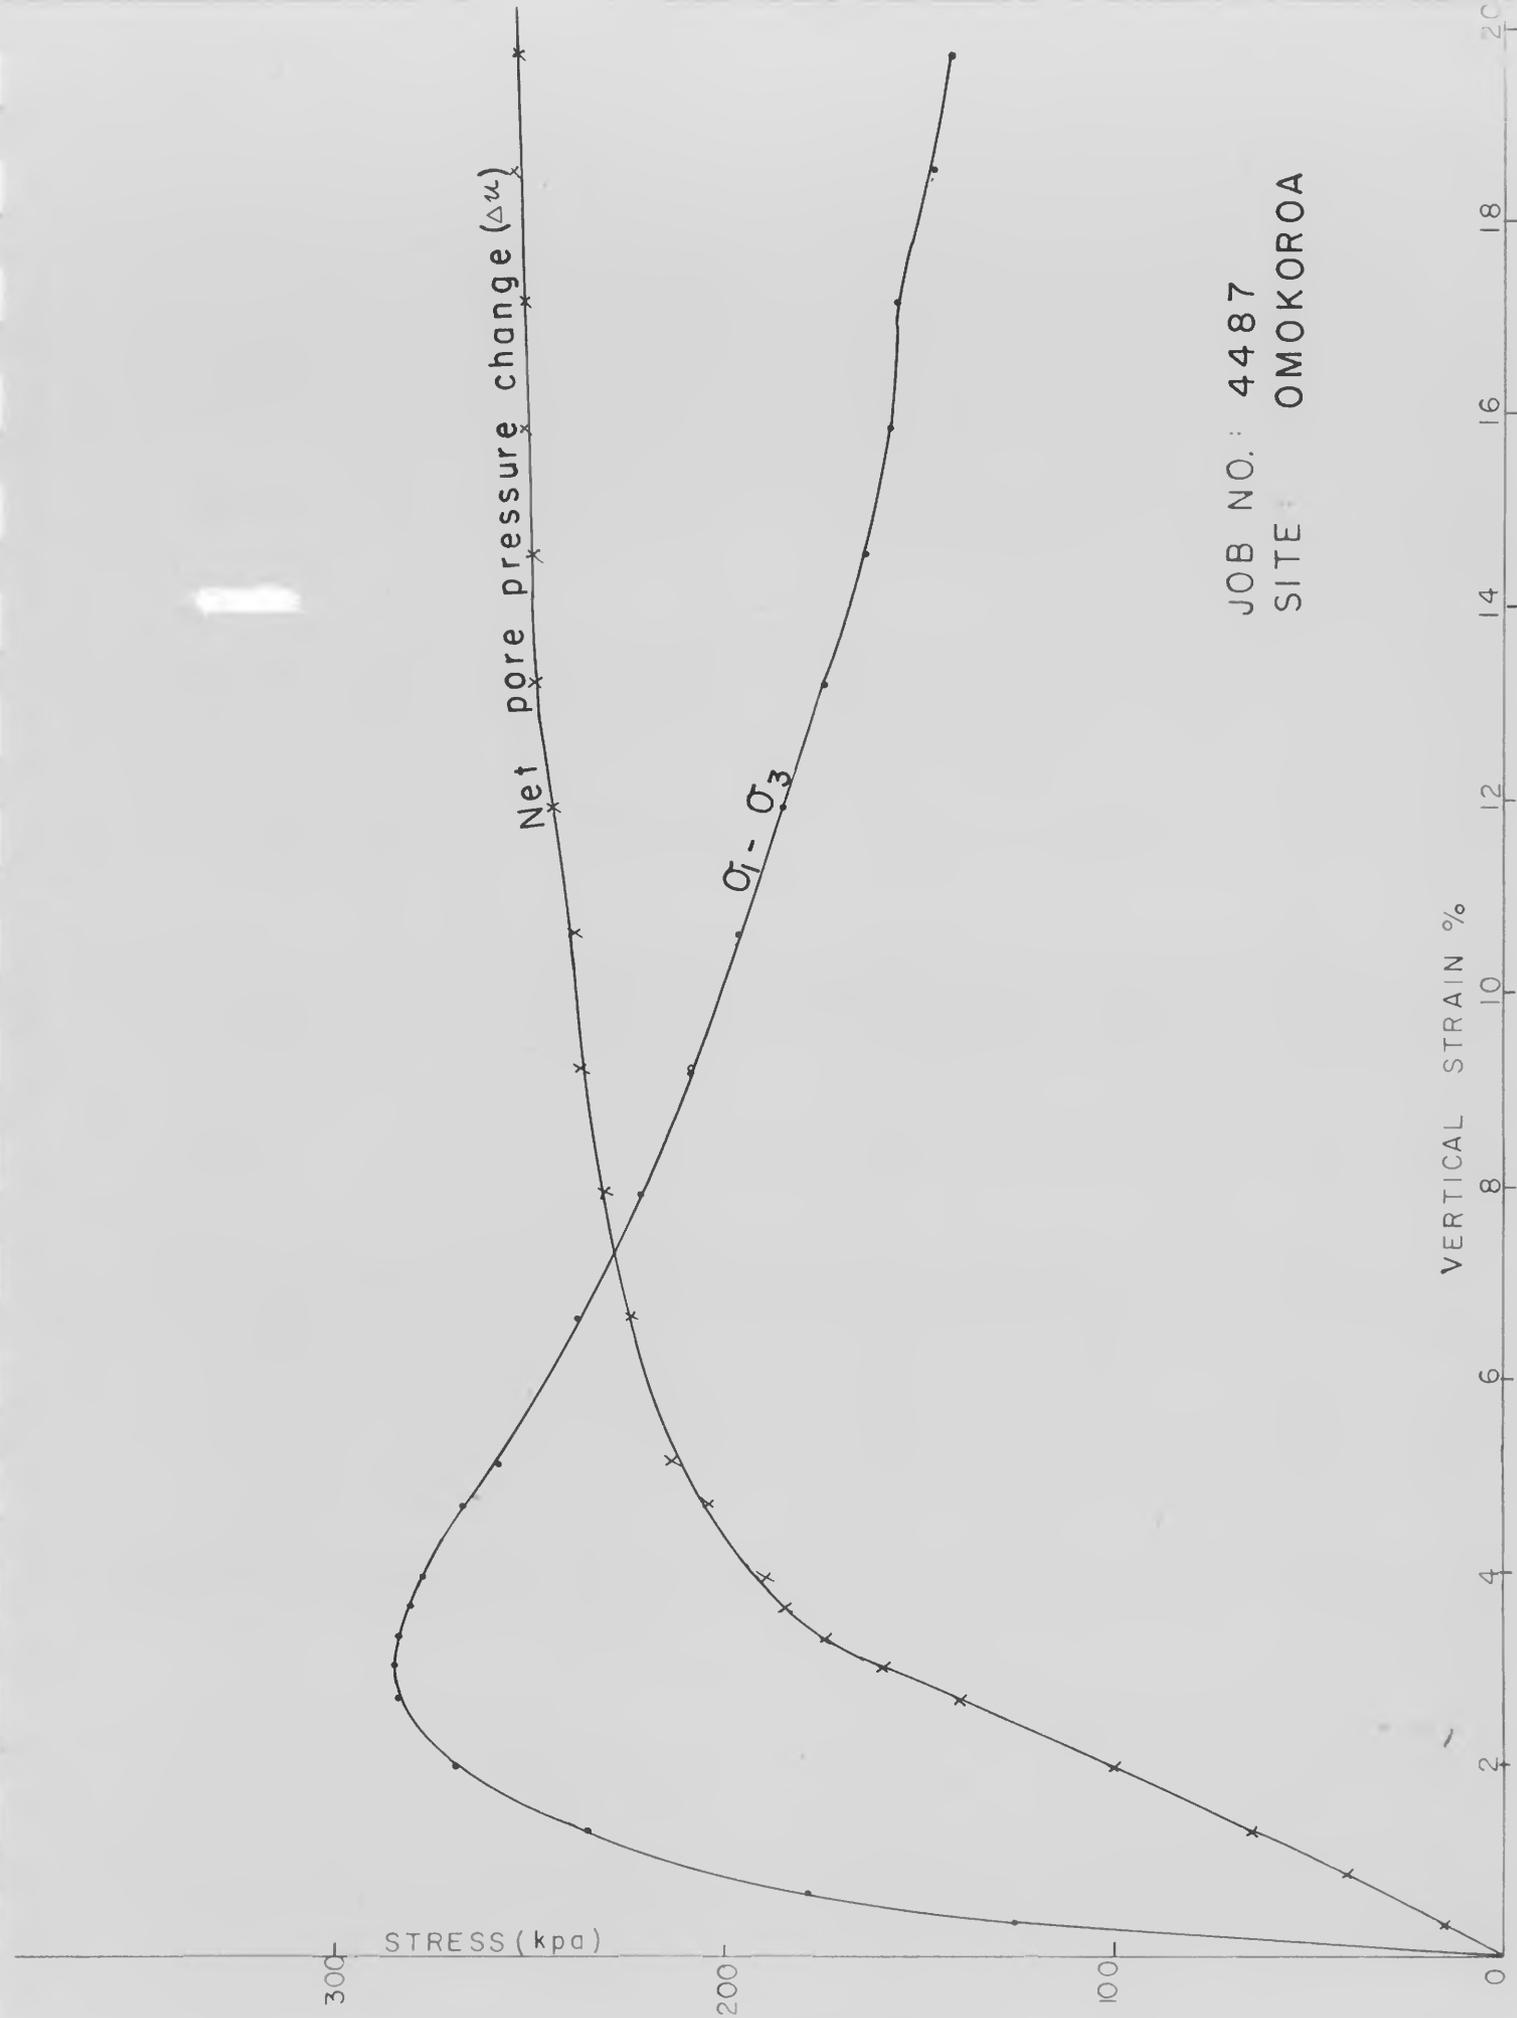
FIG. 3

In the case of the effective stress tests, loading was continued well beyond failure up to axial strains of 20%. Deviator stress and pore pressure plotted against strain are shown on figures 2 to 4. The significant aspect of these graphs is that the deviator stresses reach a peak at fairly small strain, indicating sudden brittle failure, then decreases with further strain, however, the pore pressure continues to increase even after the deviator has reached its maximum. This behaviour reflects the unstable skeleton structure of the sensitive clay. As the clay shears the soil structure collapses and the clay suffers a great decrease in volume. As this occurs large positive pore pressures are induced as load is transferred from the soil skeleton to the water held in the voids, since the sample is sheared undrained. The effect of this

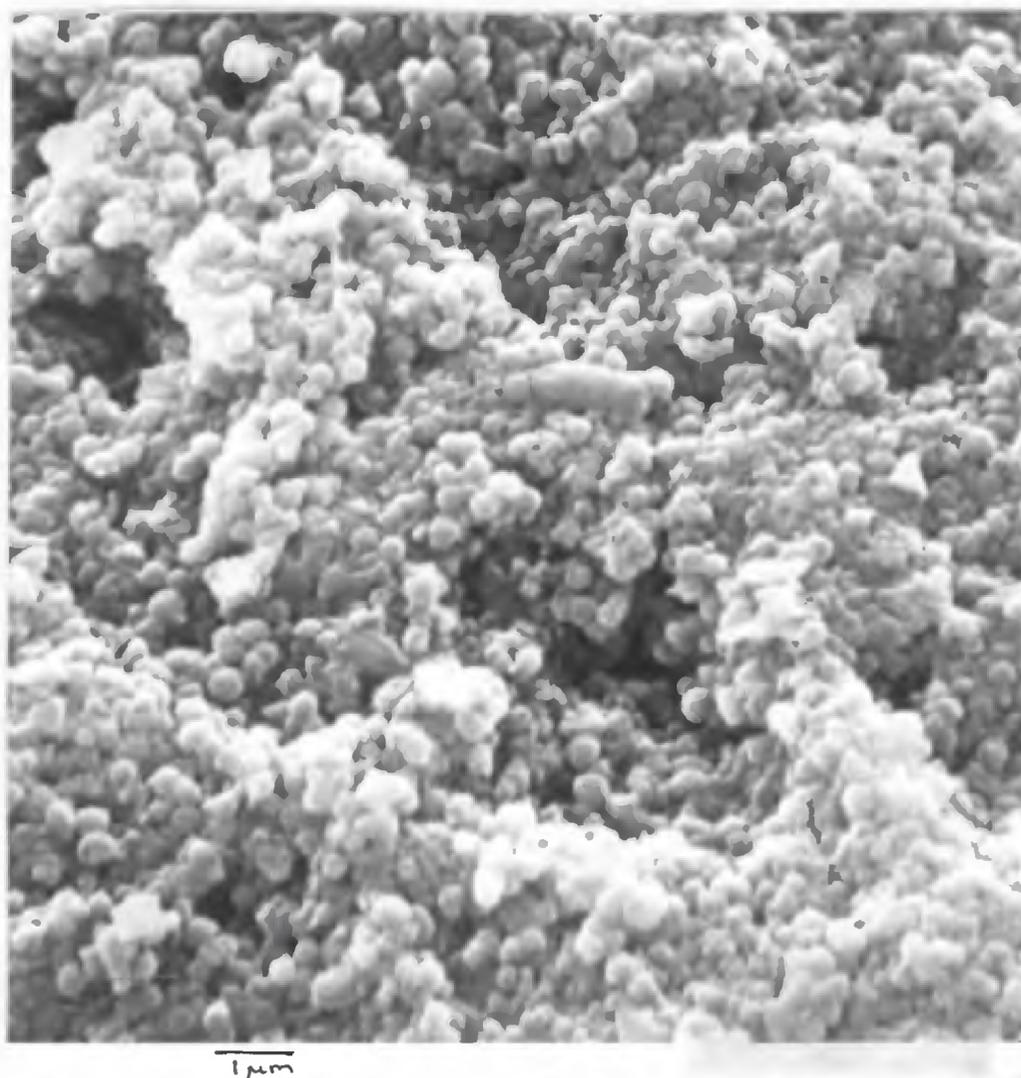
The soil sample supplied to Soil Bureau, D.S.I.R., (sample 4/13), was also subjected to an electron microscopic scan. The results indicate that the Halloysite is of an unusual spherical variety as shown in Fig. 6.1. The soil structure consists essentially of a mass of halloysite spheres with diameters of about 0.2 microns with no evidence of cementation between particles. These particles appear to be single crystalline units and not aggregations of smaller particles. It seems that the sensitivity of the soils results from very low attraction or bonding forces between the loosely packed particles. Thus although clay mineral particles predominate in the soil, long range interparticle forces are essentially absent and structural collapse can readily occur. The studies carried out on this soil by Soil Bureau lends some support to the inactive - particle theory of soil sensitivity (Cabrera & Smalley, 1973).

Fig. 6.1 Scanning electron microscope picture of spherical halloysite particles comprising sensitive soil from bore-hole 4, depth 20.6 m. Magnification 7,500 times.
