Canal Failure, Ruahihi Hydro Electric Power Scheme, Bay of Plenty, New Zealand

L.E. OBORN

SUMMARY The Ruahihi power station canal failed on 20 September 1981, one day after being officially opened. Water losses from the canal, and a number of slope failures resulting from these, were observed soon after the canal was filled for the first time.

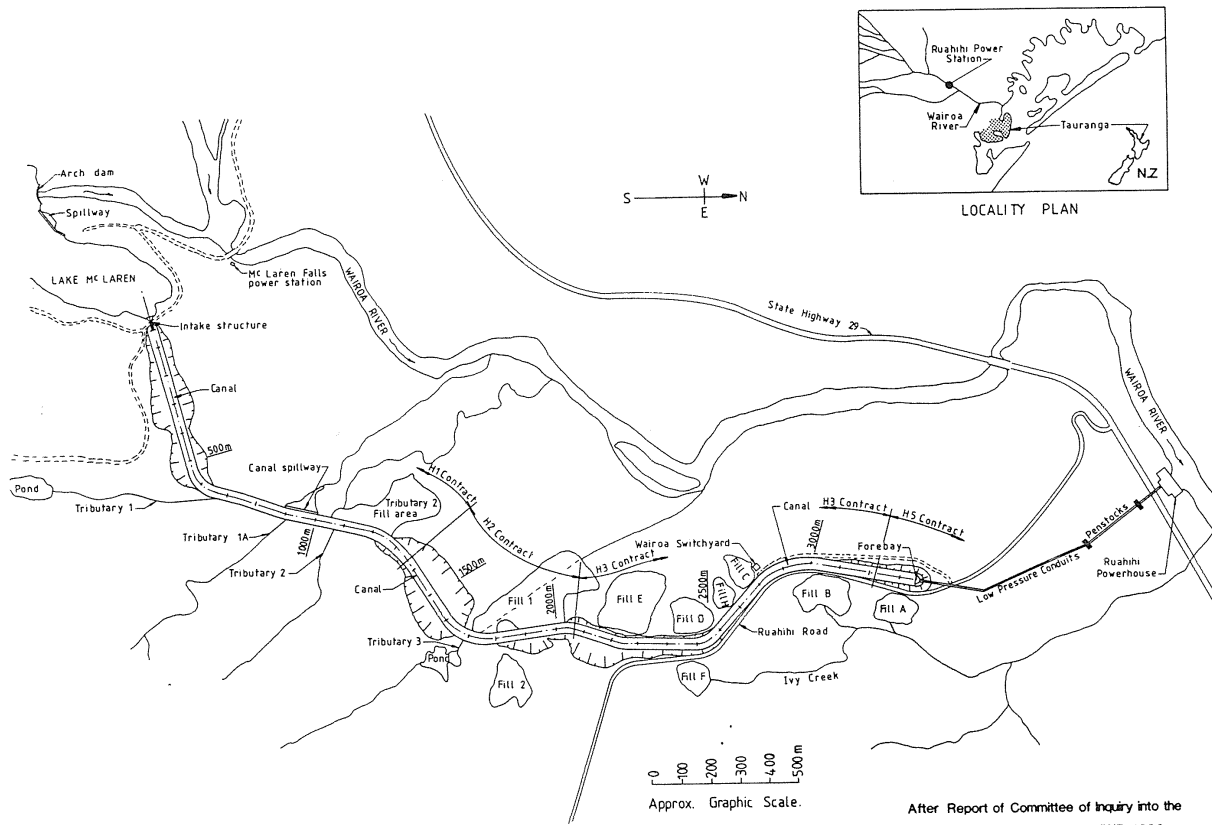
FIGURE 1 MAP OF RUAHIHI HYDRO-ELECTRIC SCHEME

Canal filling began on 25 February 1981. On 30 March seepages were observed at the toe of Fill D (see Figure 1). Flows increased, seepage water became discoloured, and, on 31 March, an arcuate crack 20 m long was seen above the seepage area. By 1 April the crack had widened, and the ground down stream of the crack had slumped 300 mm. Seepage at this time was ca 1 litre/sec. Remedial work was undertaken.
