## Management of geotechnical risks for some tunnels in the Wellington Region

David Stewart

Opus International Consultants, Wellington, New Zealand

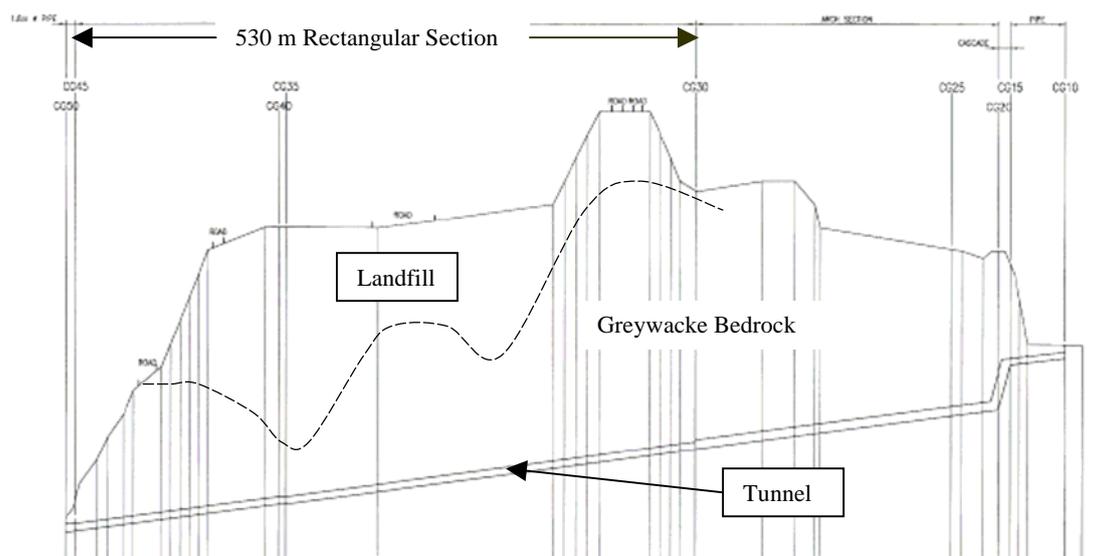
Figure 4 : Carey's Gully stream tunnel profile

This tunnel carries the Carey's Gully Stream under the Wellington City Council's (WCC) Southern Landfill (Figure 4). The tunnel was constructed in the mid 1990's to replace a collapsed circular culvert which had been laid prior to landfilling. The tunnel was excavated 530 m through highly fractured greywacke bedrock, and is fully lined with a rectangular (1.8m wide by 1.6 m high) cross section, with a 250 mm diam. leachate pipe running down the side (Figure 5). Soon after construction, checks revealed sections of substandard concrete lining (very thin concrete) and voids between the roof lining and surrounding greywacke bedrock. At the worst (160m long) section adjoining the downstream portal, the roof was reconstructed with concrete in 1999. Throughout the remaining 370 m of the 1990's tunnel, timber supports were installed at 1100 mm centres (Figure 5a) to support the tunnel roof.

Due to concerns about the structural integrity of the lining and potential for tunnel collapse WCC subsequently engaged Opus to develop options for management of the risks.
