## Correlations between liquefaction induced damage and former river channels in Kaiapoi

L M Wotherspoon, M J Pender, R P Orense  
Civil & Environmental Engineering, The University of Auckland, NZ.  
[l.wotherspoon@auckland.ac.nz](mailto:l.wotherspoon@auckland.ac.nz) (Corresponding author)

The town of Kaiapoi, 17 km north of the city of Christchurch, suffered significant liquefaction induced damage during the Canterbury earthquake sequence. Severe lateral spreading and large volumes of ejecta were present throughout the town and surrounding region after multiple earthquakes in this sequence. This region has also seen significant changes to the paths of rivers since European settlement in the 1850's, and as a result there are many areas within the town and surrounding area that were, until recently, channels of the Waimakariri River. Using historical data, the reclaimed channels were identified, which were shown to have a strong correlation with the areas of severe liquefaction damage following these earthquakes. Examples of damage in these areas are presented and related to the relatively recent changes to the river channels in the region. The significant damage to the infrastruc

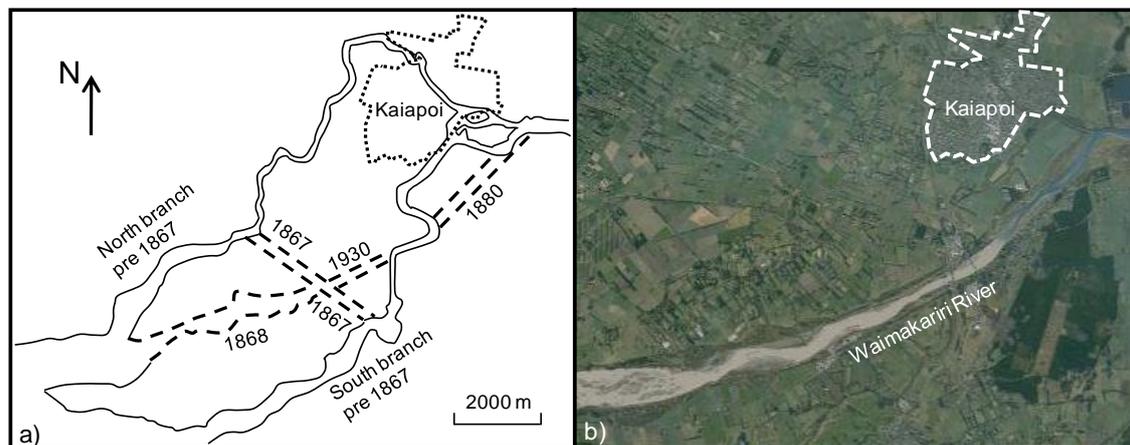
The dates of the major natural and man-made changes to the Waimakariri River that have occurred since the settlement of the town are shown in Figure 1 (Wood, 1993, Logan, 1998). Throughout the 1860's the main flow of the river was along the north branch and through the centre of the town. As a result, the town suffered many serious floods in its early years, with only very rudimentary flood protection works were in place. In 1867 and 1868 the local residents constructed new channels that choked off the north branch of the Waimakariri and shifted the entire flow of the river along this new path. In 1880 a new channel was formed that shifted the main flow of the river away from the town, reducing the old main channel down to a small stream that still exists today. In response to floods in the 1920's a major river improvement scheme known the Hays No. 2 scheme was implemented, completing the straightening of the river to its present course and the construction of stopbanks. This system of stopbanks has been further improved in response to flooding to the scheme as it exists today. The present day Waimakariri River has only one branch, following the path of the 1868, 1930, and 1880 river modifications shown in Figure 1a and b, with a system of stopbanks constraining the flow along this path. A more detailed account of the river modifications is given in Wotherspoon et al. (2012).

**Figure 1: Kaiapoi and its surrounds a) historical river modifications; b) present day river characteristics**

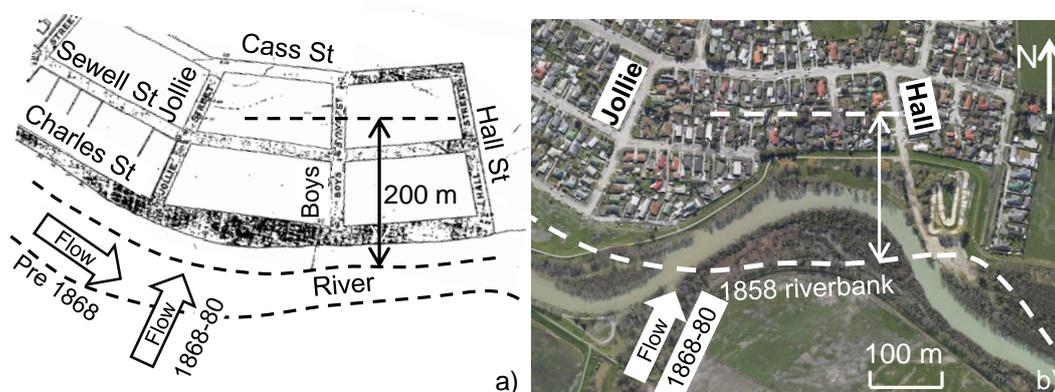
To provide a conservative estimate of the erosion, the river banks at mean water level from 1858 were used as the origin of the 200 m offset to show the extent of erosion in 1878. This erosion would have removed much of the planned positions of Charles, Sewell and Boys St shown in Figure 5a. It is also clear from Figure 5b that the present day river banks are much closer to the 1858 position, indicating that much of the eroded area was either aggraded due to the accumulation of loose sediments as a result of the reduced flow of the river or reclaimed by other means.

**Figure 5: Eastern Kaiapoi a) 1858 street plan and river characteristics; b) present day river location**
