Engineering & Development

in **HAZARDOUS TERRAIN**

NEW ZEALAND GEOTECHNICAL
SOCIETY 2001 SYMPOSIUM

Hazardous Terrain – An Engineering Geological Perspective

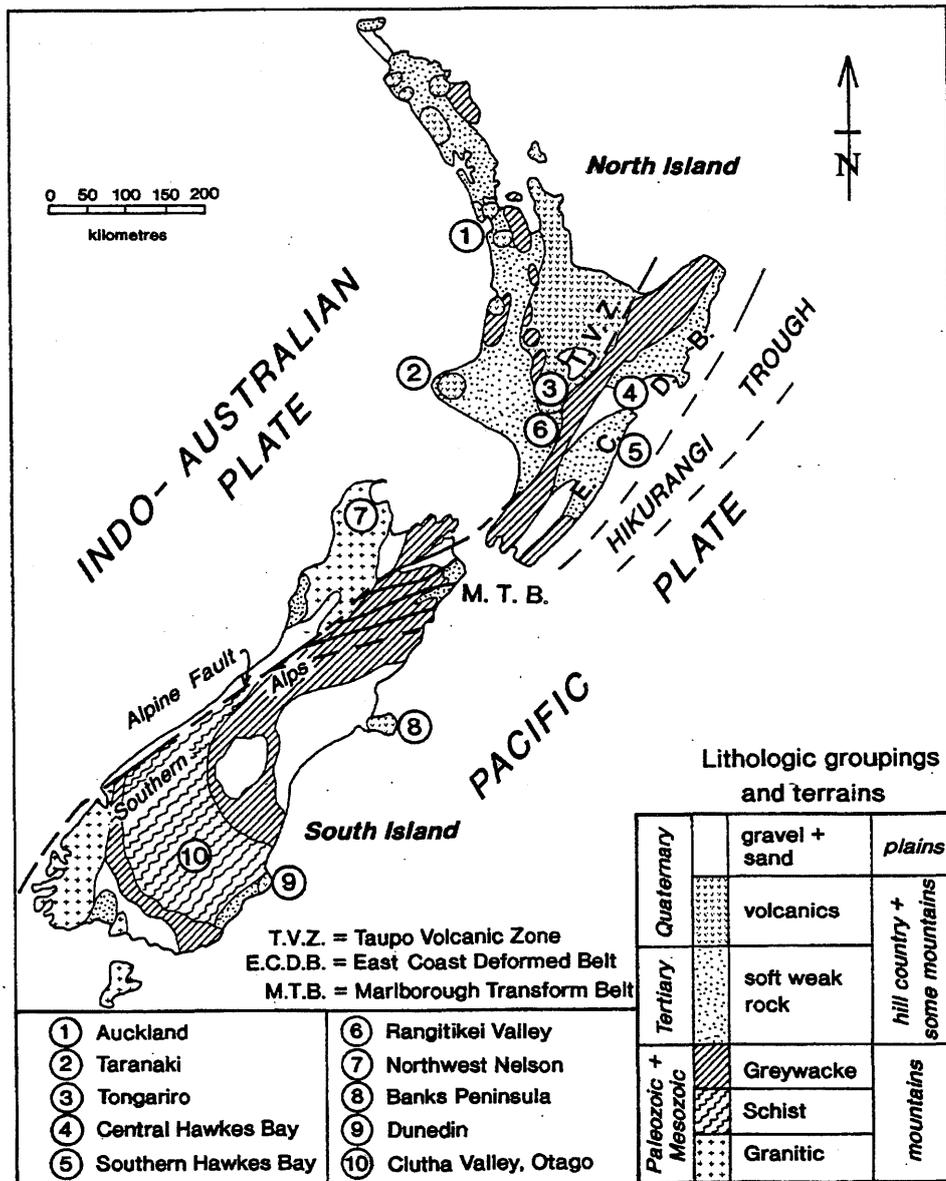
Figure 1. Major tectonic features, main lithologic groupings and engineering geological terrains of New Zealand

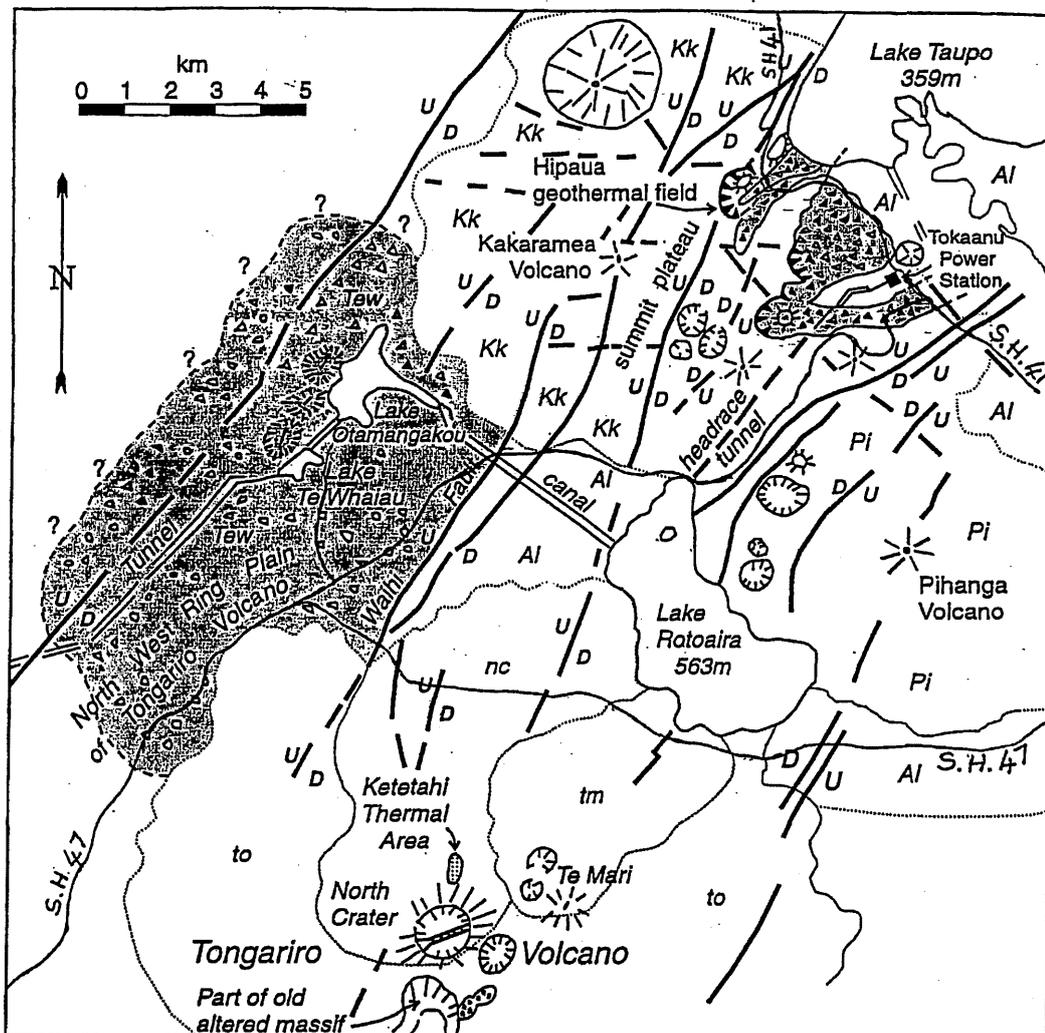
Figure 2. Tongariro Volcano, north-west ring plain and the Tokaanu area. Taupo Volcanic Zone. Cover beds of volcanic ash and tephra have been omitted.

The area around the Tokaanu Power Project and the Otamangakau and Te Whaiiau dams (Fig.2) was particularly enigmatic. A successful resolution came only with the help of the regional approach and photo-geology. The complex Tongariro Volcano with its collection of craters, thermal areas and lava flows became a type area for elucidating the obscure and altered formations at Tokaanu and also provided clues as to the source of unusual deposits at Te Whaiiau and Otamangakau.

Active andesite cones in the Taupo and Taranaki Volcanic Zones have a history of generating lahars and ash frequently and, less often, pyroclastic flows and lava. They are also subject to much larger, less frequent but catastrophic cone collapse, giving rise to large debris avalanches, debris flows and mud flows. (Palmer, Alloway and Neall 1991). Sector collapse, similar to that seen at Mt St Helens in 1980 (Schuster, 1983) is inferred to have happened numerous times at Taranaki and Ruapehu. Some original field work (Prebble, 1967) and current research (LeCointre, Neall, Wallace and Prebble in press) indicate that similar events are also characteristic of the Tongariro volcano, affecting in particular the north-western summit, cone and ring plain. Some debris avalanche and debris flow deposits from the region are shown in Fig. 3 and the geomorphology of the volcano in Figs 4a and 4b. Modern, smaller debris avalanches and flows caused by the collapse of hydrothermally weakened ground along fault scarps in the Hipaua geothermal field (Fig. 2) high above Lake Taupo, have happened twice in the last 150 years. These clay rich flows overwhelmed local villages. Prehistoric debris flow deposits are also found in the Tokaanu area (Figs 2 and 3).

The Te Whaiiau Formation (Figs 2 and 3) is a cohesive debris flow deposit, which originated from a massive debris avalanche on Tongariro volcano. This example shows the value of a regional approach in which field mapping and geomorphology were combined in order to clarify the origin, nature and distribution of the formation. This was critical to the Power Development in two ways. Firstly the formation provided a foundation for 2 dams displaced for geological reasons from their original sites during excavation. Secondly it marks a major debris avalanche and debris flow event which could happen again.

The andesitic massifs of Kakaramea and Tihia volcanoes lie in the centre of the Taupo Volcanic Zone rift, south of Lake Taupo (Figs 2 and 6). The form of these volcanoes has been much modified by erosion, faulting and graben development into a series of step-like scarps and benches.

Most of the north-east slopes of Tihia behind Tokaanu and Waihi show signs of slope failure (Figs 2 and 6). Long sinuous tongues and shorter lobes of hummocky slope are more or less ubiquitous, except for the penstocks ridge which is considered to be in place. The penstocks are founded on ribs of fractured andesite. In the case of the bottom rib beneath anchor block 1 and the rear wall of the power house the rock is also very seamy with a network of soft clay seams and gouge. The ribs are surrounded by firm to stiff clay, a fairly uniform residual andesitic soil derived from alteration of lava, breccia and rubbly scoria. Reference to the exposures on the Tongariro volcano (Fig. 7, for instance) clarified the origin of the formations at Tokaanu through a careful textural and stratigraphic comparison at a range of scales.

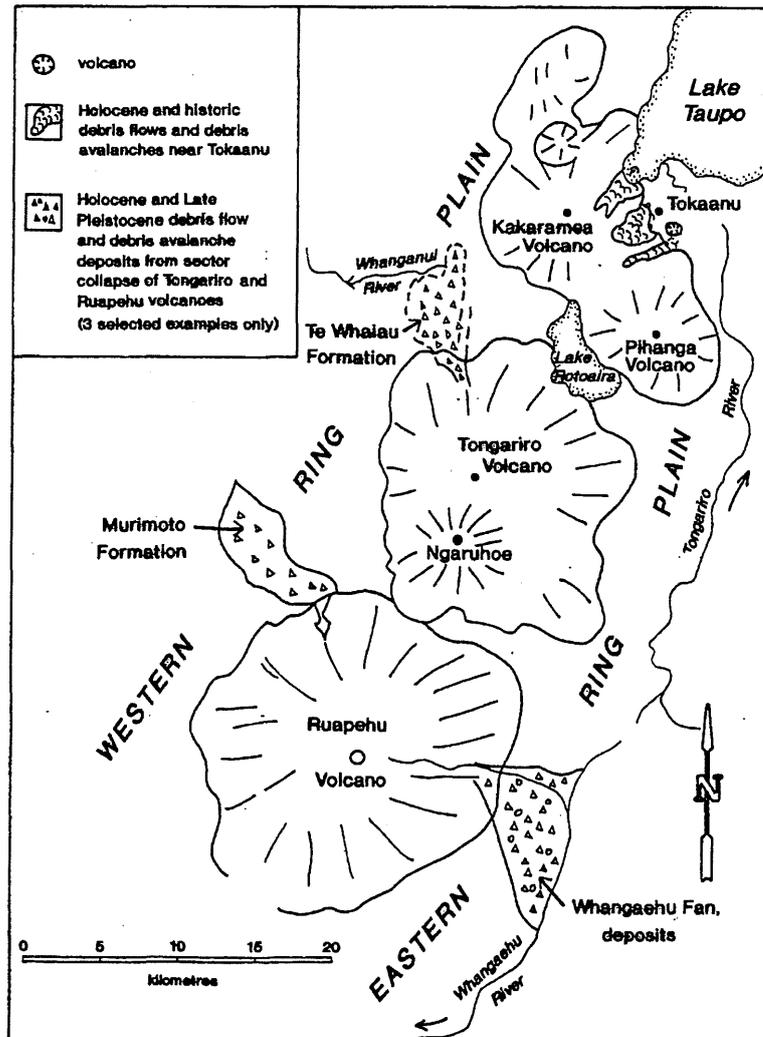
Figure 3. Selected debris avalanche and debris flow deposits in the Tongariro Volcanic District, southern Taupo Volcanic Zone. The Te Whaiiau Formation and 2 other large, more recent (Holocene) debris avalanche deposits are shown. The Holocene and historic debris flow deposits from the Kakaramaea Volcano behind Tokaanu are also shown.

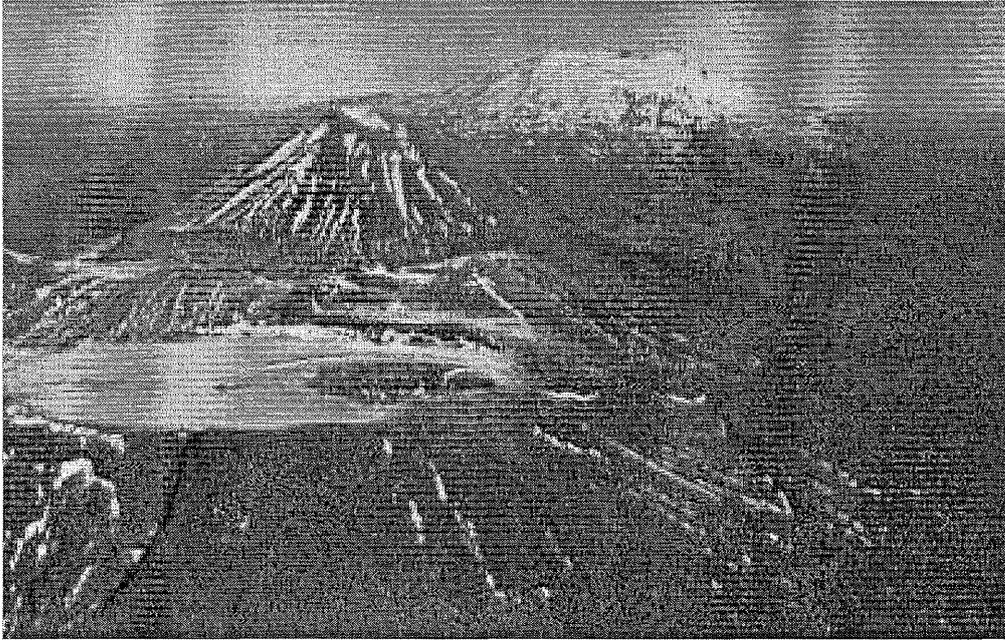
Figure 4a. Aerial view of Tongariro Volcano from the North. The flat-topped North Crater in the foreground lies in front of the old altered massif of the summit of Mt Tongariro, considered to be the remnants of the source area for the Te Whaiiau Formation. A model derived from this view is shown below in Fig. 4b.

In the Tokaanu area, accurate geomorphic interpretation was essential to hazard identification and assessment. Recognition of volcanic facies through a mask of intense alteration was an important step towards distinguishing landslide deposits from in-situ ground. Regional geological information and a detailed knowledge of the range of facies that could be met came only with experience of the volcanoes to the south, in particular Tongariro. Figures 4 and 7 are examples of reference localities, which were used for information on andesite volcanoes.

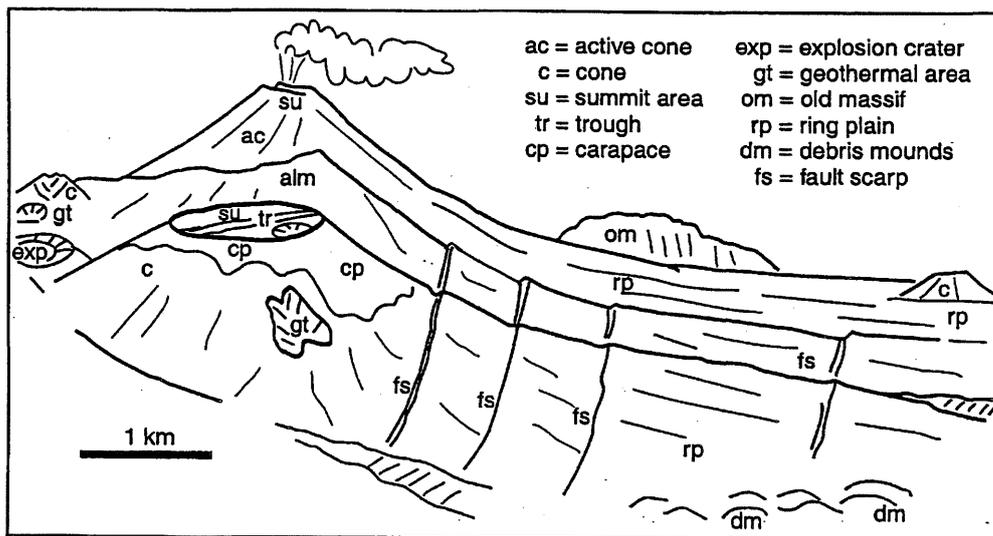
Figure 4b. Geomorphic elements of a complex andesite volcano. This model is based upon the Tongariro volcano, illustrated above in the photograph, Fig.4a. Note that "alm" in the figure represents the altered massif of the old Tongariro volcano.

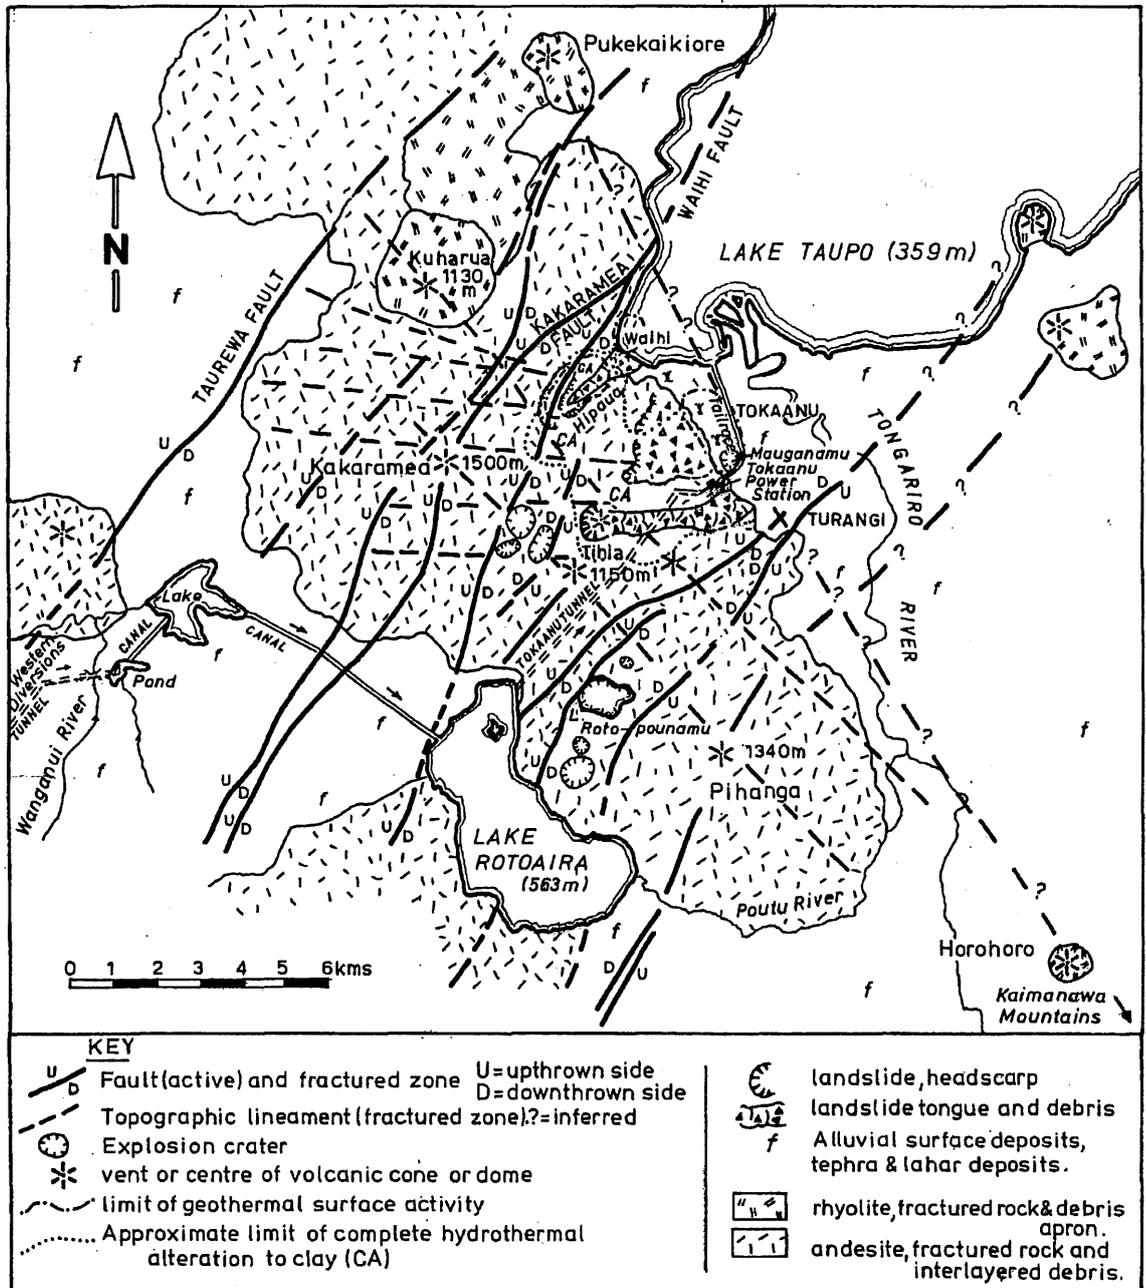
Figure 6. Geology of the faulted andesitic massifs of Kakaramea and Tihia volcanoes, in the centre of the Taupo Volcanic Zone, south of Lake Taupo.

The Hipaua geothermal field is situated along the zone of the Waihi Fault (Fig 6), in steep unstable ground 500m above lake Taupo. Thermal activity is concentrated along 1 km of the fault scarp where it is intersected by E-W and NW-SE trending topographic lineaments. The latter lineament is defined by breaks in slope, saddles, small andesitic cones, a rhyolite dome and stream directions. It can be followed into the Kaimanawa Mountains as a series of co-linear streams, saddles and valleys, which probably follow a large fractured zone. Similar evidence for the fracture control of geothermal fields north of Taupo is presented by Wan Tianfeng and Hedenquist(1981) and also by Hamlin and Prebble(1998). Where the major NW-SE lineament was intersected in Tokaanu Tunnel, a 1 km wide zone of soft extremely weak smectite clay was encountered with some very closely fractured and altered rock, crushed zones, gouge, water inflows and temperatures of 27 to 40°C (Prebble, 1977 and 1986). The smectite clay made up 50 to 80 % of the ground and caused severe swelling in the 1km long section of weak material.

Large curved landslide scarps and slide blocks are found along the Waihi Fault scarp (Fig.6) where alteration has weakened the ground. The landslide area covers up to 12 km² and extends up to 500m above Lake Taupo. Historic landslides in 1846 and 1910 originated as massive failures of the fault scarp in the geothermal field and culminated in debris avalanches and debris flows which engulfed the lower slopes south of the present Waihi village. The debris forms a huge fan, which protrudes out into the south-west corner of the lake. Very soft, extremely weak clayey deposits are found in a broad zone for 2 km along the Waihi Fault scarp where it coincides with the Hipaua geothermal field. Above this zone, tension cracks several m deep and some up to many m wide were recorded in the andesite flow rock mass and breccia along and parallel to the top of the fault scarp (Prebble, 1986). The soft clay and thermal activity are directly below. Continuing retrogressive failure of the scarp is to be expected. Elevated topography and permeable ground above the continuing thermal activity will presumably maintain a groundwater supply and significant pore pressures in the extremely weak clayey materials.

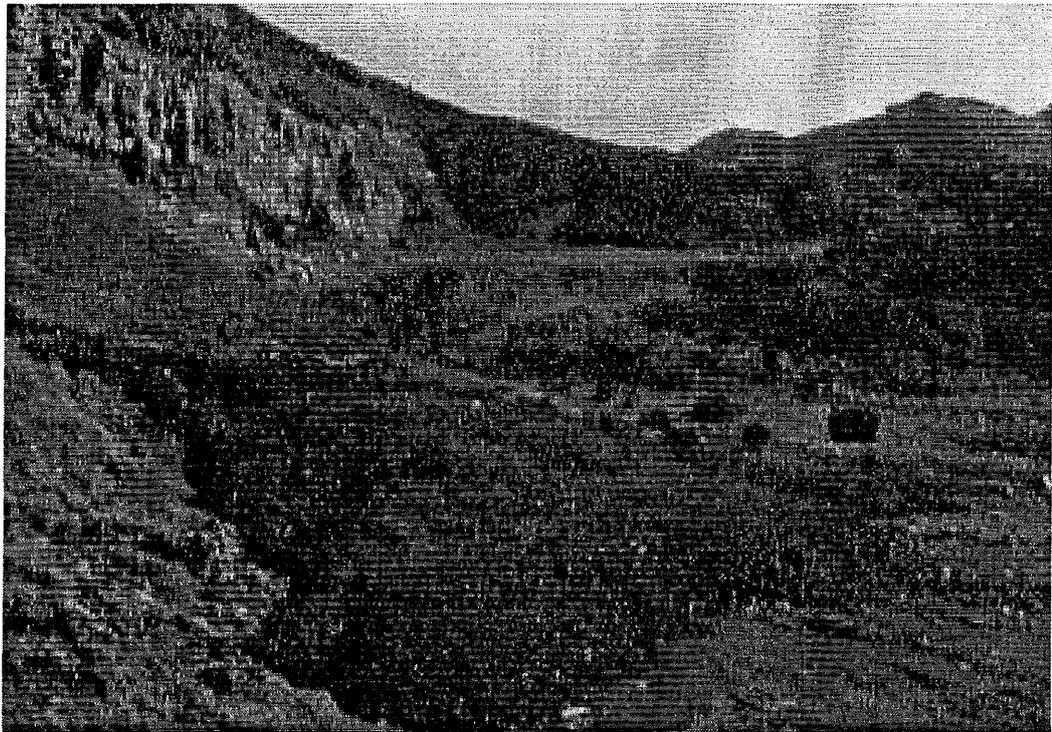
Figure 7. A reference locality for an engineering geological model of andesitic deposits, at the base of Ngauruhoe volcano in the head of the Mangatepopo valley. A fractured rock tongue (lava flow) is exposed at top left. Scoria rubble covers lava flows to the right.

Avalanche debris and reworked alluvial deposits are seen in the foreground.

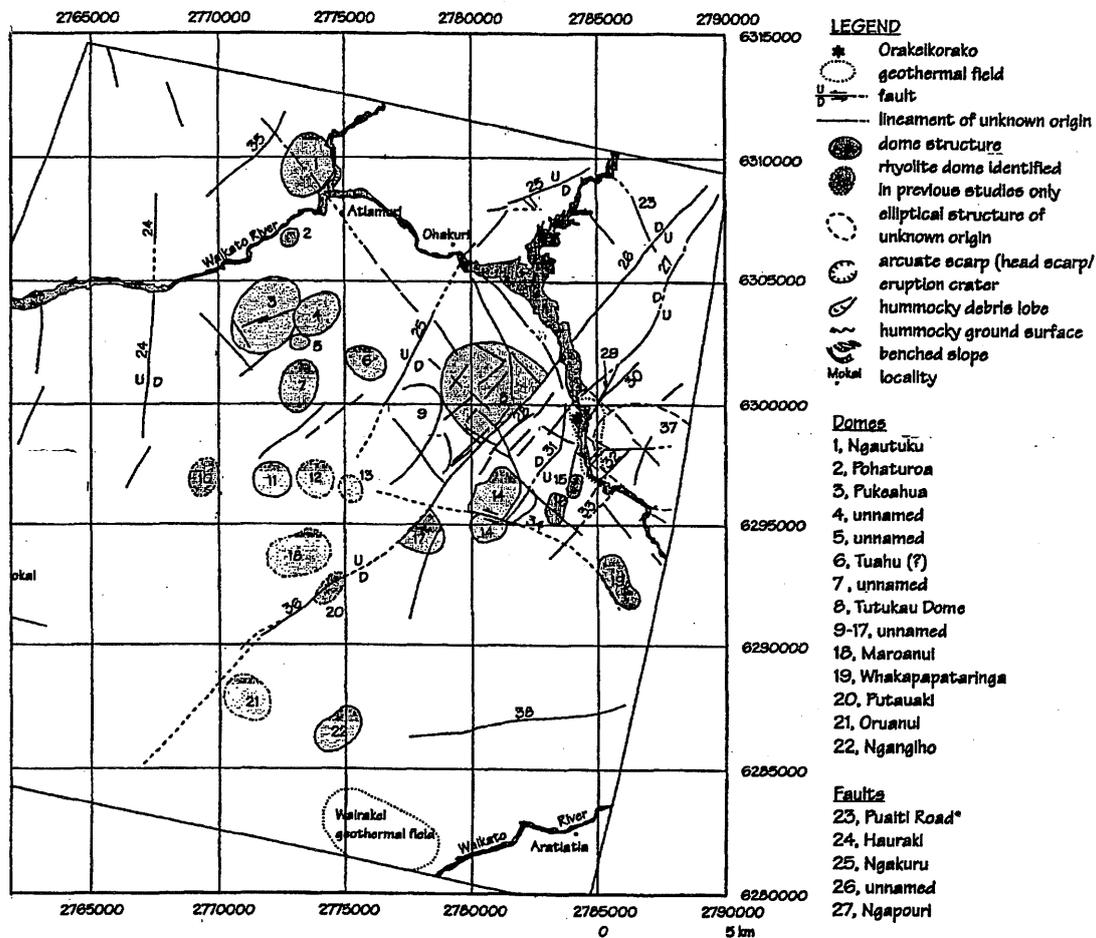
Figure 8. An example of an interpretative map of regional geomorphic features produced from remote sensing. This is the main part of a map for the Orakei Korako – Atiamuri area, Taupo Volcanic Zone, by K. A. Hamlin, from Hamlin and Prebble (1998). Legend continues alongside Figure 9, on the next page.

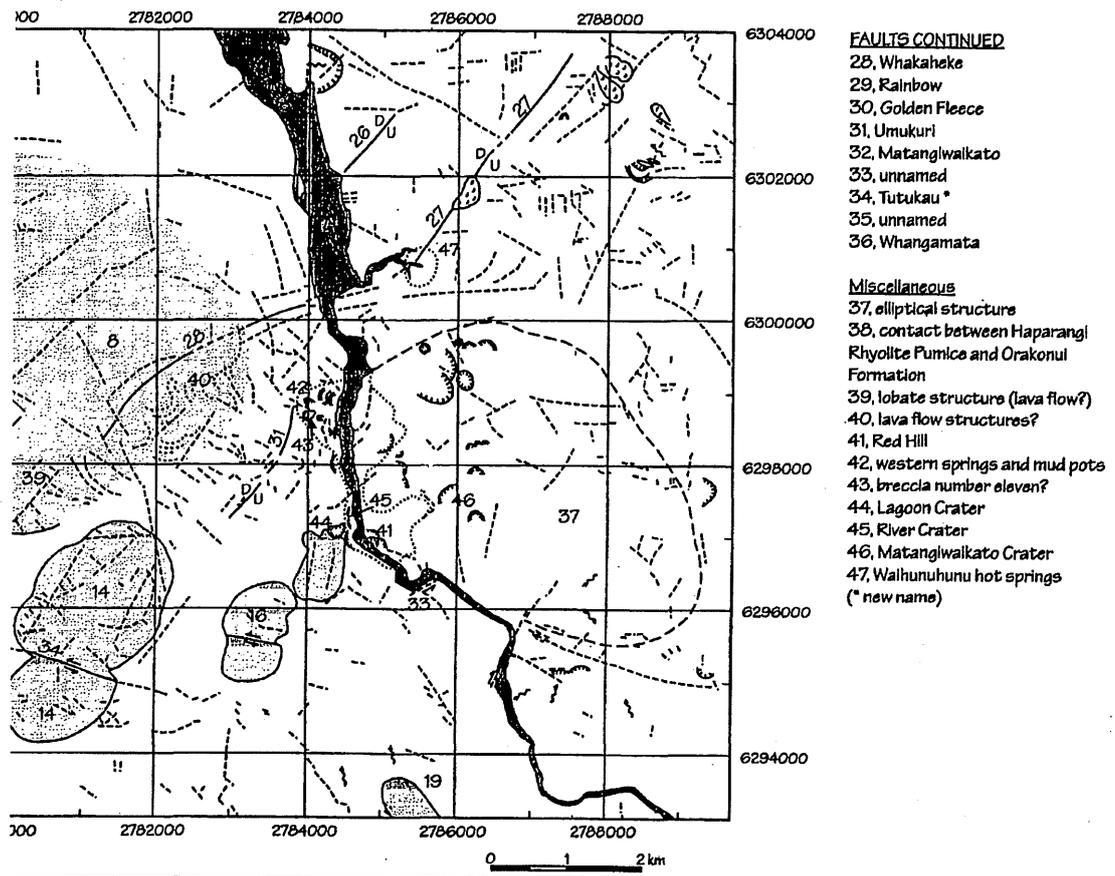
Figure 9. An example of an interpretative map of local geomorphic features for the Orakei Korako area. This is the main part of a map produced from remote sensing by K. A. Hamlin, from Hamlin and Prebble (1998). Note that the Legend is a continuation from alongside Figure 8, back on the previous page.

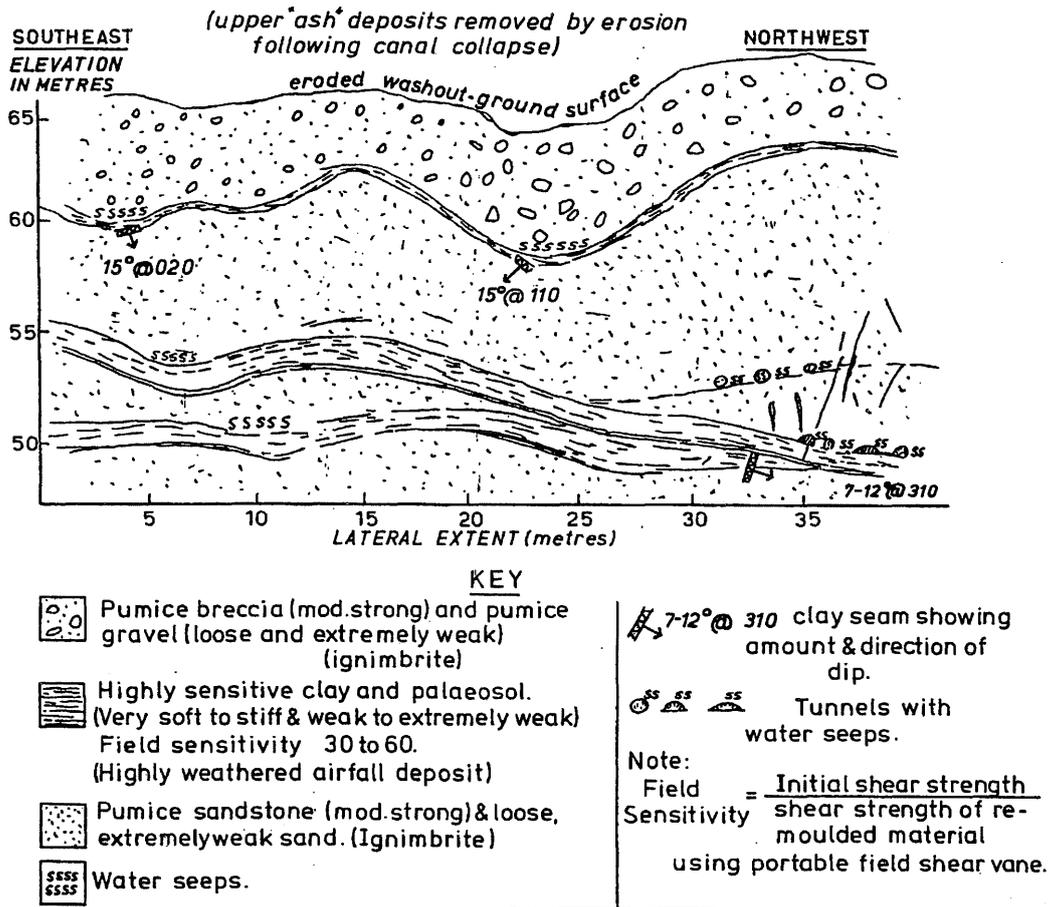
Figure 10a. Elevation sketch of a portion of in-situ ground beneath the Ruahihi Canal washout. The exposure is a vertical face located in the deepest part of the centre of the main gully, which formed immediately after the collapse of the canal. Undulating, irregular layers of sensitive clay overly rhyolitic pumice sand to sandstone. A photograph of this exposure appears below in Fig. 10b.

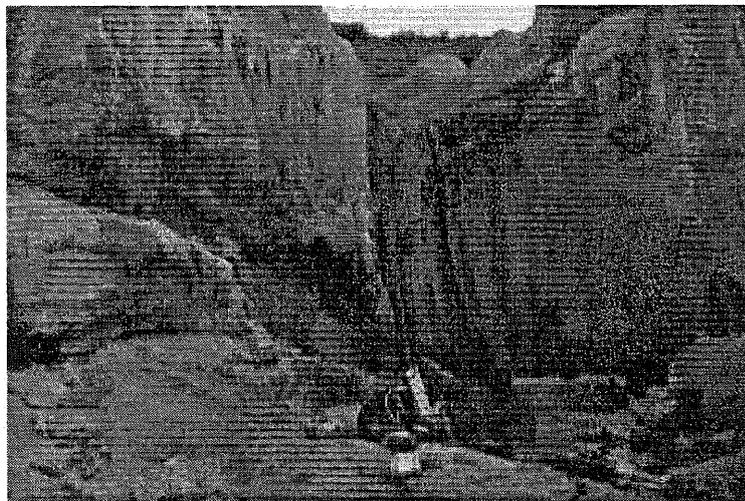
Figure 10b. Moderately strong rhyolitic pumice sandstone, sand and extremely weak, highly sensitive clay layers exposed beneath the Ruahihi Canal collapse. A laminated sensitive clay layer dips down to the right in the middle distance. This exposure is also illustrated above in line drawing Fig. 10b.

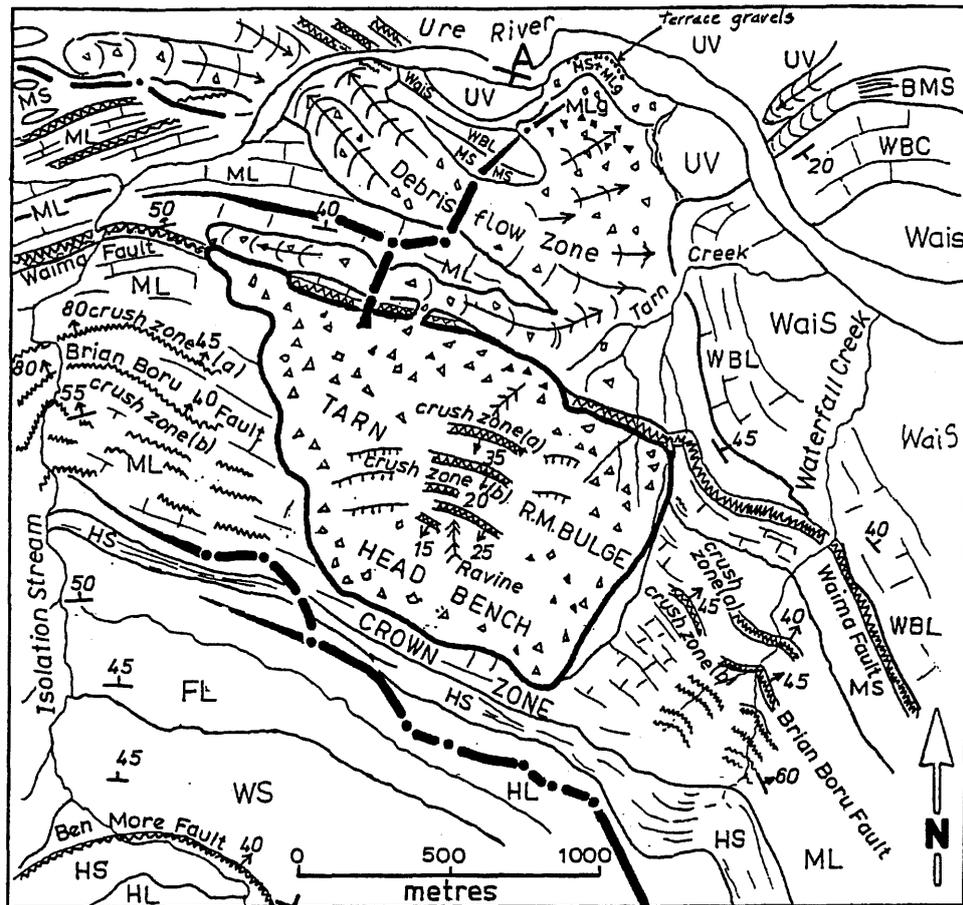
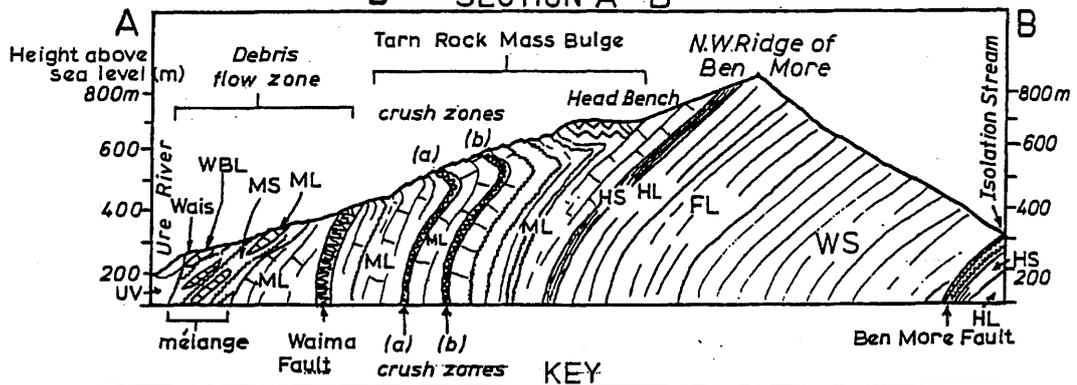
Figure 11. An example of an overtopple. The Tarn slope failure – a rock mass bulge in Marlborough.

Outline geologic map, TARN. ROCK MASS BULGE.

B SECTION A - B

KEY					
WaiS	Waima Formation	HL	Isolated Hill Limestone		ridge
WBL	Whales Back Limestone	FL	Mead Hill Flint		Peak
MS	Ben More Shale	WS	Whangai Shale		scarp
UV	Ure Volcanics	Bedding			face
ML	Ben More Limestone	Fault			Debris
HS	Isolated Hill Shale	Crush zones			Debris flow
					ravine

An example of overtopping is given in Fig.11. Age and recurrence of toppling and collapse are not well constrained. Stratigraphy in the run out area for debris avalanches indicates that a large collapse took place in the last 3500 to 5000 years. Successive aerial photos show that the ravine discharges significant debris flows every 50 years. These are sufficiently large to carry through to the river 1 km below. Comparative geomorphology indicates that the scarps on the bulge may be 100 to 500 years old.

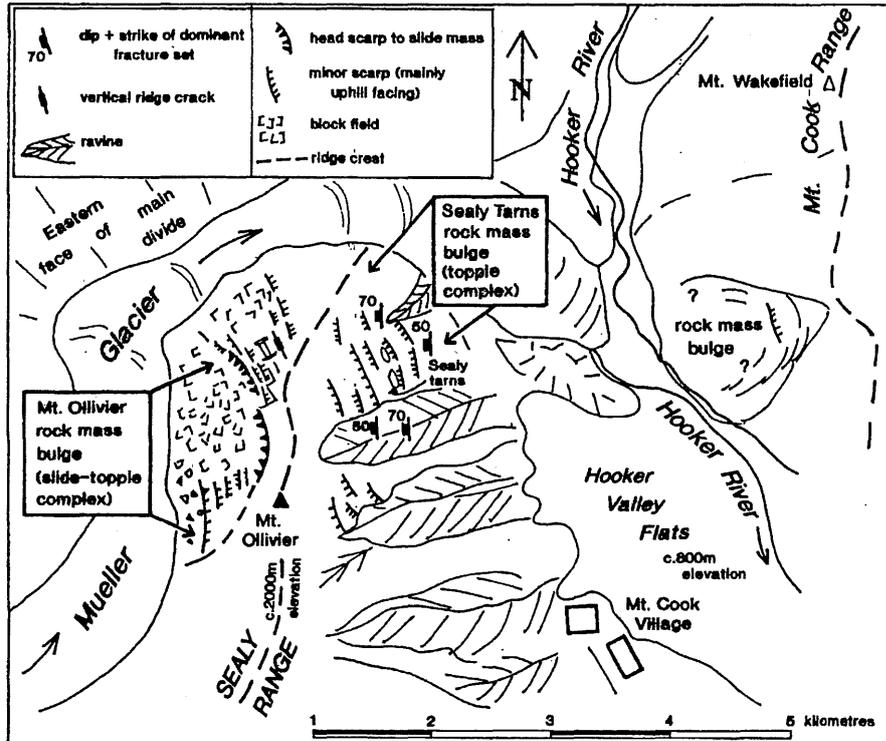
Figure 12. Map of the Sealy Range, showing large complex topples at the Sealy Tarns and below Mt Ollivier. Referred to as rockmass bulges by Prebble (1995a).

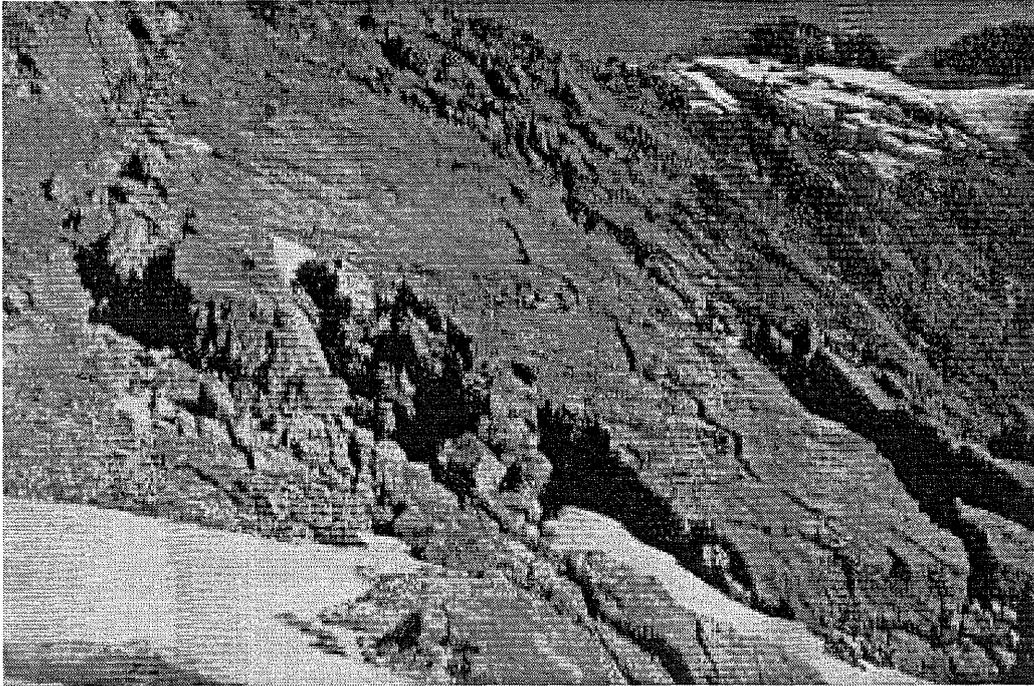
Figure 14. A topple – rock slide complex on the Sealy Range, above the Mueller Glacier, Mt Cook National Park. Open ridge cracks, fracture dilation, uphill facing scarps (these are dark and in the shade in the photograph) and secondary block sliding are found in this complex slope failure. Further downslope to the right is a block field of chaotic rock fall debris.

Spectacular uphill facing scarps can be seen on the Sealy Range above the Hooker Valley and near Mt Cook village. Some of these have trapped bogs and ponds behind them such as the famous Sealy Tarns. Toppling on this scarp slope (anaclinal slope) has produced a series of scarps on the side of the ridge, which is a sloping bench and was previously referred to as the Sealy Tarns rock mass bulge (topple complex) by Prebble (1995a) and is shown in the map on Fig.12. This bench terminates along the side of the ridge, in a deep ravine with a large fan below it. Several bending surfaces and progressive block toppling are exposed in the ravine (Fig. 13). The other side of the range is, at least in part, a cataclinal slope and is occupied by a large, chaotic, slide-topple complex (Fig. 14). This was referred to in the 1995 account as the Mt Ollivier rock mass bulge. One scenario for geomorphic development suggests that the ravines are the sites of previous collapses and that the Sealy Tarns bench will be the next bulge to fail. Failure can also be take the form of combined sliding and toppling as seen on the Mueller Glacier side of the range. The two styles of failure combine to produce mountain range collapse.

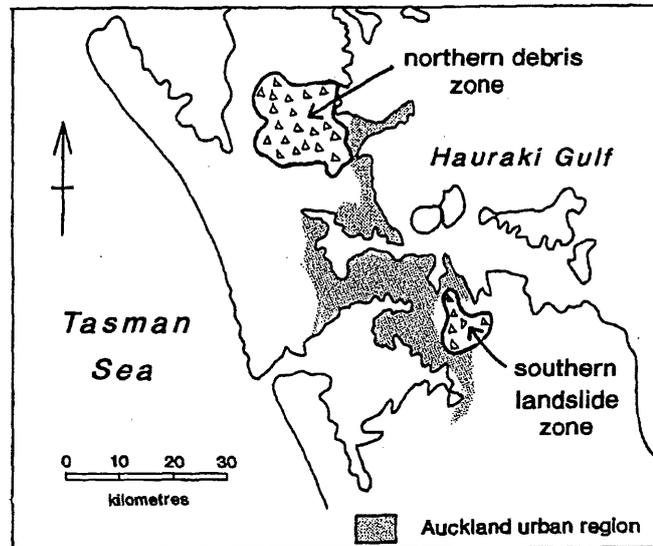
Figure 15. Map of the Auckland region showing location of the southern landslide zone. The northern debris zone is Miocene but has Holocene reactivation. (After Kermode, 1991).

It was some time before clay seams and block slides were confirmed in the Auckland region, leading to the recognition of the southern landslide zone (Prebble, 1995a). This is an area of around 100 km² (Fig. 15) in which most of the slopes have deep-seated failures on bedding-parallel clay seam rupture surfaces. Wedge and complex failures are also found. Slope instability was known to be widespread in the area (Kermode, 1991).

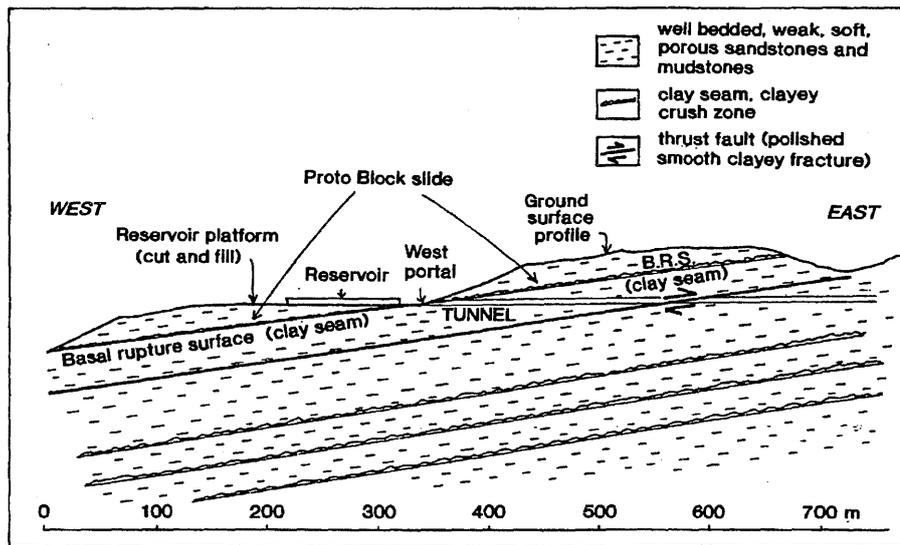
Figure 16. Section through a proto block slide, clay seams and crush zones in weak rock in a water supply tunnel, southern landslide zone, Auckland. (After Wylie, 1989).

Clay seams of significant continuity were confirmed by Wylie (1989) in a water supply tunnel and reservoir platform (Fig. 16). Residual soils up to 20m thick, close fracturing and faulting of the bedrock and the relatively slow rate of uplift and erosion all reduce the opportunity for inland exposures. The landslide topography is subtle. Geomorphic mapping as in Fig.17 for instance (Prebble, 1990 and 1999) and regional studies (Table 2) for seismic hazards and for earthquake-induced slope instability (Williams and Prebble, 1998) indicate that clay seams are likely to be present throughout the southern landslide zone and elsewhere in weak rock terrain in Auckland. The seams are found throughout all weathering grades and deep within unweathered rock. They vary from coatings on fractures to seams of gouge and show crushed wall rock and splays, typical of a tectonic origin, probably that of flexural slip at depth during macroscopic open folding. A flexural slip origin for bedding plane shears in gently dipping claystone and siltstone was proposed by Fell, Sullivan and Macgregor (1988). The shears provided rupture surfaces for slope failures. Hutchinson (1988 and 1995) contends that the potential for flexural slip has been underestimated as an origin for shears, which can develop into basal ruptures of landslides.

A clay seam in a tunnel in the southern landslide zone penetrates narrow fractures above the seam, but not the fractures below it, which are tightly closed. This may be evidence for a very small displacement or incipient block sliding on the seam and is referred to as a proto block slide (Figs. 16 and 18). Trenches adjacent to the tunnel confirmed the presence of pull away zones and sliding which could be related to the seam in the tunnel. Proto block slides in which the movement has been several cm were recognised in the gorge walls of the Rangitikei River (Fig. 19). Geomorphology of the gorge and terrace surfaces indicated that short displacement block sliding and slabbing, on clay seams was an important process of gorge widening. It was observed that the proto block slide shown in Fig. 19 is at the narrowest part of the gorge for that section of the river. The argument was put forward that it is the narrowest part because it will be the next portion of the wall to fail. The age of the terraces are known so that a rate of gorge widening and of river downcutting can be established.

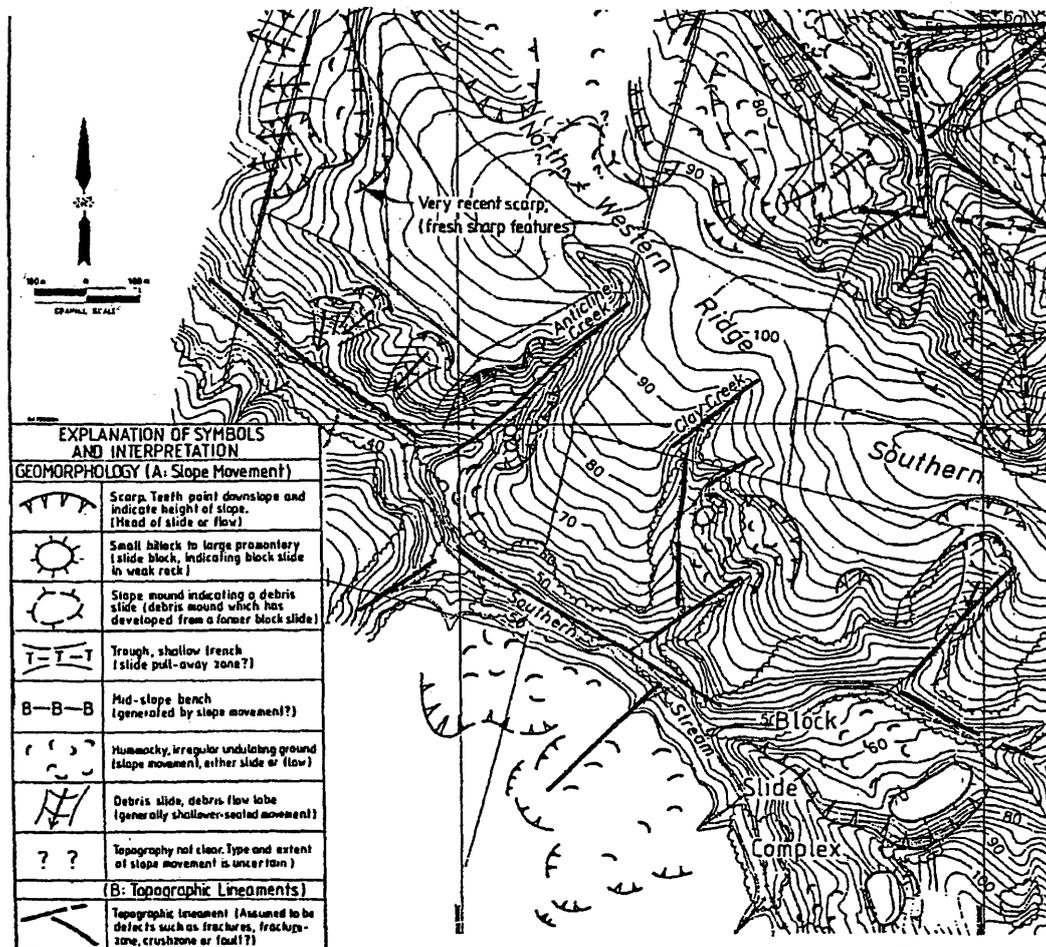
Figure 17. Part of a geomorphic map produced from aerial photograph interpretation in the southern landslide zone, Auckland. (From Prebble, 1990 and 1999).

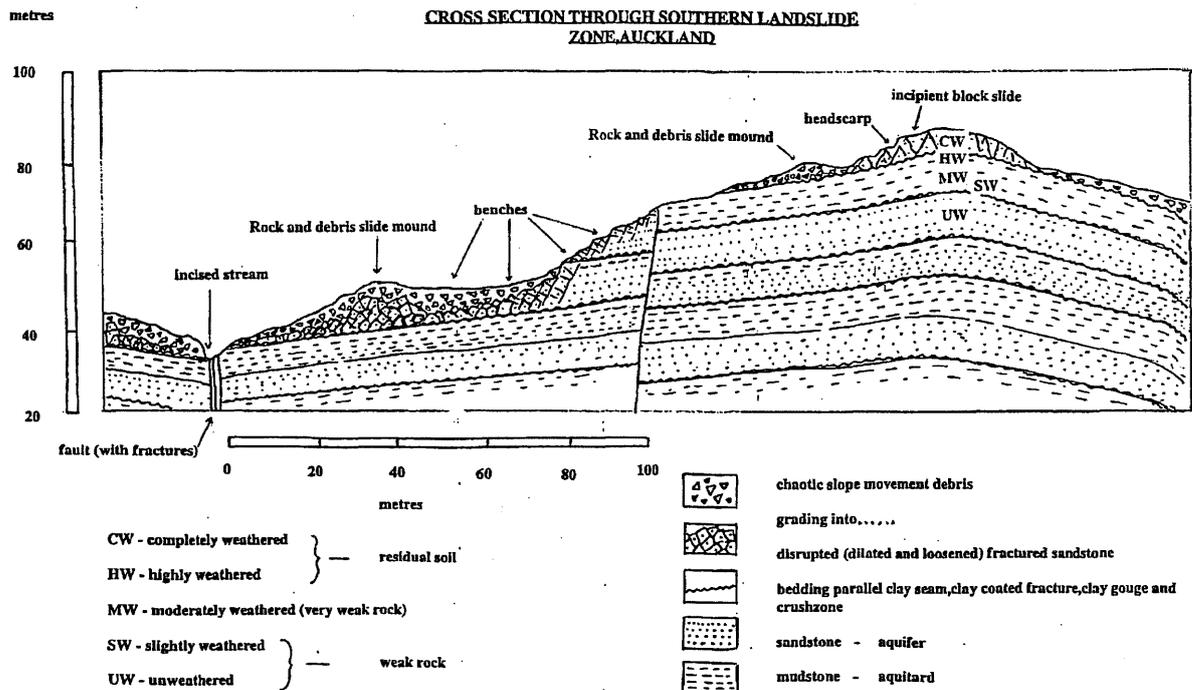
Figure 18. Cross section view of a general model for block sliding in the southern landslide zone, Auckland

A major problem in developing a rigorous engineering geological model is determining the variability, continuity and strength of the clay seams. These are all critical to stability. Continuity of a seam over 50 m, with continuous exposure, was provided in a tunnel excavation in South Auckland. However, correlation of seams between drillholes during investigation is usually very difficult unless there are distinctive marker beds. Careful and detailed logging of cores, inspection shafts, trenches and natural exposures has achieved such correlation at sites in the southern landslide zone. Earthworks have subsequently confirmed the continuity of the seams and all aspects of the model in general (Fig. 18).

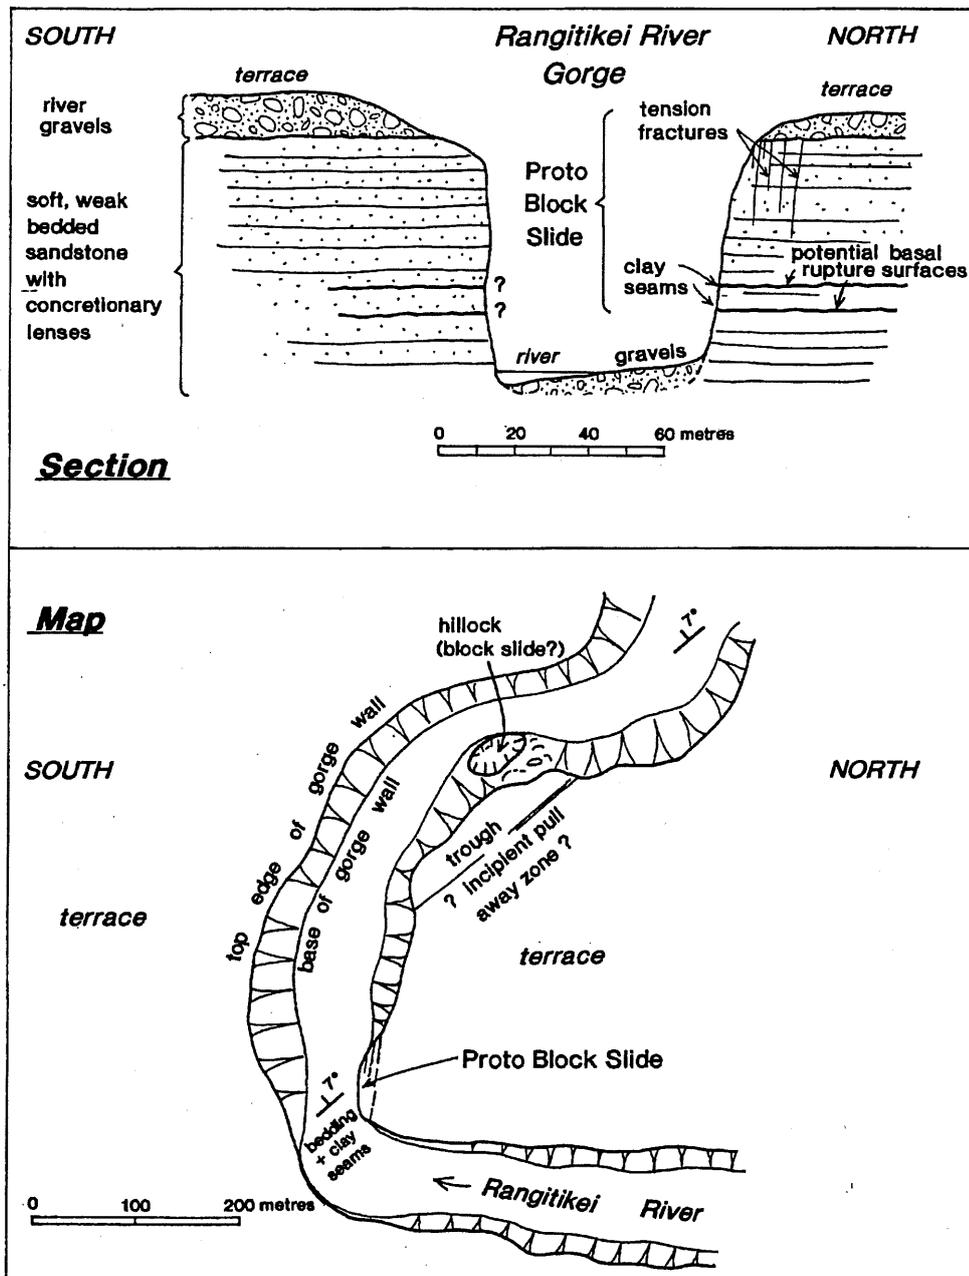
Figure 19. Map and section through a proto block slide in the gorge of the Rangitikei valley, central North Island. (From Prebble, 1995a).

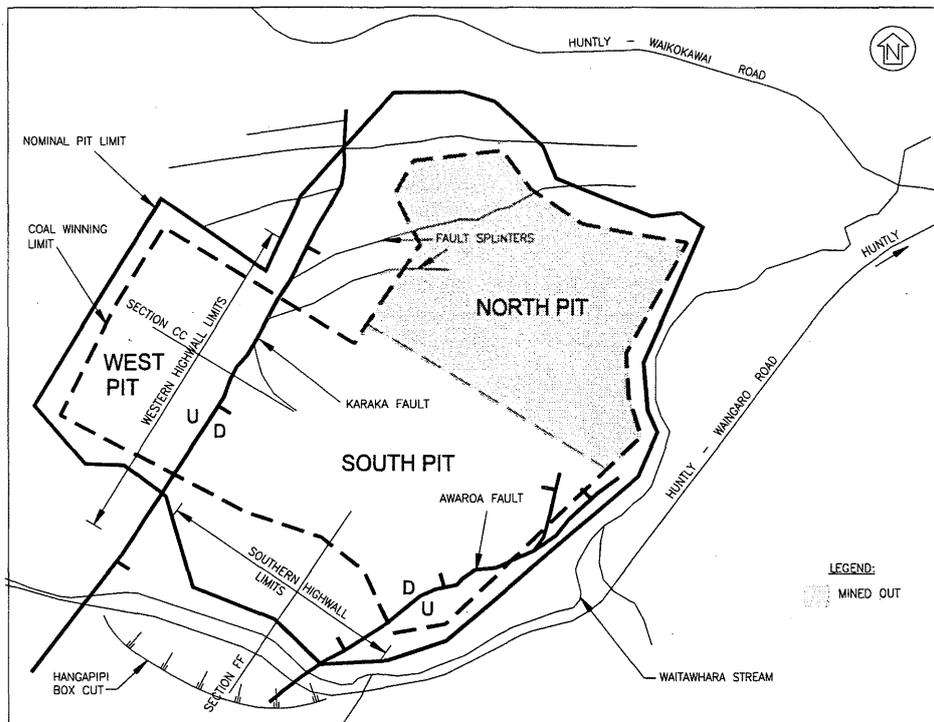
Figure 2: Plan View of Township Opencast Mine

This paper presents an overview of geotechnical aspects of the mine design project with emphasis on the application of probabilistic methods to the design of the Southern and Western Highwalls (Figure 2). On completion, these highwalls will be up to 100 m high. The paper addresses aspects of the site investigation, laboratory testing, assessment of groundwater and groundwater conditions and key elements of the stability models. It demonstrates how the application of probabilistic-based risk analysis can be used to make informed risk management decisions with respect to design selection and optimisation.

environmental impacts that result from slope failures. An inherent requirement is the protection of civil engineering structures, such as the Rotowaro Road, and the associated Waitawhara Stream diversion (Figure 2), situated close to the southern economic limit of the opencast mine. Other factors that introduce uncertainty for mine design have been incorporated into the development models, including the presence of the historic Alison underground mine workings, in which the main economic seams were mined between 1939 and 1974.

failures within the pits, especially adjacent to faults and basement highs. Bedding shears are extensively developed along the Western Highwall on the down-thrown (east) side of Karaka Fault (Figure 2). Some evidence for low strength shear surfaces in the basement was noted in cored investigations holes. Pre-shearing is inferred to result from flexural slip along unit contacts during induration, folding and faulting of the strata.

- The Karaka and Awaroa Fault zones associated with the proposed Western and Southern highwalls, respectively (Figure 2). Adjacent to these faults is a wide disturbance zone of highly fractured/shattered basement and sheared, drag-folded MT and WCM. Drag folding accentuates the dip of bedding on the down-thrown side dipping toward the proposed pit (Figure 2).
