Engineering & Development

in **HAZARDOUS TERRAIN**

NEW ZEALAND GEOTECHNICAL
SOCIETY 2001 SYMPOSIUM

Hazardous Terrain – An Engineering Geological Perspective

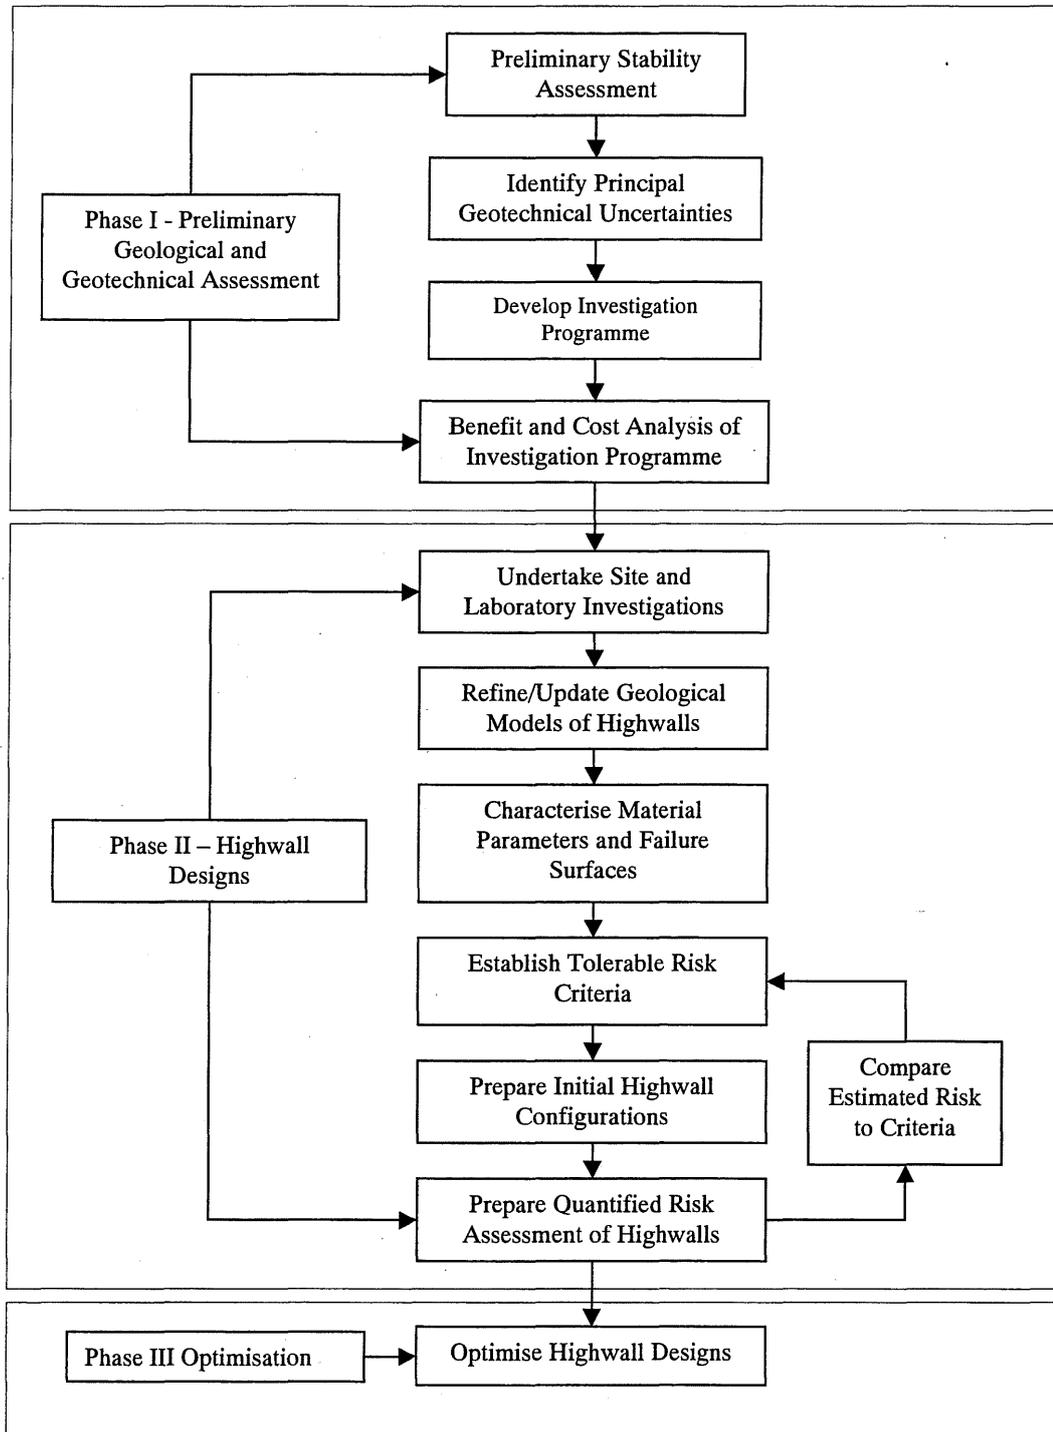
Figure 3: Phases of Project

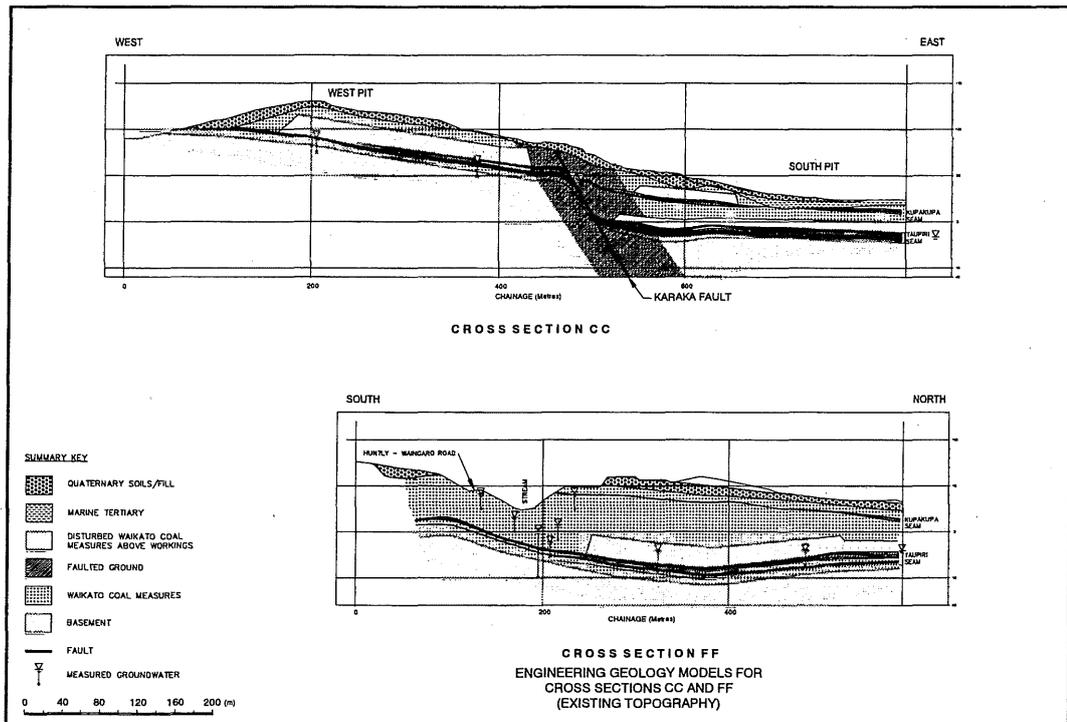
Figure 4: Engineering Geological Models of Western and Southern Highwalls

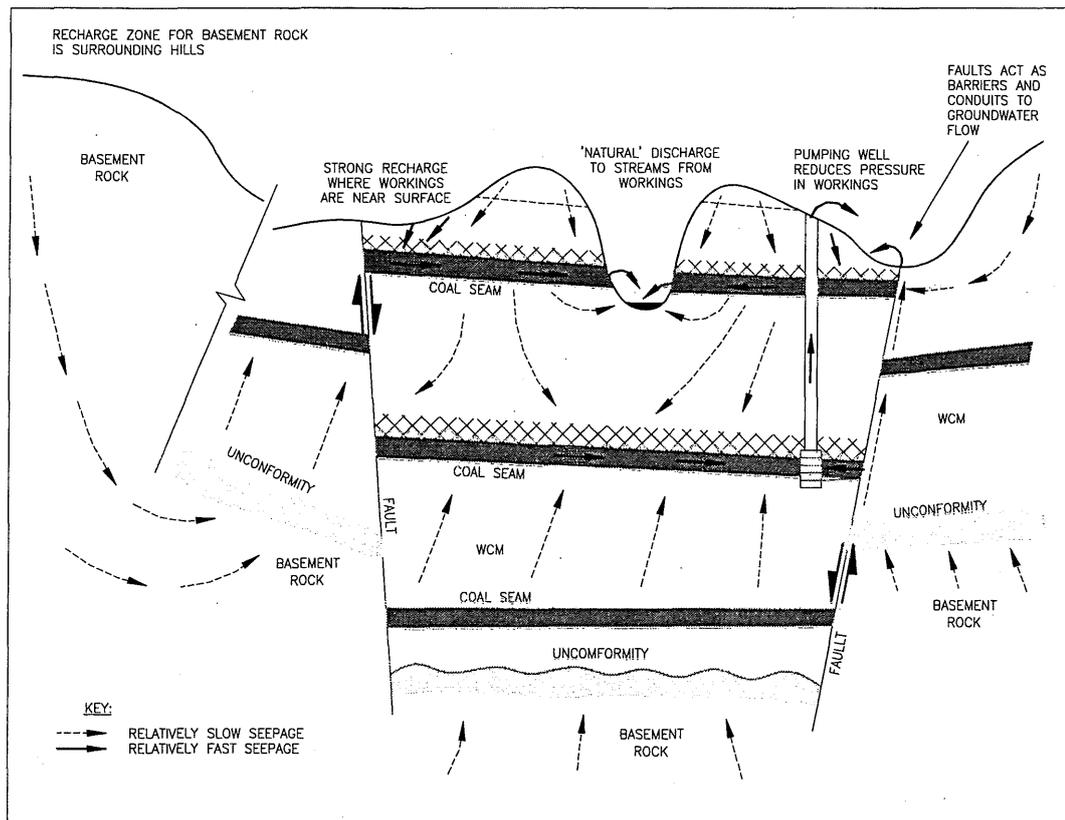
Figure 5: Conceptual Groundwater Model (Pre-Mining)

Piezometric data collected from a network of piezometers installed over the site coupled with an understanding of the engineering geology have enabled a groundwater model of the site to be developed as summarised on Figure 5.

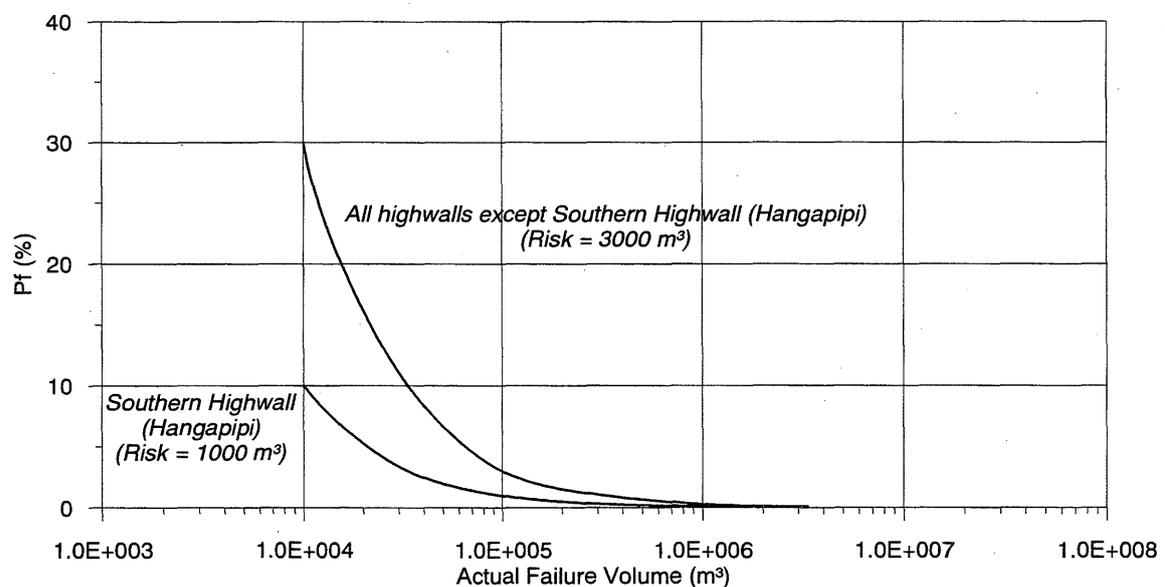
Figure 6: Tolerable Risk Criteria

An assessment the tolerable risk criteria was developed setting an upper bound on levels of acceptable risk as shown in Figure 6. Choosing a separate and lower tolerable risk volume (i.e. $P_f \times \text{failure volume} = \text{constant}$) for the Southern Highwall reflects the need to ensure that the road and stream diversions through the Hangapipi Boxcut behind this area are unaffected in the long-term by mining and the subsequent pit end use (a lake). The risk-volume criteria make an allowance for small, but high probability failures to be acceptable within the design. However, larger scale failures require high levels of stability (low probabilities of failure) to achieve the design criteria.

The adoption of the risk volume criteria is consistent with the mining industries greater tolerance of small failures and intolerance of large failures. For example, a risk volume criteria of 1,000 m³ would equate to a 10,000 m³ failure having a 10% probability. While small failures of this size represent an inconvenience to the mining operation, possibly adding to operational cost, they do not result in a major loss, disruption or cessation of mining. Conversely, a large failure, say 400,000 m³ in volume, would have a major adverse consequence. To meet a risk volume criterion of 1,000 m³, the probability of failure would need to be 0.25% or lower.

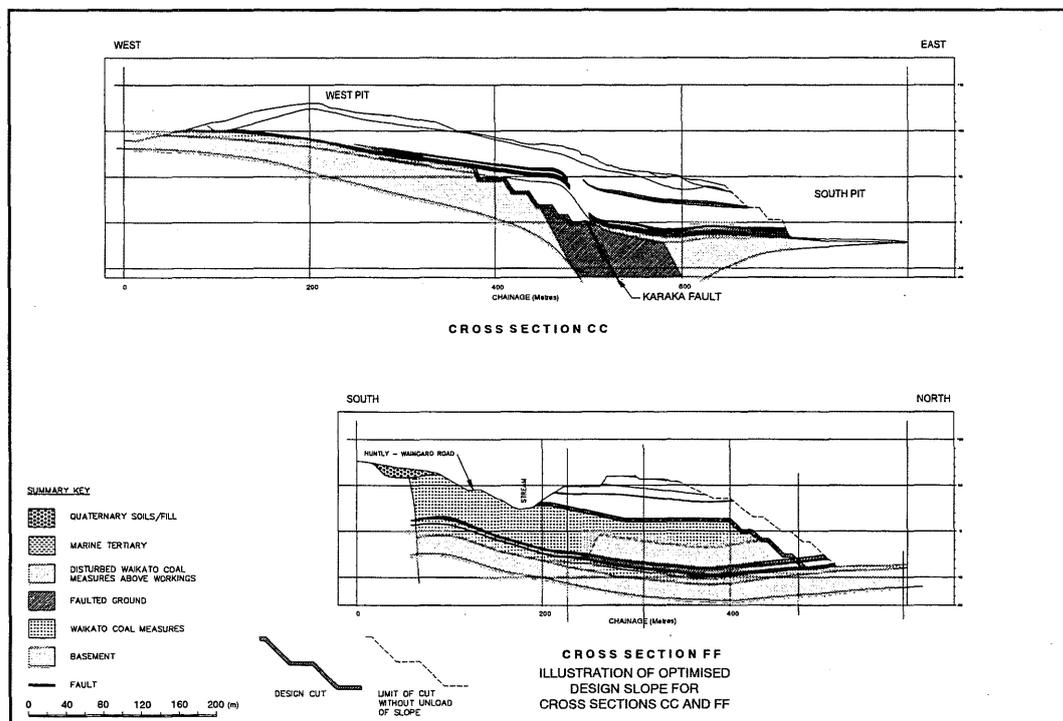
Figure 7: Optimised Highwall Profiles

Using the pit shell from Phase II as a reference point, a series of additional analyses were developed. The optimisation process included a series of analyses to assess not only the coal-winning limit in more detail and to look at construction issues, such as highwall transitions and benching/battering configurations. A key component in the assessment of sequence options was the identification of mining limits that required head unloading of the design cut before the final highwall could be developed. This design element is critical for highwall construction along the Karaka Fault and formation of the final Southern Highwall. Figure 7 illustrates the design developed for Sections CC and FF.

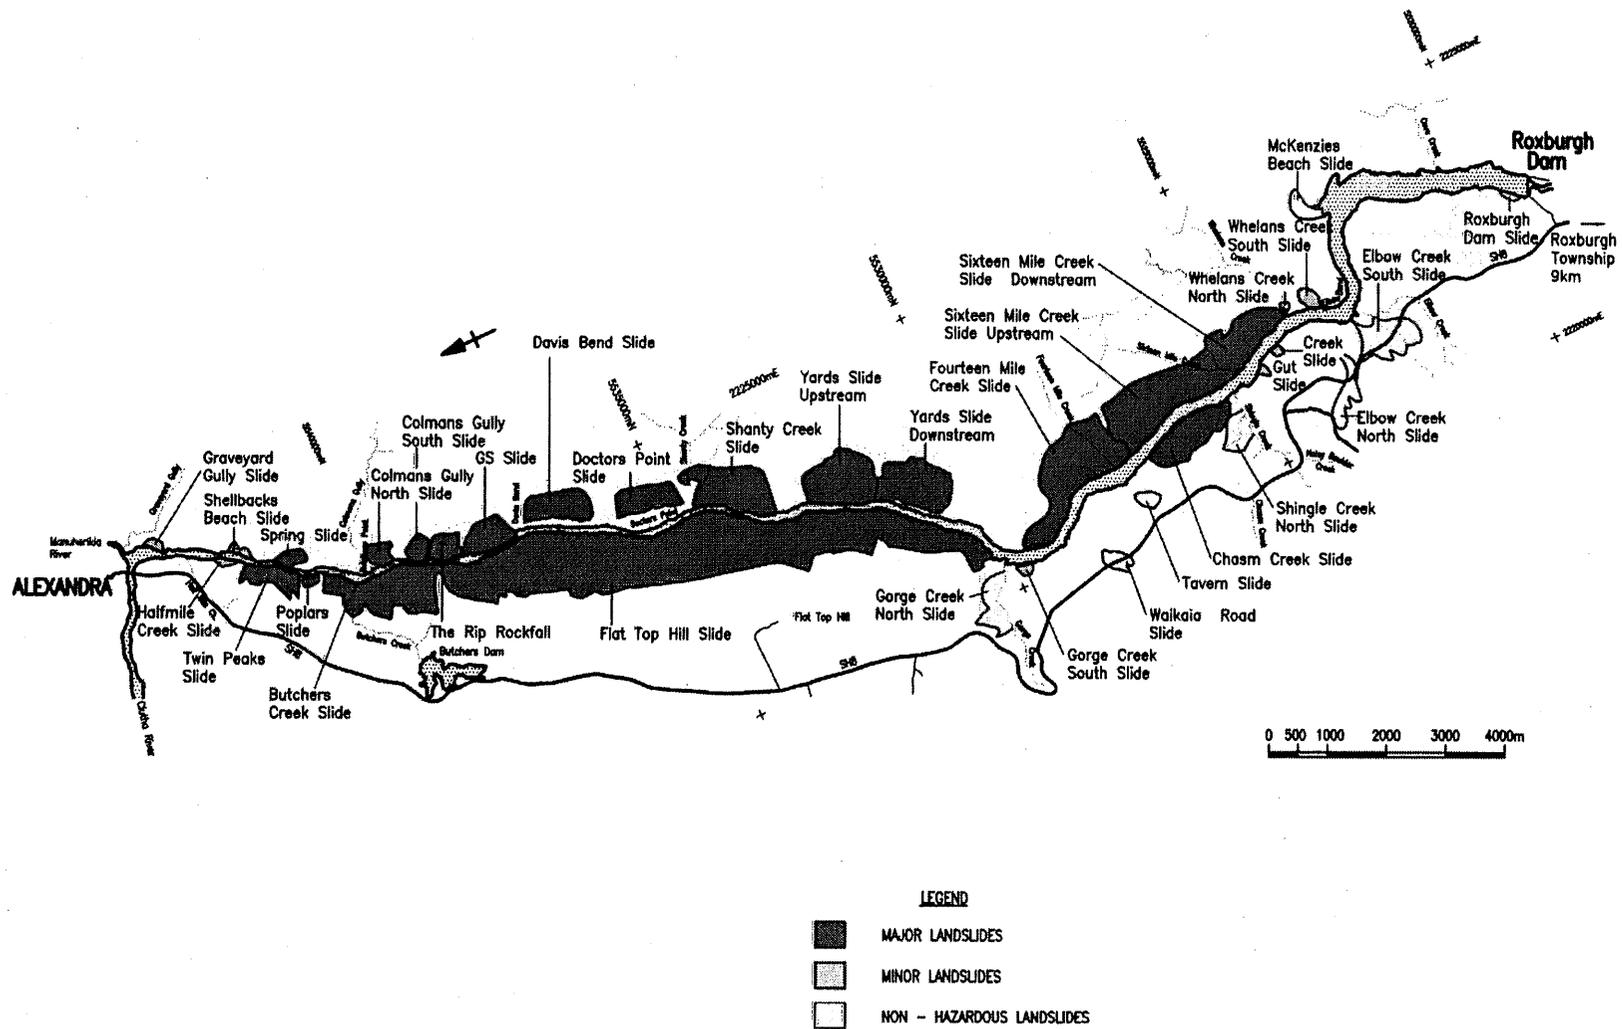
Figure 1. Location and classification of Roxburgh Gorge landslides

The initial air photo interpretation and mapping identified 34 landslides along the Roxburgh Gorge (Figure 1), many of them large in relation to the width of the reservoir (see also Figure 2). All of the landslides were present before lake filling. Figure 3 is a photo that helps to illustrate the extent and nature of landslides in the narrowest part of the gorge.

Subsequent work has classified 18 of the landslides as 'major', 8 as 'minor' on the basis of their size and location. It has also been determined that the eight other landslides show movement or past movement towards tributary streams or gullies rather than towards the lake, and are thus of no potential hazard to the reservoir.

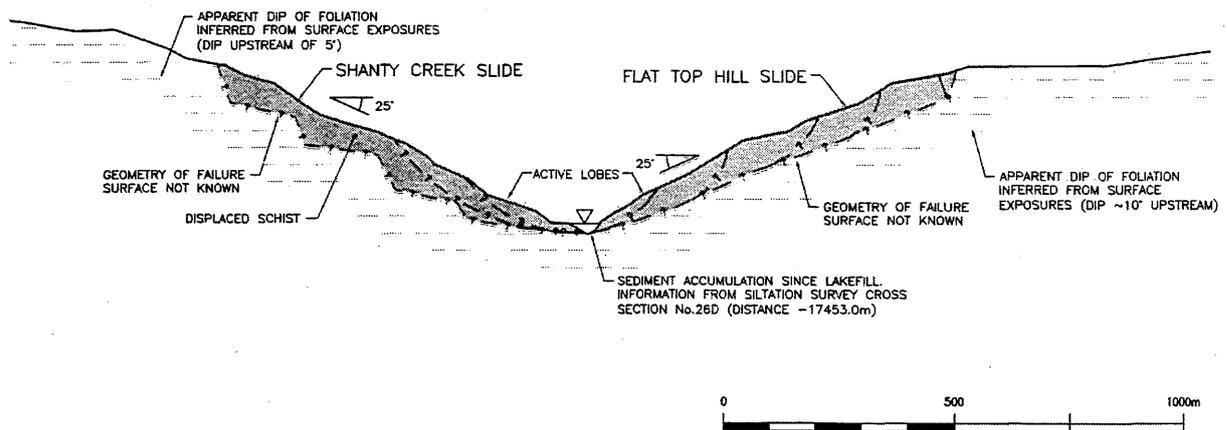
Figure 2. Typical cross section of Roxburgh Gorge.

Field evidence indicates that the landslides are large, dormant or creeping features. Some are deep seated and extend down to below lake level; these were present along the river prior to lake filling. Other landslides are perched high on the valley walls above rock bluffs (eg. Doctors Point Slide in Figure 2). Several left bank slides, including the Shanty Creek Slide (Figure 2), appear to be partly perched and partly deep seated, possibly indicating that they originally failed onto an eroded rock bench with a later failure of the rock bluffs causing deepening of the slide base.

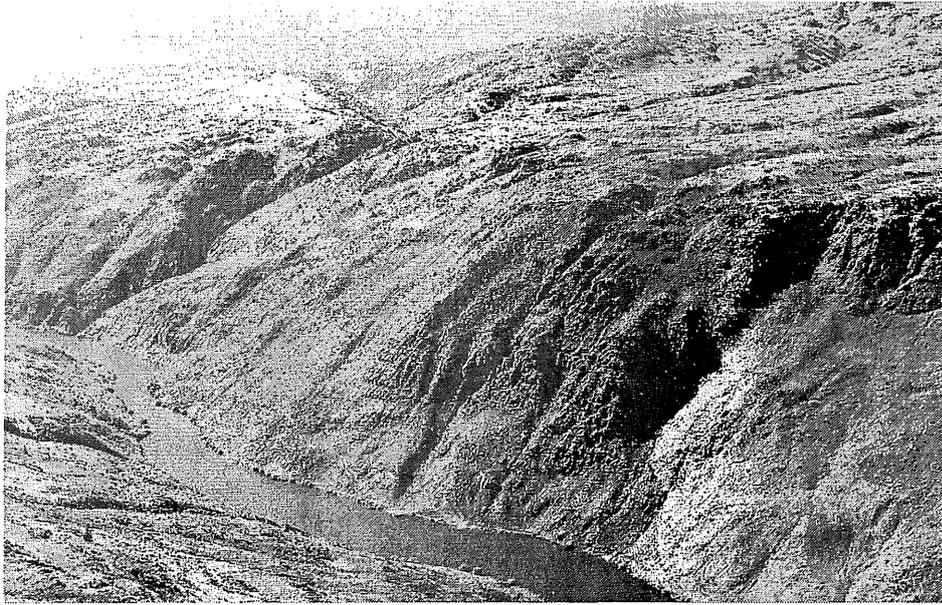
Figure 3. View upstream from Flat Top Hill Slide showing Shanty Creek Slide between the incised creek and the bluffs extending down to the lake. Yards Upstream Slide is to the right of the bluffs, and Doctors Point Slide is perched above the low bluffs upstream from the deeply incised Shanty Creek. The low relief surface above the slides is the Otago peneplain.

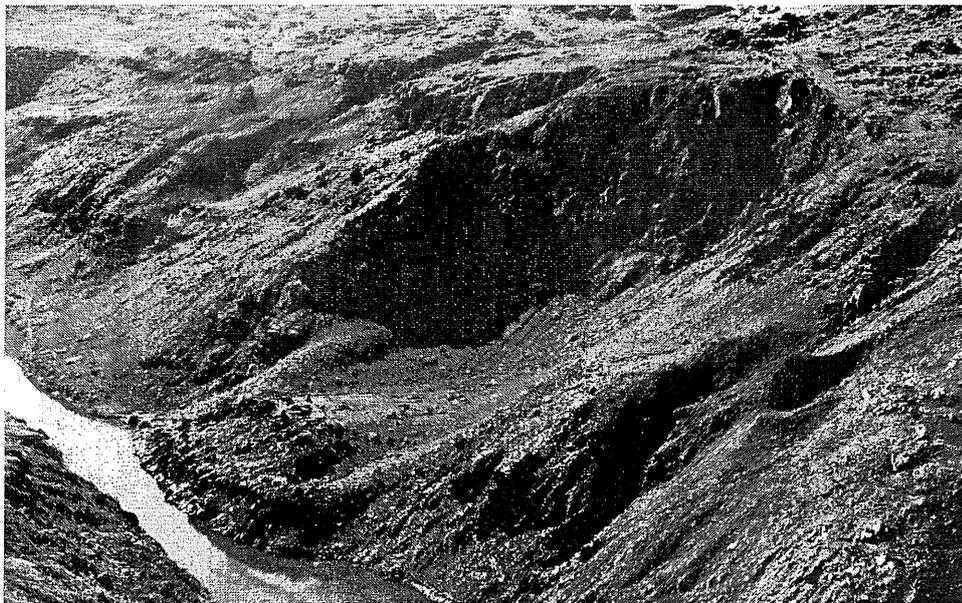
Figure 4. Aerial oblique view of the Rip Rockslide, a probable breached landslide dam about 7 km downstream from Alexandra. The slopes above the low bluffs to the right of the debris tongue are also slide debris and are inferred to have been part of the original slide mass.

The Rip Rockslide (Figure 4), the only obvious geomorphic evidence suggesting a past landslide blockage of the Roxburgh Gorge, appears to be an example of a later failure of part of an original slide perched above rock bluffs. While it seems likely that this conspicuous feature formed a landslide dam in the Roxburgh Gorge at some stage in the past, specific investigations found no conclusive evidence to confirm this. Geological and pedological studies have indicated that the Rip Rockslide is probably more than 80,000 years old and could be older than 110,000 years. There is no other clear evidence that any pre-existing landslide within the Roxburgh Gorge has ever undergone large scale rapid movement.

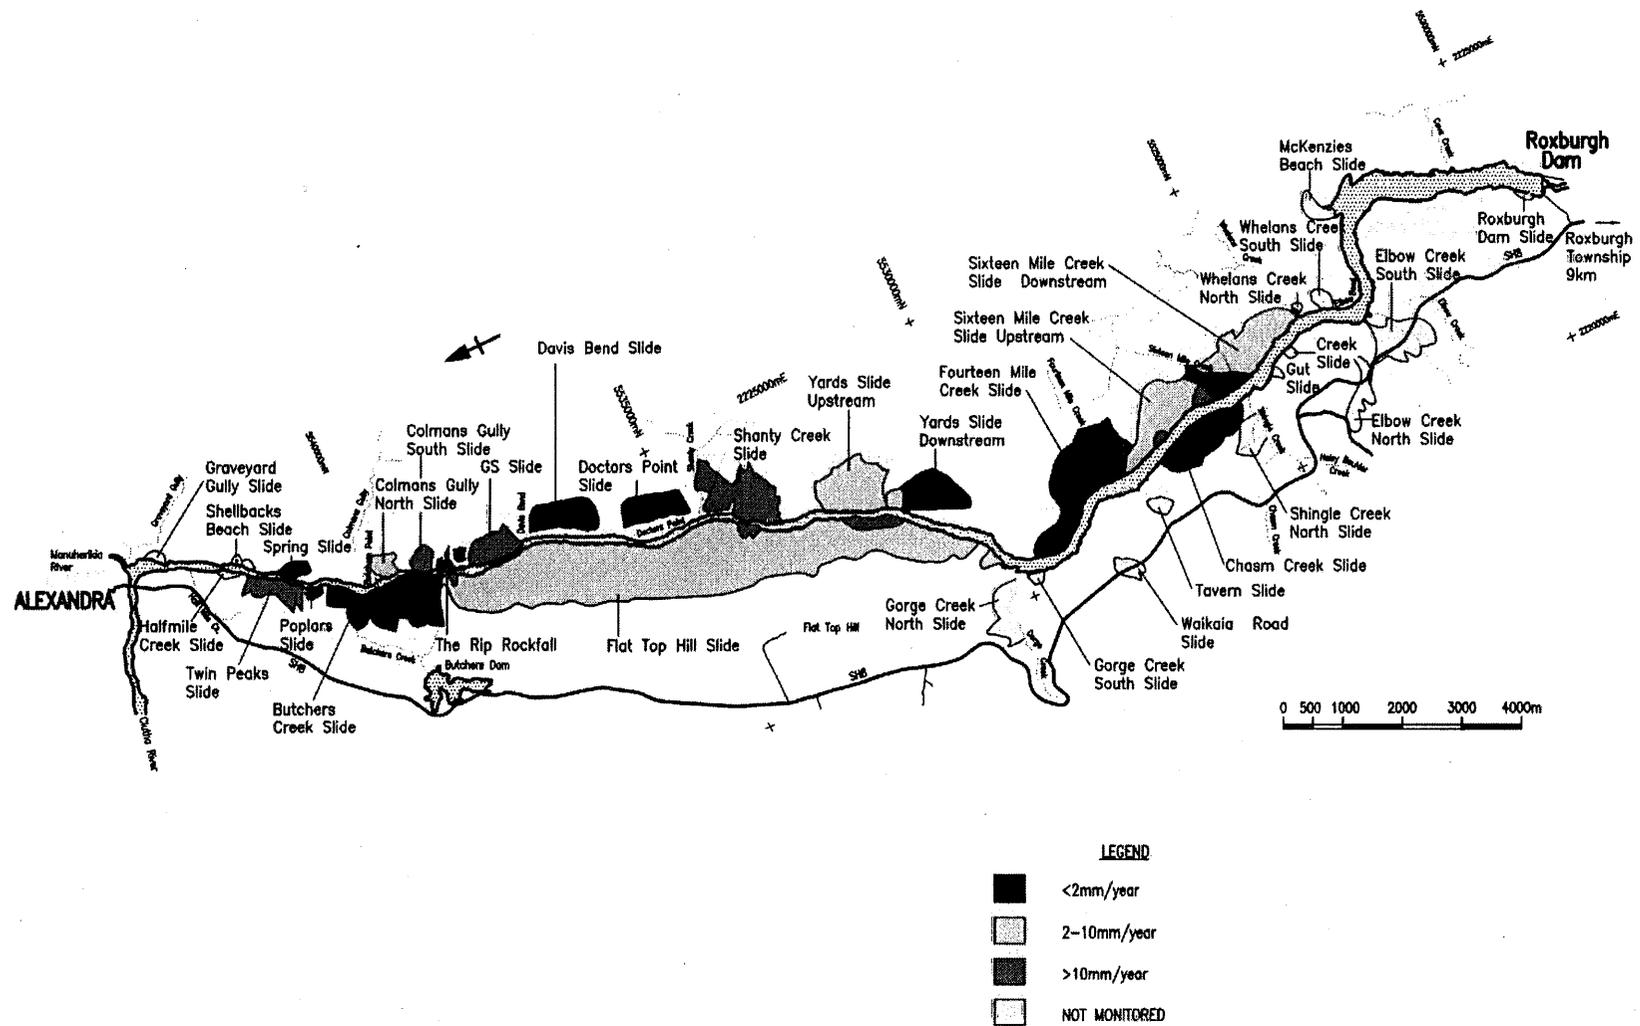
Figure 5. Current movement rates for Roxburgh Gorge landslides

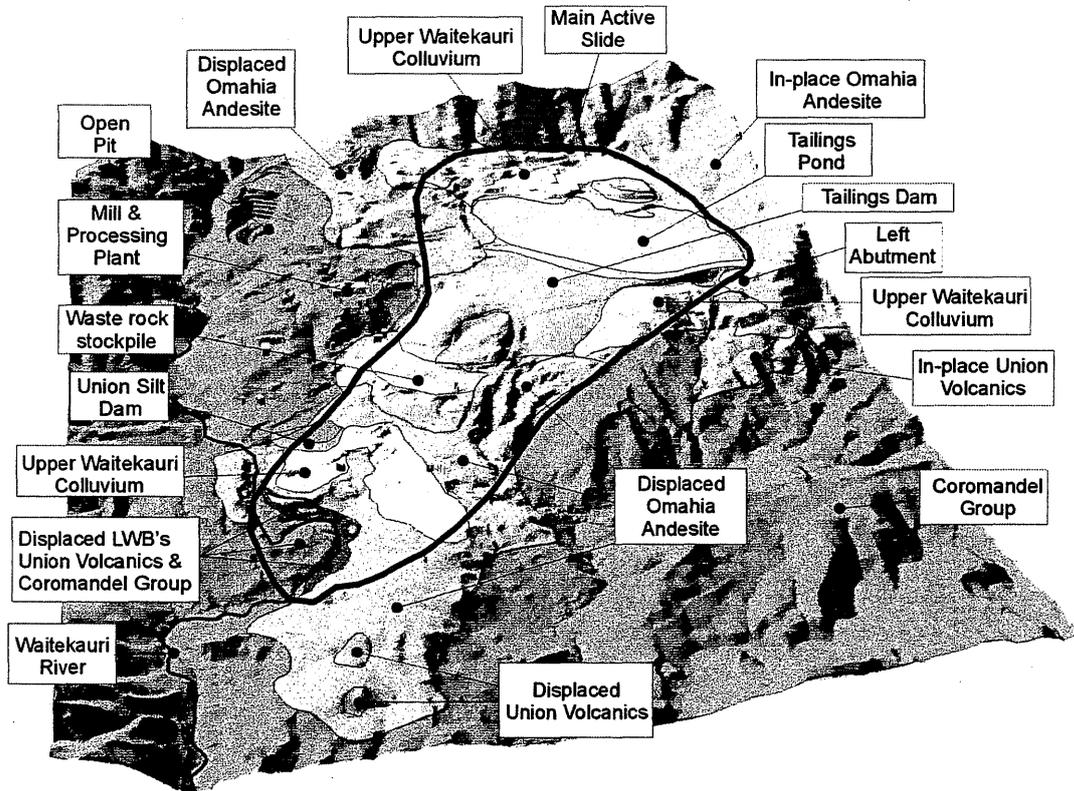
Figure 2: General site surface geology and the location of the Golden Cross Landslide

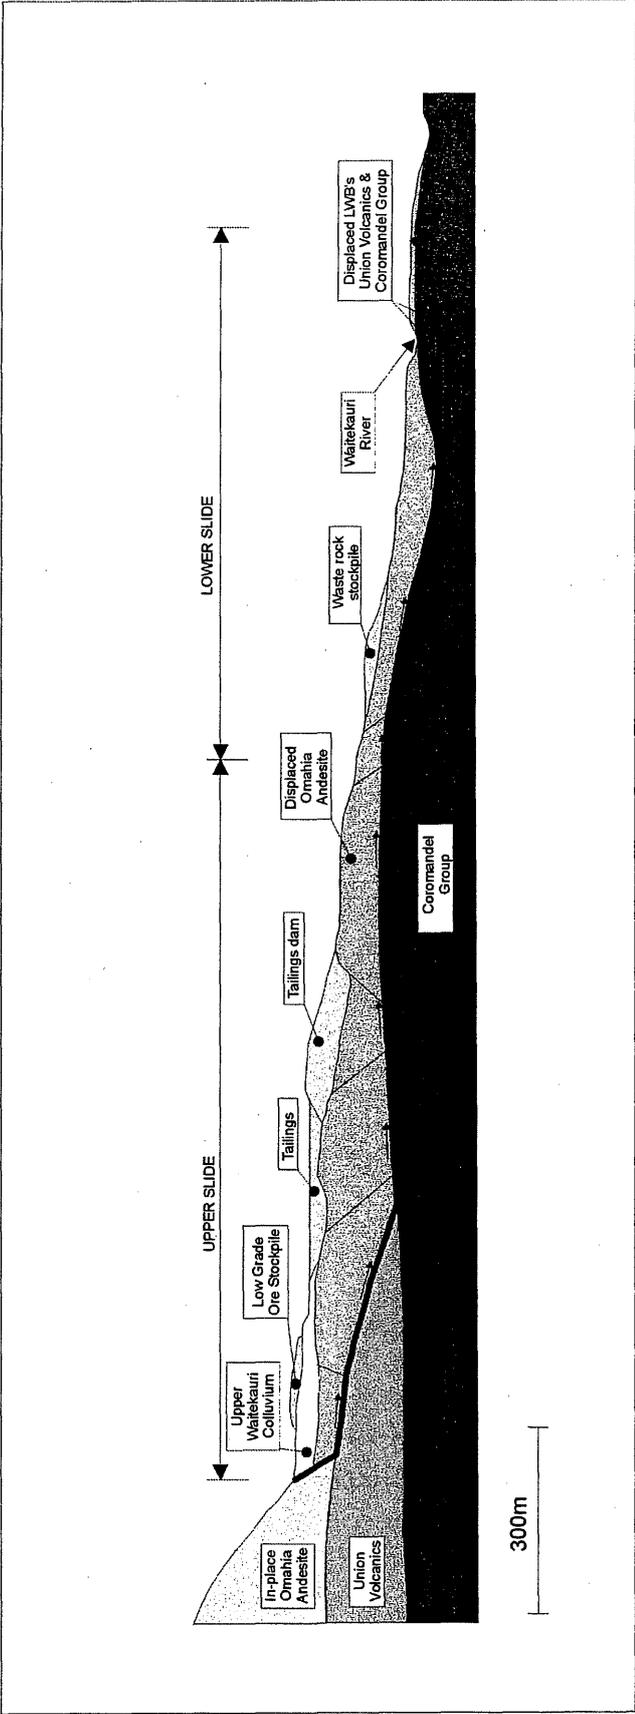
Figure 3: Geological cross-section of the Golden Cross Landslide

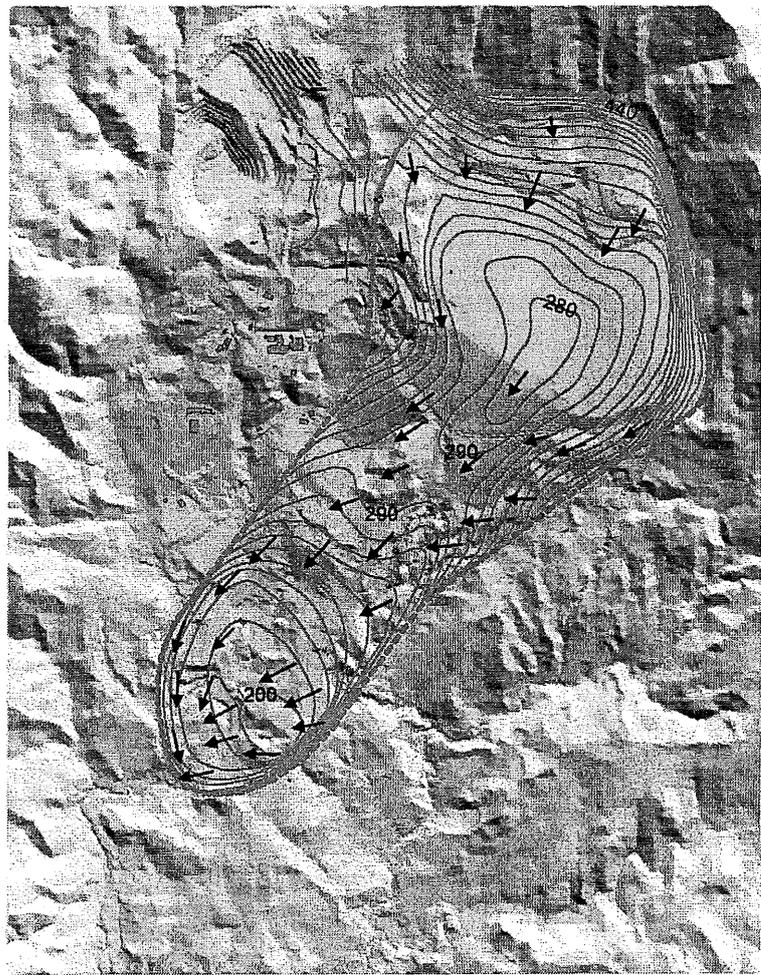
Figure 4: Slide failure surface contours (10m intervals), and movement vectors. Elevations shown in mRL.

The slide failure surface topography is shown on Figure 4, which also generally represents the pre-Omahia paleotopography formed in the Coromandel Group and Union Volcanics. Beneath the upper slide area the surface is bowl shaped narrowing down to and rising up to a saddle, before it drops in elevation down to the base of the paleovalley below the present day valley floor. The dam was located above this saddle, where the interface dips back to the east and is isolated from the westerly dipping interface downslope. In the toe of the landslide the failure surface passes through a relatively thick mixture ("melange") of mainly highly sheared and disrupted

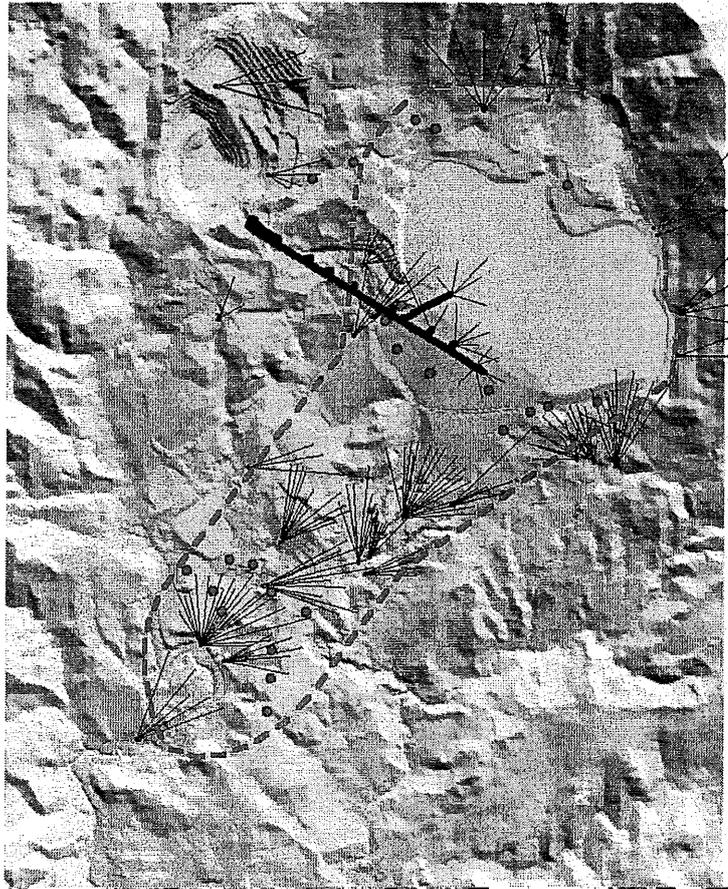
Figure 5: Drainage plan showing locations of horizontal drains, pumping wells, and drainage drive

25 horizontal drain fans and over 220 individual horizontal drainholes with lengths up to 348m were installed around the site (Figure 5). The total length drilled is more than 35,000m (35km). Up to four drill rigs were used simultaneously to install the drain fans, which were typically set out in an array of holes from a centralised location. Approximately 70% of the drain holes were 120mm in diameter, with 25% being 200 mm in diameter. Slotted Class E uPVC pipe or 70mm galvanised steel pipe was installed within the drainholes to minimise potential clogging from hole collapse. All holes were collared with a minimum of 6m long steel casing. Flows from many of the holes were spectacular, with initial flows of 400 to 600 litres per minute being relatively common and some holes initially producing flows in excess of 2000 litres per minute. The effect of the drainhole fans was very favourable overall, with piezometric drawdown of more than 10m being common. The maximum drawdown achieved from any of the drains was 29m.

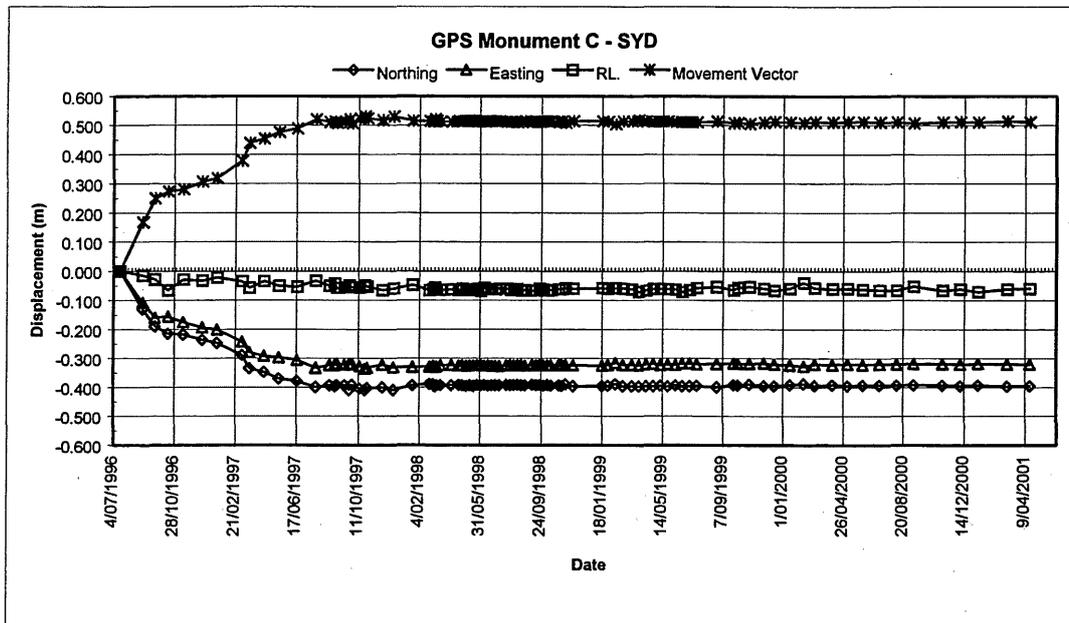
Figure 6: Central lower slide GPS monument C-SYD, showing change from continuous movement to stability in August 1997

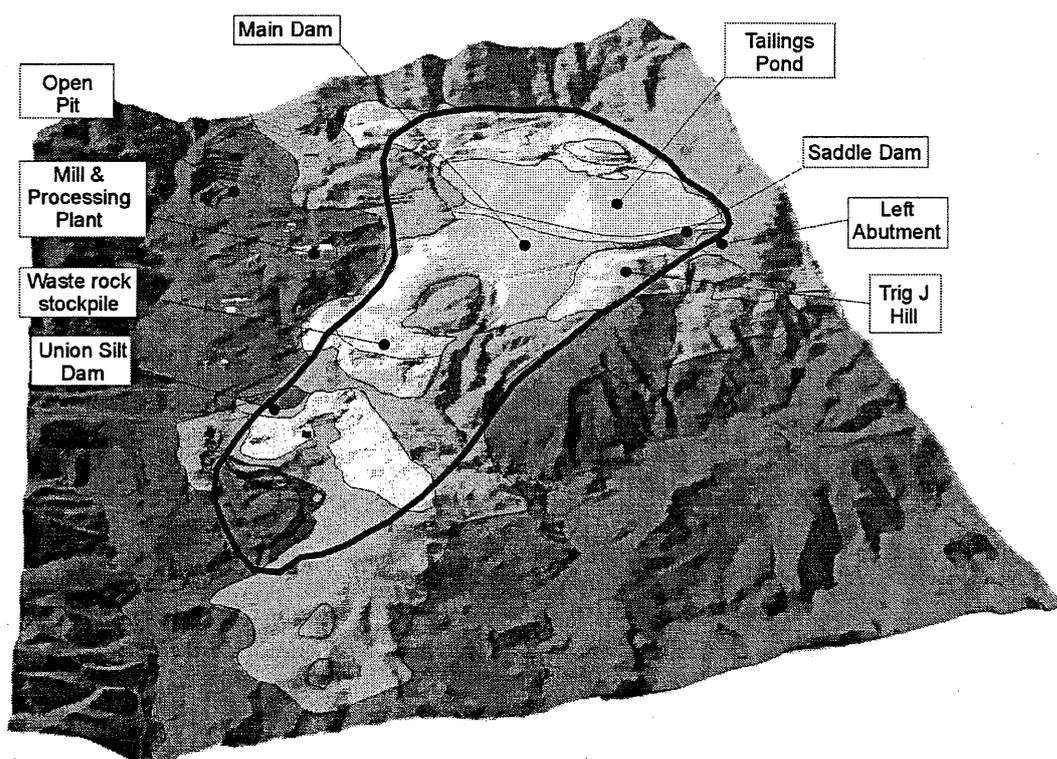
Figure 2: General Site Layout

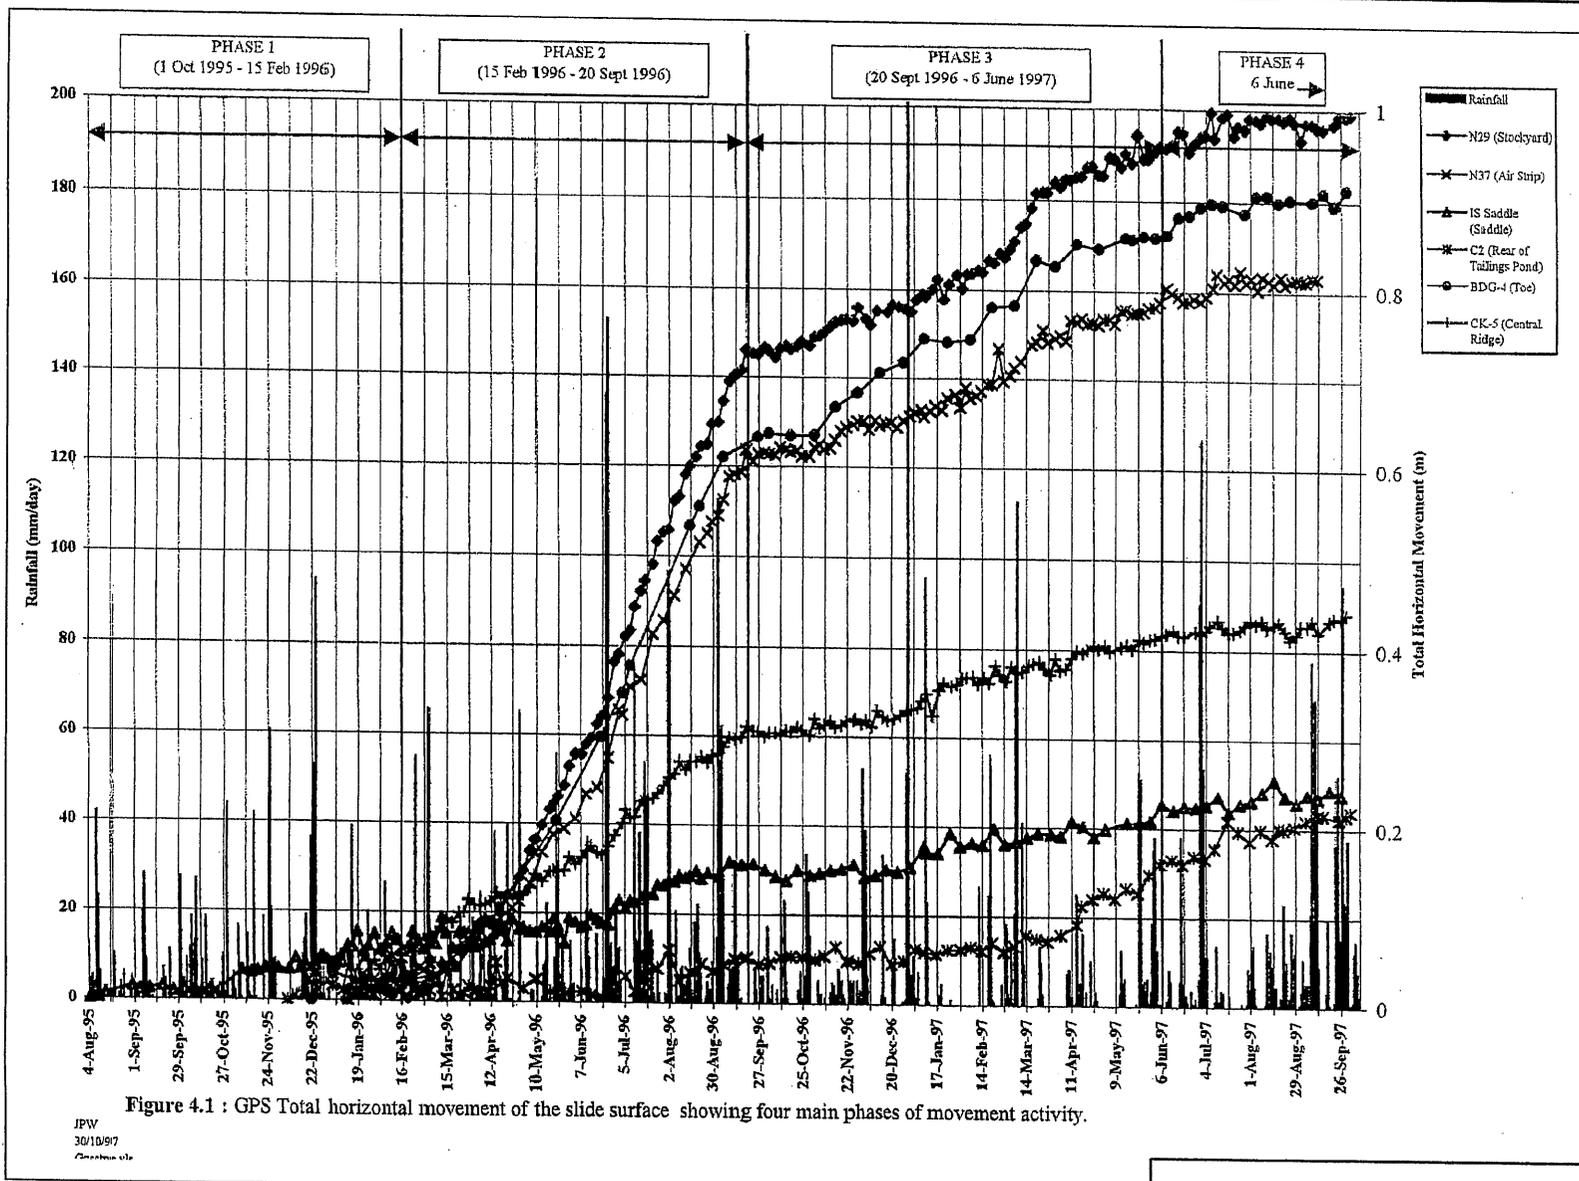
Figure 4
SURFACE MOVEMENT
OF LANDSLIDE

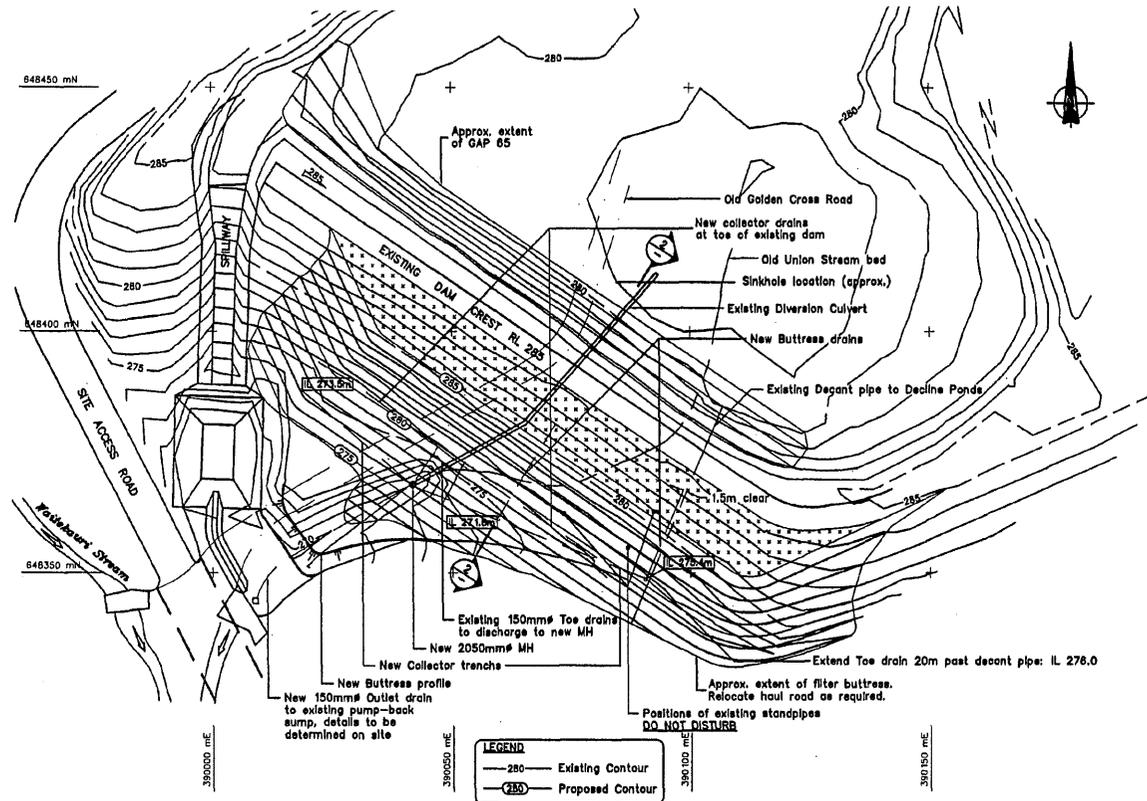
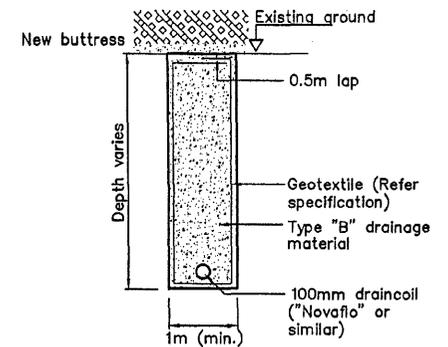
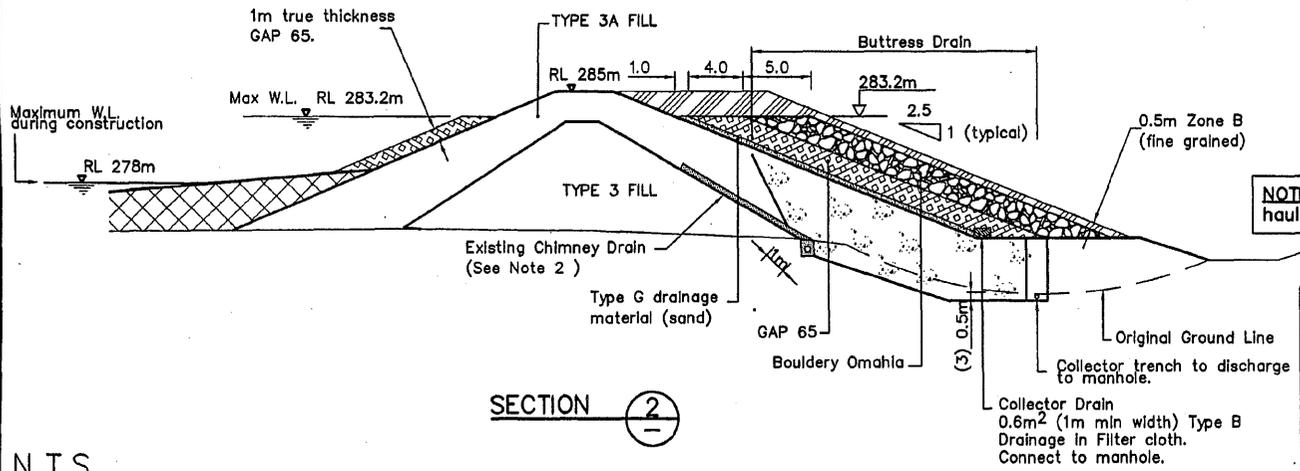
PART LAYOUT OF UNION SILT DAM

SECTION 1
SCALE 1 : 100

BUTRESS DRAIN DETAIL

SECTION 2

Figure 7
UNION SILT DAM
BUTRESS PLAN AND
CROSS - SECTION

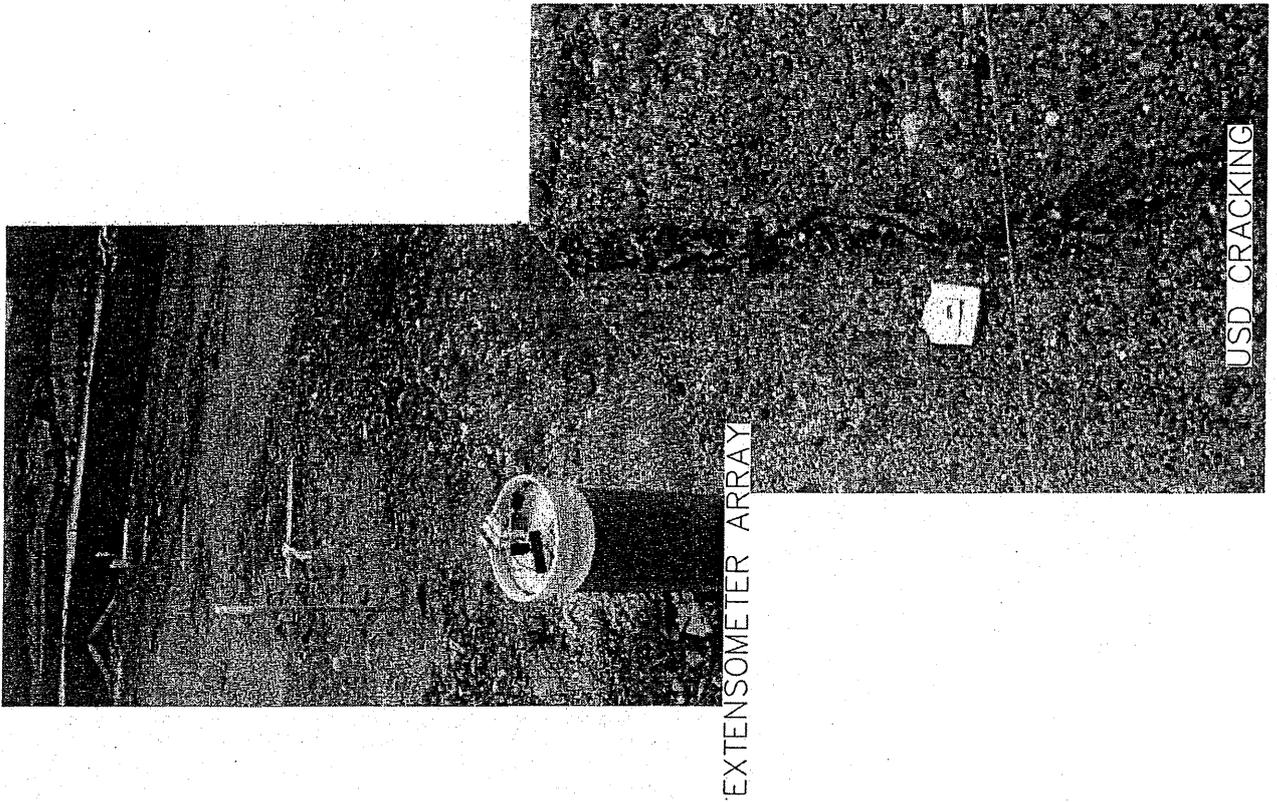
Figure 8

PHOTOS

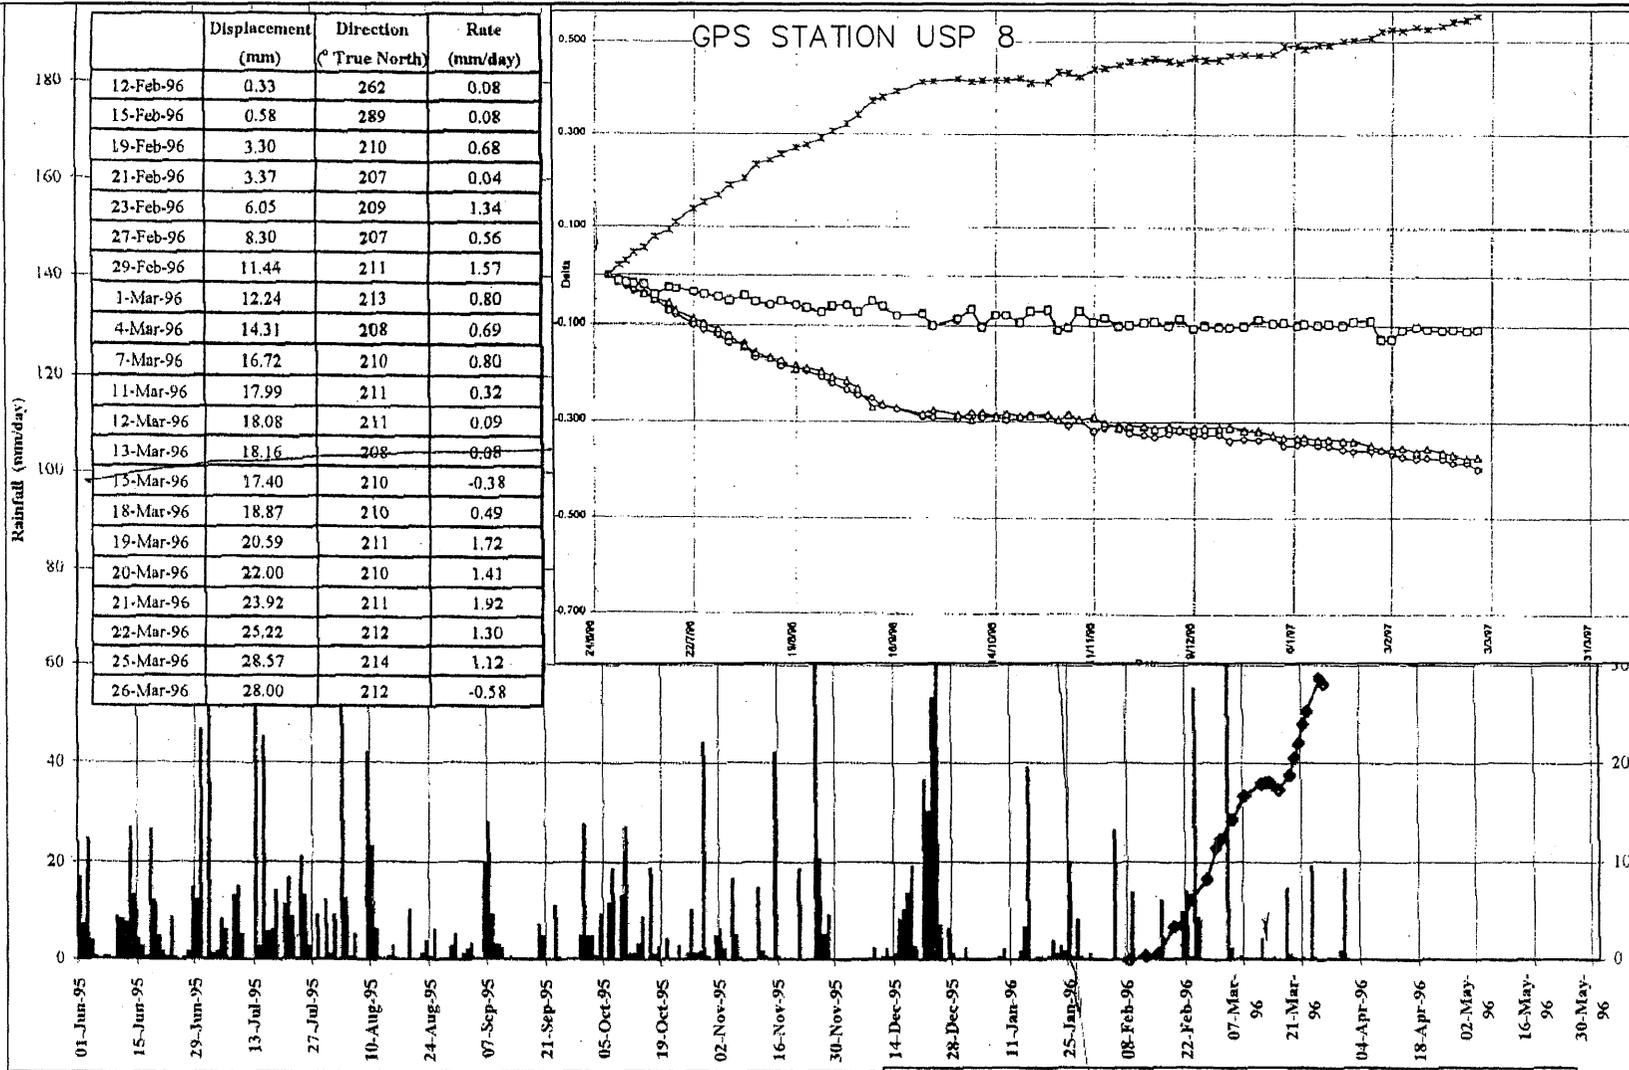
COEUR GOLDEN CROSS PROJECT
Inclinometer N55 (Deformation Interval: 60.25 & 72.25 m)

Figure 9
 INCLINOMETER AND
 GPS DATA
