Engineering & Development

in **HAZARDOUS TERRAIN**

NEW ZEALAND GEOTECHNICAL
SOCIETY 2001 SYMPOSIUM

Hazardous Terrain – An Engineering Geological Perspective

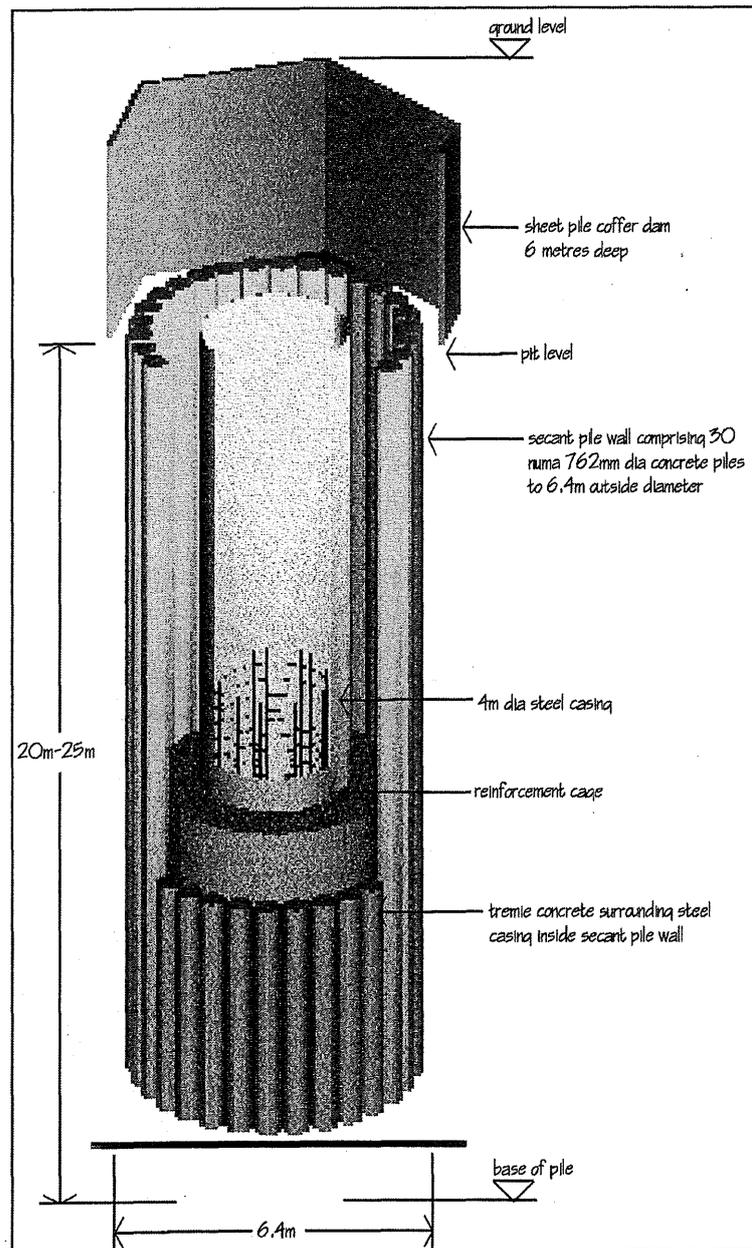
Figure 3: Foundation construction method employed to build the bridge.

The actual methodology for construction of the foundations was left open to the tenderers, and the method adopted by the contractor is illustrated in the figure below. The design required the installation of 4m diameter steel cased piles, and the contractor elected to achieve this by installing a ring of secant piles, creating a concrete tube in the ground inside which excavation could occur. The secant piles were drilled with a NUMA percussion drill of 762mm diameter. The overlapping drill holes were then tremie concreted full to form the concrete "casing".

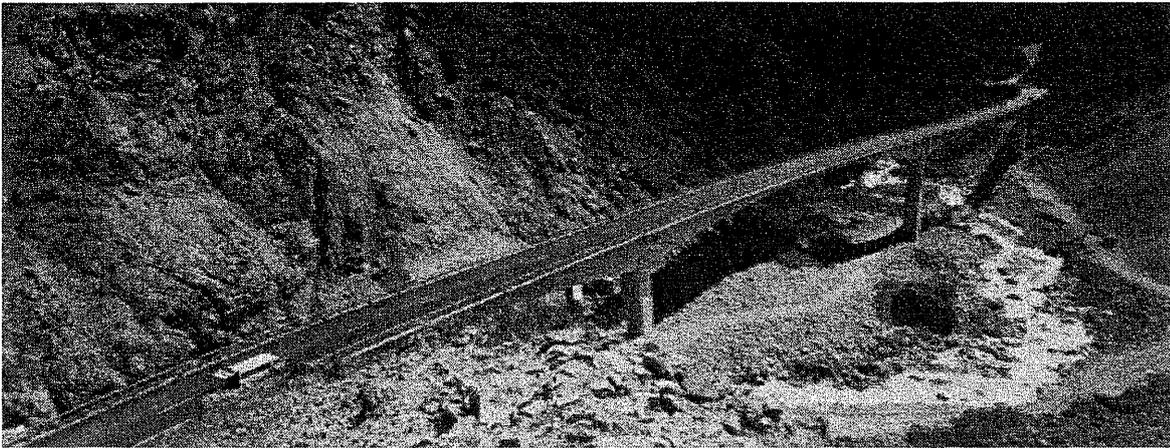
Figure 4: The completed viaduct as seen from the Zigzag

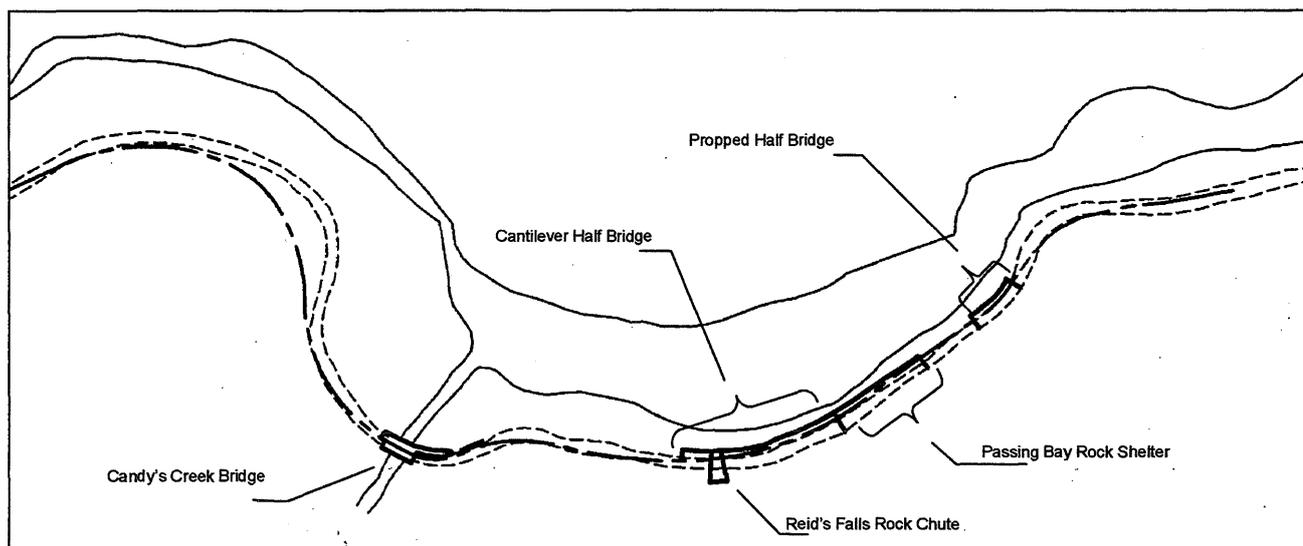
Figure 5: Layout plan of Candy's Bend widening.

- Widening of the existing Candy's Creek Bridge downstream.
- An overhead chute to carry the waterfall and rock debris over the road at Reid's Falls.
- A cantilever half bridge structure between Reid's Falls and the Passing Bay.
- An overhead rock fall protection structure at the Passing Bay.
- A propped half bridge structure between the Passing Bay and Starvation Point.

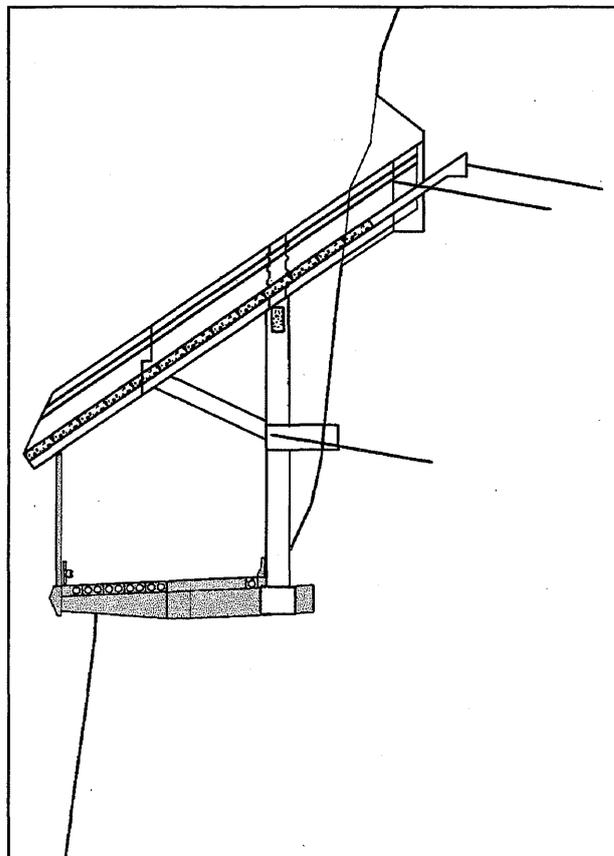
Fig 6 – Reid's Falls Rock Chute

The topography of the hills above the road at Reid's Falls provides natural confinement of the rock debris originating in this area. There is a basin approximately 20m above the existing road, which collects debris until an extreme rainfall event flushes the basin and deposits as much as 500 m³ of material on the road below. This poses both a safety hazard and an ongoing maintenance problem. The solution selected at this site was to provide a chute to carry the waterfall and any rock fall debris over the road and into the river below. The general arrangement is shown on figure 6.

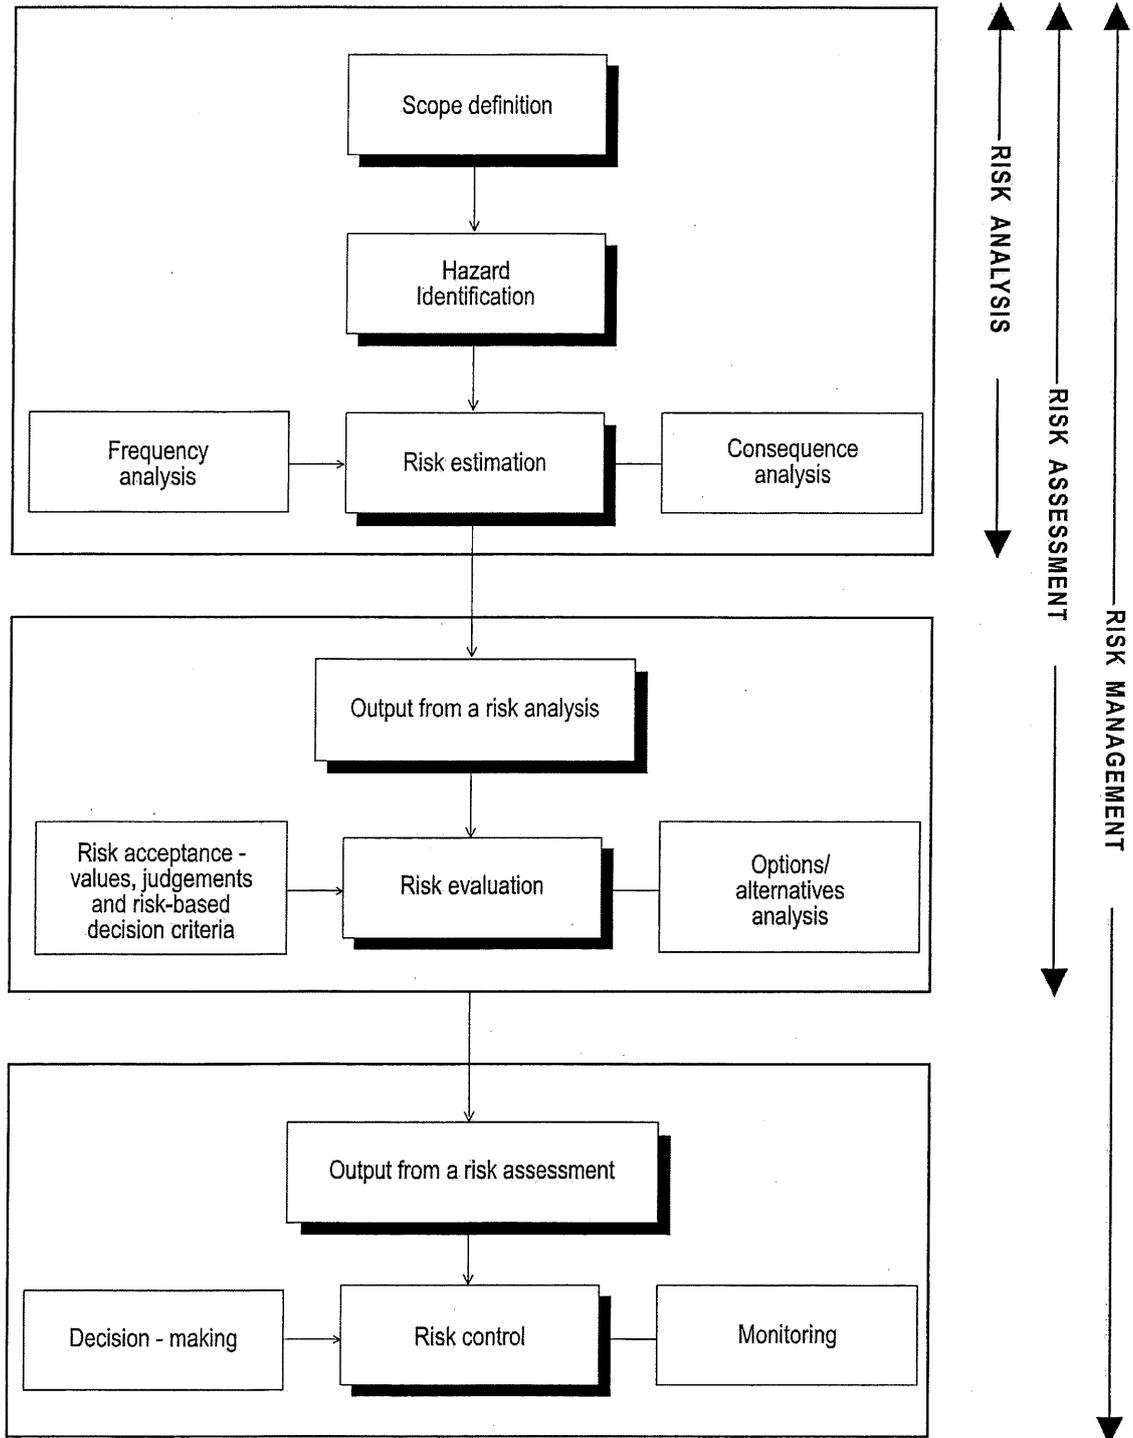
Figure 1: Quantitative Risk Assessment (based on Fell & Hartford 1997; IUGS, 1997)

Risk analysis involves identification of the landslide hazard and assessment of probability of failure $P(F)$, as well as consideration of the consequences of landsliding if persons and/or property are impacted by failure. An assessment of the types, characteristics and probability or frequency of landslides in a given study area is carried out. If the frequency cannot be determined directly from field evidence, or where engineered slopes are involved, analytical techniques such as first order second moment extrapolation (Christian, 1996) the point estimate method (Harr, 1987, Mostyn and Li, 1993) or Monte Carlo simulation are required to evaluate the probability of failure.

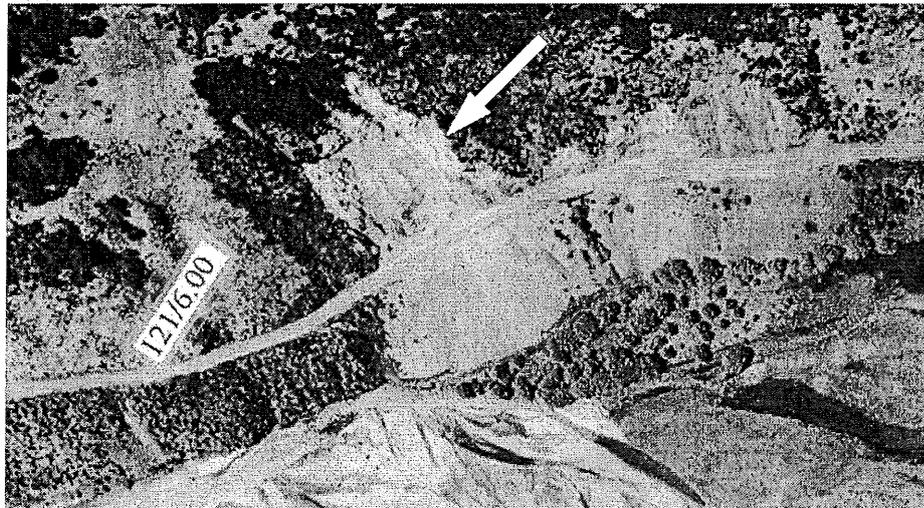
Figure 3. Air photograph of SH 73, showing Paddy's Slip

In 1982, construction commenced on upgrading a 2.2 km long section of SH73 immediately west of TranzRail's Midland Railway bridge across the Waimakariri River (see Figures 2, 3, and 4). The work involved easing the sharpest corners and widening sections of road located on failed retaining walls, by excavating a minimal distance into the slope. Soon after construction commenced at the western end, reactivation of an existing rock slide known locally as "Paddy's Slip" occurred, temporarily closing the highway (Paterson 1982a). Further widening was postponed indefinitely, although local widening was later carried out near the eastern (Midland bridge) end of the highway.

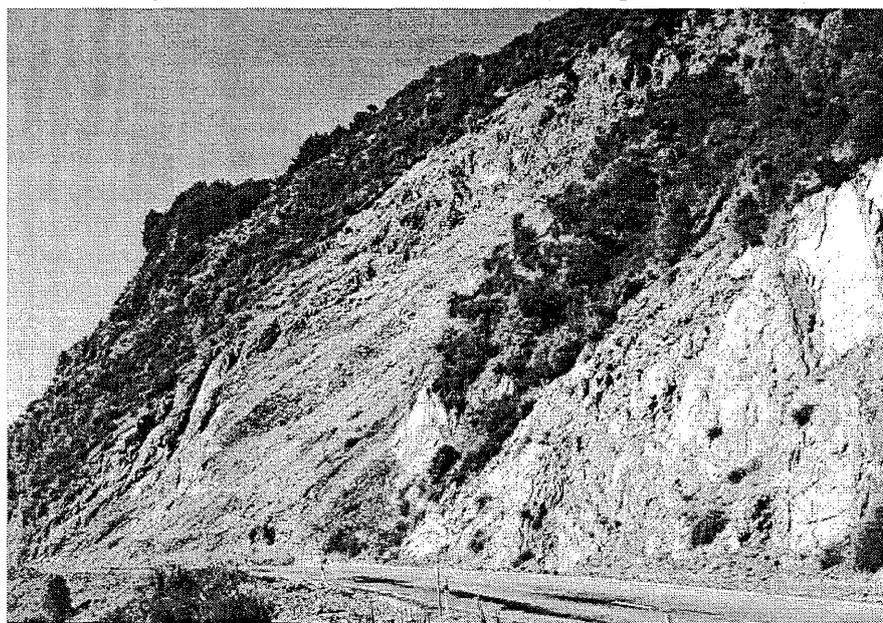
Figure 4: View of instability at Paddy's Slip from SH 73

Subsequent to 1982, rockfalls have been a continuing problem at Paddy's Slip where a large area of exposed bedrock is now contributing a significant number of rockfalls on to the road. Small rockfalls occur almost on a daily basis, and much of this material ultimately ends up on the road in the form of detritus. Large falls of discrete blocks also occur infrequently, one such being in 1997 when "several blocks up to 0.6 m in size" failed (Montgomery Watson 1997b). Rockfall activity increases during severe north west rainfall activity, and during the winter freeze-thaw.

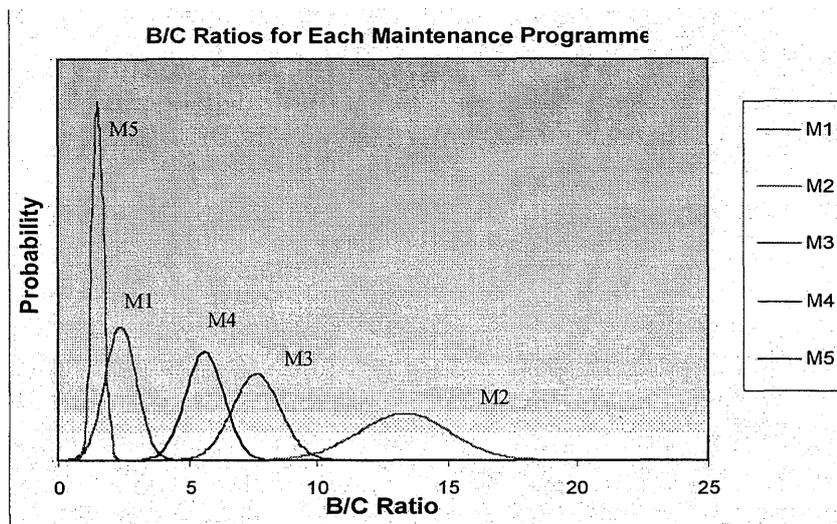
Figure 5: B/C Ratios for each maintenance programme approximated to normal distributions

A spreadsheet numerical simulation was set up, and benefit/cost ratios were determined for each maintenance programme. A simple economic analysis was carried out, discounting benefits and costs of each alternative maintenance option to net present value over 25 years, and incorporating uncertainty in the various inputs by Monte Carlo simulation. The results were expressed as probability distributions of benefit/cost (see Figure 5). The results indicate maintenance programme M2 (wire mesh catch fence) to be cost optimal (B/C ratio around 13) when considered over 25 years.

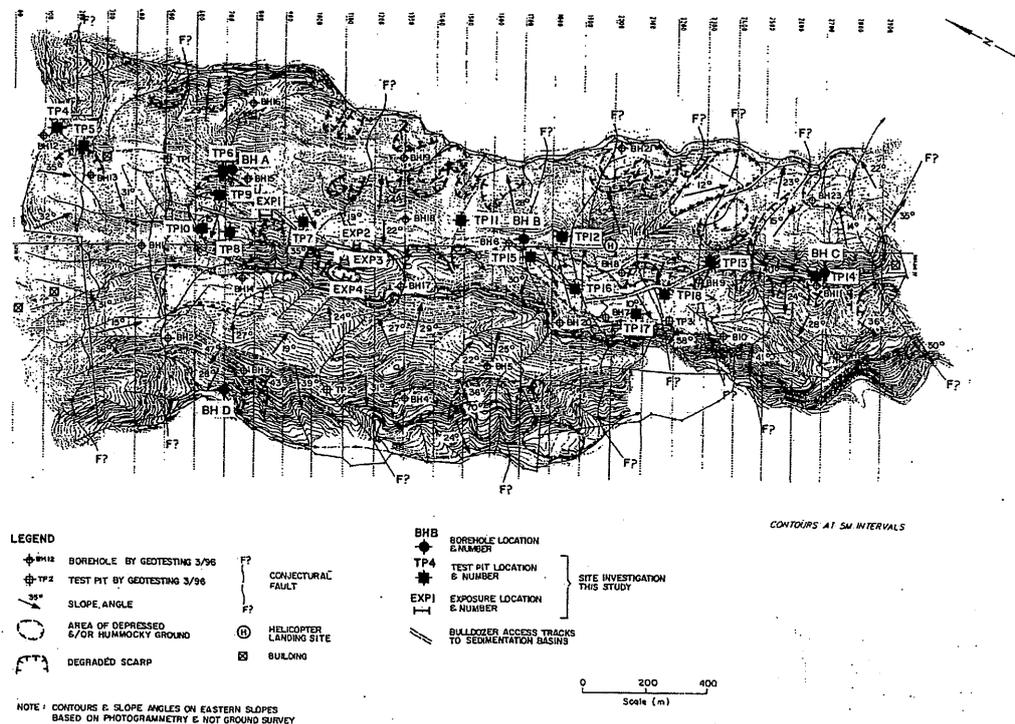
Figure 2. Engineering geology plan.

The site comprises a series of sharp ridgelines and narrow valleys which trend approximately perpendicular to the caldera rim (Figure 2). Ridge slopes are steep and average around 30° but range to over 40° in some areas. In long section the ridge crests are characterised by a mound and saddle topography interpreted to be eroded remnants of a series of normal faults inferred to underlie the site (Figure 3). These faults are considered to be related to caldera formation where crater collapse occurred along this family of structures.

The results of aerial photography interpretation and mapping showed a number of degraded scarps and areas of depressed and/or hummocky ground (Figure 2). Three types of slope failures were recognised:

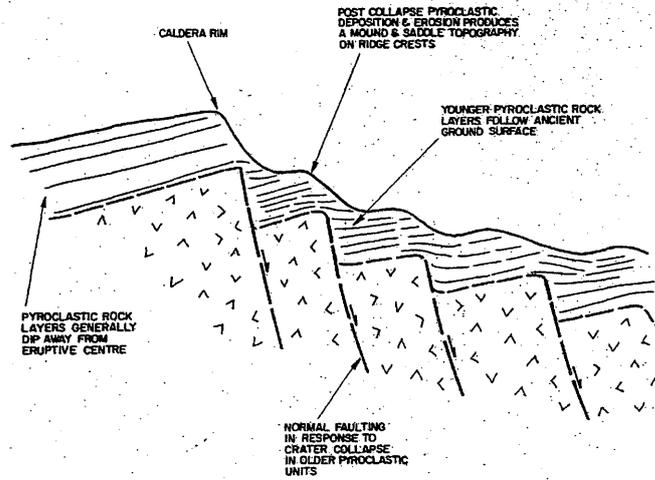
Figure 3. Schematic section showing normal faulting resulting in mound and saddle topography.

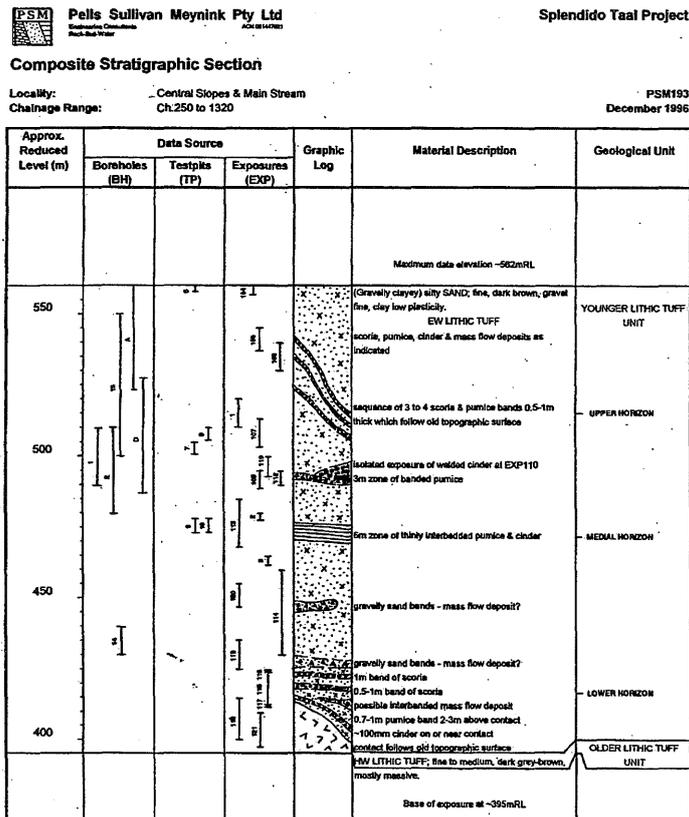
Figure 4. Example of a composite stratigraphic section.

Composite stratigraphic sections were compiled from the results of cored boreholes, test pits and mapping of natural outcrops and access road cuttings. An example is shown in Figure 4 which represents sub-surface conditions under the central slopes and main stream.

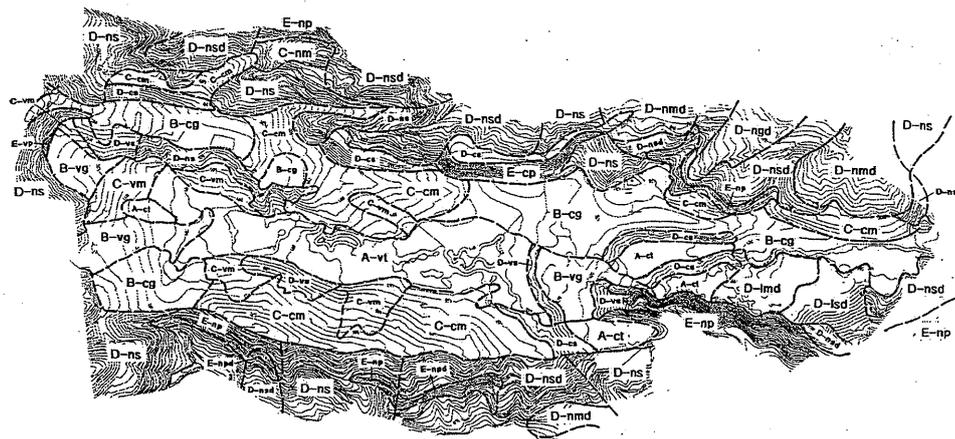
A majority of the pre-development, natural slopes were zoned Class D based on steep slope gradients and/or the presence of slope instability features (Figure 5). Areas of the

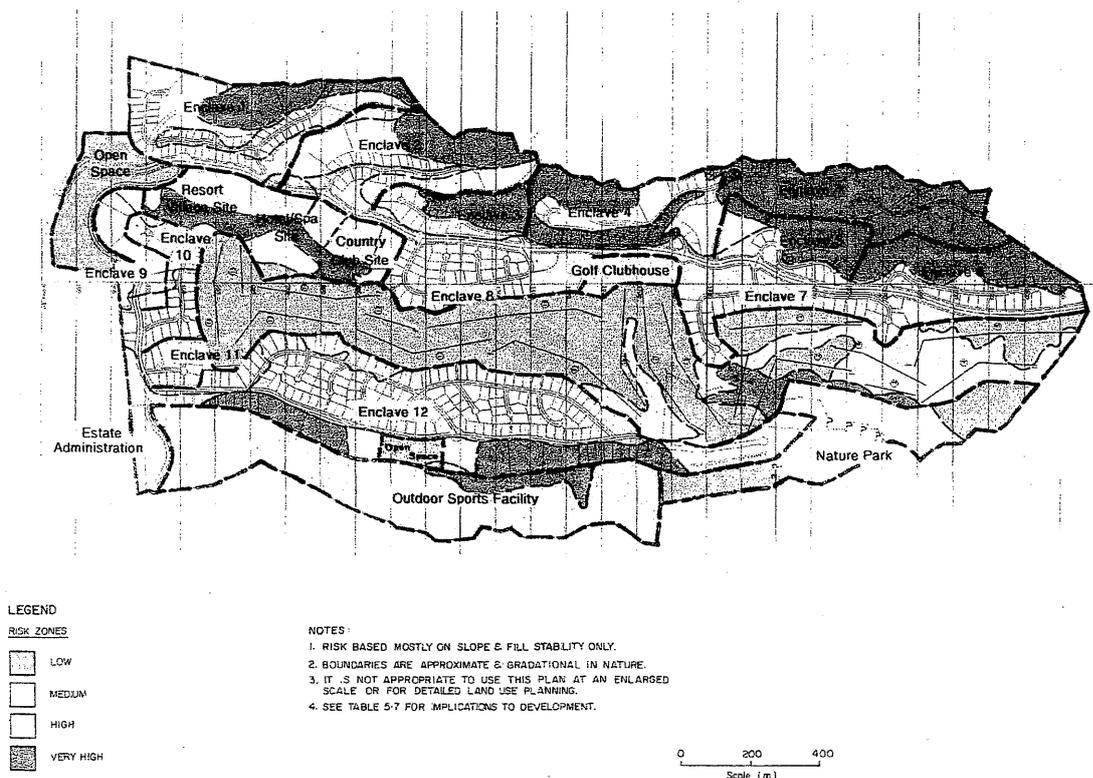
Figure 7. Qualitative risk plan.

To assist the planners, development categories suitable for each major capability sub-class were recommended. The development layout was revised using the capability plan of the post-earthworks slopes as a framework. The resulting development plan was sub-divided into zones indicating the different levels of qualitative risk as shown in Figure 7. A majority of the development was classified as low and medium risk. However, there remained areas of high and very high risk.

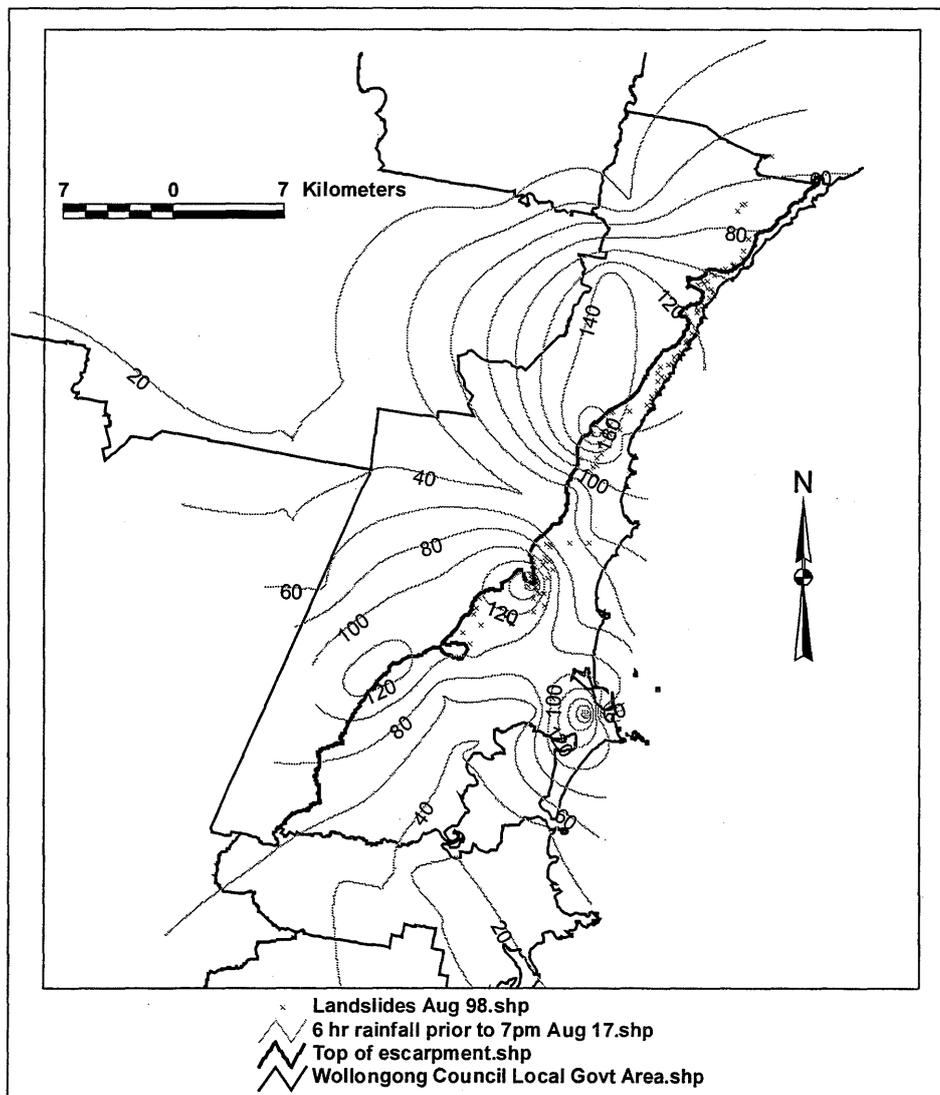
Figure 1. GIS based 6 hr rainfall distribution prior to 7pm on August 17th 1998, with documented landslides. Local Government Area boundary and top of Escarpment are shown.

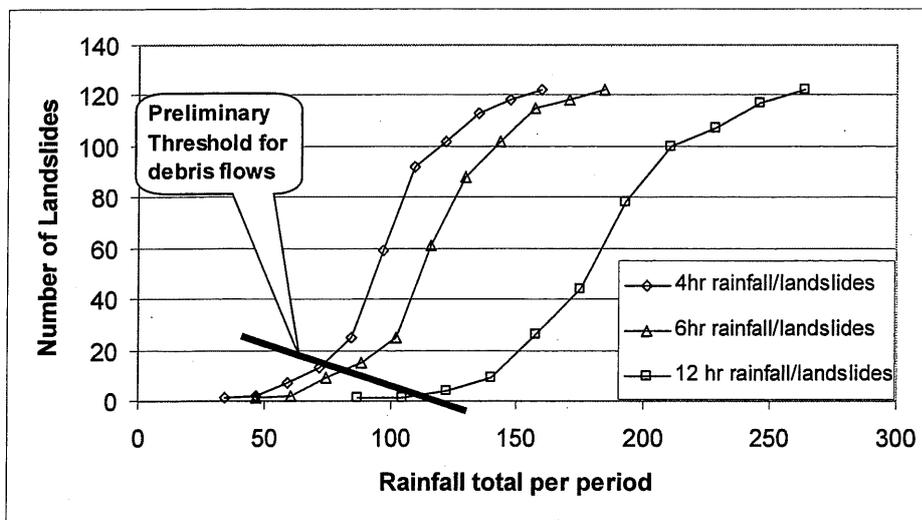
Figure 2. Number of landslides outside of given rainfall contour (20mm rainfall contours) with preliminary debris flow threshold for the Illawarra (after Murray 2001).

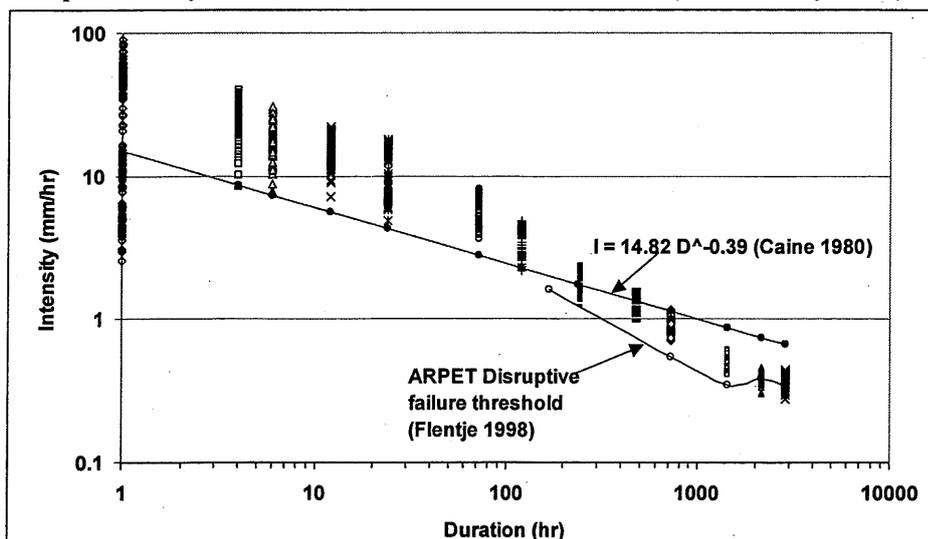
Figure 3. Rainfall intensity/duration thresholds for initiation of all landslide types (including debris flows) in the Illawarra during the August 1998 rainstorm event (vertical data series at various cumulative periods). Included is the Caine (1980) threshold line for internationally published rainfall intensity/duration and associated debris flow data on undisturbed slopes (Murray 2001). ARPET threshold line for disruptive failure involving deep-seated, slow-moving landslides (Flentje 1998) is also included.

A rainfall intensity/duration graph of all landslide types (including debris flows) in the Illawarra during the August 1998 rain storm is shown in Figure 3. A threshold relationship developed by Caine (1980) for internationally published rainfall intensity/duration and debris

flow occurrence data on undisturbed slopes has been superimposed on the Wollongong data. An excellent correlation is found with the Wollongong data for debris flows associated with rainfall over a short duration. The Wollongong August 1998 series falls below the Caine threshold line for rainfall of longer durations. This would have been expected since the longer durations are clearly more relevant to deep seated landsliding. For this range of durations (240 hrs or 10 days up to 2280 hrs or 120 days), ARPET thresholds (Flentje 1998) for deep seated slow moving landslides have been developed during previous research and are also shown on Figure 3.

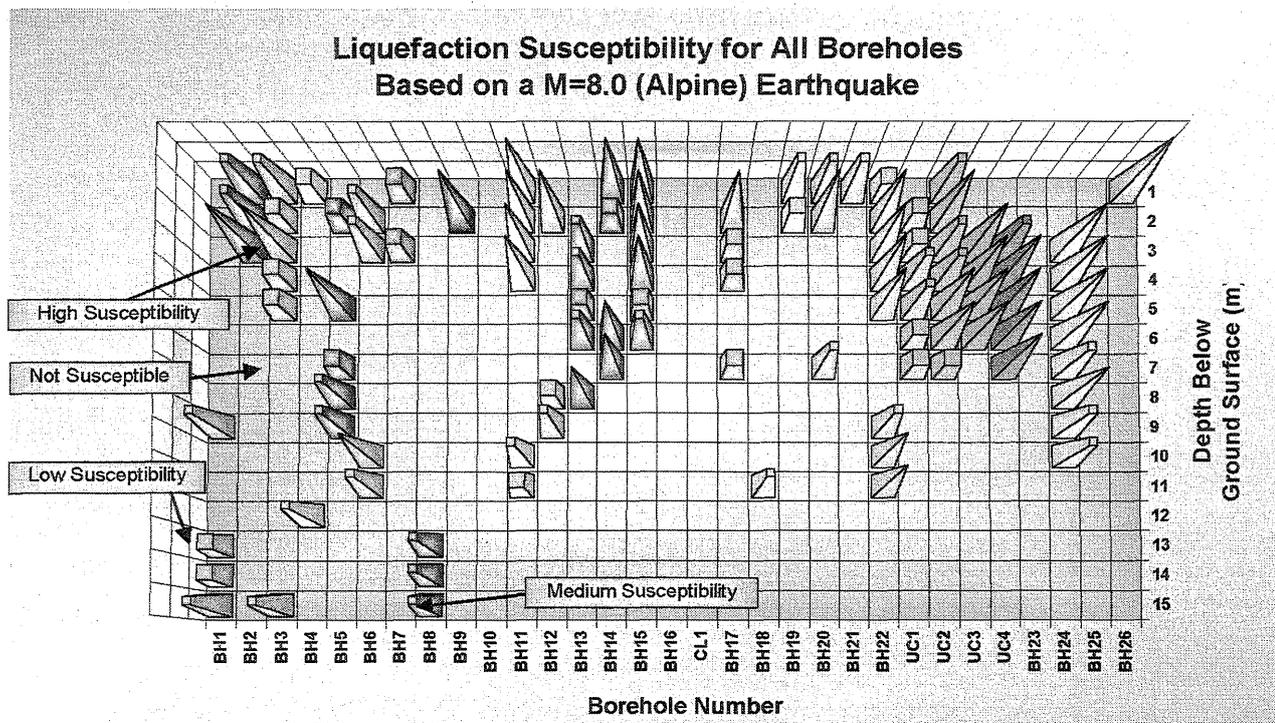
Figure 2. Liquefaction susceptibility for all boreholes based on a M=8.0 Alpine Earthquake

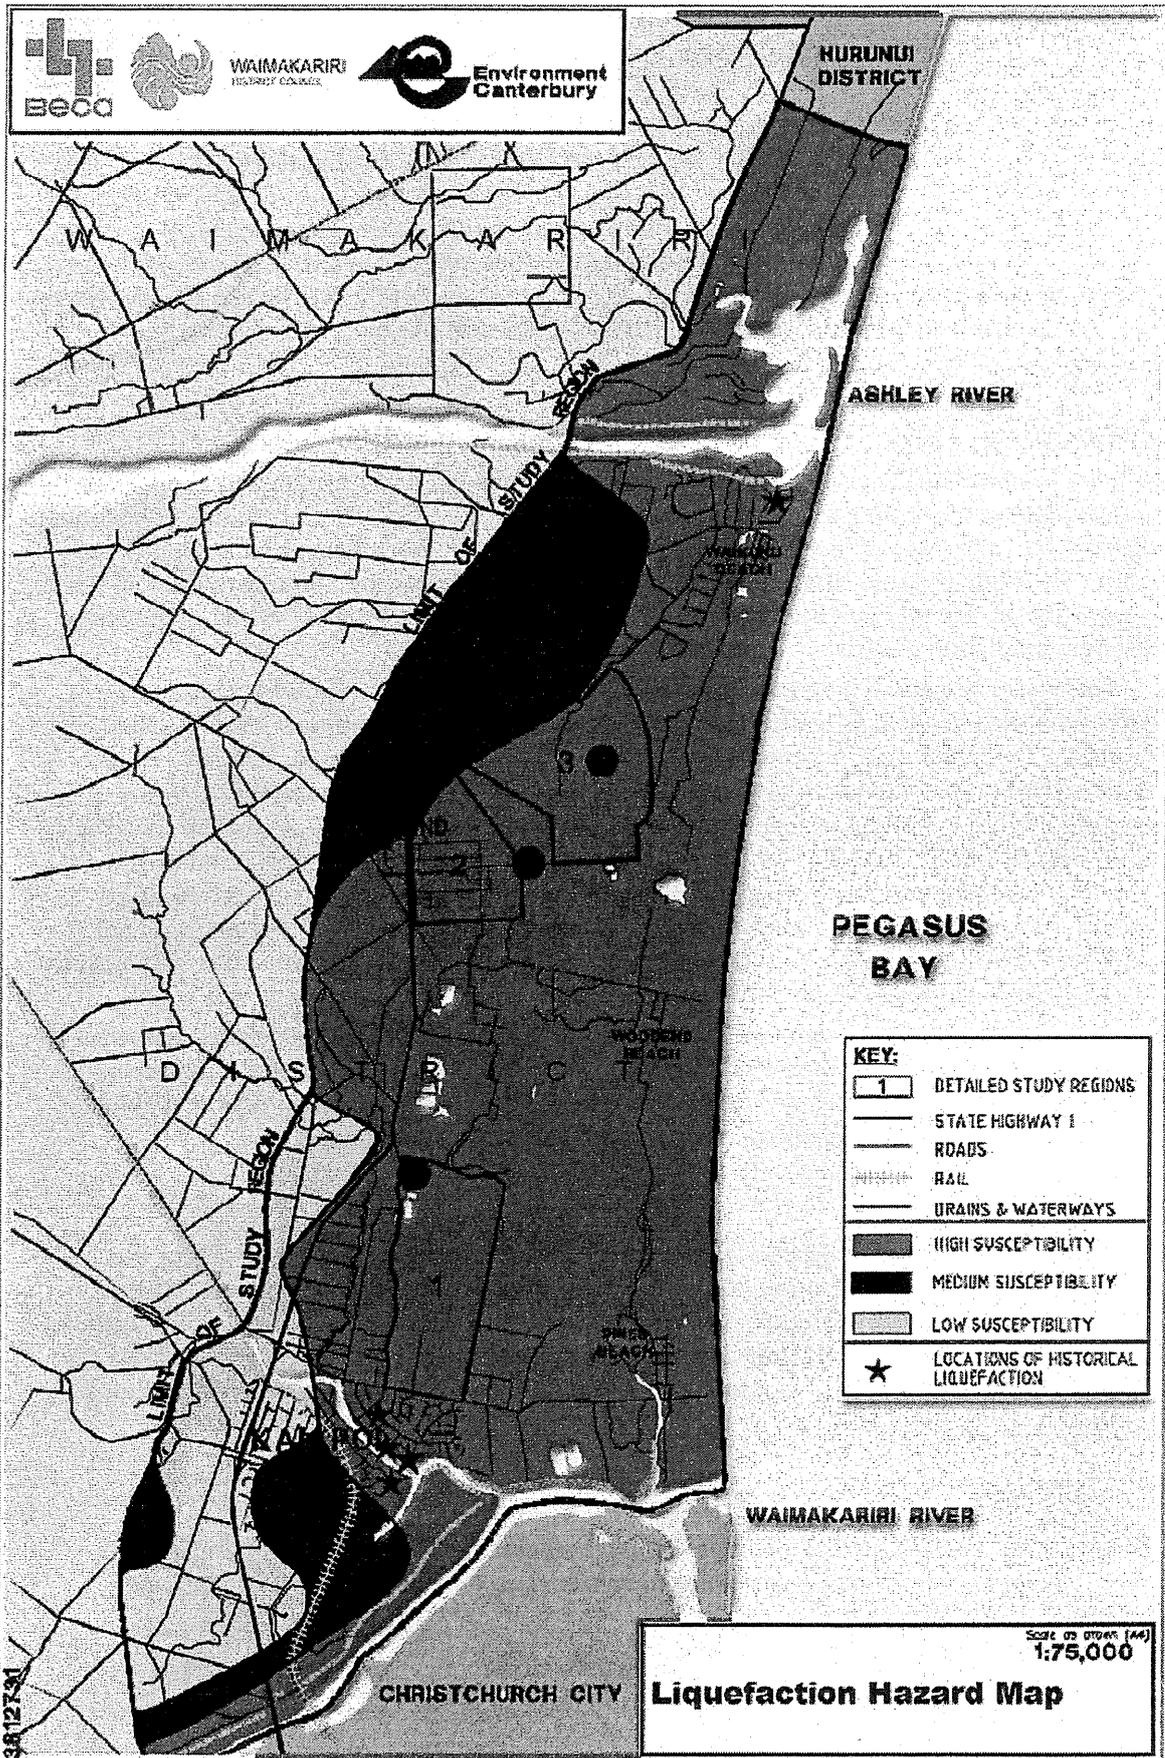
Figure 3 Liquefaction Hazard Map for the Study Region, showing locations of historical liquefaction.

Three sets of data were used to generate the map as follows:

- The results of this current borehole investigation were used to define regions of high, medium and low hazard of liquefaction. These results were given a high rating in terms of accuracy.
- The CPT results (Berrill et. al., March 1994 and Connell Wagner, 1999) were treated in a similar manner to results from this study and were given a high accuracy rating.
- Lastly the Environment Canterbury well logs (January 2000) were used, albeit cautiously, to in-fill areas between the above two sets of data. This set of data was given a low rating in terms of accuracy and therefore when a conflict arose, the more highly rated data above was given priority. Environment Canterbury well data was mapped as follows:
 - 0 – 1m of sand recorded within 15m of ground surface – low susceptibility

- 2 – 5m of sand recorded within 15m of ground surface – medium susceptibility
- 5 – 15m of sand recorded within 15m of the ground surface – high susceptibility

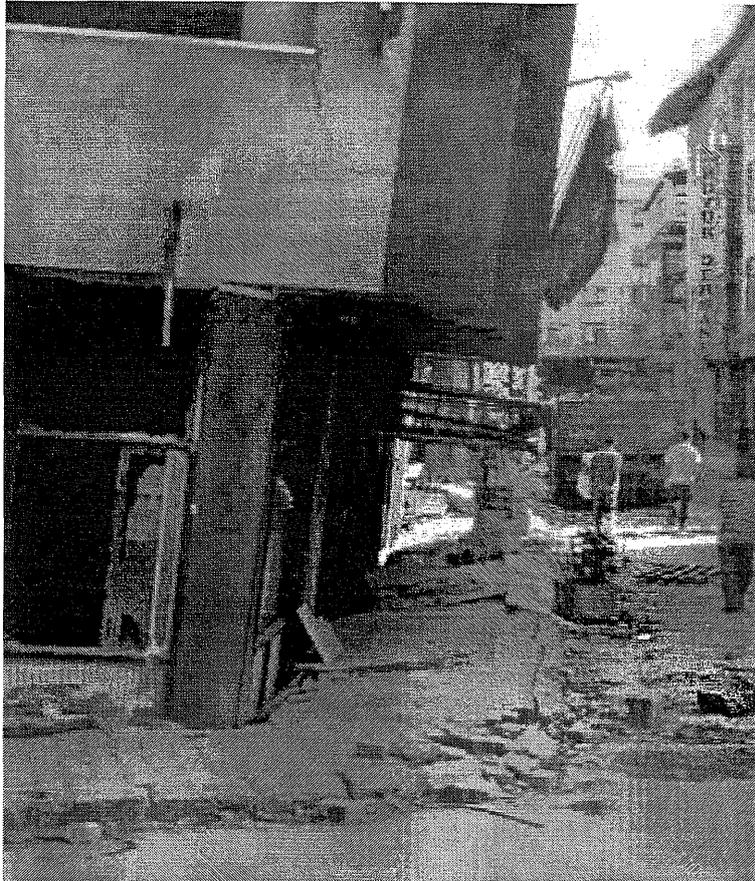
Figure 1. Settlement of building on raft foundation in Adapazari, Marmara Sea earthquake, 1999.

or only minor damage while other areas were affected by ground fractures and lateral movements and heaving associated with settlement of adjacent buildings. In the worst affected areas building settlements of one metre were typical, as shown in Figure 1, with some buildings becoming unstable and tipping over, as in Figure 2. Pipeline damage in Adapazari was extensive. Sand boils were not widely observed but close inspection of many settled buildings showed small amounts of ejected, stratified, fine sand.

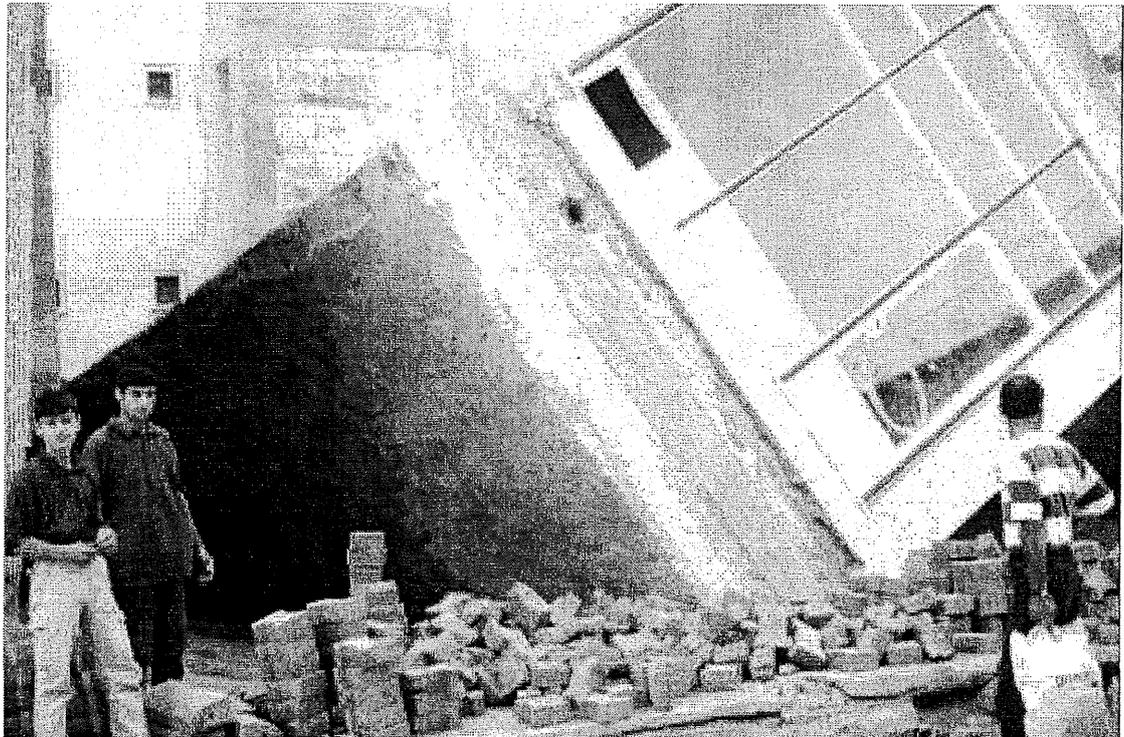
Figure 2. Overturning of building in Adapazari during Marmara Sea earthquake, 1999.

Typical foundation conditions are illustrated in Figure 2 with a heavy raft foundation (often hollow and ribbed) founded in the upper silty-clay material. Failure has presumably occurred because of liquefaction in shallow underlying sand strata (as seen in Figure 5) allowing a punching failure under one side of the foundation.

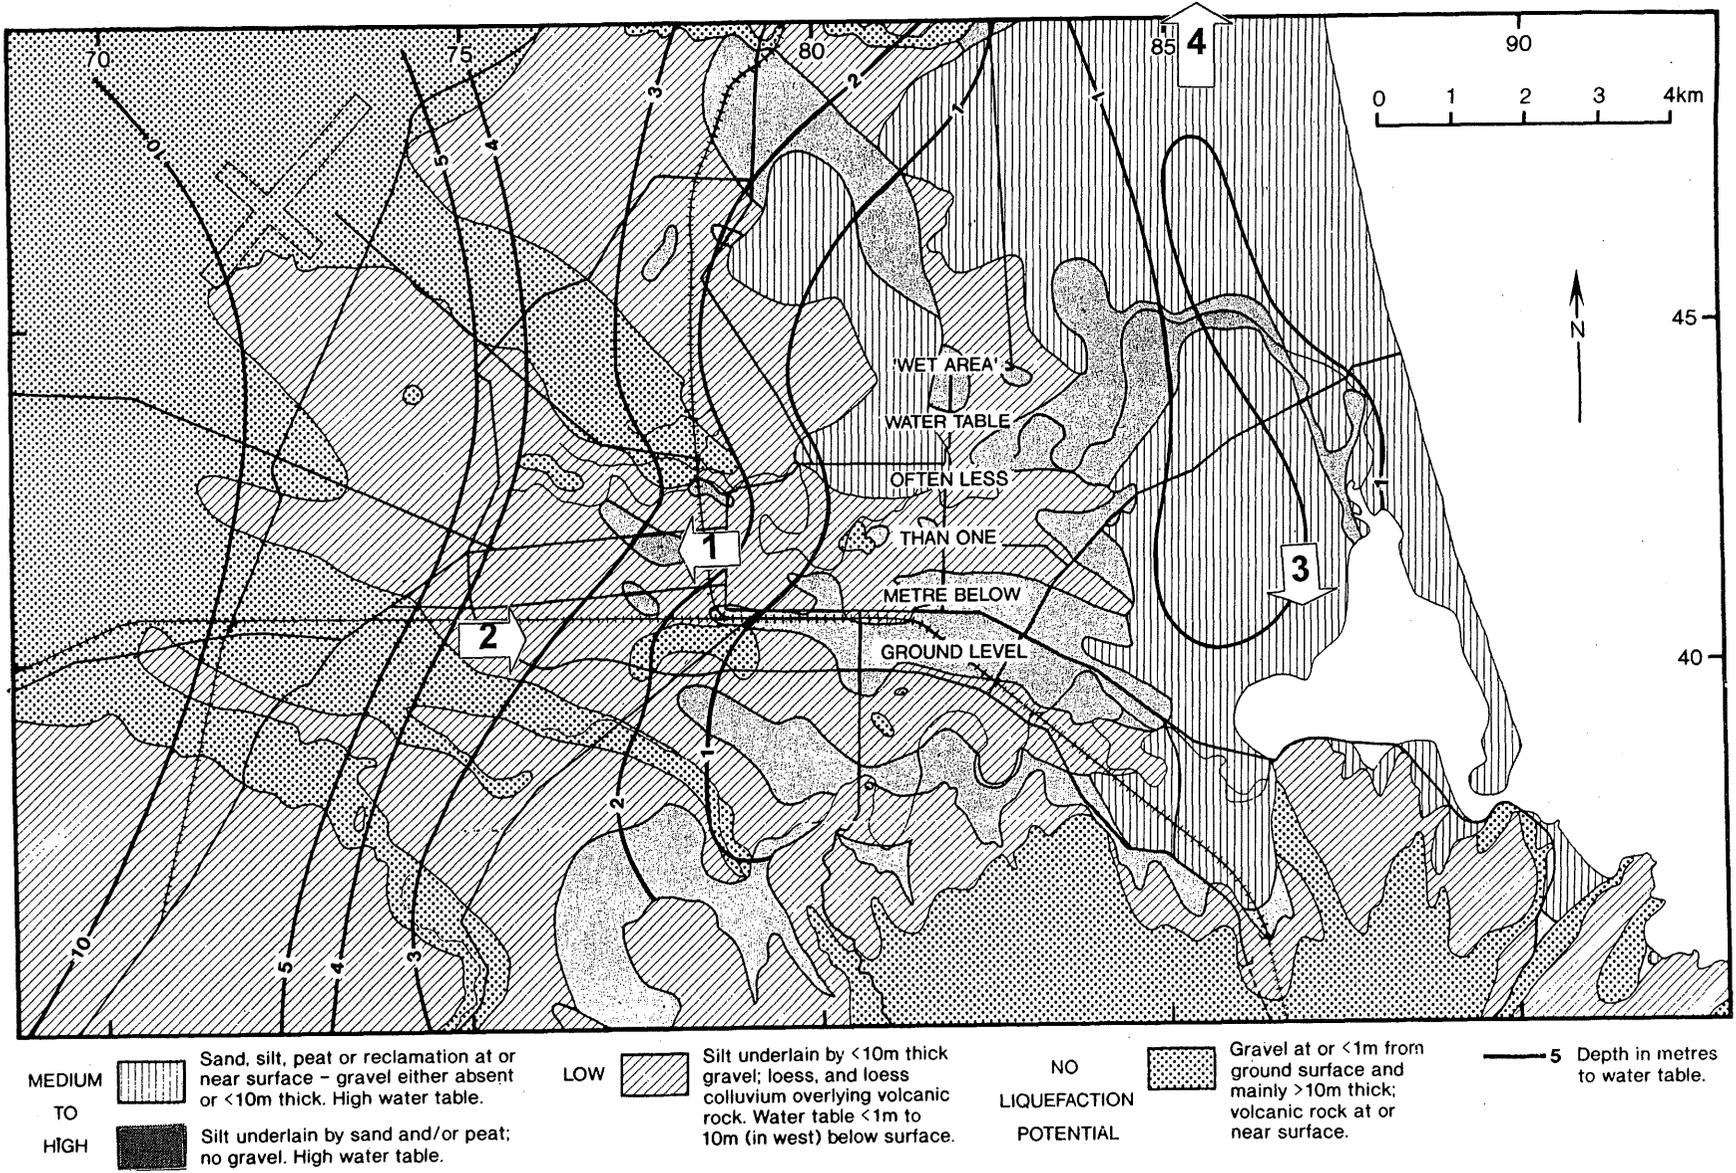
Figure 3. Liquefaction hazard map for Christchurch. Location of study sites indicated by arrows. (Source: Brown and Weeber, 1992)

This site is considered to represent a *high* hazard from soil liquefaction and is probably typical of soil conditions that exist in many parts of Christchurch albeit in isolated pockets that are difficult to locate and map accurately. In this instance, the site is mapped correctly as being *high* hazard by the map of Brown and Weeber shown in Figure 3.

This site also represents a *high* hazard to structures on shallow foundations and to in-ground services, but is mapped incorrectly as a *low* risk area on the liquefaction hazard map of Figure 3.

This site represents a *low* hazard but is mapped as *medium* on the liquefaction hazard map of Figure 3.

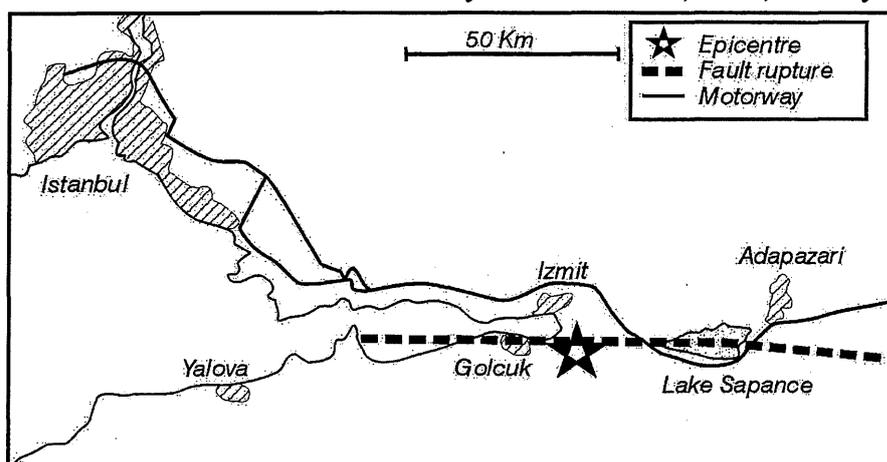
Figure 4. Surface trace of the Marmara Sea earthquake, 1999.

The part of Adapazari which was badly affected by soil liquefaction during the 1999 Marmara Sea earthquake was situated on level ground on a river flood plain. Adapazari was located approximately 30 km from the fault trace of earthquake, as shown in Figure 4. At the time of the earthquake the only information available concerning the sub-surface soil conditions was from some borehole logs with some SPT blow count data. Since the earthquake, a major international effort has been made to study the damage and underlying soils including a large number of CPT soundings with the as yet unpublished results available on the internet (Youd et. al.). The result from one of these CPT soundings from central Adapazari is shown in Figure 5 and indicates 8 metres of weak and thinly interbedded silts, sands, and clays.

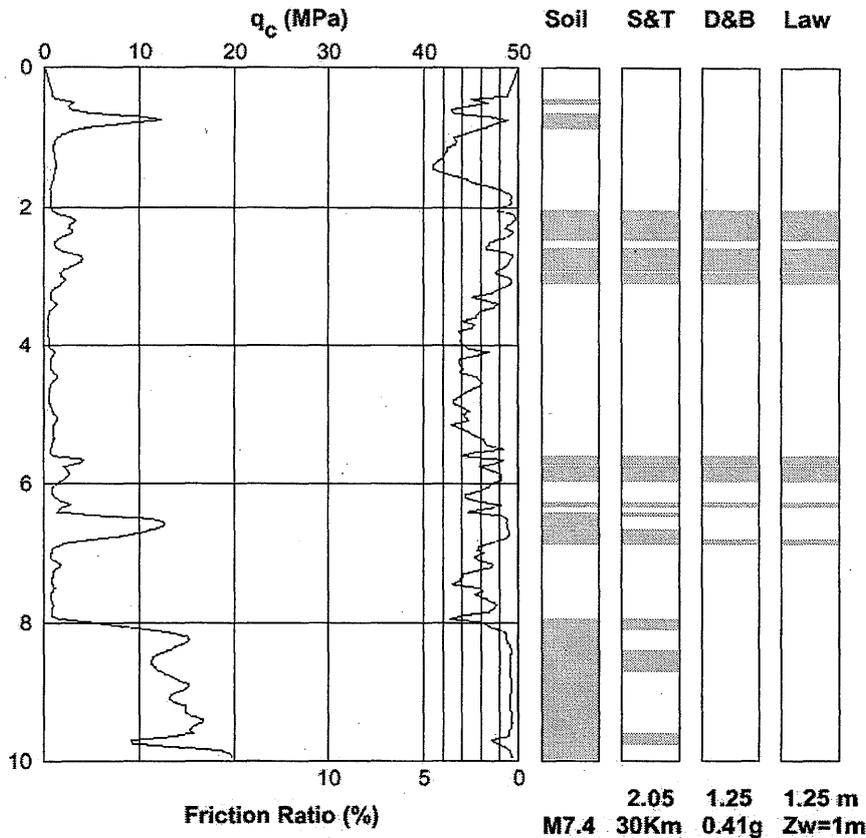
Figure 5. CPT profile and liquefaction assessment for site in Adapazari.

The data from the CPT sounding of Figure 5 has been analysed for this study using the methodology described herein and the measured parameters of the Marmara Sea earthquake: Richter magnitude of M_w 7.4, epicentral distance of 30 km. A ground acceleration of 0.41 g was adopted being the largest of the reported near field strong motion measurements (Sharpe et. al. 2000). The resulting predictions of soil liquefaction are shown graphically as the shaded bands in Figure 5.

All three procedures used in this study predict a high risk of liquefaction in shallow, thinly interbedded sands (classified as silty sands by the analysis procedure used herein) between 2 and 3 metres below the surface. The modest thickness of liquefiable materials identified in this CPT sounding (less than 1 m in the first interval), together with the 2 m thick capping of cohesive materials, probably explains the lack of sand boil activity reported.

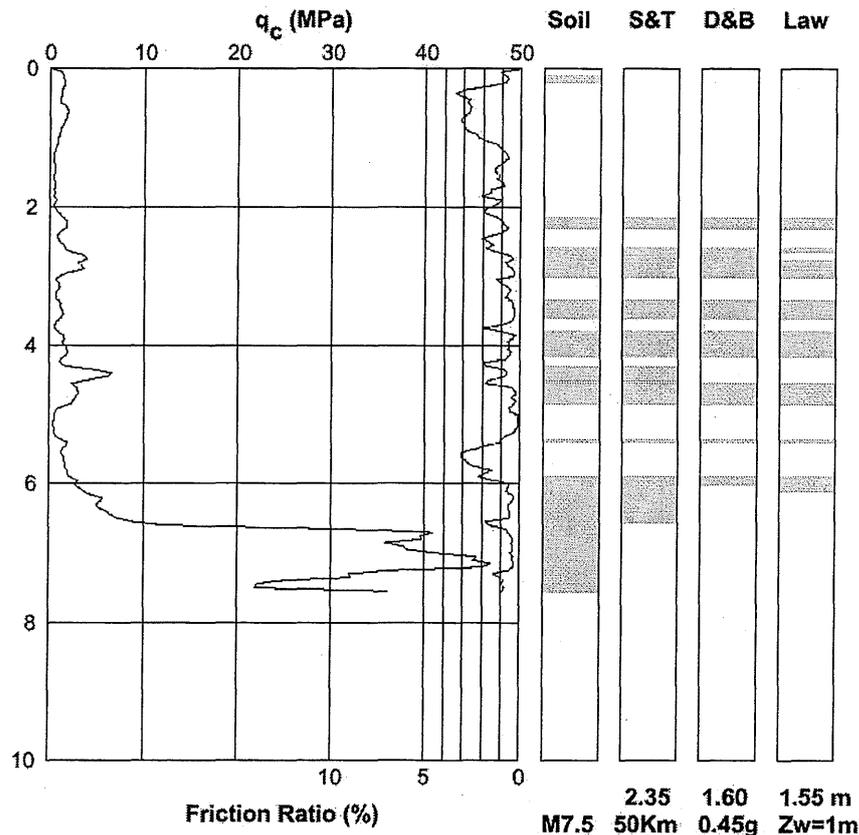
Figure 6. CPT profile and liquefaction assessment for Site 1, Riccarton.
