Engineering & Development

in **HAZARDOUS TERRAIN**

NEW ZEALAND GEOTECHNICAL
SOCIETY 2001 SYMPOSIUM

Hazardous Terrain – An Engineering Geological Perspective

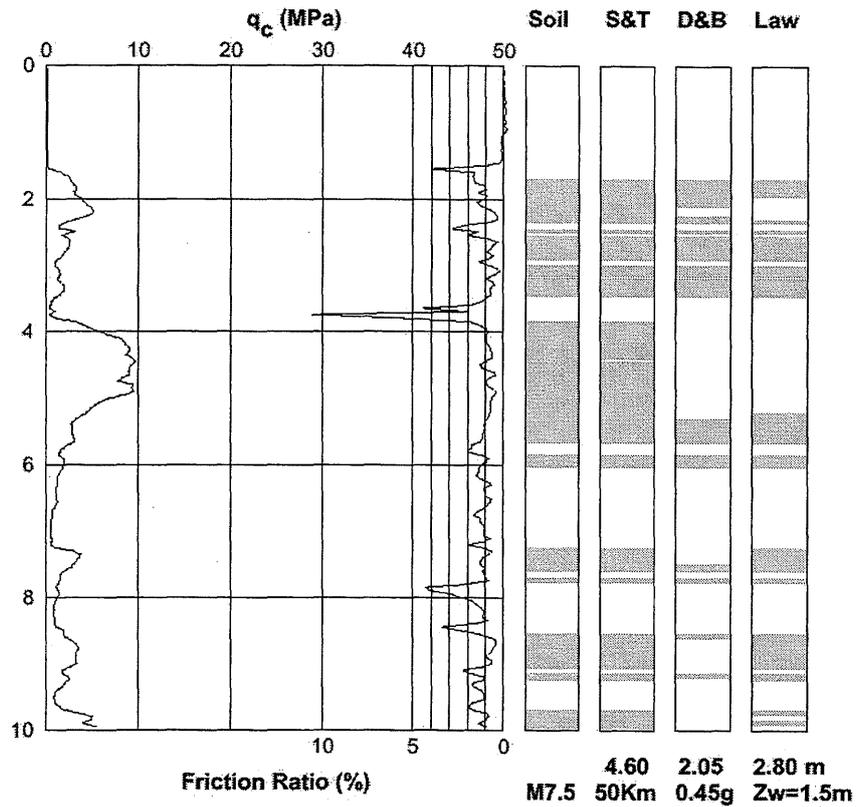
Figure 7. CPT profile and liquefaction assessment for Site 2, Annex Road.

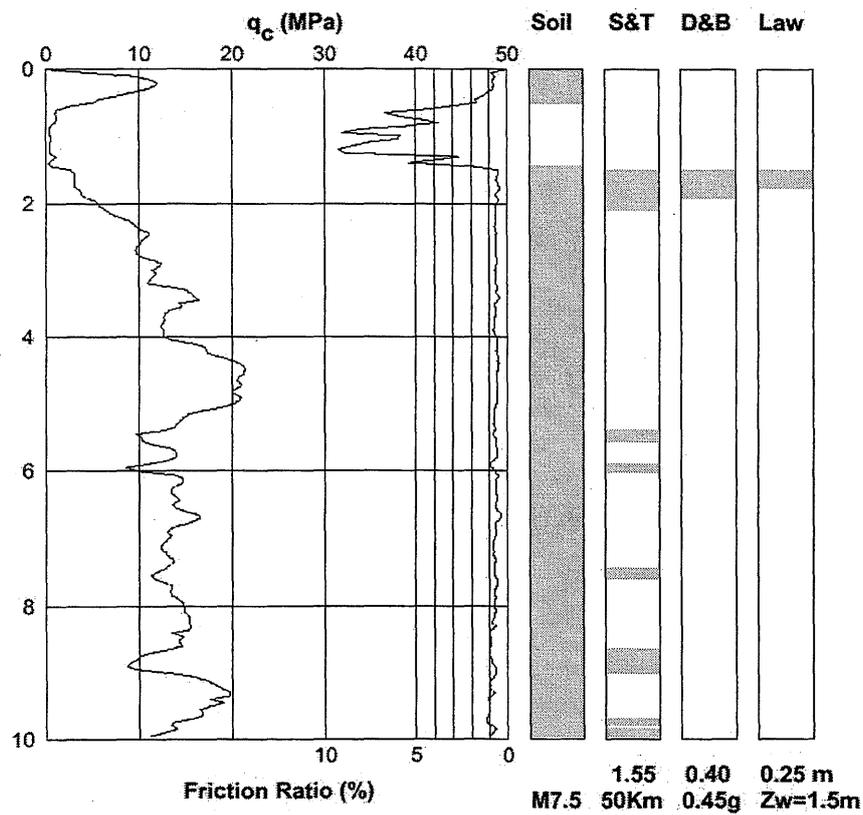
Figure 8. CPT profile and liquefaction assessment for Site 3, Bromley.

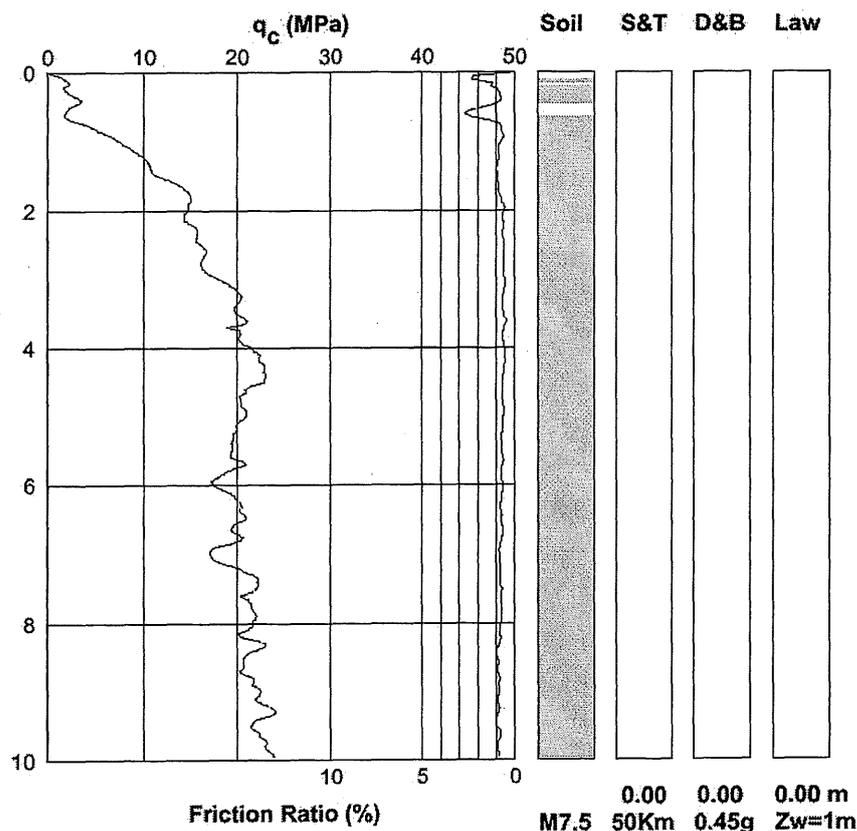
Figure 9. CPT profile and liquefaction assessment for Site 4, Stewarts Gully.

The CPT profile is shown in Figure 9 and indicates 10 m of very dense sand. All three procedures agree that there is little risk of soil liquefaction at this site under the scenario earthquake.

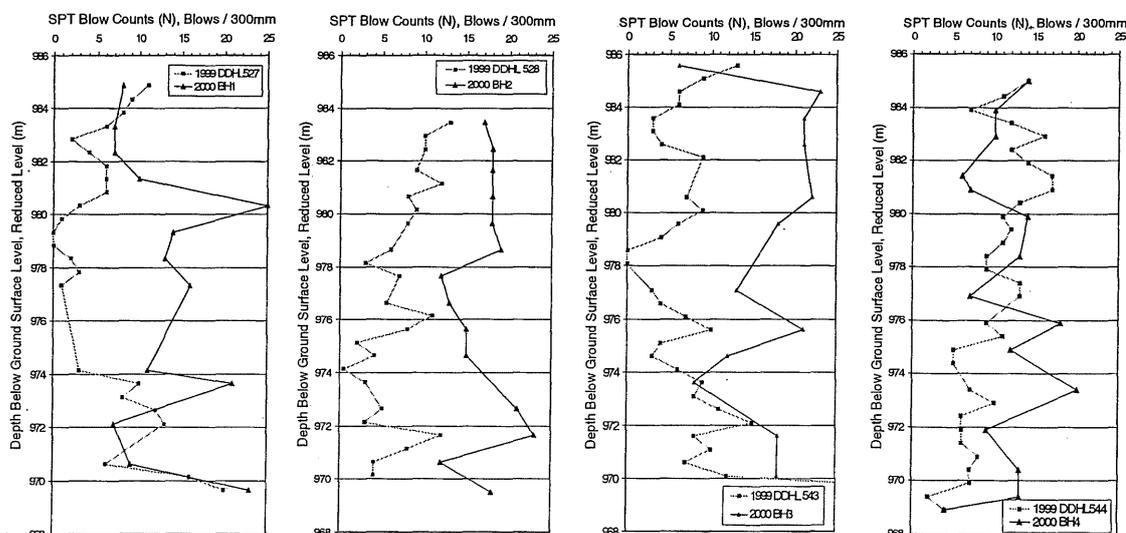
Figure 2. Comparison of SPT N-values recorded at each borehole site in 1999 and 2000.

The SPT measurements recorded in the 1999 and 2000 investigations are plotted against depth in Figure 2.

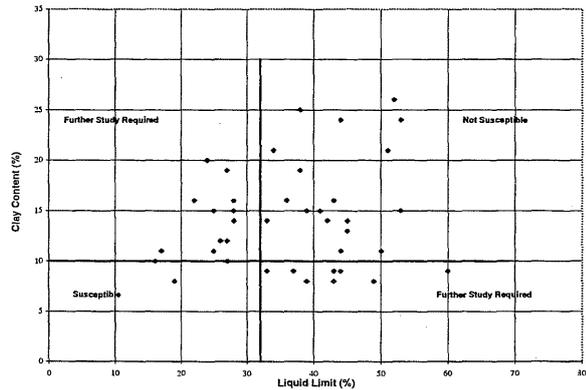
Figure 3. Andrews & Martin (2000) criteria, Unit 3

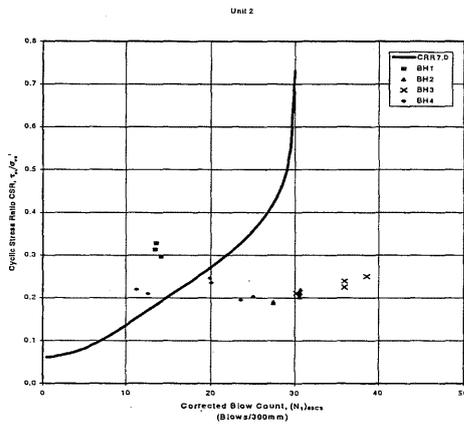
Figure 4. Liquefaction prediction Modified Seed Procedure. 4a Unit 2; 4b Unit 3

The analyses indicate that Unit 2 may liquefy, in particular where looser sand occurs beneath each end of the reclamation (Figure 4a). Unit 3 is unlikely to liquefy in earthquakes with PGA up to 0.4g, but localised liquefaction may occur in earthquakes of 0.45g (Figure 4b).

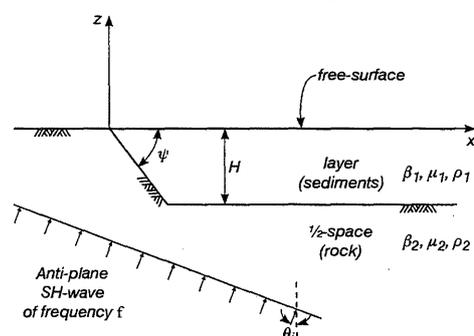
Figure 1. A semi-infinite layer of depth H with various angles of edge-slope overlies a uniform half-space.

The model shown in Figure 1 represents the edge of a basin where soft sediments exist to a given depth, H (typically between 10m and 2km deep), and are bounded below and to one side by a much stiffer basement rock. Both the sediments and rock are modelled as homogeneous elastic solids with a shear wave velocity, β , a shear modulus, μ , and a bulk density, ρ . The shear wave velocity of the sediments typically ranges between 50 and 1000m/s, whereas in the rock the shear waves travel much faster at around 1000-3000m/s.

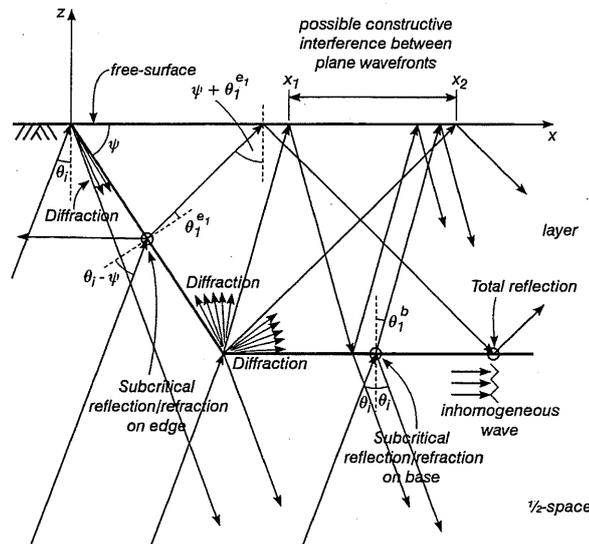
Figure 2. Ray path diagram of wave propagation within the generic model for one possible combination of θ_i , ψ and β_2/β_1 .

What is not so well understood is how the layer responds to seismic input when it is bounded by bedrock on one side. Figure 2 shows a geometrical ray path analysis of refraction and reflection within our model. The processes of diffraction and total reflection are not able to be modelled accurately as they involve frequency-dependent phase changes, yet we can gain a qualitative understanding of their effect.

The incident wave initially sets up three different wavefields within the layer. The first is a near-vertically travelling wavefront that is refracted upward from the base of the layer and which becomes partially trapped within the layer by repeated sub-critical reflection between the surface and the base of the sediments. A second wavefront is refracted or reflected near-horizontally by the edge. This wave front becomes trapped within the layer by total reflection at the base of the soft sediments. Frequency dispersion by total reflection eventually leads to the development of a Love wave propagating away from the edge. A third wave field is generated by diffraction of a small amount of incident energy at the vertices of the edge and enhances the frequency-dependant nature of the response.

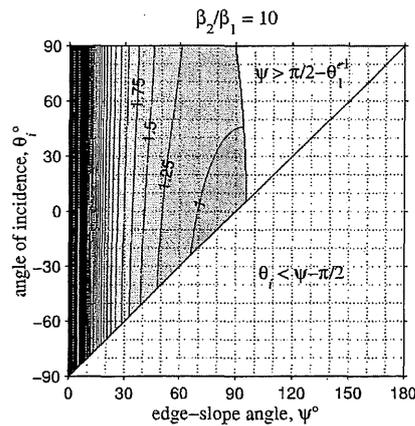
Figure 3. A graphical interpretation of Equation 10 in which contour height represents the distance out from the edge, x^c , of constructive interference between undispersed base and edge refracted waves.

The derivation of Equations 6 to 10 are shown in Adams (2000). Figure 3 shows a graphical representation of Equation 10 for various combinations of angle of incidence, θ_i , and edge-slope angle, ψ . It is apparent that the angle of the edge has significantly more effect on the position of the high-amplitude pulse than does the angle of incidence. In addition, we note that x^c is undefined over a significant portion of the graph where the two undispersed wave fields do not interact.

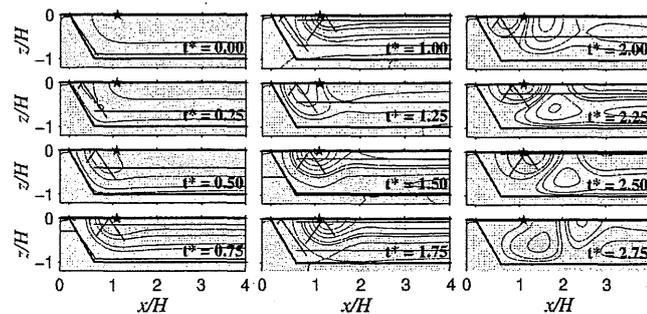
Figure 4. FEM results shown as consecutive frames of contoured anti-plane displacement in the x - z plane. The time variable, $t^* = \beta_1 t/H$, is dimensionless.

Figure 4 shows transient displacement results of a 2-D numerical analysis with the FEM software package, Archimedes (Bao et al., 1998), used to model the propagation of a vertically incident ($\theta_i = 0^\circ$) Ricker wavelet interacting with the normal edge of a soft basin ($\psi = 60^\circ$). The Ricker wavelet (Ricker, 1940) is a triple peaked function containing a range of frequencies up to approximately three times its characteristic (strongest) frequency, f_c . In this example we use a velocity contrast, $\beta_2/\beta_1 = 10$ and a dimensionless characteristic frequency, $f_c/f_0 = 2$, where f_0 is the fundamental vertical frequency of the layer ($n = 0$ in Equation 3).

Overlain on the contoured FEM results is a series of lines showing the position of each of the three peaks in the undispersed Ricker wave field. The position of these lines has been calculated using the ray path analysis described in the previous section. In addition a small

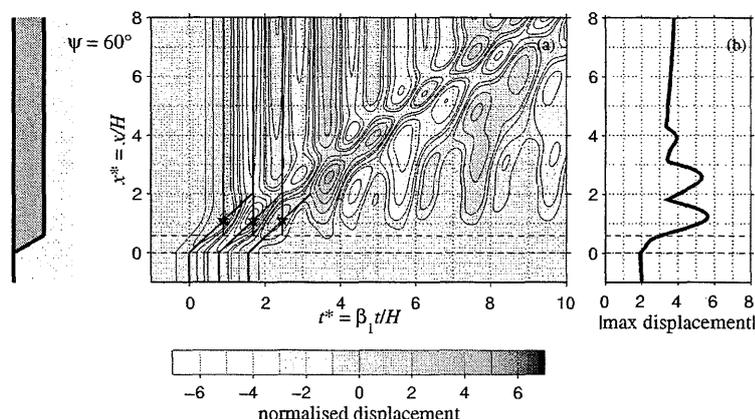
Figure 5. Contours of transient anti-plane displacement on the surface of the FEM model. Peak displacement is shown on the right-hand plot.

pentagram indicates the expected position, x^c (from Equation 10), of constructive interference between undistorted wave fronts on the surface. Since we are most interested in the displacement response on the surface of the model, we can look specifically at this as it changes with time in Figure 5.

FEM contours show clearly the higher amplitude pulses associated with constructive interference some distance out from the edge. In this example, the position of peak displacement calculated by the finite element analysis almost matches that calculated by the ray path analysis of a plane undispersed wave field (Equation 10). While the first peak is undoubtedly the strongest, constructive interference between the horizontally propagating Love wave and vertically propagating SH wave can be seen to occur consecutively across the layer (diagonally across the contour plot in Figure 5). This is a result of repeated vertical reflections of the base-refracted wavefronts, and of the multi-peaked nature of the Ricker wavelet. The position of constructive interference is better related to the velocity of the dispersed wave field and resultant Love wave than the initial edge-refracted pulse.

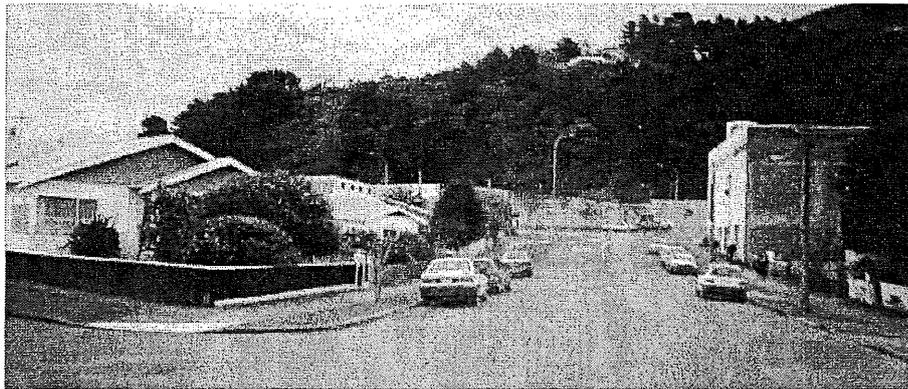
Figure 6. The surface trace of the Wellington Fault in Lower Hutt is indicated by the small rise at the far end of Te Mome Street.

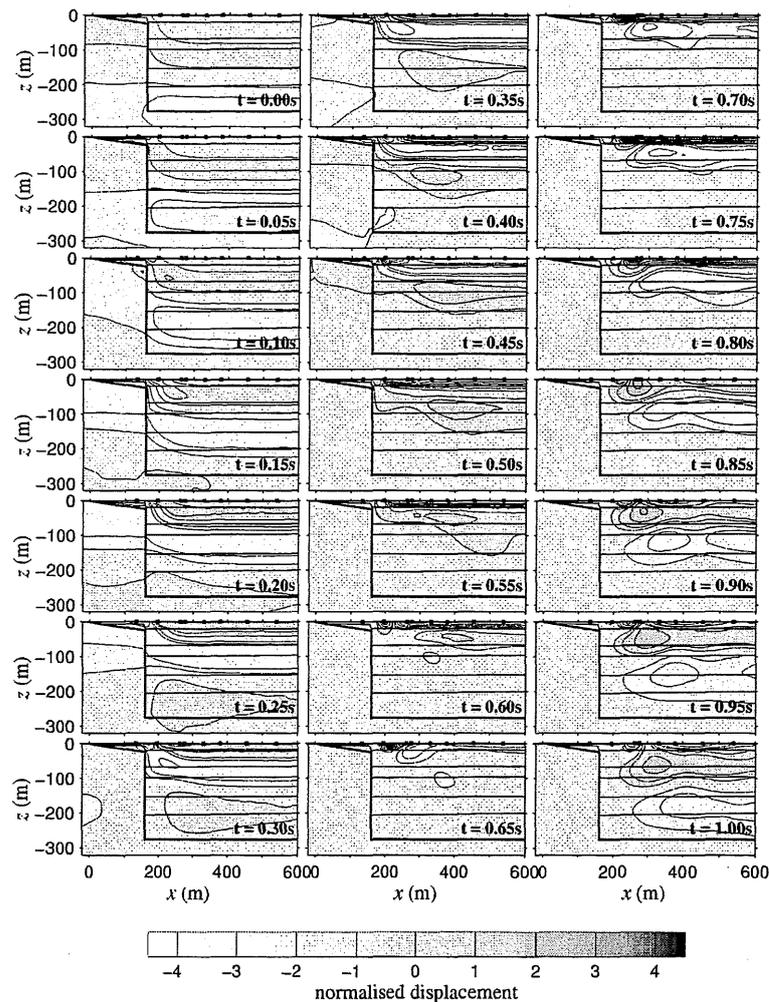
Figure 7. Consecutive frames of edge-parallel displacement computed for the Lower Hutt Valley subject to a vertically incident 2Hz Ricker pulse. Time $t = 0$ occurs when the first peak of the wavelet reaches the surface through the rock on the left hand edge of the model.

Horizontally propagating pulses do not properly form at the shallow edge of the valley ($x = 0$), but rather above the deep vertical edge (at $x = 160\text{m}$). The bulk of the Love wave amplitude travels within the top layer and meets the vertical arrival to generate peak displacement at $x = 250\text{m}$. This process occurs three times, once for each peak of the Ricker pulse. While the geometry of the problem in this example is significantly more complex than

A finite element analysis of Ricker pulse propagation through a 2-D geological model of the Lower Hutt Valley (Adams, 2000) has generated the displacement results shown in Figure 7. The bedrock boundary is shown with the thickest line and the soft sediments have been modelled as six horizontally layered units.

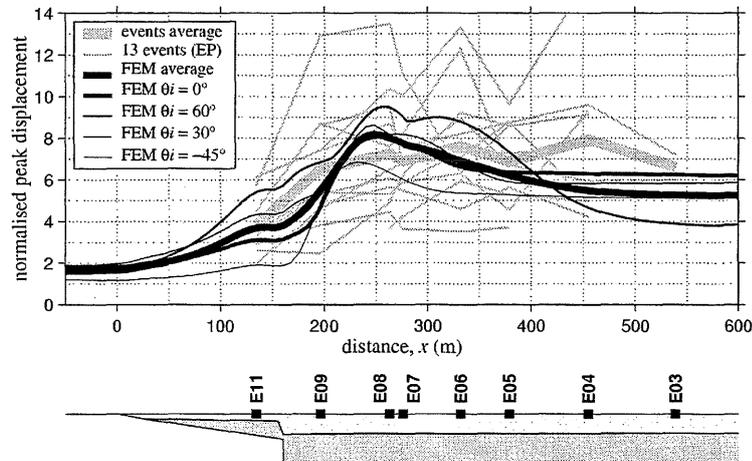
Figure 8. Variation in (edge parallel) peak ground displacement across the array. The locations of 8 recorders (E03-E11) with respect to the valley edge is shown in cross-section on the lower plot.

The general amplitude of average peak displacement is similar, yet the distinct peak in the modelling at $x = 250\text{m}$ is not apparent in the recorded motions. Array data also shows a much wider range of peak displacement than does the modelling for different angles of incidence. Both these observations are, however, not a surprising result considering the variety of input motion in the 13 earthquakes.

An array of seismographs was deployed across the fault bounded edge of the Lower Hutt Valley during a six week period from December 1998 to January 1999 (Osborne, 1999). Normalised peak ground motions recorded on the array have been plotted in Figure 8 alongside the results obtained by the numerical FEM analysis. Results from the modelling have been plotted for four different angles of incidence, while peak displacements from each of the 13 recorded events are shown with a lighter colour.

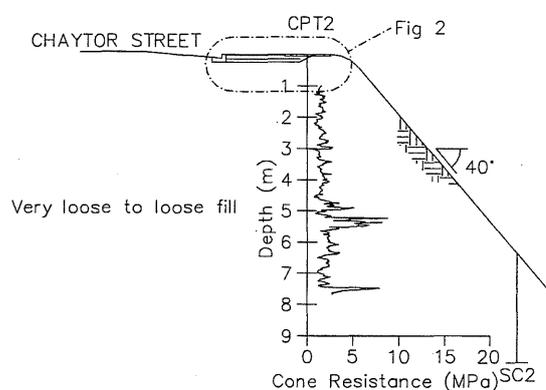
Figure 1: Chaytor Street Section 1 – Sub-surface conditions

An example of a roading instability investigation and remedial solution proposed for Wellington City Council is shown in Figures 1 to 4. The project is in Chaytor Street, an arterial road linking the suburb of Karori to Wellington City Centre. Chaytor Street is constructed as a sidling cut to fill, traversing a steep slope standing at 40 to 60°. The slope forms the western side of a valley overlying the Wellington Fault. The fill depth underlying the downslope footpath varies but is in excess of 30m deep at Section 1 (shown on Figure 1) and 17.8m deep at Section 2 (shown on Figures 3 and 4). Significant cracking has been observed in the footpath at both sections and the outside lane of the carriageway at section 2. Downslope creep movement is likely to be the cause of the cracking.

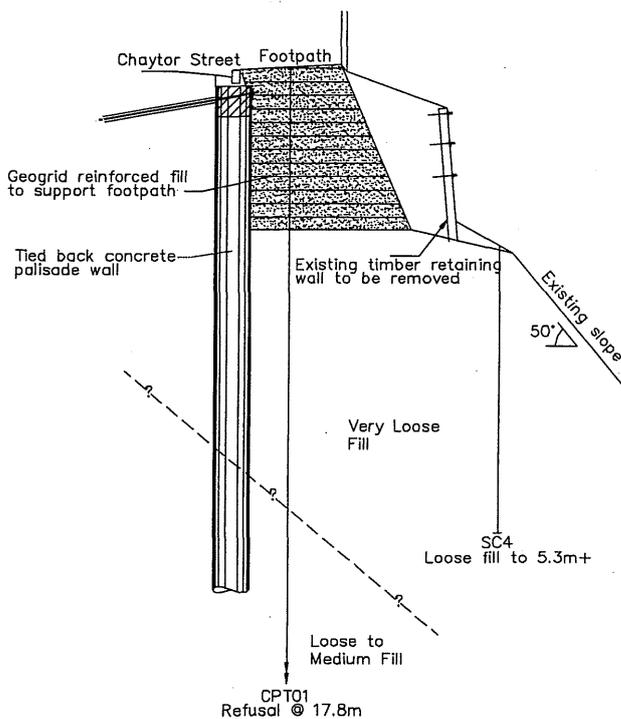
Figure 3: Section 2 Palisade wall and Geogrid reinforcement.

The Client has indicated a preference for a low risk solution for Section 2. Two of several schemes presented to the client are shown in Figures 3 and 4. Shown on Figure 3 is a tied back palisade wall beneath the kerb and channel and a geogrid-reinforced fill supporting the footpath. The conceptual design is designed to support up to 7m of loose fill under an ultimate seismic loading. The geogrid-reinforced fill (and footpath) is likely to undergo significant deformation under this seismic load.

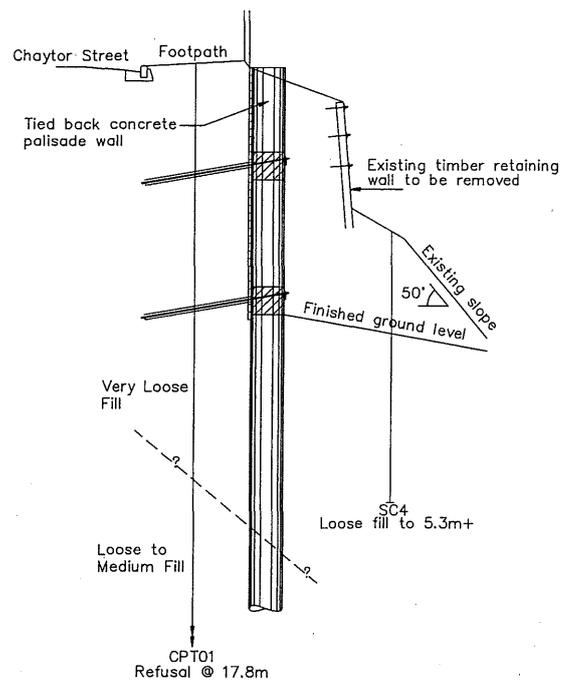
Figure 4: Section 2 Palisade wall only

A second conceptual alternative for Section 2 is shown in Figure 4. A tied back retaining structure positioned on the downslope edge of the footpath is designed to provide support to both the carriageway and footpath under ultimate seismic loading. Reducing the risk to the footpath (using the more secure Figure 4 design) is likely to increase the construction cost of remedial works by approximately one third. The client will need to consider if a higher risk for the footpath is acceptable.

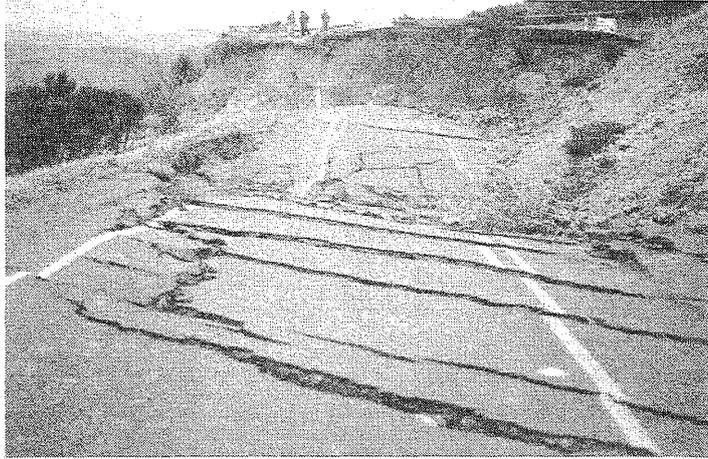
The initial slip (Stockman's I) occurred on 8 July 1998 when a 120m-150m section of SH3 dropped 5m (Figure 2) as adjacent land on the eastern side of the road slipped downslope immediately closing the road to traffic. A temporary controlled single lane diversion was

Figure 2: Stockman's Hill: 8th July 1998

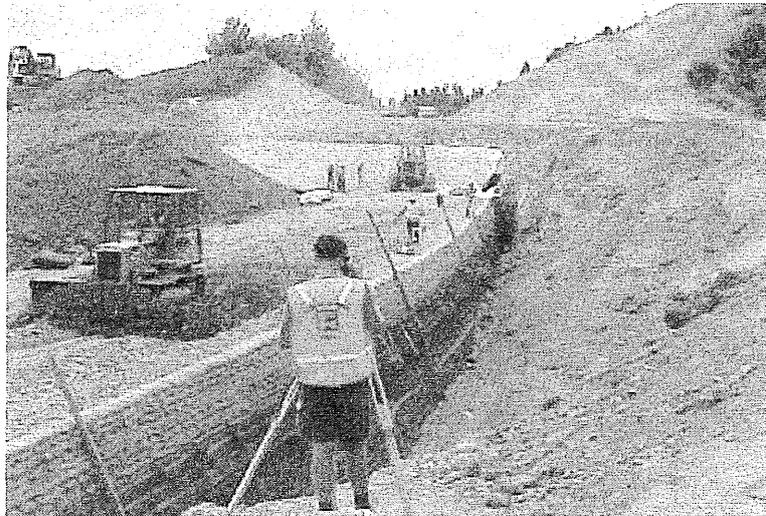
Figure 5: Stockman's I under construction

The excavations at Stockman's I revealed suitable founding materials at generally higher levels than assessed during the design phase. The criteria for the foundation was the absence of fracture clay infill/lining and no visual evidence of weathering along the fractures. This was achieved by taking the excavation down in a series of benches until the criteria was fulfilled. Thereafter the MSE wall was constructed back up to road pavement level (Figure 5).

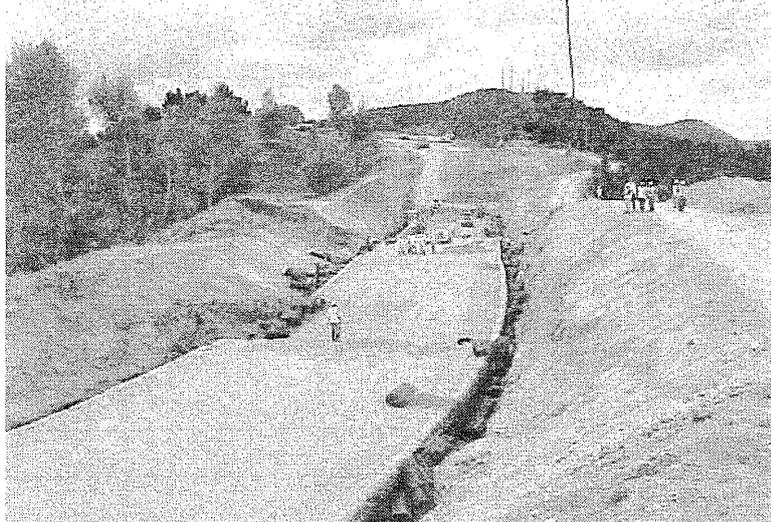
Figure 6: Stockman's II under construction

At Stockman's II (Figure 6) the founding levels were generally as assessed during the design phase, although two areas did require deeper excavation to achieve the approval criteria. Whilst this did not affect the wall as designed since allowance for deeper excavation was made, it did cause concern for the quantity of geogrids required. Being sourced from the UK, any major increases in grid quantities would result in long delays or high delivery costs if shipped by air.

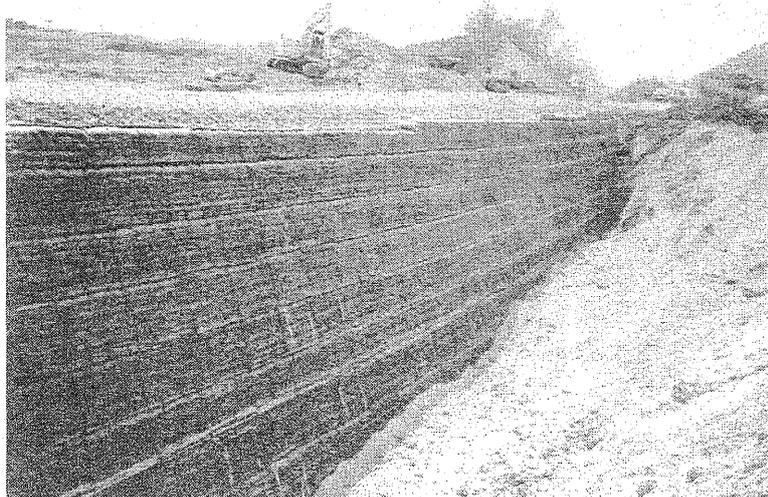
Figure 7: Completed Stockman's I prior to 'backfilling'

Following construction of the walls the adjacent weak soils and spoil were placed against the walls such that the full height of the walls is no longer visible (Figure 7). This was not necessary for the stability of the wall, which was designed to be fully free-standing with no lateral support, but was needed to return the land to contours similar to that prior to commencement of the works.

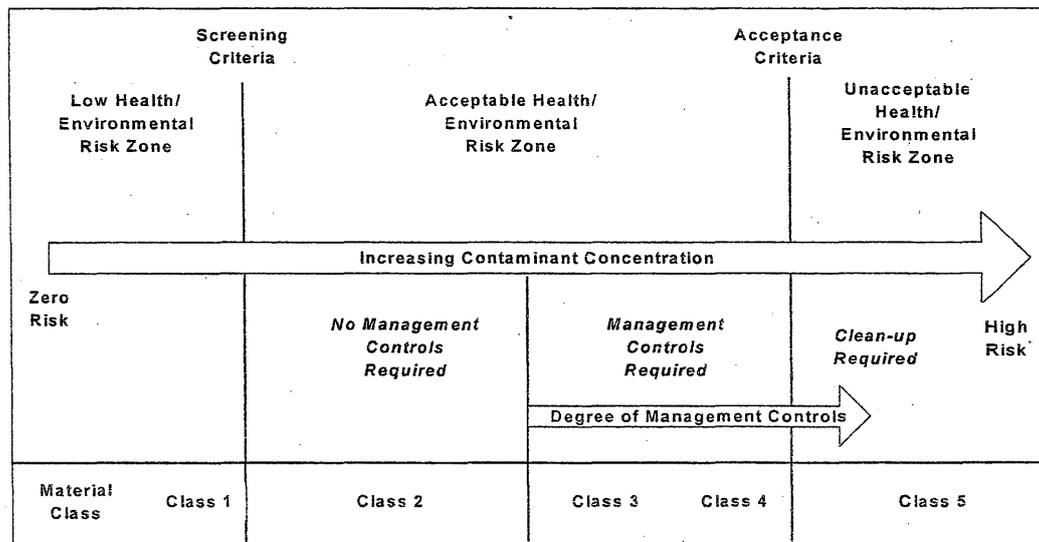
Figure 1. Risk Approach to Contamination Identification and Management

The clean up criteria were developed on the basis that the base-line criteria which represented a very low risk to all site users and the environment be Screening Criteria. Above these Screening Criteria was a zone where acceptable risks were achievable with the implementation of management controls. The upper limit of this zone became the threshold for material that was disposed of to the on-site repository (Acceptance Criteria). The approach is shown diagrammatically in Figure 1.

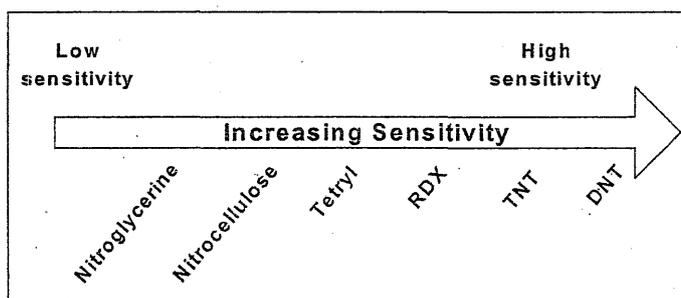
Figure 2. Sensitivity of explosive compounds present on site

Understanding the types of explosives that may be present was important in completing the review due to the various sensitivities associated with those explosives. Sensitivity for the purposes of the risk assessment was defined as the ease with which an explosion could be caused by the remediation activities due to the presence of residual amounts of these chemicals. The order of sensitivity of these explosives from highest to lowest is shown in Figure 2. The higher sensitivity explosives could be detonated by impact alone while the lower sensitivity explosives were more likely to require a more intense source of ignition.

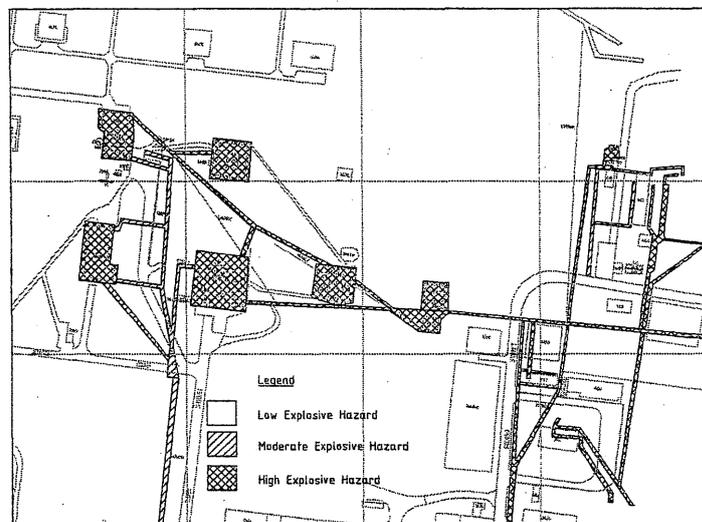
Figure 3. Example of an explosive hazard map

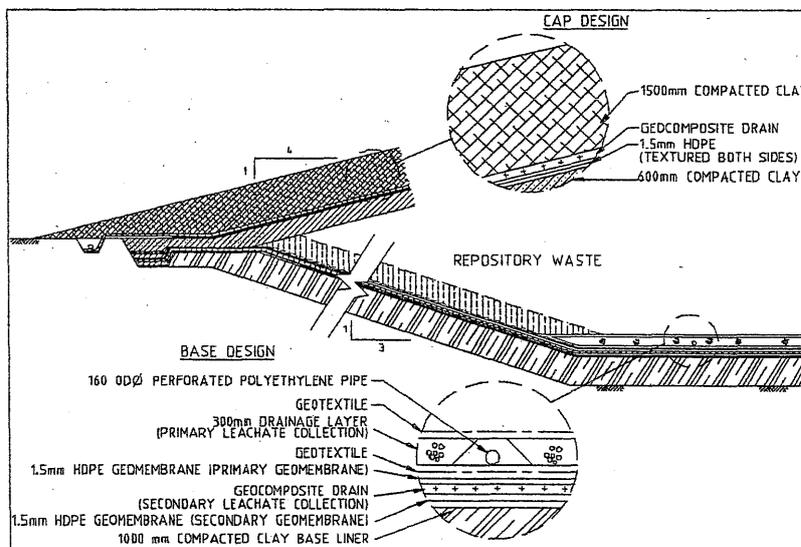
Figure 4. Repository liner and cap design

The design included a requirement for stringent quality assurance program during construction and a provision for on-going post-closure management including groundwater and leachate monitoring.

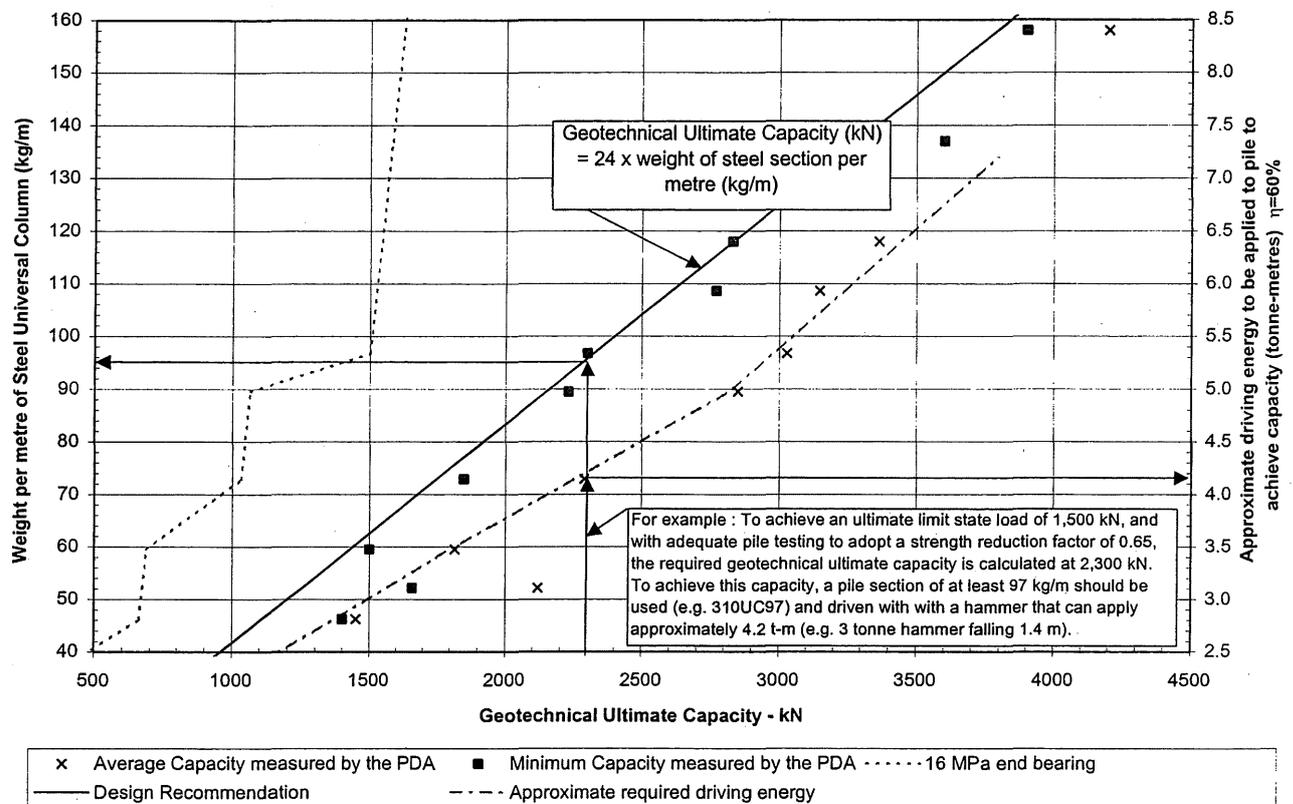
Figure 1 : Capacity of Driven Steel Piles within ECBF "bedrock"

Figure 1 shows the geotechnical ultimate pile capacity for all steel piles dynamically tested by the author and founded in the ECBF “bedrock”. For comparison, this graph also shows the ultimate pile capacity if a design end bearing capacity of 16 MPa was used. The results show that for larger pile sections, the pile is able to be embedded further into the ECBF “bedrock” mobilising an increased capacity due to increased length of skin friction and embedment into less weathered rock. The use of an increased pile size also requires an increase in the driving energy - either hammer weight or drop height.

An indication of the applied energy needed for each pile type to achieve the capacity indicated in Figure 1 has been undertaken using a wave equation analysis programme (Goble et al, 1997). The pile model consisted of a 15 m long section, with no cushioning for either the hammer or pile and a hammer efficiency (η) of 60%. Confirmation of the hammer weight, drop height and section size to achieve the required ultimate geotechnical capacity without overstressing the pile during driving will need to be undertaken for each site.

From Figure 1, the following formula (equation 1) provides a lower level of the ultimate capacity of steel piles driven into the ECBF "bedrock".

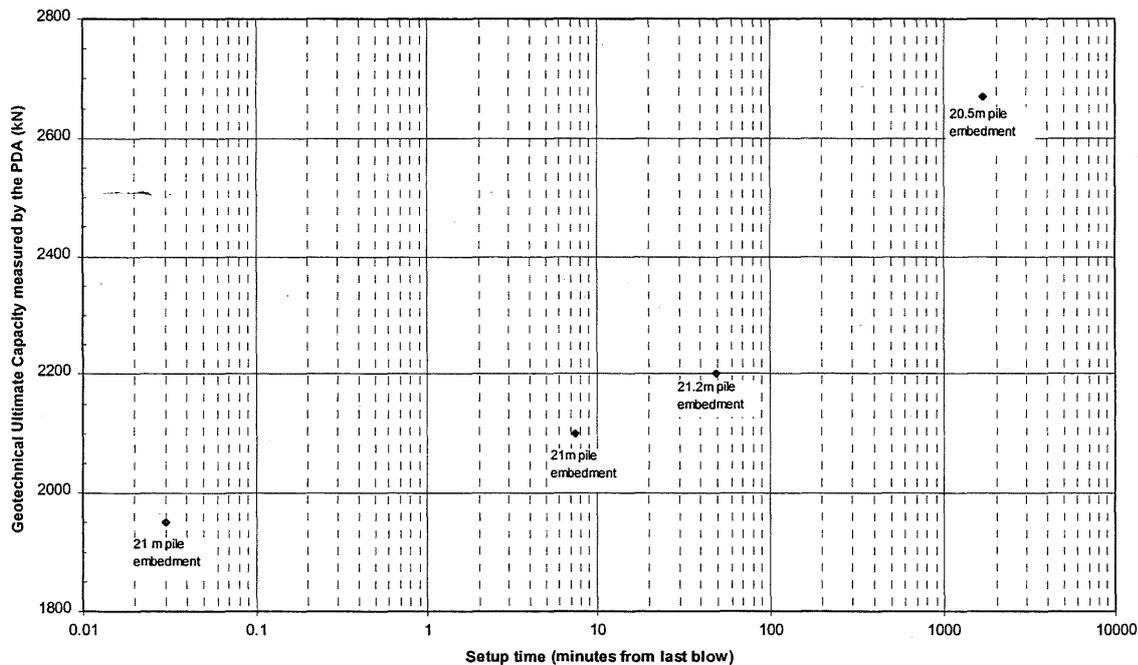
Figure 2 : Pile (310UC97) capacity increase with time within ECBF

Two examples of pile set up occurring with driven steel piles are shown in Figure 2 (founding in ECBF “bedrock”) and Figure 3 (founding in alluvial/aerial volcanic deposits). These figures indicate that pile capacity increases significantly with time. For the two piles tested, the pile embedded in the ECBF exhibited a 42% increase in capacity and the pile embedded in the volcanic deposit exhibited a 417% increase in capacity.

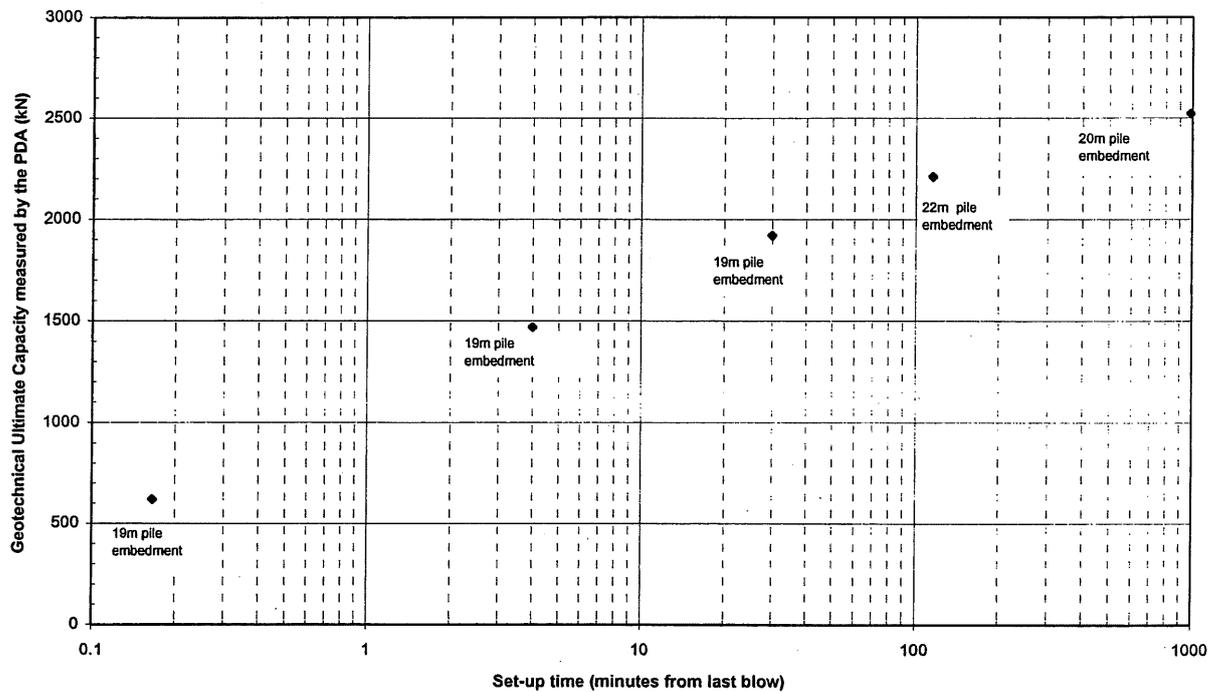
Figure 3 : Pile (310UC97) capacity increase with time within volcanic deposits

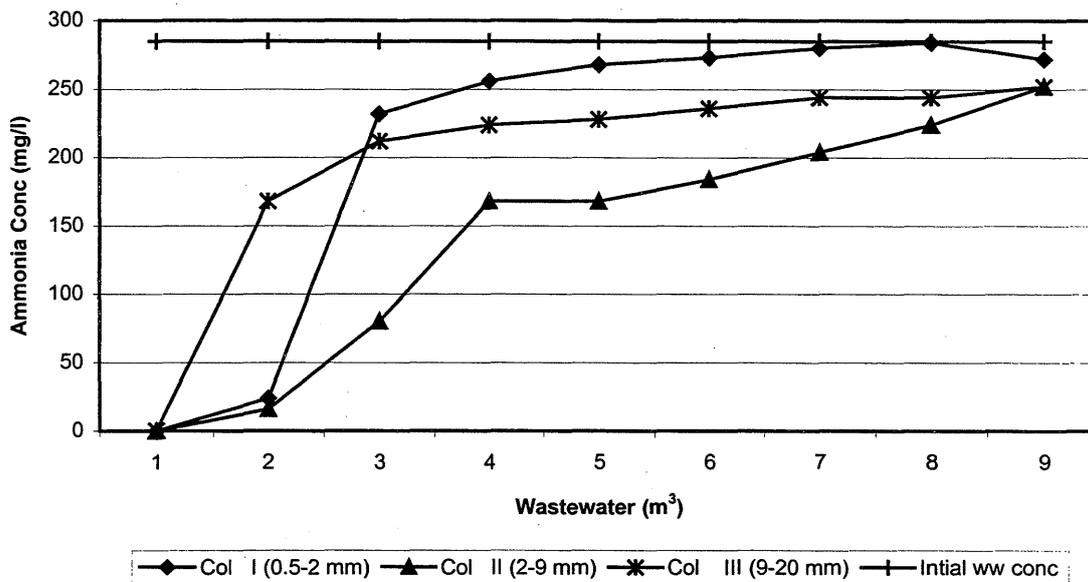
Figure 1: Ammonium absorption by Ngakuru zeolites. Three size fractions are analysed.

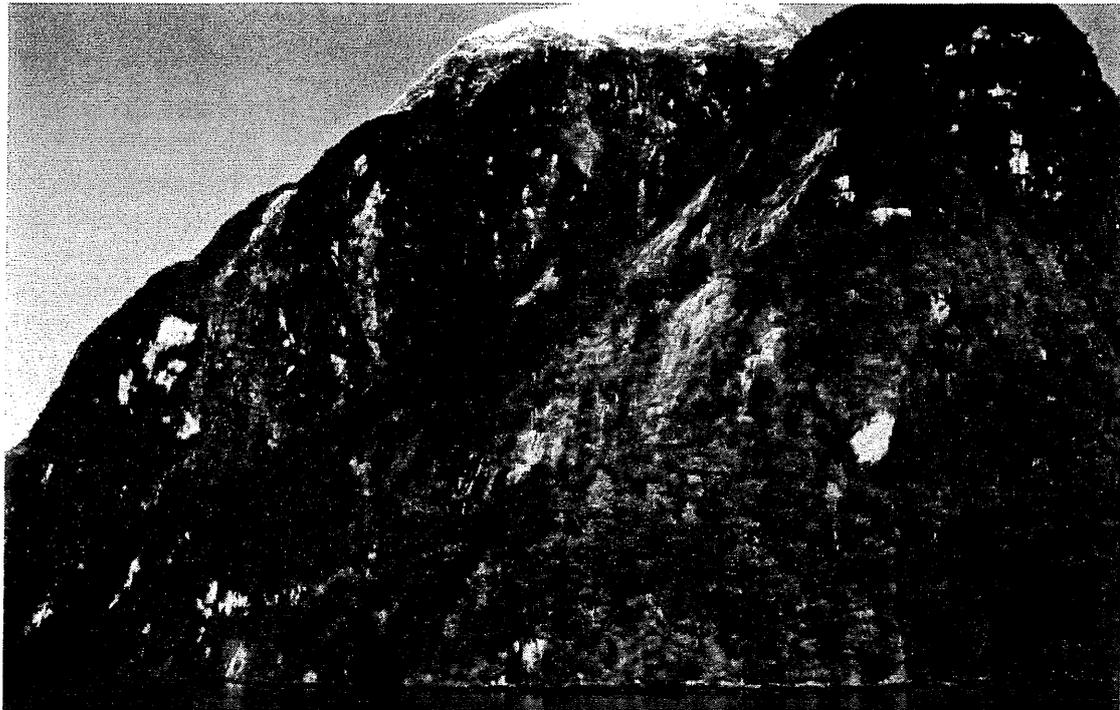
Figure 2 Typical slope in study area (Commander Peak) showing scars resulting from treeslides of different ages.

Treeslides observed during the study are characterised by long narrow strips of bare rock where the vegetation, soil and often some rock has been removed as a rapid landslide (Figure 2). The high rainfall, thick vegetation, competent underlying rock and very steep slopes in Fiordland are conducive to this type of failure.

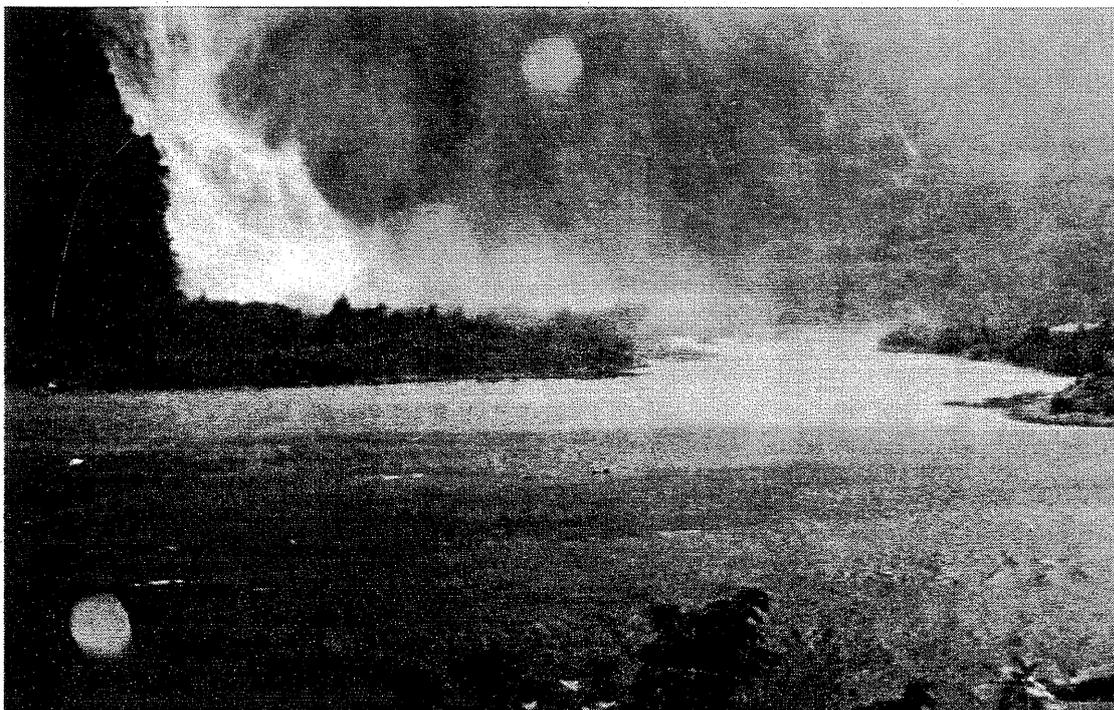
Figure 3 Plume of dirty water and debris resulting from discharge of floodwater from Helena Falls into Doubtful Sound. The sediment source is the Helena Falls treeslide which occurred in March 1998. *Photograph by Alan Crowther – Meridian Energy Limited*

Slide	Date	Estimated Volume	Comment
Helena Falls (Figure 3)	21 March 1998	25 000 m ³	Sediment observed entering Deep Cove
Marble Creek (Figure 4)	6 February 2000	17 000 m ³	Sediment observed entering Deep Cove via Tailrace
Lyvia	June 2000	6400 m ³	Sediment observed entering Deep Cove via Lydia River

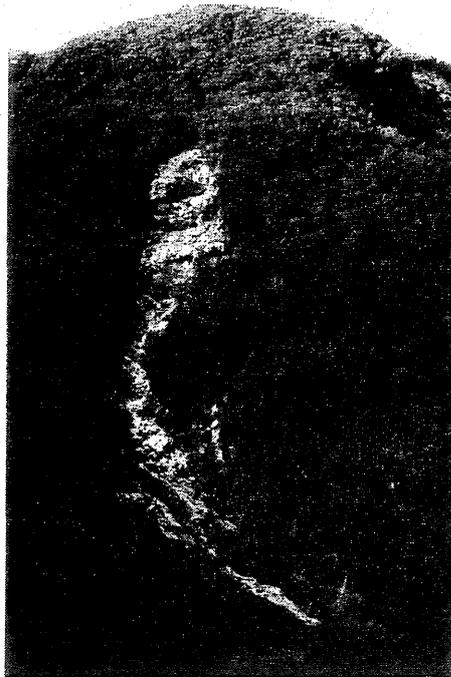
Figure 4 Marble Creek slide of 6 February 2000

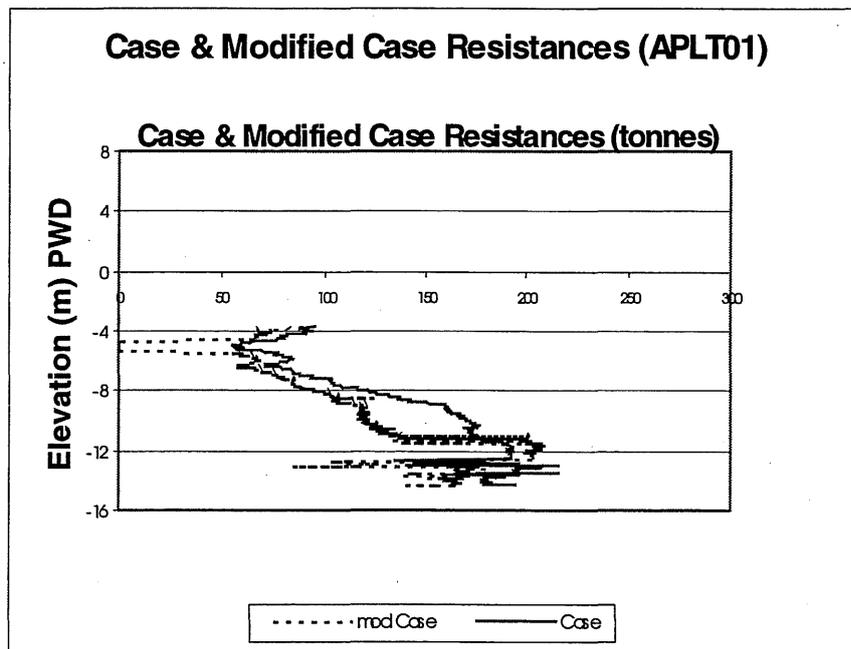
Figure 1. Case resistance versus depth – APLT01

The modified Case resistance is a modified version of the original Case method. In the figure above, local maximums of the Case and the modified Case resistance occur at PWD -4 m, -6 m, and -12 m, indicating that there is a favourable founding layer that provide a high bearing capacity at these levels. Similar trends were observed in the other APLT's as well. A 12m pile driven from the ground level of PWD +8 m would be founded at PWD -4 m, which is a favourable founding level. The above figure indicates that the 12 m pile founded at PWD -4 m would have approximately the same capacity as a 15 m pile founded at PWD -7 m.

The PDA generates a plot of the Case method pile capacity versus depth. One can identify favourable soil layers that provide a good end bearing capacity by observation of this Case method pile capacity plot. It was decided that a 12 m test pile would provide a sufficient capacity following inspection of the Case capacity plot for APLT01-05. To demonstrate this point, the Case pile capacity plot for APLT01 is shown below.

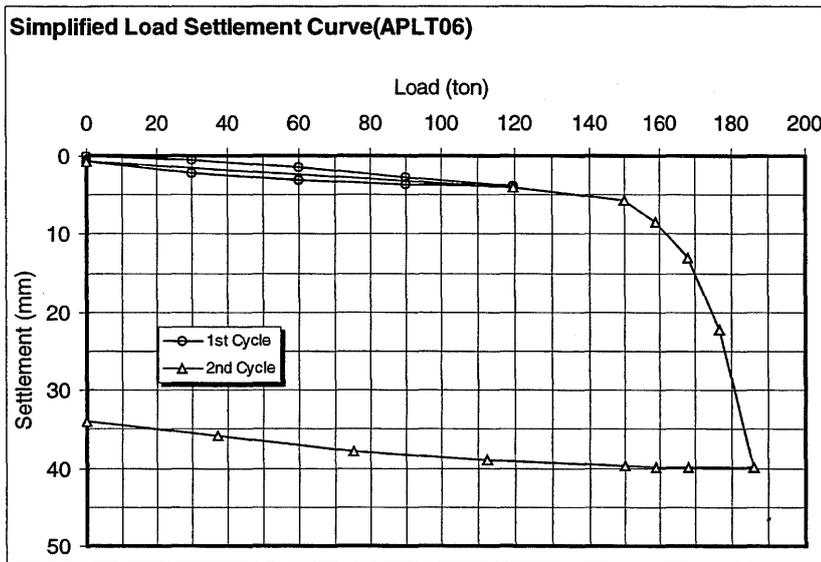
Figure 2. Load-displacement curve for APLT06 (Main Power Block)

By inspection of the above figure, the estimated settlement of a 12 m pile in the improved ground carrying a design working load of 800 kN is 2-3 mm. Similarly, the settlement of a Substation pile under the design working load was estimated from the load-displacement curve of APLT02 (Fig. 3). It was found that the expected settlement of the Substation pile was also less than 5 mm. Settlement of less than 10 mm is generally considered acceptable.

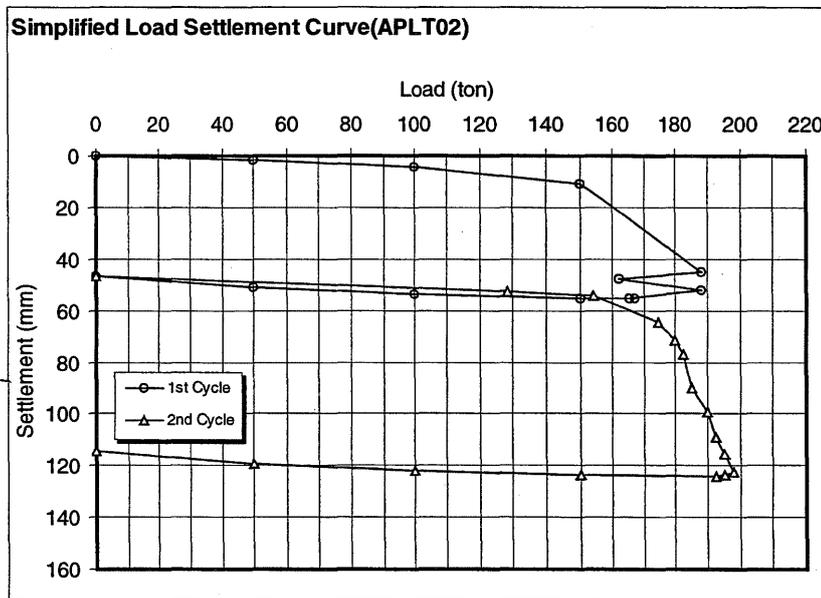
Figure 3. Load-displacement curve for APLT02 (Substation)

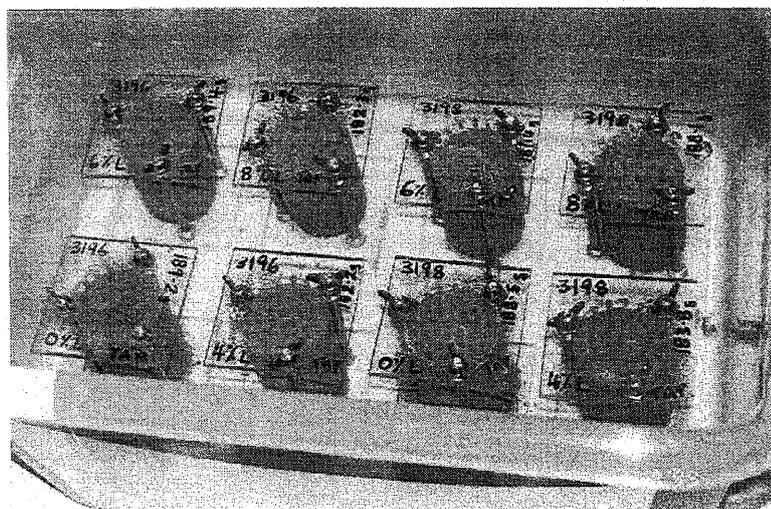
Figure 1 Specimens immersed in water

Initially, both samples were subjected to standard compaction tests to determine maximum dry densities and optimum moisture contents. Two series of soil specimens were stabilised with 0%, 4%, 6% and 8% hydrated lime and remoulded to 98% standard compaction in cylindrical specimens, 50mm diameter and 100mm long. The specimens were positioned vertically in prefabricated frames for safe handling. Both series of specimens were cured at room temperature under plastic cover, for a period of 24 hours before being fully immersed in Sydney tap water (SW) and in local water (LW) respectively (refer to Figure 1). To simulate dry and wet site conditions, the specimens were kept in water at a temperature of $15^{\circ}\text{C} \pm 2^{\circ}\text{C}$ for a duration of 3 days. Then they were removed from the water, cleaned of any eroded soil particles at the base plate of the frame, weighed and their physical conditions recorded. The specimens were left at room temperature for 6 hours before transferring them to an oven. The specimens were kept in the oven at a temperature of $43^{\circ}\text{C} \pm 5^{\circ}\text{C}$ for a duration of 3 days. Selection of the oven temperature was based on expected maximum temperature in the evaporation pond area. The specimens were then removed from the oven and weighed after cooling, and their physical conditions recorded. This was repeated for seven wet and dry cycles with duration of 2-4 days in each cycle. The total duration of testing was 23 days.
