Engineering & Development

in **HAZARDOUS TERRAIN**

NEW ZEALAND GEOTECHNICAL
SOCIETY 2001 SYMPOSIUM

Hazardous Terrain – An Engineering Geological Perspective

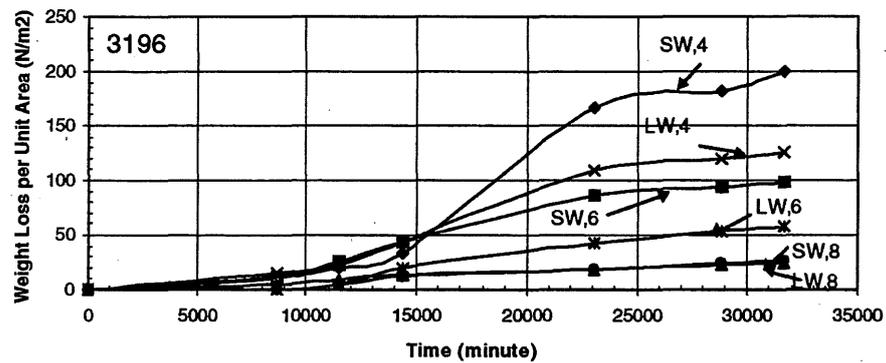
Figure 2 Weight loss per unit area for specimen 3196.

Apart from the bottom of the specimens, erosion occurred from the top and circumference of the cylindrical specimens. Considering that any error in water content measurement causes error in estimating the initial dry weight of the specimen, which in turn causes error in weight loss, saturated weights of specimen were used in the interpretation of test data. Based on the initial void ratio, dry and saturated densities of the specimens, and saturated weights at the end of each wet cycles, an equivalent cylinder height and surface area for each specimen was calculated. The initial saturated weight of the specimen is calculated by measuring the initial water content, wet weight, void ratio and degree of saturation of the specimen. The amount of erosion (weight loss) was defined as the difference between the saturated weights of the specimens after each wet cycle. The weight loss per unit surface area for both samples plotted versus erosion time is presented in Figures 2 and 3. Please note that both specimens with 0% hydrated lime collapsed within few hours during first wet cycle and are therefore not shown in the figures. In the figures, SW and LW denoted for Sydney water and local water, and numbers 4, 6, and 8 denoted for specimens stabilised with 4%, 6% and 8% hydrated lime respectively.

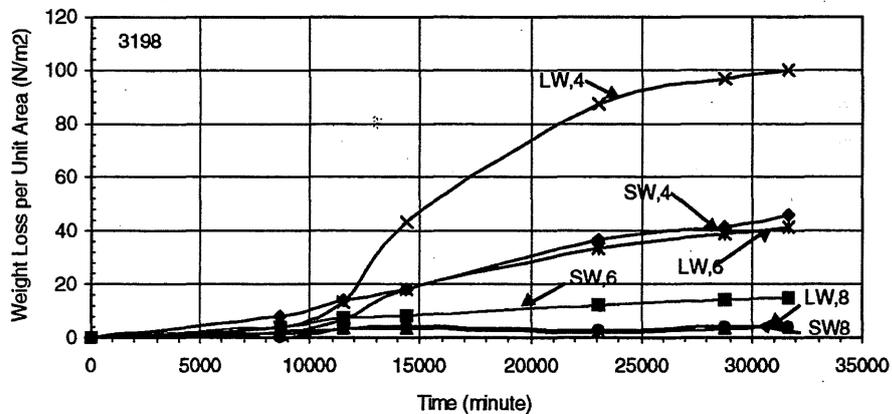
Figure 3 Weight loss per unit area for specimen 3198.

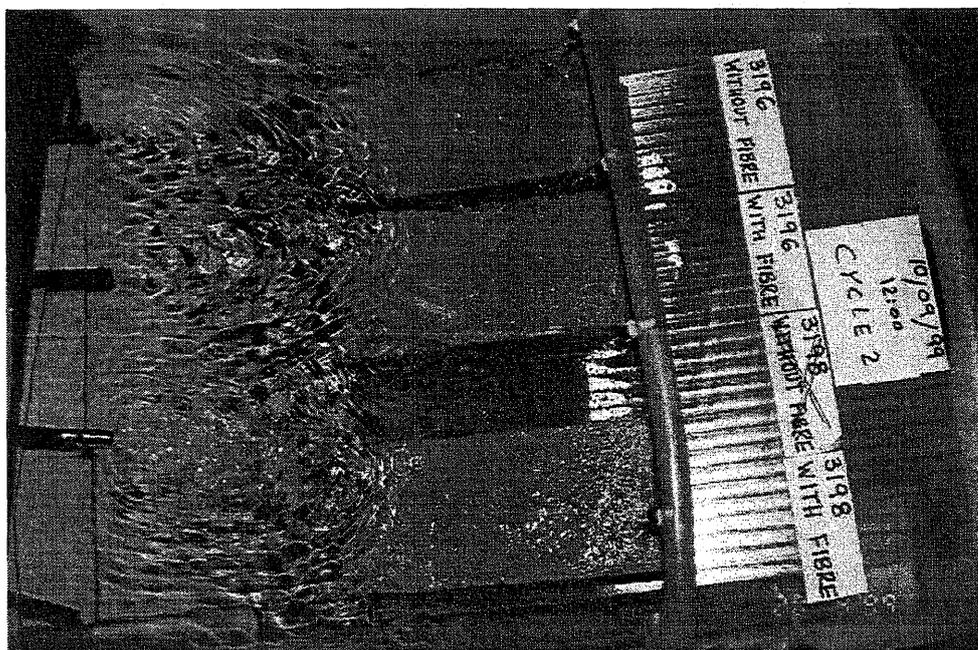
Figure 4 Specimens partially immersed

Based on Stage 1 test results a minimum of 8% hydrated lime was selected for soil stabilisation. Two series of specimens were made, denoted with NF and WF for no fibre and with fibre respectively. Straw fibres selected for reinforcement were approximately 2.8% by weight, with aspect ratio of 15-20 (ratio of length to diameter). The straw fibres were soaked in Sydney tap water for 3 days, before preparation of the specimen. The soil samples were mixed thoroughly with 8% hydrated lime and 2.8% straw fibres and formed into a brick specimen of approximately 205mm x 85mm x 63mm. The densities achieved were 98% standard compaction. The specimens, were cured at room temperature under a plastic cover for 24 hours before partially immersing in LW at temperatures of $17^{\circ}\text{C} \pm 2^{\circ}\text{C}$ for a duration of 6 days. A pump operating at 400-600 l/h was selected to circulate water and simulate wave action. The specimen was partly immersed, and partly water sprayed, and was considered to be saturated within 2-3 days (refer to figure 4). The procedures adopted are identical to those described in Stage 1. Six wet and dry cycles with varying duration of wet and dry cycles were repeated for a total duration of 74 days.

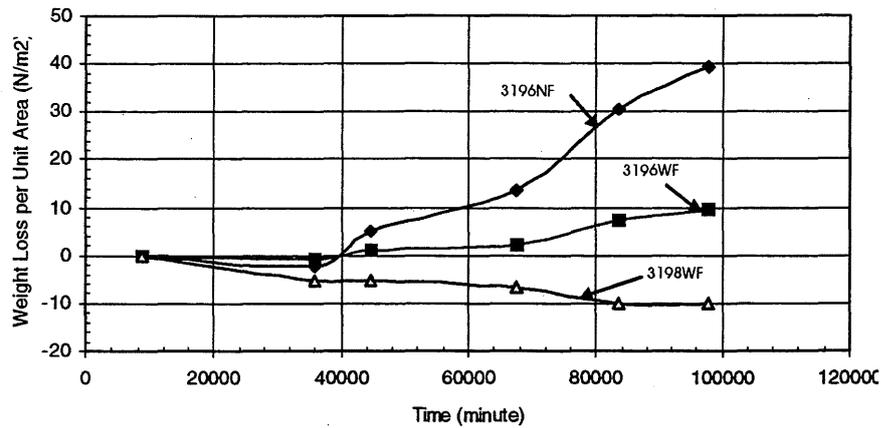
Figure 5 Weight loss per unit area for specimens partially saturated.

The weight loss of the specimen per unit surface area was plotted versus erosion time, and is presented in Figure 5. Please note that the specimen 3198NF failed during handling after the first wet cycle and is not shown in the figure. Specimen 3198WF failed after 6 wet and dry cycles (74 days).

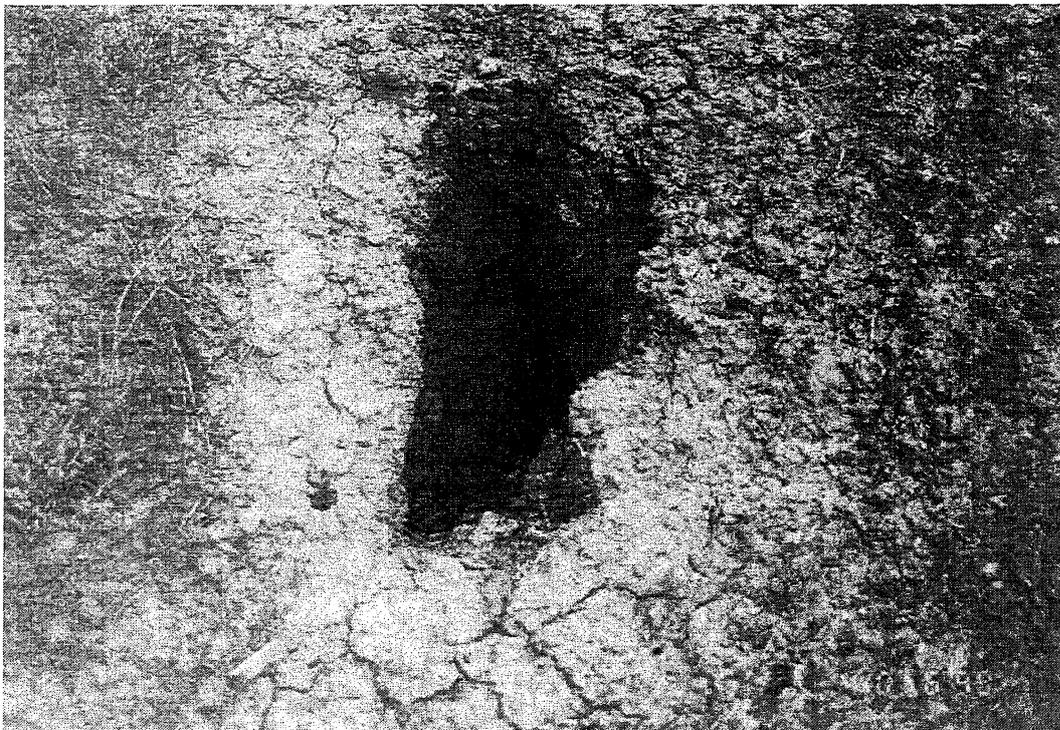
Figure 6 Internal erosion

Pinhole tests indicated "Non-Dispersive" ND1 category for all specimens apart from sample 3196 in Sydney tap water which yield a "Possible Dispersive" PD2 category. The above results indicate that both samples are non-dispersive. It should be noted that physical tests are unable to identify dispersive soils when free salts are present (refer to Section Dispersive Soil). However, laboratory test results on the compacted soil samples immersed in water indicated that non stabilised soil specimens were eroded and completely failed within first wet cycle in SW and LW. Therefore, both samples should be considered as dispersive and erodible. It should be noted that, highly dispersive soils are also highly erodible. The erodibility of a soil depends also on the salt concentration of the eroding fluid, decreasing with an increasing salt concentration. It is expected that dispersion/erosion due to rain should be higher than erosion due saline water. In the investigation of the evaporation pond, stormwater runoff has formed very deep erosion channels along the embankment crest and down the batter slope. This has resulted in internal erosion of the batter and crest at many locations (refer to Figure 6).

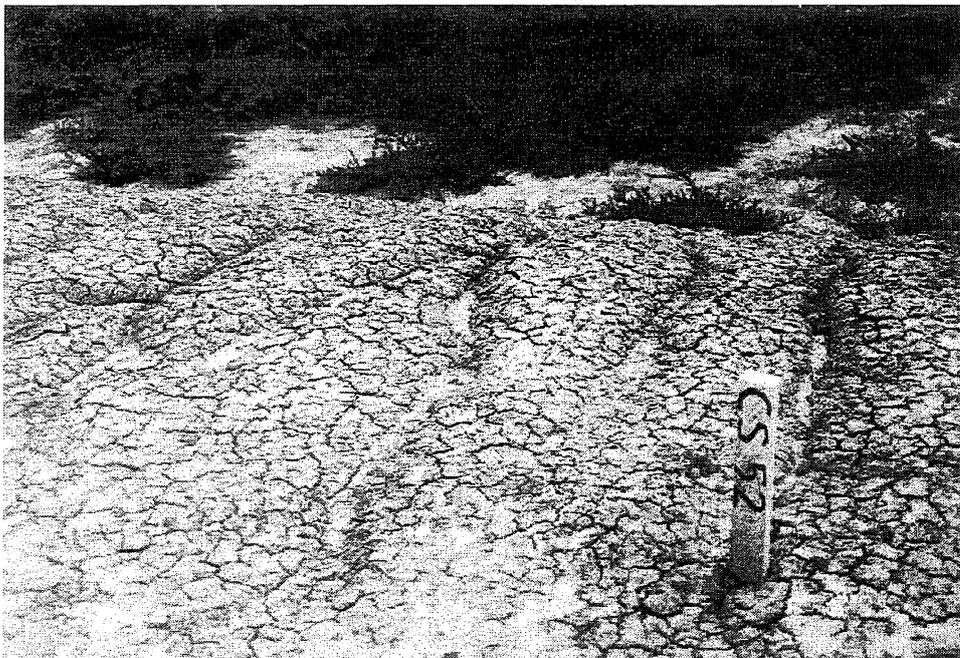
Figure 7 Surface erosion

Erosion for both specimens stabilised with 4% and 6% hydrated lime is linear within short-term (within first cycle) and non-linear within long-term. The reason for non-linearity can be explained by analysing specimen conditions during wet and dry cycles. It was observed that horizontal and vertical micro cracks were apparent during first dry cycle at the top edge of the specimens. These cracks were spreading and deepening during successive cycles, until vertical and horizontal cracks joined together to form rectangular blocks. These blocks collapsed in a form of soil lumps and removed during the next cycle. This condition is similar to that observed on site (refer to Figure 7).

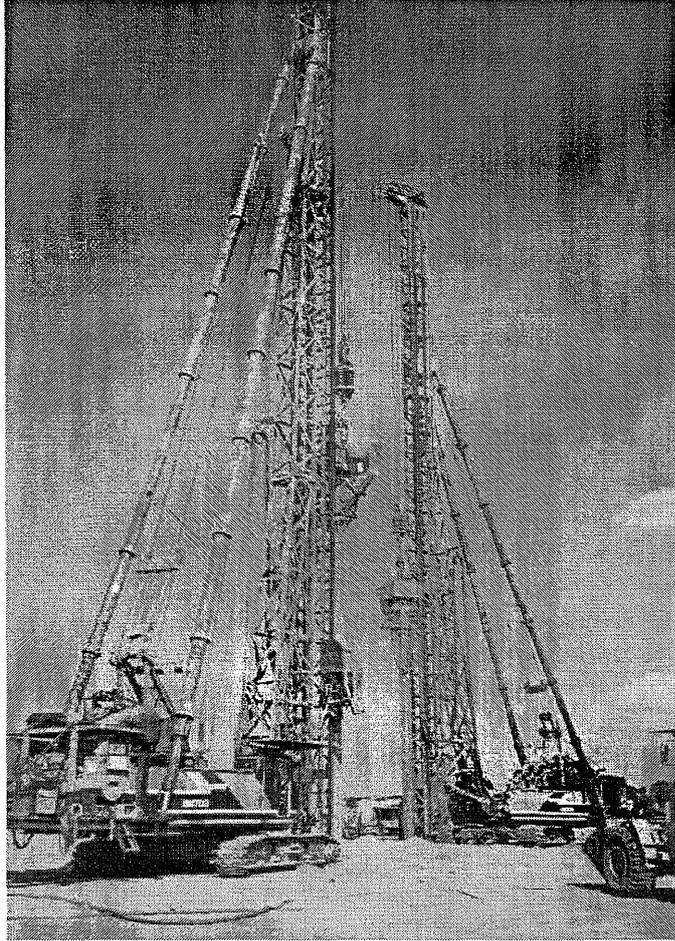
Figure 1. Sand Compaction Piling Rigs

Sand Compaction Piles are installed to increase the relative density of sandy soils, which decreases the potential for liquefaction. SCP places and compacts sand into the ground by vibration. The initial installation of the sand column and subsequent placement and compaction of additional sand in the column by vibration decreases the Void Ratio (e) of the surrounding in-situ soils. The decrease in Void Ratio increases the Relative Density and the resistance of the in-situ soils to liquefaction.

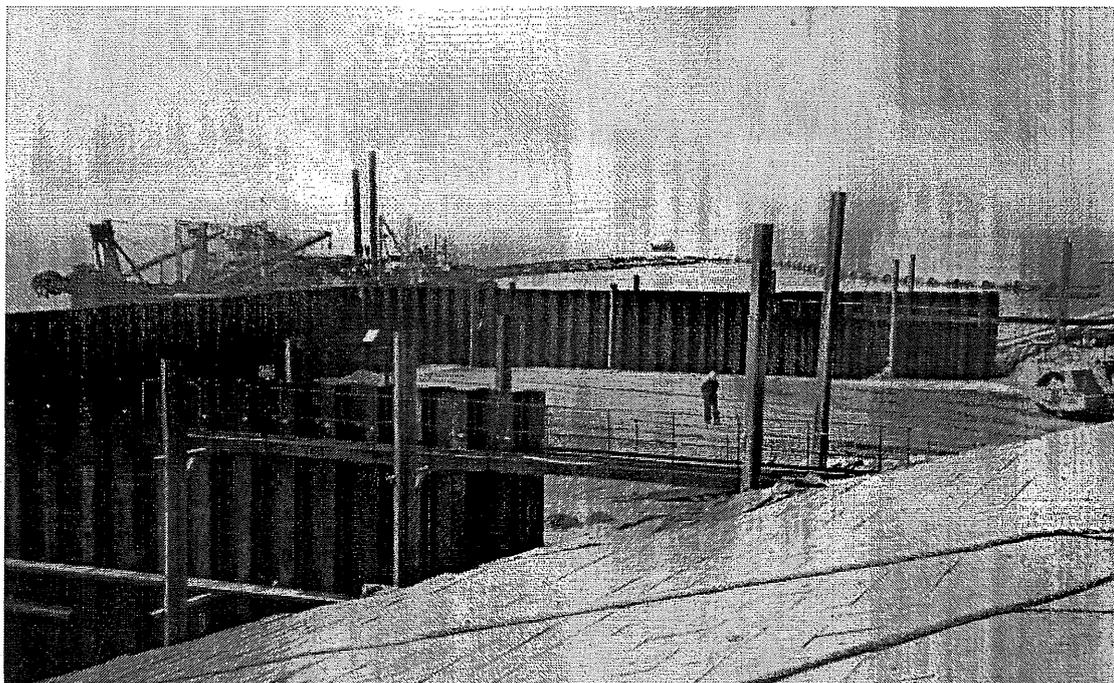
Figure 2. Unrestrained armoured slope face and sheet-piled jetty.

The lateral extent of ground improvement outside the footprints of the various infrastructure was assessed using methods outlined in the Japanese Port and Harbour Research Institute (PHRI, 1997). Depending on the type and location of structure, the horizontal width ranged up to 11m outside the structure footprint. These widths were designed to ensure a buffer zone with sufficient lateral support, assuming ground outside the improved areas has liquefied. All ground beneath critical infrastructure footprints was improved. Sheet piled walls and anchors were also improved, to ensure continuing function during and after strong ground motions. Improvement was undertaken along the margins of the reclamation platform, where there was interpreted to be a hazard from lateral spreading or flow sliding. The requirement for improvement to mitigate the hazard from lateral spreading was relaxed in an area where a sheet piled jetty (see Figure 2) had been formed, with well compacted backfill and deadman anchors restraining the facing sheet piles with tierods.

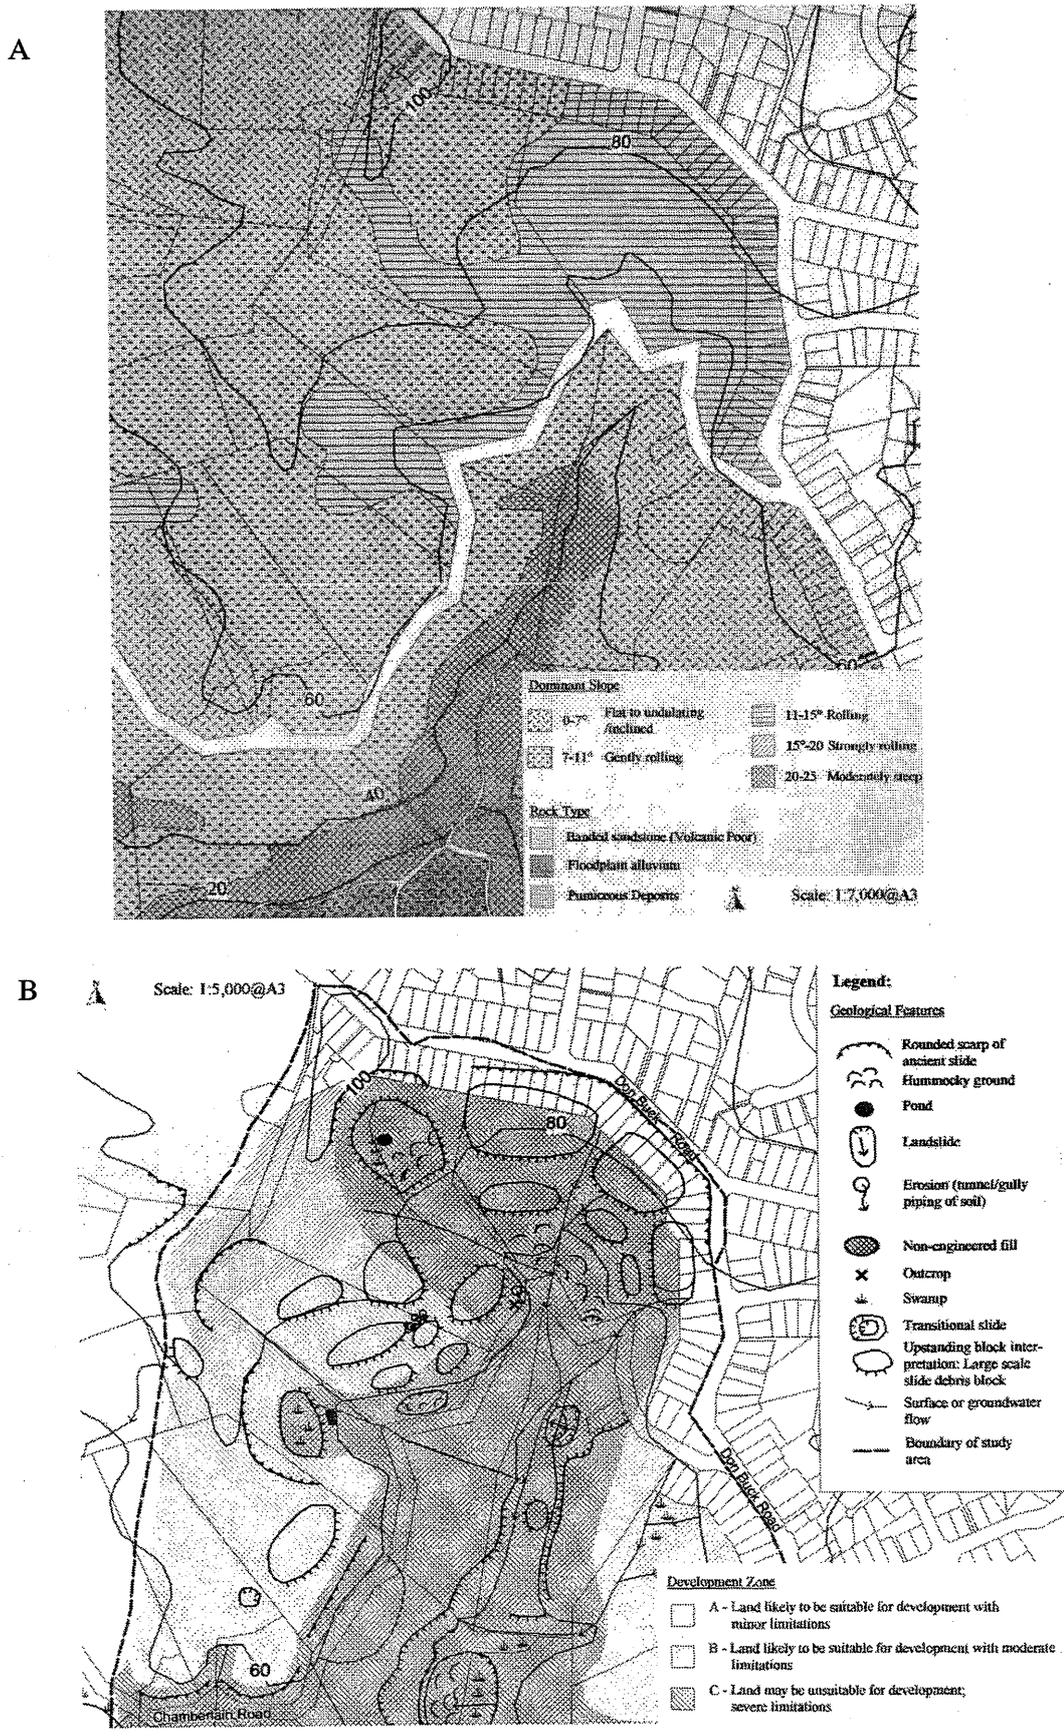
Figure 1. Extracts from slope grade and lithologic map (A) and observed slope movements overlain on resultant slope instability hazard map (B).

A classification system for land capability zoning in terms of slope instability hazard assessment is proposed in Table 1. The system considers the findings of field and desk based work and implications for development in terms of current legislation.

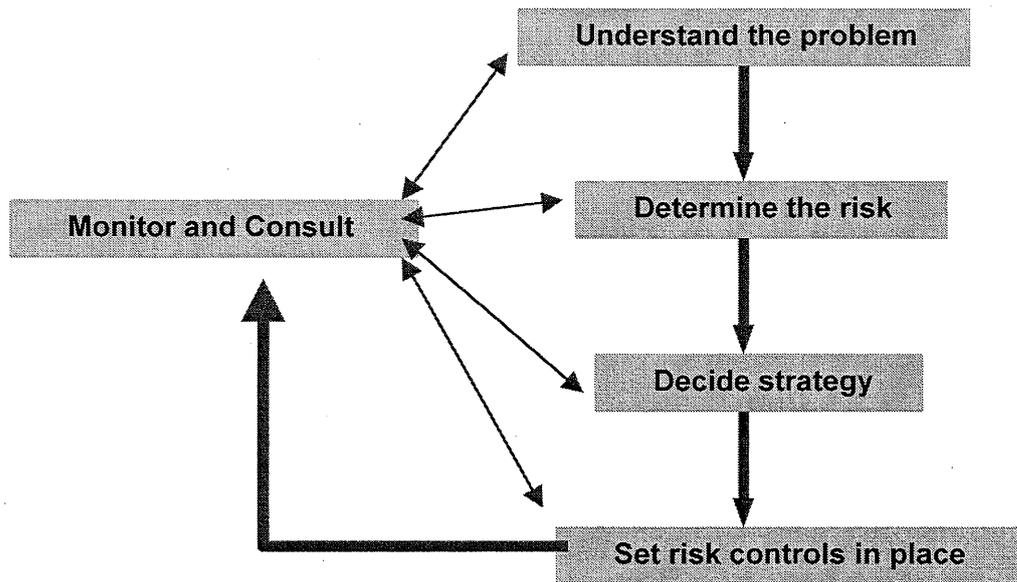
There is a further element, which is usefully applied across the whole process as shown in the figure below. Consultation and feedback are necessary if an integrated approach is to be taken, and the most useful outcome obtained.

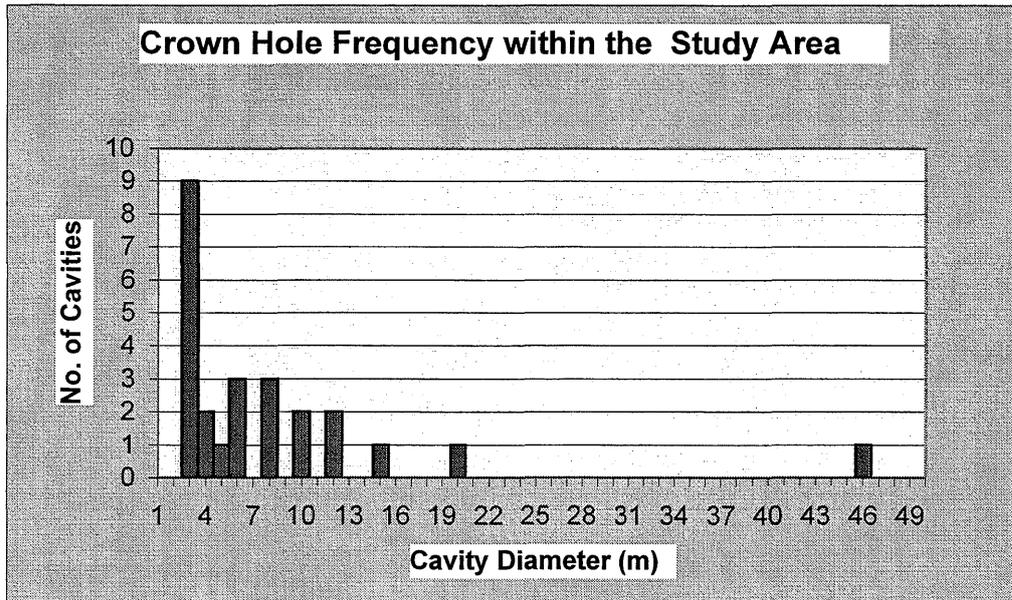
Figure 2 Distribution of Crown Hole Diameters within the Study Area.

The study area is approximately 850 m long (2850m-3700) and extends approximately 150m either side of the proposed motorway centreline. Crown hole collapse features and zones of trough subsidence have been mapped within the study area, specifically in the area underlain by old mine working. A crown hole is a surface depression or cavity created by the collapse of overburden soil into a mine working. The size of the 23 crown hole features identified within the study area range from 3 m to 46m diameter, and these have occurred over the last 100 years. The date of each crown hole development is not certain, but crown holes have been appearing on a regular basis. The known cavities are graphed on Figure 2 according to cavity size.

The crown holes appear to be randomly distributed over the study area, although the larger cavities (20 m+) appear to predominate towards the centre of the area, and the smaller holes predominate to the west of the study area. Overburden (rock and superficial materials) thickness above the worked coal seam does not appear to affect crown hole development. In fact the largest crown holes occur where the overburden thickness is greatest. For these larger holes (eg Bremner St, and on motorway shoulder at 3200m), the ratio of mine workings height to overburden rock thickness (i.e. excluding superficial materials) is 1:19. It is likely that the presence of the uncemented sand layer some distance above the workings may disrupt the usual bulking mechanism. The larger crown holes dominate the study area. To illustrate the dominance of the large crown holes, Figures 3a and 3b show a comparison between the number of holes of various sizes and the area they affect. If a cavity exists it is likely to affect an area around the cavity as well, and the affected area has therefore been taken as two cavity diameters.

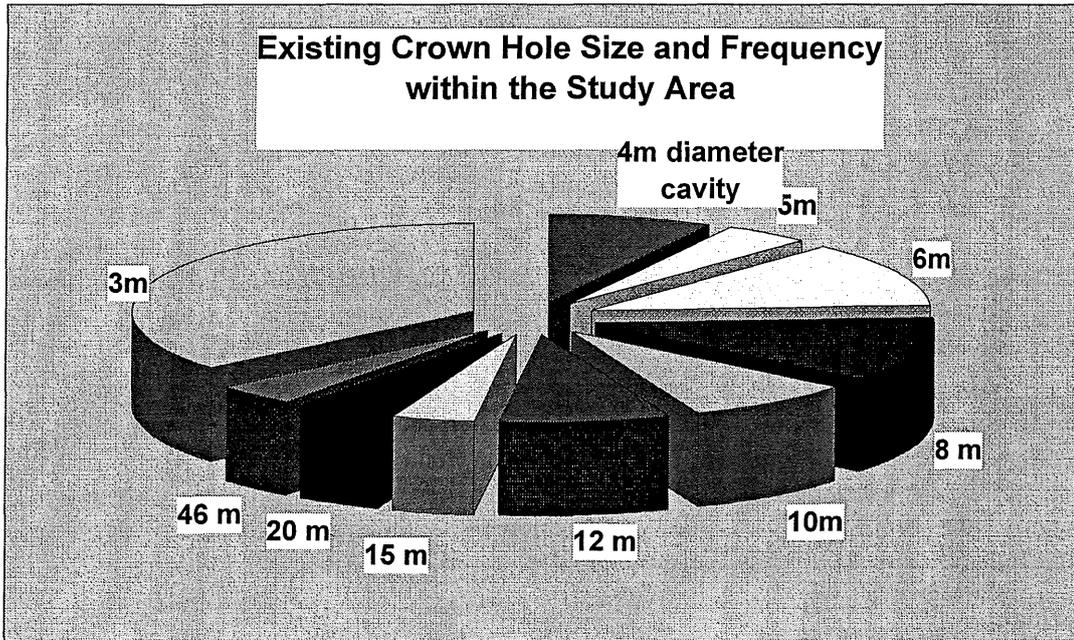
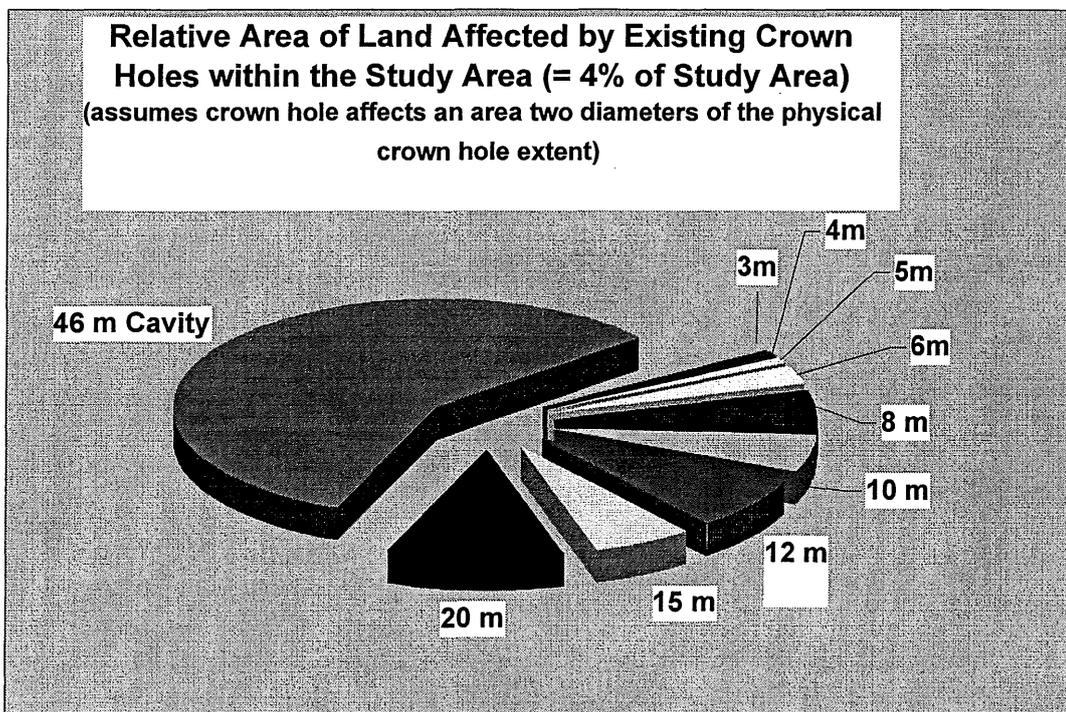
Figures 3a and 3b Size and Effect of Crown Holes within the Study Area

The summary graphs in Figure 3 show the area directly affected by crown holes covers some four percent of the study area. While the smaller diameter crown holes occur more frequently than the larger diameter holes, the larger holes affect a far greater area of land.

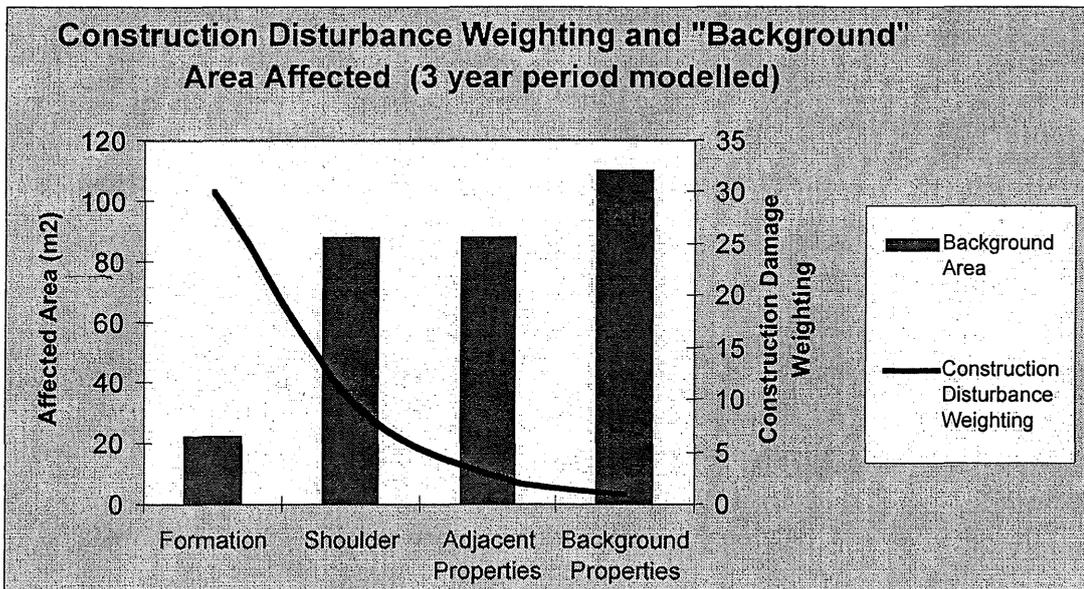
Figure 4. Methodology for weighting areas potentially affected by Crown Hole formation during construction

The predicted affected areas obtained from this method are intended to be a conservative assessment for risk planning purposes and should not be viewed as the expected outcome. Summary figures showing the model development steps, and the subsequent expected surface area affected by crown hole development during construction and during operation are presented in Figures 4 to 6 below.

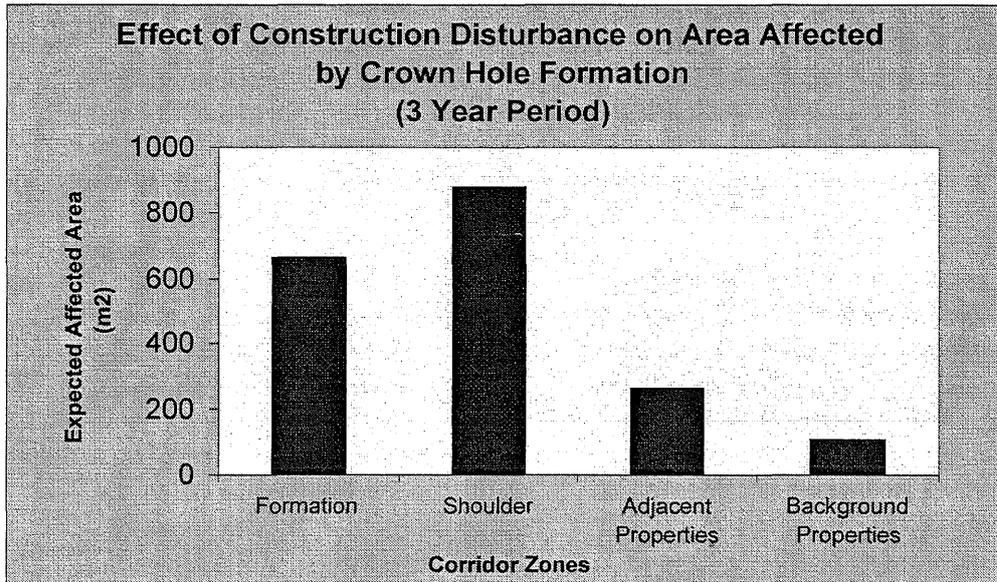
Figure 5 Effect of Construction Disturbance on Area affected by Crown Hole Formation

These graphs indicate approximately 700m² or 3.9% of the formation corridor may possibly be affected by crown hole features during construction (e.g. four 7.5 m diameter crown holes). The areas arrived at above are not the expected values, but rather they reflect a conservative possibility that it would be prudent to plan for. That is, the subjectively derived 90-95%ile outcome. The most likely outcome could well be an order magnitude lower than these figures.

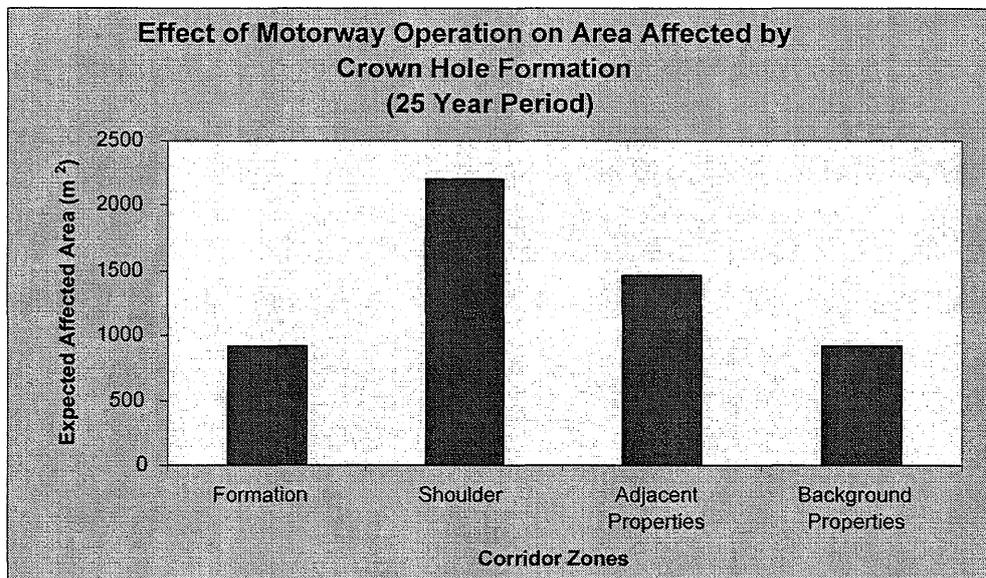
Figure 6 Effect of Operational Disturbance on Area affected by Crown Hole Formation

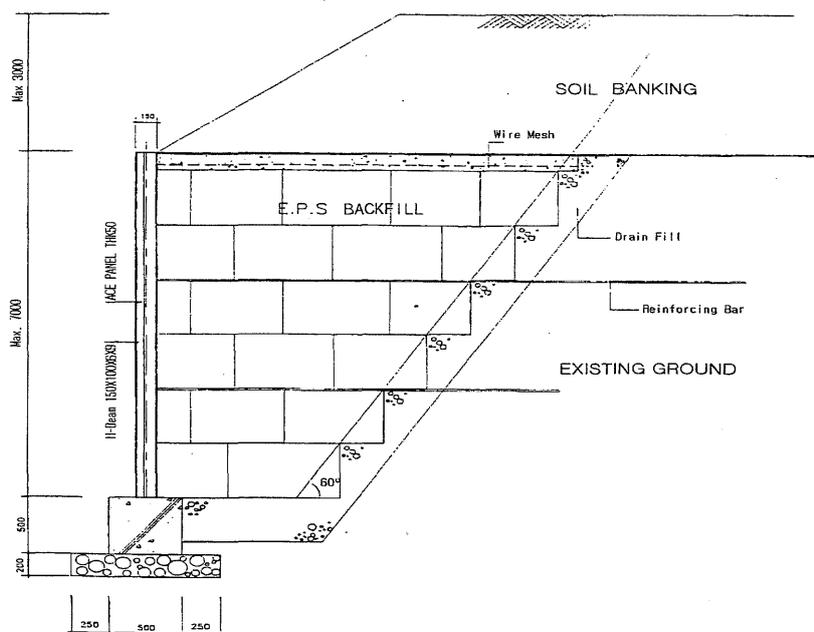
Figure 2. Part section of embankment showing EPS.

In the area where the EPS was placed, loose soil and organic material was removed back to solid bearing prior to placement of blocks. A drainage layer was also provided at the sloping interface between the existing ground and the stepping EPS blocks (refer Figure 1.). Figures 11 and 12 show the EPS being installed.

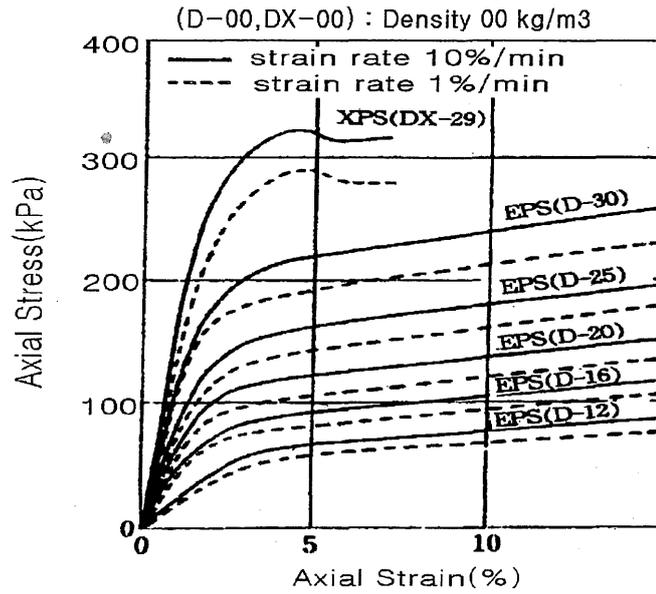
Figure 2. Typical stress-strain curve of EPS (from EPS C.M.D.O., 1993)

Figure 2 shows various densities of EPS ranging from D-12 (12kg/m^3) to D-30 (30kg/m^3), as well as a comparison with 29kg/m^3 Extruded Polystyrene, denoted as XPS DX-29. By way of clarification, XPS is a generically different form of polystyrene to EPS.

In the range $0 \sim 2\%$ strain, the EPS graphs are linear (i.e. elastic). Above a strain threshold of $\sim 2\%$, plastic deformation of the EPS commences with further increases in the applied compressive load. It can also be noted that as density increases, the deformation modulus (the gradient of the graph) increases. The rate of load application also influences this value, albeit marginally. Another factor affecting the deformation modulus is the level of applied confining pressure.

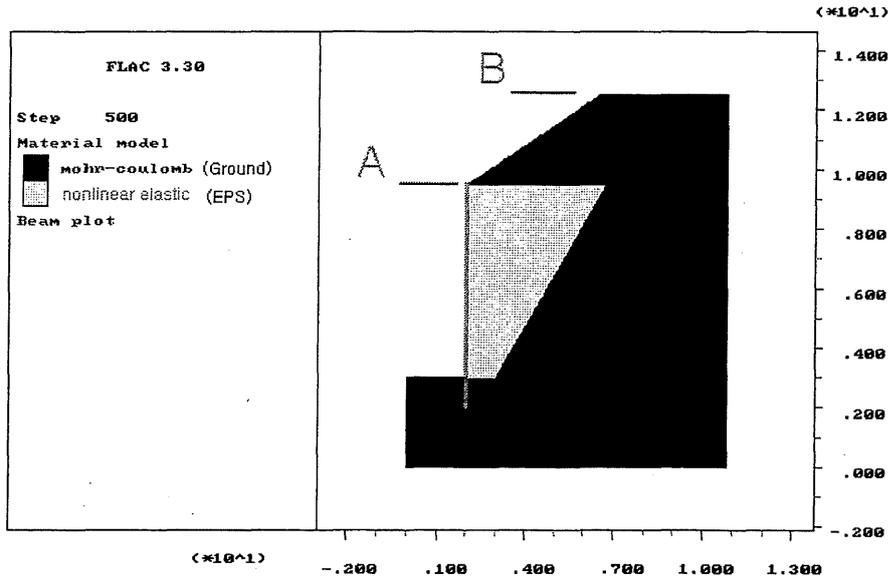
Figure 3. Geometry of model

As well as incorporating the non-linear elastic behaviour of the EPS into the analysis, the Mohr-Coulomb method was used for the section that consisted of soil. Figure 3 shows the geometry used in the computer analysis.

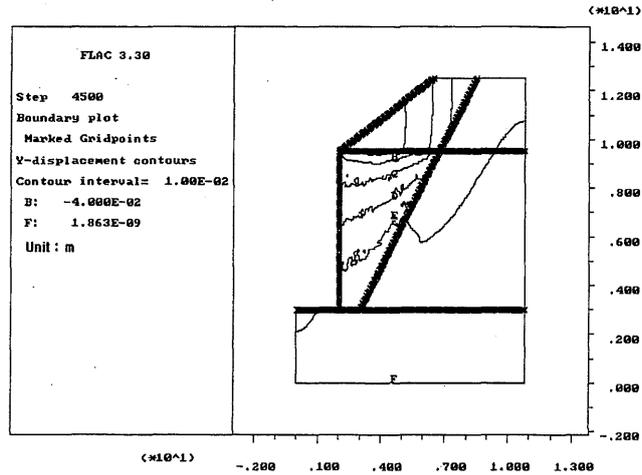
Figure 4. Vertical settlement distribution

The FLAC programme provided a prediction of the settlement and stress distributions, as illustrated in figures 4. to 7.

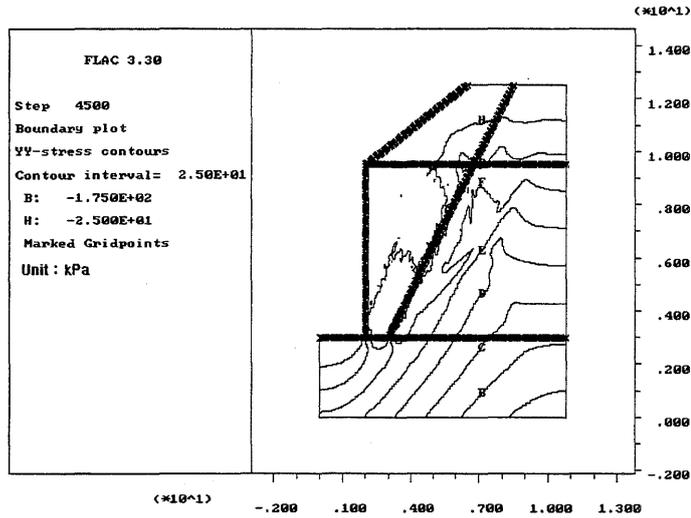
Figure 5. Vertical stress distribution

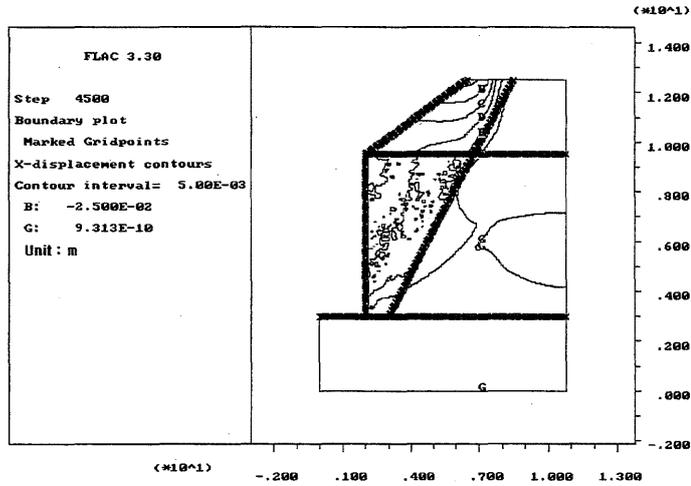
Figure 6. Horizontal settlement distribution

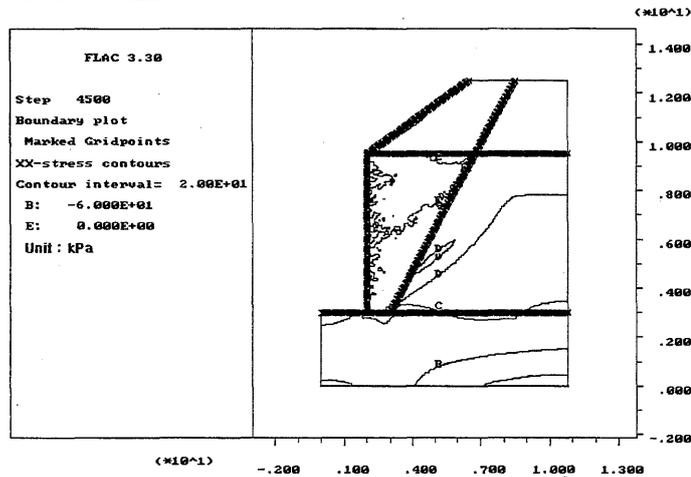
Figure 7. Horizontal stress distribution

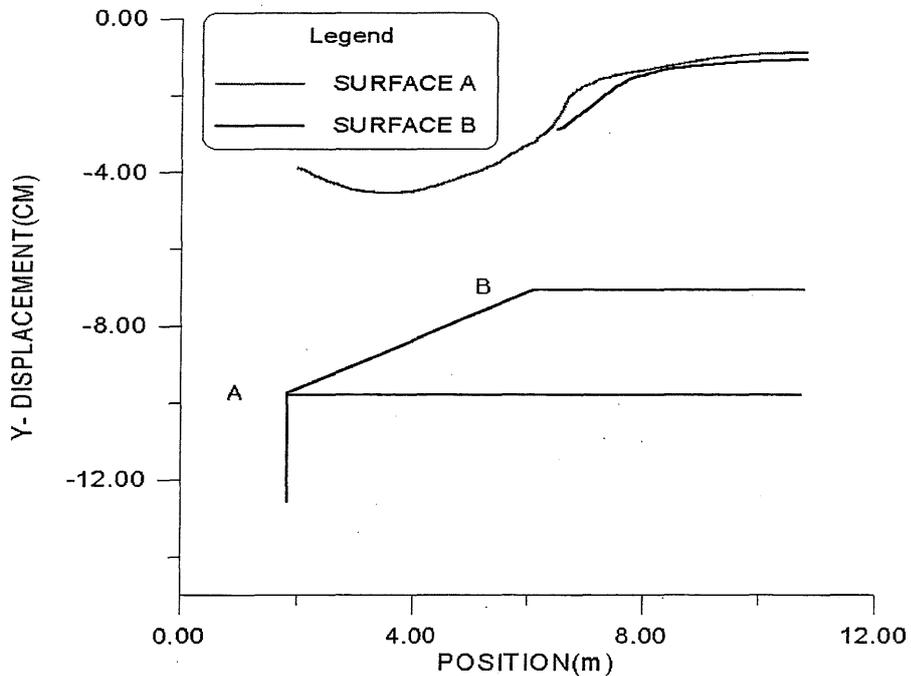
Figure 8. Vertical settlement relative to horizontal

The resulting settlement of the ground surface at points A and B is shown in Figure 8. Based on the analysis, a maximum vertical settlement of 3.6cm was expected to occur at the boundary between the embankment and the original ground (point A). At the proposed new ground surface (point B), which resulted from soil fill on top of the embankment, vertical settlement of 1.8cm was predicted by the analysis. On the basis of these results, it was judged that differential settlement between the two different materials would not be significant. In addition, it was clear that there would be minimal differential settlement in the area adjacent to the embankment.

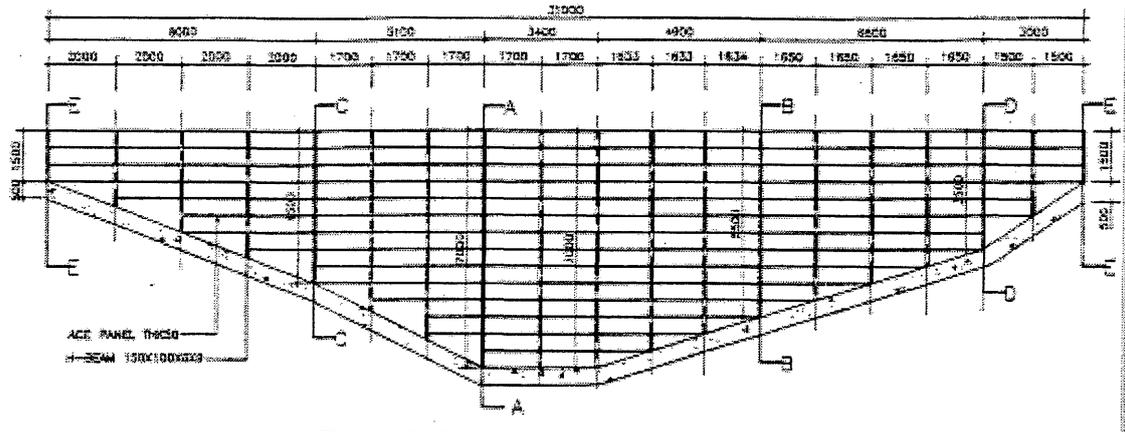
Figure 9. Long-section of EPS fill

Figure 9 shows a long-section through the part of the embankment that contained EPS.

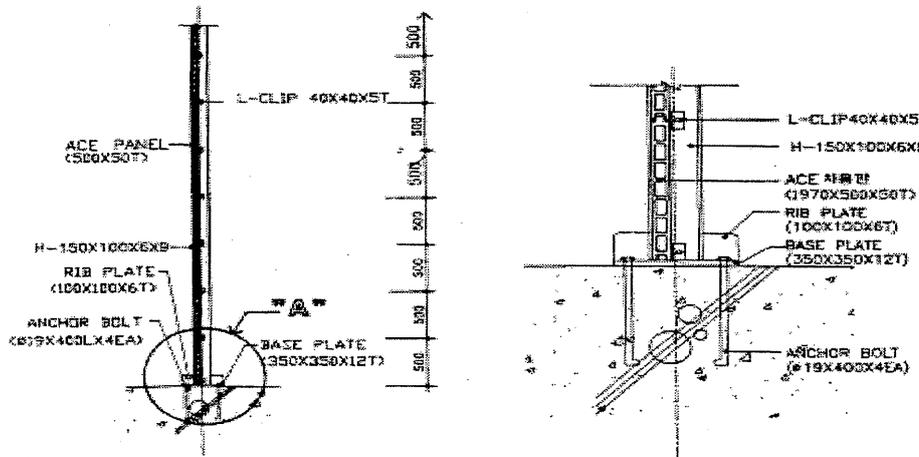
Figure 10. Cross-section of EPS retaining wall

A lightweight wall was constructed to protect the EPS blocks from environmental exposure. The wall consisted of a reinforced concrete footing, steel posts bolted into the footing and lightweight concrete infill panels between the posts, as shown in Figure 10. The steel posts were anchored back into the existing mountainside to provide stability under lateral load.

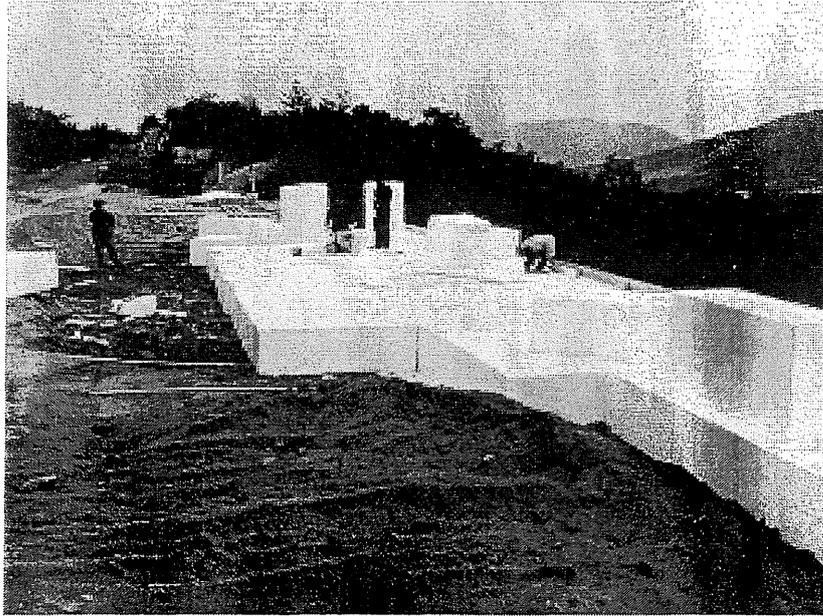
Figure 11. EPS block being placed

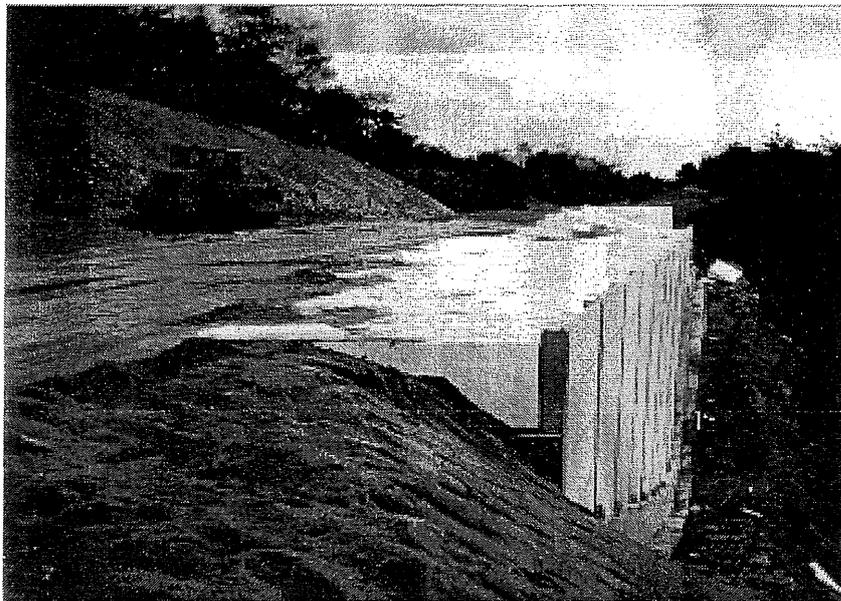
Figure 12. EPS blocks after placement

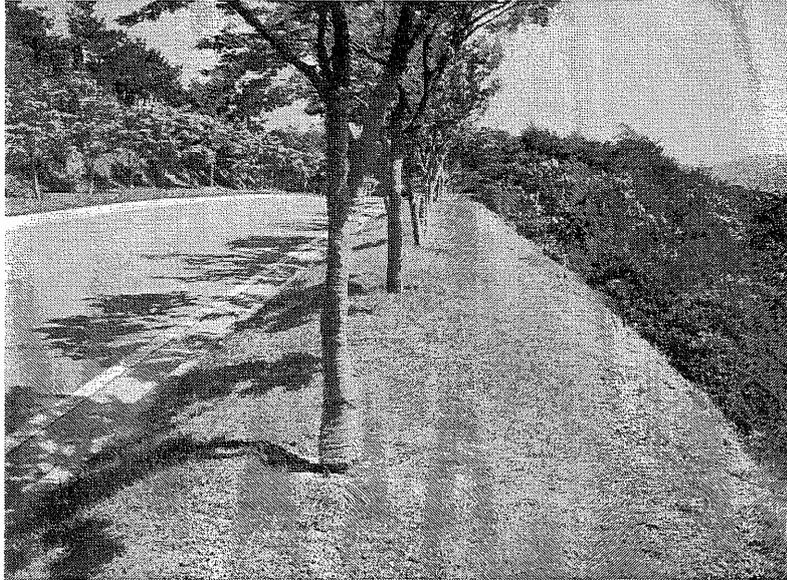
Figure 13. Embankment and access road , 2001

Since the embankment was constructed in 1995, there have been no observed problems of settlement or the like. A thorough visual inspection in early 2001 showed that this section of the access road was performing very well and that the lightweight EPS fill was standing up to all in service loads satisfactorily. Figure 13 shows the embankment six years after it was built.

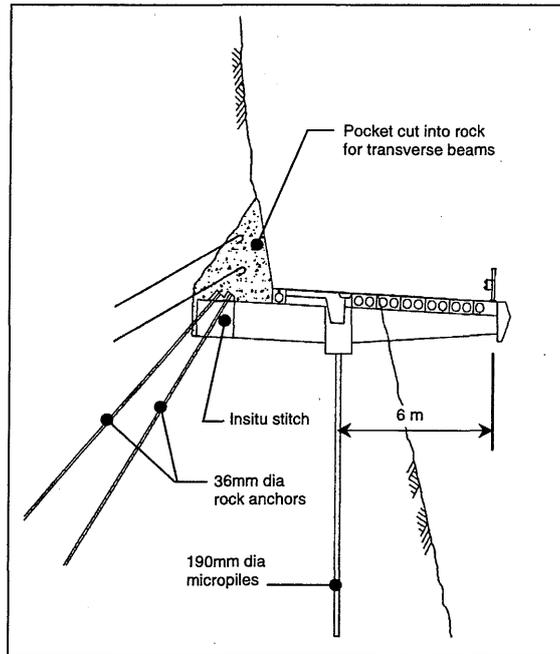
Figure 2: Cantilever Half Bridge

Geotechnical input was required for the design of foundations and anchorage for various structures. The conceptual form of the structures is shown in Figures 2 to 5.

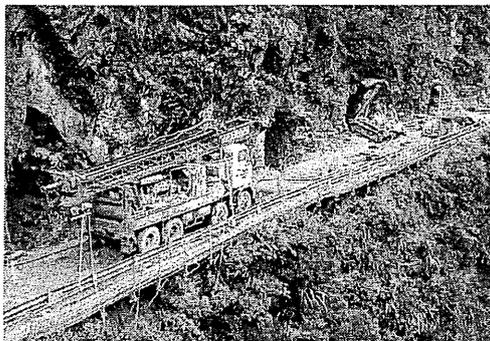
Photo 1: Pockets for Cross Beams and Piling Rig

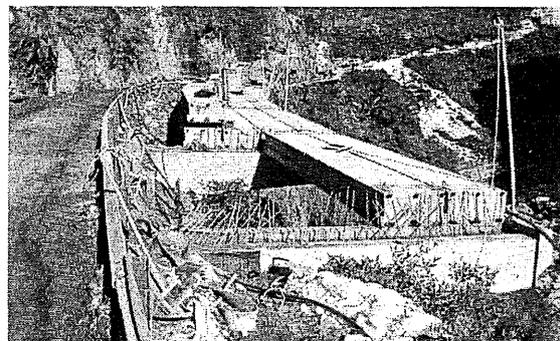
Photo 2: Cantilever Half Beams

arm for the beams and added security to uplift. Two, 36 mm diameter, 1250 kN UTS anchors were installed at each cross beam. The anchors were double corrosion protected with plastic encapsulation and were pre-stressed to 65% of the bar UTS. The anchors were tested and installed to BS8081:1989 with three proving and suitability tests, and acceptance load testing on each anchor. The load test results indicated a rock to grout bond strength of greater than the 900 kPa, used in design.

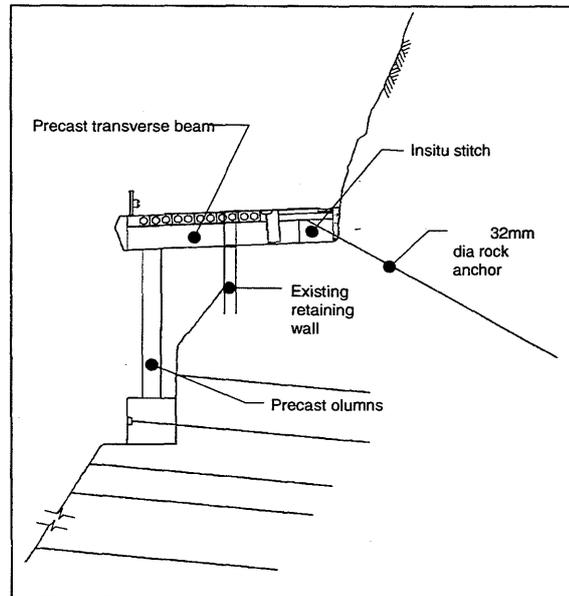
Figure 3: Propped Half Bridge

The 48 m long section of half bridging between the Passing Bay and Starvation Point (5 spans) was able to be supported on the outside by columns with pad foundations because the slope below the road reduced to about 50°. However a predominant joint set dips parallel to the slope and required anchorage of the column bases and additional anchors for stabilisation of the rock below. Also poorer rock was encountered at the northern most column foundation during construction, which required additional anchorage and a load beam between anchors immediately downslope from the column. Structural rock anchors were provided on the uphill side of each cross beam for lateral load resistance. The vertical load resistance was less critical than for the cantilever beams.

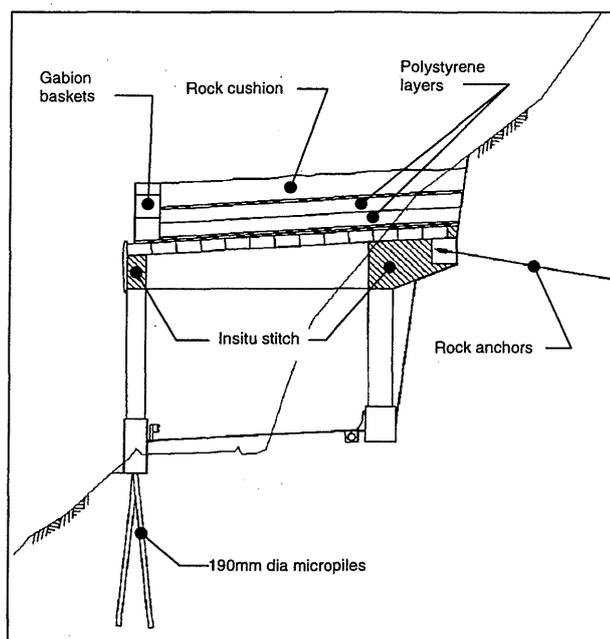
Figure 4: Passing Bay Rockfall Protection Shelter

A 60 m long section of rockfall protection structure (Photo 5) was required at the Passing Bay (10 bays). A steep, self cleaning, rockfall protection structure was considered, but would have continued too far upslope and would have been vulnerable to impact damage. Instead a relatively flat roof framed structure was adopted (Figure 3). A cushioning layer of gravel, overlying polystyrene blocks, was included to absorb the energy and spread the impact load of the design rockfall. Design loading utilised South African and Japanese research, but judgement was required as no standards provide guidance on design for rockfall impact. The highway was widened by cutting 5 m into the uphill side of the road, and this allowed the

uphill column of each frame to be founded on a continuous foundation beam. Micro-piles and a pile cap provide support for outer columns. Structural rock anchors tie the roof beam to the slope above the road and provide lateral seismic load resistance for the frames. The roof beams carry the vertical loading from rockfall debris, and no vertical support is required where the roof beam meets the rock slope.
