Engineering & Development

in **HAZARDOUS TERRAIN**

NEW ZEALAND GEOTECHNICAL
SOCIETY 2001 SYMPOSIUM

Hazardous Terrain – An Engineering Geological Perspective

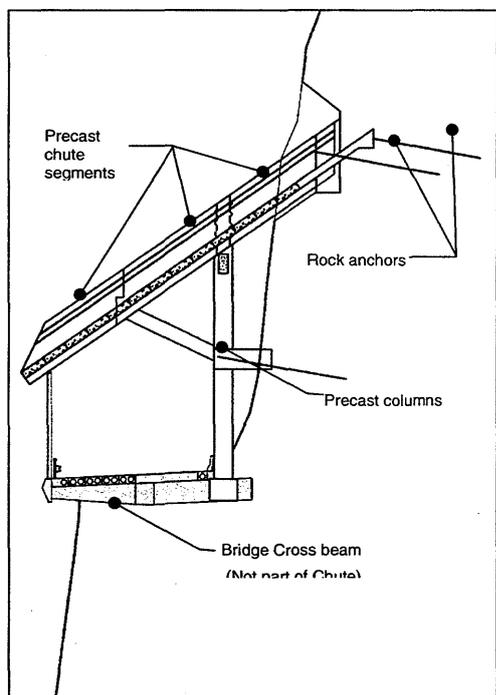
Figure 5: Reid's Falls Chute

The water flow and debris loading of the stream at Reid's Falls is carried in a 20 m high, steep and narrow, U shaped chute over the highway (Figure 5 and Photo 6). The chute is supported by a diagonal prop from the uphill columns to avoid additional vertical loading to the outside of the cantilever half bridge at this location. The column is founded on a shallow pad foundation. Lateral support is provided by, structural anchors at two levels. A fascia wall prevents wind from blowing water back onto the road.

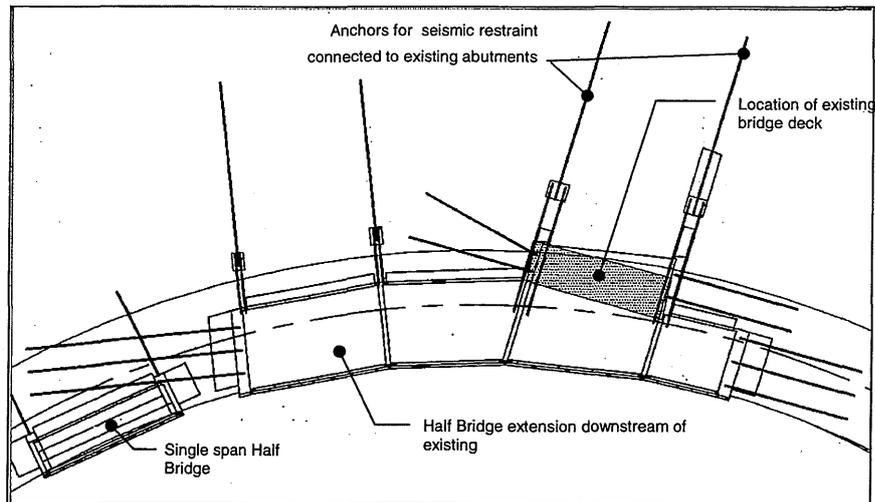
Figure 6: Candy's Creek Bridge Plan

A 40 m long bridge comprising four, 10m long spans, was designed at Candy's Creek (Figure 6). The original bridge abutments were reused and the bridge was widened in the downstream direction. The bridge was extended with three land spans. The bridge extensions were founded on 400 mm diameter, 12 m deep piles in gravel and boulders of Candy's creek bed. The piles have permanent casing to provide additional resistance to deformation.

The stability of the slope below the bridge is marginal, particularly under seismic conditions, and erosion may occur during flooding. Therefore, lateral and longitudinal resistance for the bridge was provided by structural anchors. These anchors are within gravel and boulders. Proof load testing proved that the skin friction and anchor capacity was greater than the required overall design skin friction for gravel of 300 kPa.

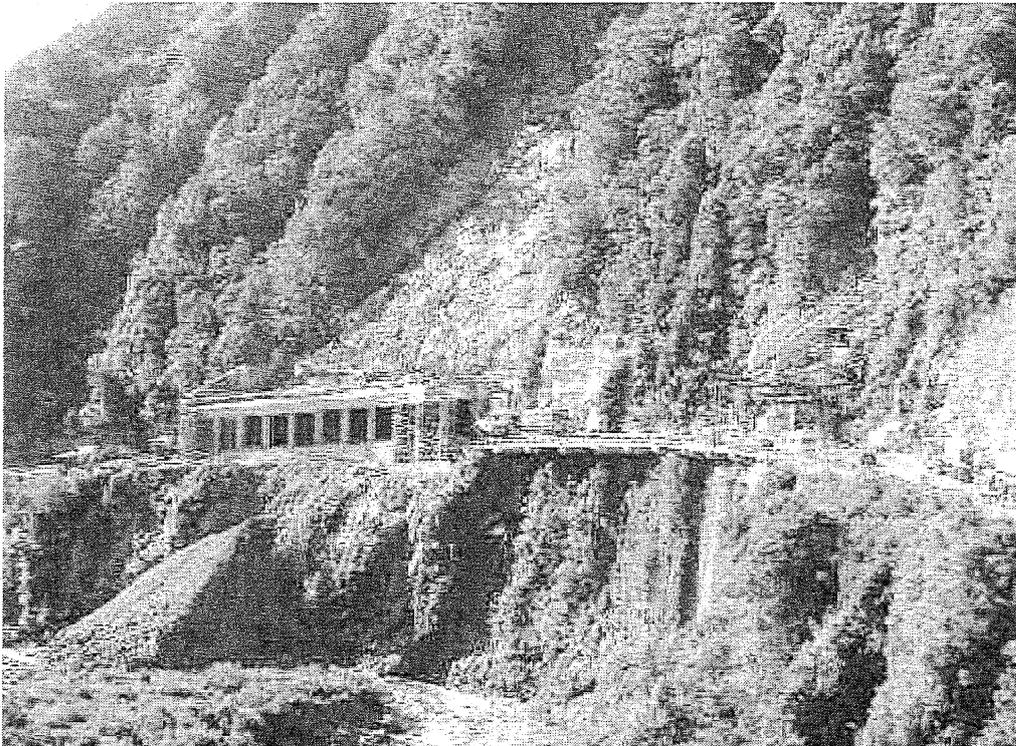
Photo 7: Passing Bay Rockfall Protection Shelter and Reid's Falls Chute

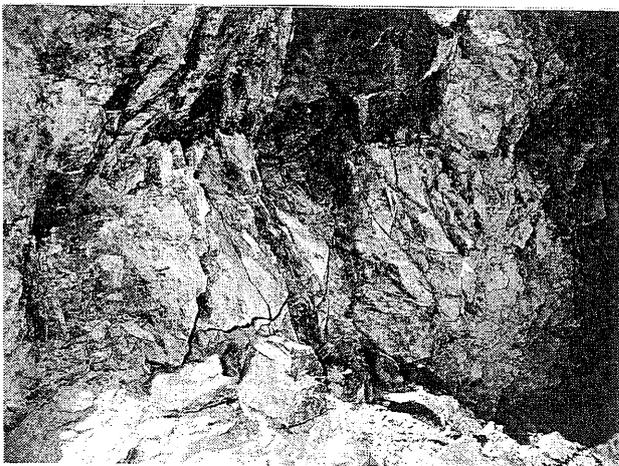
Photograph 1: Typical sheared Onerahi Chaos mudstone with highly polished fractures. The rock had undergone stress release dilation and fell apart on handling.

The Onerahi Chaos consists of grey sometimes black and chocolate brown very fractured and sheared weak mudstone/muddy limestone with slickensided and polished surfaces, some

with clay matrix. Smectite content (measured by Clay Index) decreases with increased limestone. Correspondingly relative frictional strength along the fractures decreases with a decrease in limestone content (Toan, 1981).

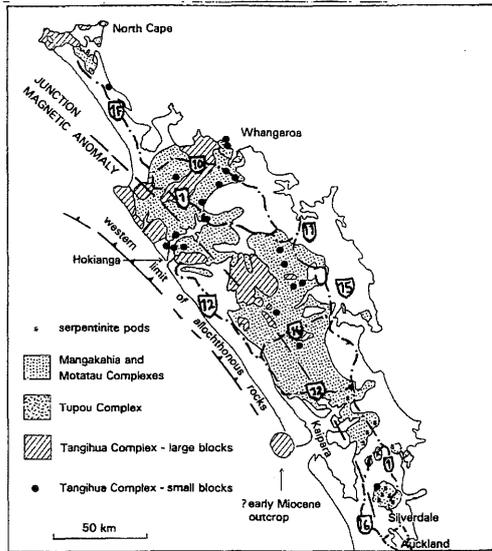
Fig.1 Outcrop distribution of Allochthonous rocks in Northland. Transit New Zealand State Highway network has been overlaid. (After Hayward et al. 1989)

The Northland Allochthon is comprised of four main geological units that include the Tangihua Complex, the Tupou Complex, the Mangakahia Complex, and the Motatau Complex. All these units can pose difficulties related to shearing and degradation associated with their emplacement. Of primary concern however, to roading development, are the sheared mudstone units comprising the Mangakahia Complex. Figure 1 above shows the widespread extent of these units across the Northland Region.

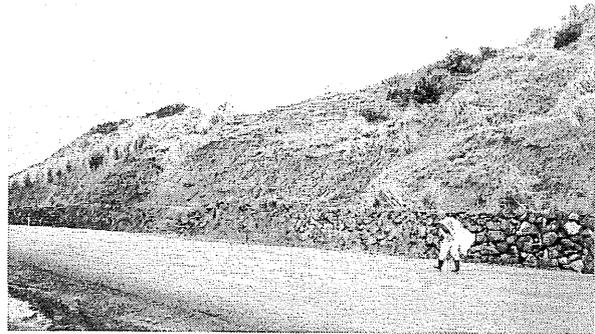
Photograph 2: Whirinaki Hill. Overslip in a cut batter with limited toe support.

Cut slope failures initiate with toe dilation followed by progressive displacement and wetting and drying that softens the material to then regress rapidly upslope and extend laterally across slope. As the slip develops the toe is often thrust out from the toe of the original cut batter slope. The head scarp areas are similar to natural slope failures.

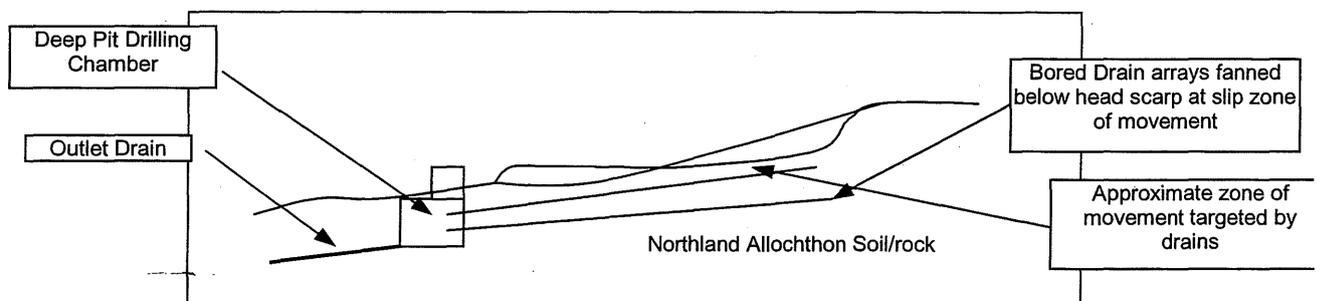
- To drain the confined water bearing fractures and reduce the piezometric head deep sub-surface drainage, generally utilising deep bored horizontal drains, is undertaken.

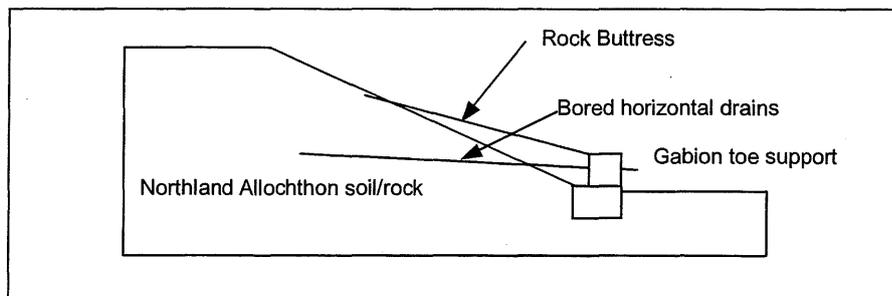
- Toe support using Gabion or rock buttresses is also utilised to alleviate the initiation of dilation and regressive type failures in cut slopes.

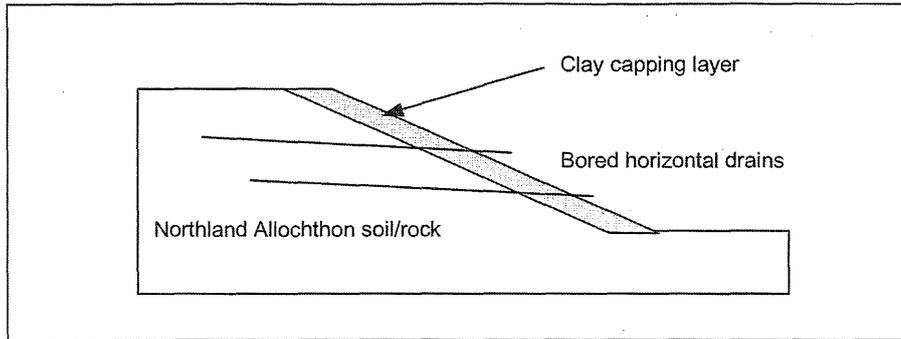
- Another cut slope remedial measure involves capping a batter with compacted soil to alleviate dilation resulting from stress release perhaps in combination with bored drainage to drain the confined water bearing fractures (see next page).

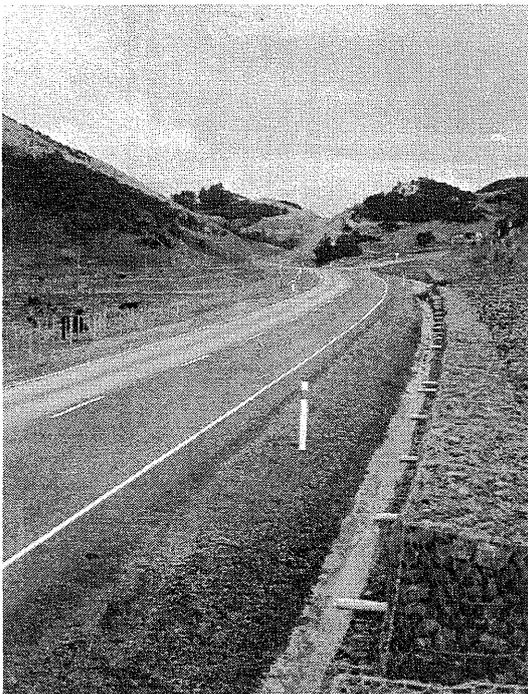
Photograph 3: Whirinaki Hill. Toe buttress support in the foreground, box cut in the background (see Photograph 2).

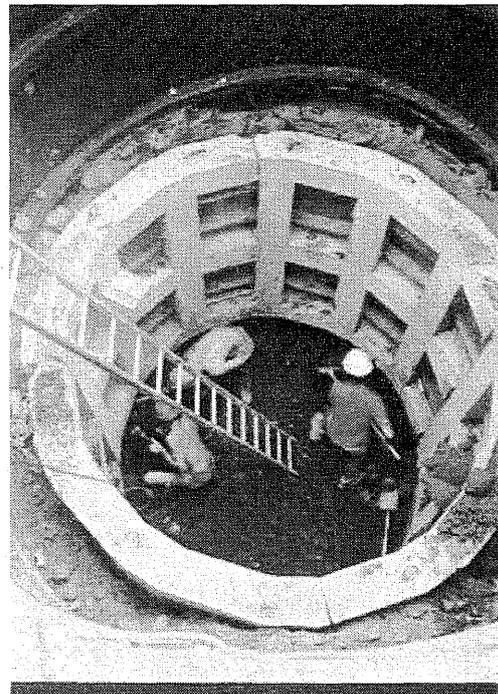
Photograph 4: Prides Slip SH16 – Construction of deep pit drilling chamber. Horizontal drains are drilled through E-Sections.

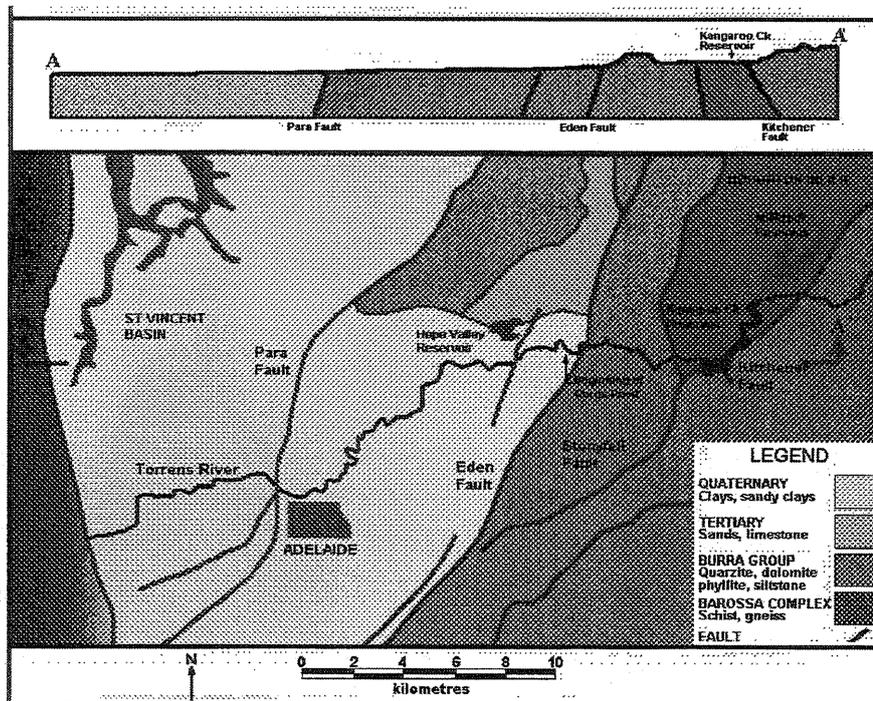
Figure 1 Geology of the region around Gorge Road

Figure 1 shows the regional geology around Gorge Road. The overall structure is largely a result of faulting and folding of the Adelaide Geosyncline sediments during the Cambro-Ordovician Delamerian Orogeny, 510m years ago.

The older Palaeoproterozoic Barossa Complex metamorphics occur in the Houghton Inlier. These rocks are considered to be the basement rocks of the Mount Lofty ranges and have been affected by steep up-thrusting during the Delamerian causing retrograde metamorphism and shearing (Preiss, 1993). The Inlier is bounded to the east by the Kitchener Fault and to the west by a continuation of the Stonyfell fault. Spry (1951) describes the rocks as augen gneisses, schists and granulites. Talbot (1963) found them to have variable chemical and mineralogical composition but grouped them into feldspar rich rocks with minor amphibole and diopside and quartz-feldspar-mica schists and gneisses. According to Preiss (1993) the distribution of the rock types within the Barossa Complex is subject to considerable uncertainty and their structural relationships are poorly understood.

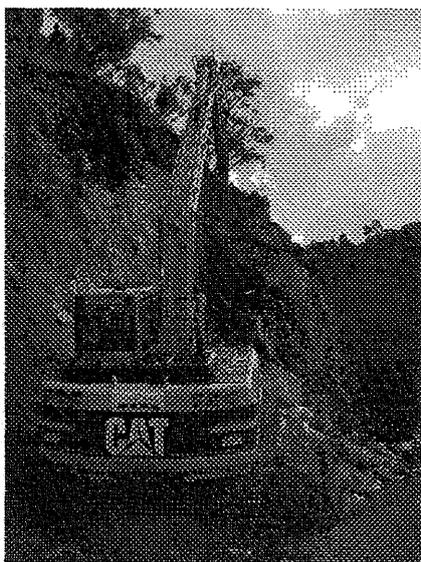
Figure 3. Scaling face

In general, the work involved scaling the loose blocks with a long-boom excavator with a 15m reach fitted with a pick (Figure 3). Additional height was obtained by standing the excavator on a 2m high bench constructed on the road out of scaled rock. When the zone of soil and extremely weathered rock at the top of a batter could be reached, it was trimmed back to reduce the batter angle to approximately 35 degrees. To dislodge boulders out of reach of the excavator, workers operating from an elevating platform used an inflatable mat placed in the crack at the back of the boulder. By inflating the mat with compressed air even large boulders could be removed.

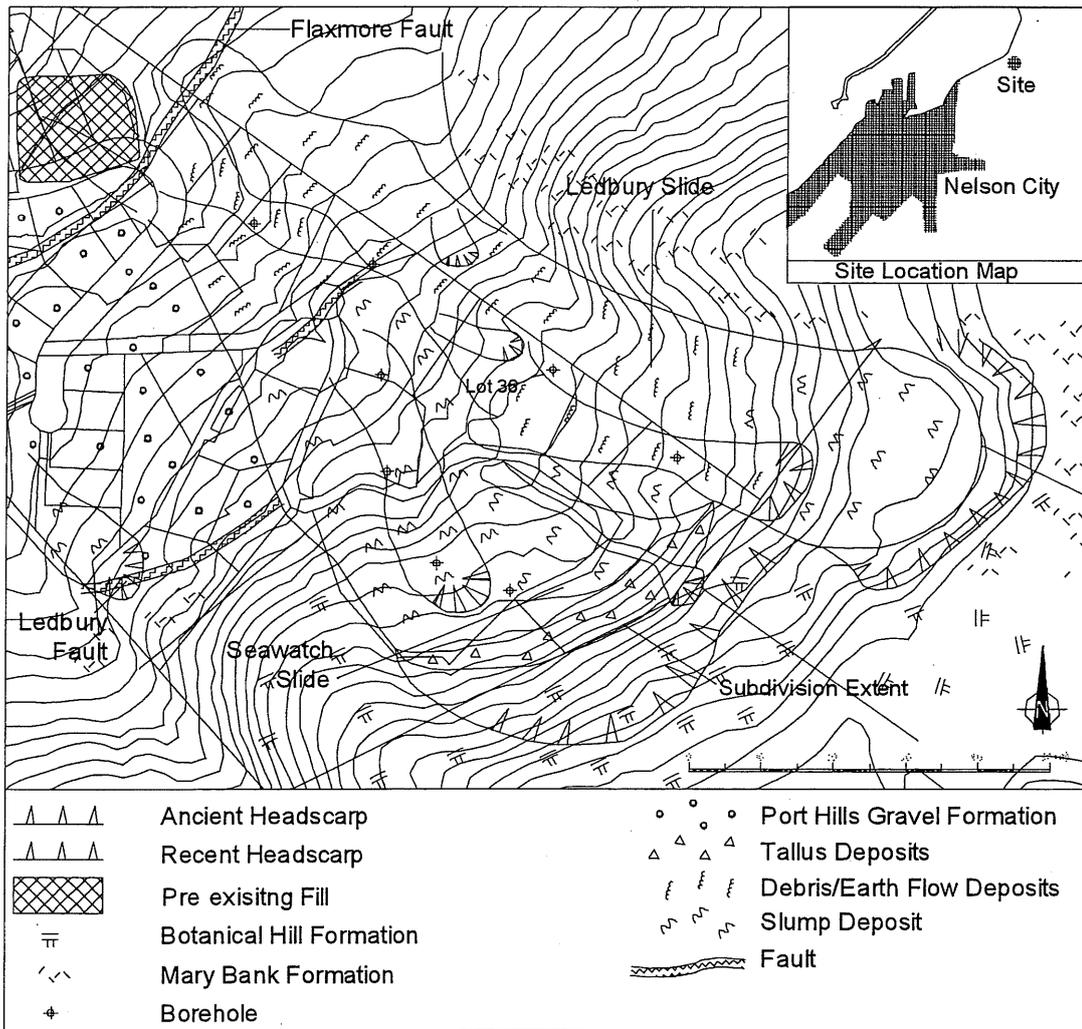
Figure1: Location and Geology

The majority of the subdivision is covered by mass movement deposits. These deposits are up to 20m thick and have accumulated over tens of thousands of years as a result of numerous episodes of landslipping. Two major landslide deposits were distinguished, the Seawatch Slide and the Ledbury Slide.

The oldest mass movement is the Seawatch Slide, Figure 1. The Seawatch Slide includes an upper portion, with characteristics of rotational slide movement. The central portion shows characteristics of translational sliding, and the downslope portion shows characteristics of both sliding and flowing. Consolidated colluvium mantles the slide debris and the deposit has locally been incised by stream erosion and then undergone partial reactivation.

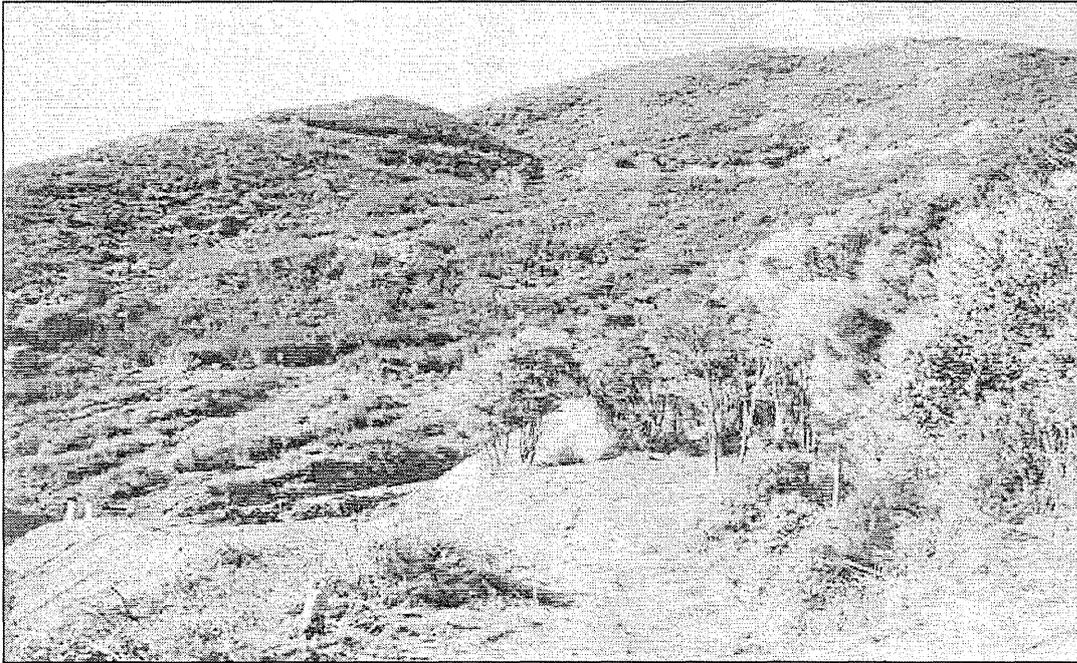
The Seawatch Slide is overlain on the northern half of the subdivision by the Ledbury Slide, (Figure 4). The Ledbury Slide consists of an upper portion upslope of the subdivision where rotational slide movement in rock is inferred. Within the subdivision it is a complex composite of earth flow and earth slide lobes. The Ledbury Slide is approximately 3.6km long (from the crown to the toe). The youngest lobe mantles the older landform and extends 2km downslope.

Figure 4. View across headscarp of reactivated portion of Seawatch Slide towards Ledbury Slide.

Recent instability on the Subdivision has involved local reactivation of the younger, less consolidated, Ledbury Slide deposits, and shallow earth flows originating on the partially degraded Seawatch Slide headscarp. The most recent recorded landslide on the subdivision occurred in July 1998 and involved a debris slide-flow failure of 200m³ of soil and weathered rock on the Seawatch Slide headscarp and developed into an earthflow extended 120m downslope.

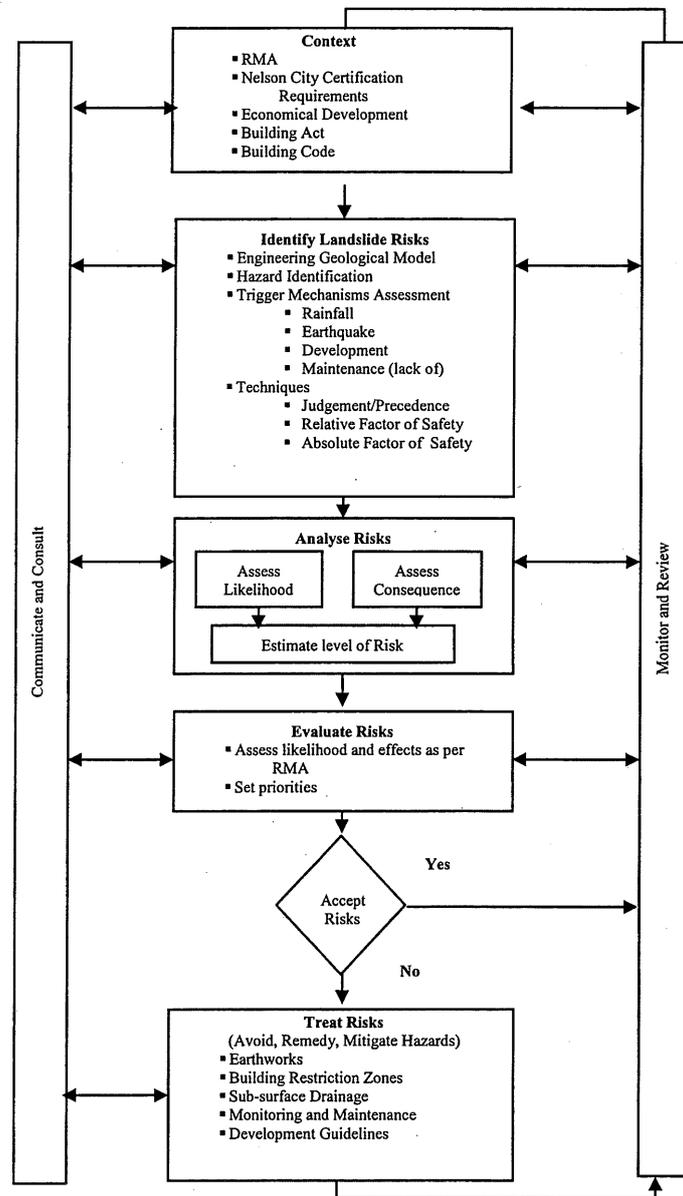
Figure 5: Landslide Risk Management Process

The risk management process, as adapted from AS/NZS 44360:1999 is summarised in Figure 5. Using risk management terminology, consequence is the outcome, or effect, of a hazard, and risk is the chance of something happening that will have an impact on objectives. Risk is measured in terms of consequences and likelihood.

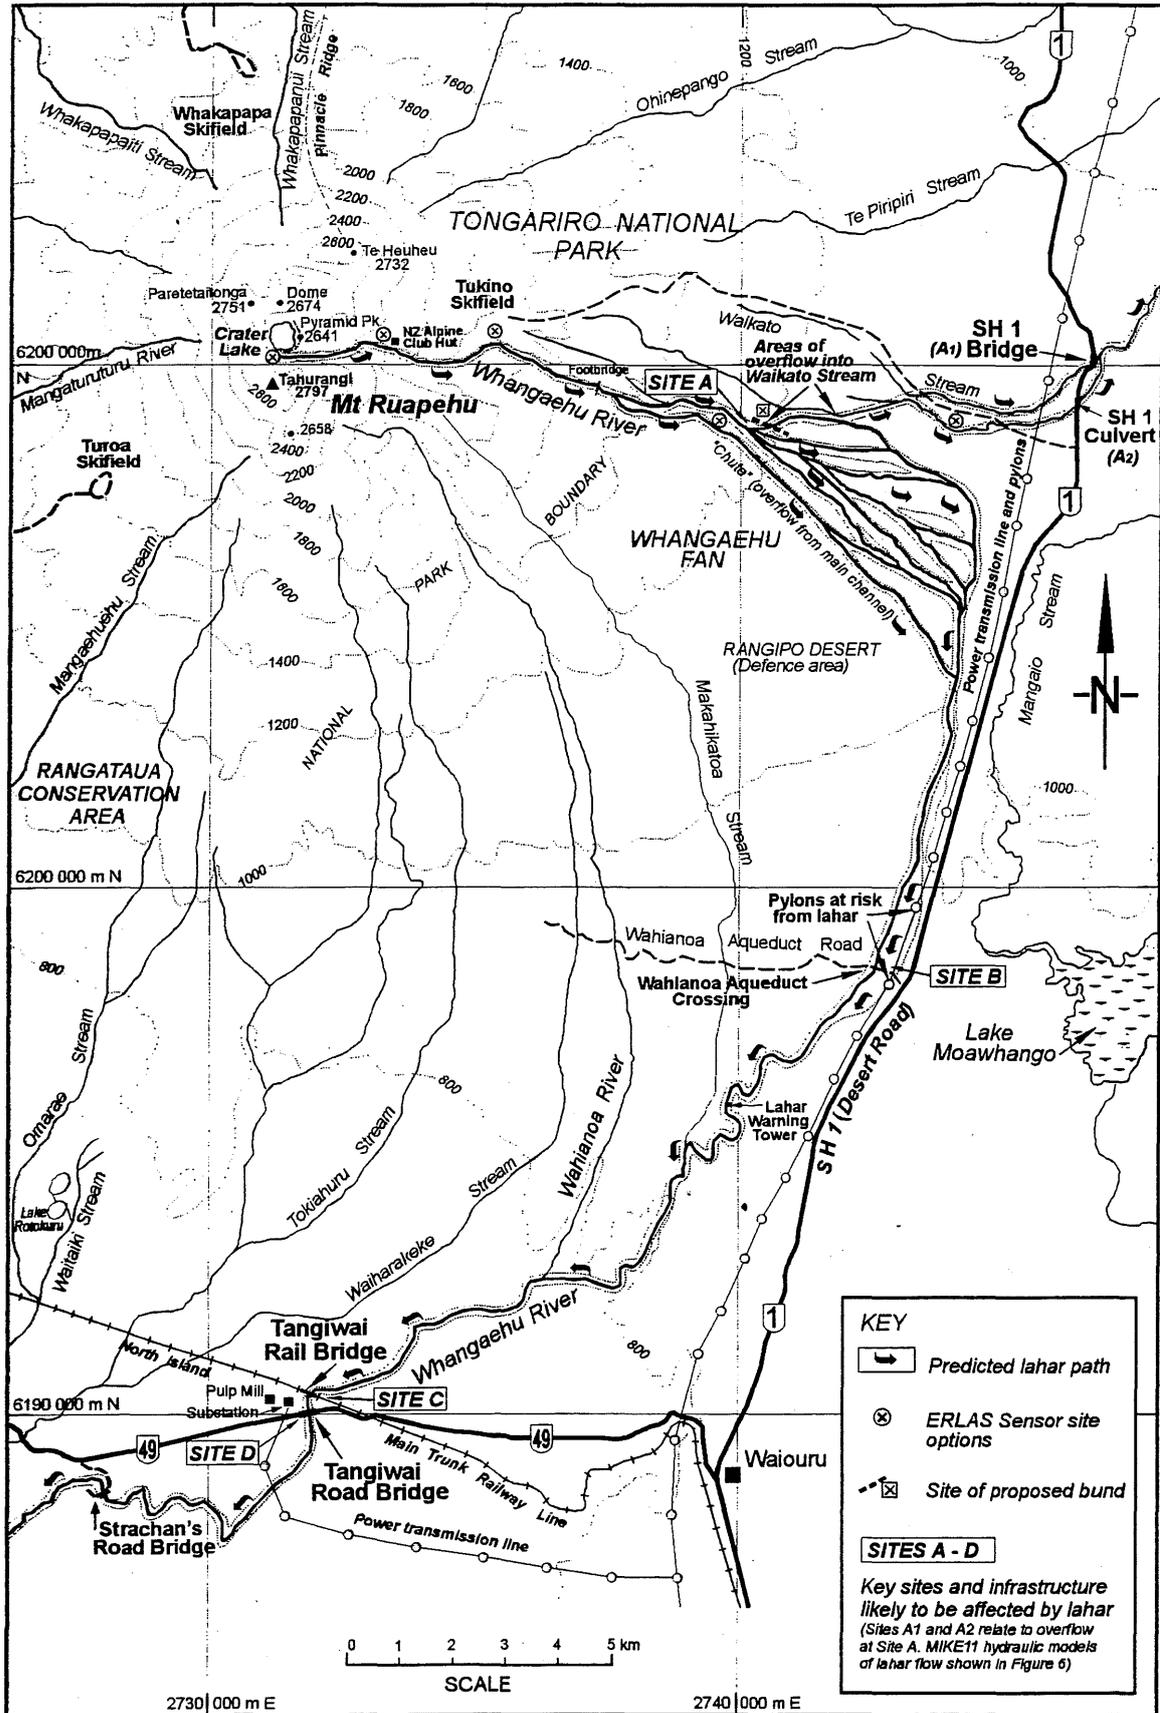
Figure 2. Map of the Mt Ruapehu area showing the predicted flow path of a potential lahar formed by collapse of the 1995-96 tephra barrier at the Crater Lake outlet. Key sites and infrastructure likely to be affected, and proposed hazard mitigation options are also shown.

The major hazard from Ruapehu eruptions in historical times has been destructive lahars caused by ejection of Crater Lake water onto the outer slope of the mountain and into the major catchments such as the Whangaehu, Mangaturuturu, Whakapapaiti and Whakapapanui rivers (Figure 2). However, non-explosive lahars caused by collapse of the crater rim, as occurred in 1953, or displacement of the Crater Lake by inflowing lava as occurred in 1968 generally affect only the Whangaehu River (Otway *et al.*, 1995). All significant explosive eruptions in Crater Lake send lahars down the Whangaehu River, but only relatively large (10⁶ m³ or greater) events eject water into other catchments. Return periods calculated for lahars from Ruapehu are: 20-50 years for 10⁶ m³, 220-270 years for 10⁷ m³, and 10,000 to 100,000 years for 10⁸ m³ (Houghton *et al.*, 1987). In the last 150 years, about 20 lahars have affected the Whangaehu River, with the largest (~6 million m³) occurring in 1861. In the Whangaehu valley lahars with volumes between 10⁶ m³ and 10⁷ m³ occur on average once every 29 years, or ~3 % annual probability (Hodgson, 1993).

The 1995 lahars also modified the northern parts of the Whangaehu Fan and caused aggradation near the boundary of Tongariro National Park so that some lahars spilled over into the northernmost channel of the fan (at Site A in Figure 2). Because of these changes the possibility exists for future lahars to break out of the Whangaehu Valley and flow into the Waikato Stream, and then into Tongariro River and Lake Taupo (Hancox *et al.* 1995, see Figure 1). On an annual basis the potential for this to occur has been low (2%, or once in 50 years) compared to the frequency of lahars down the Mangatoetoeui directly into the Tongariro River (5%, or once in 20 years). Because of aggradation, however, the Whangaehu River channel capacity is now less than before the 1995-96 eruptions, so the annual overflow probability may now be as high as 5%. In addition, when the Crater Lake refills to the top of the tephra *dam*, the lahar hazard from collapse of this barrier will be potentially much higher in the Tongariro River system than it is normally.

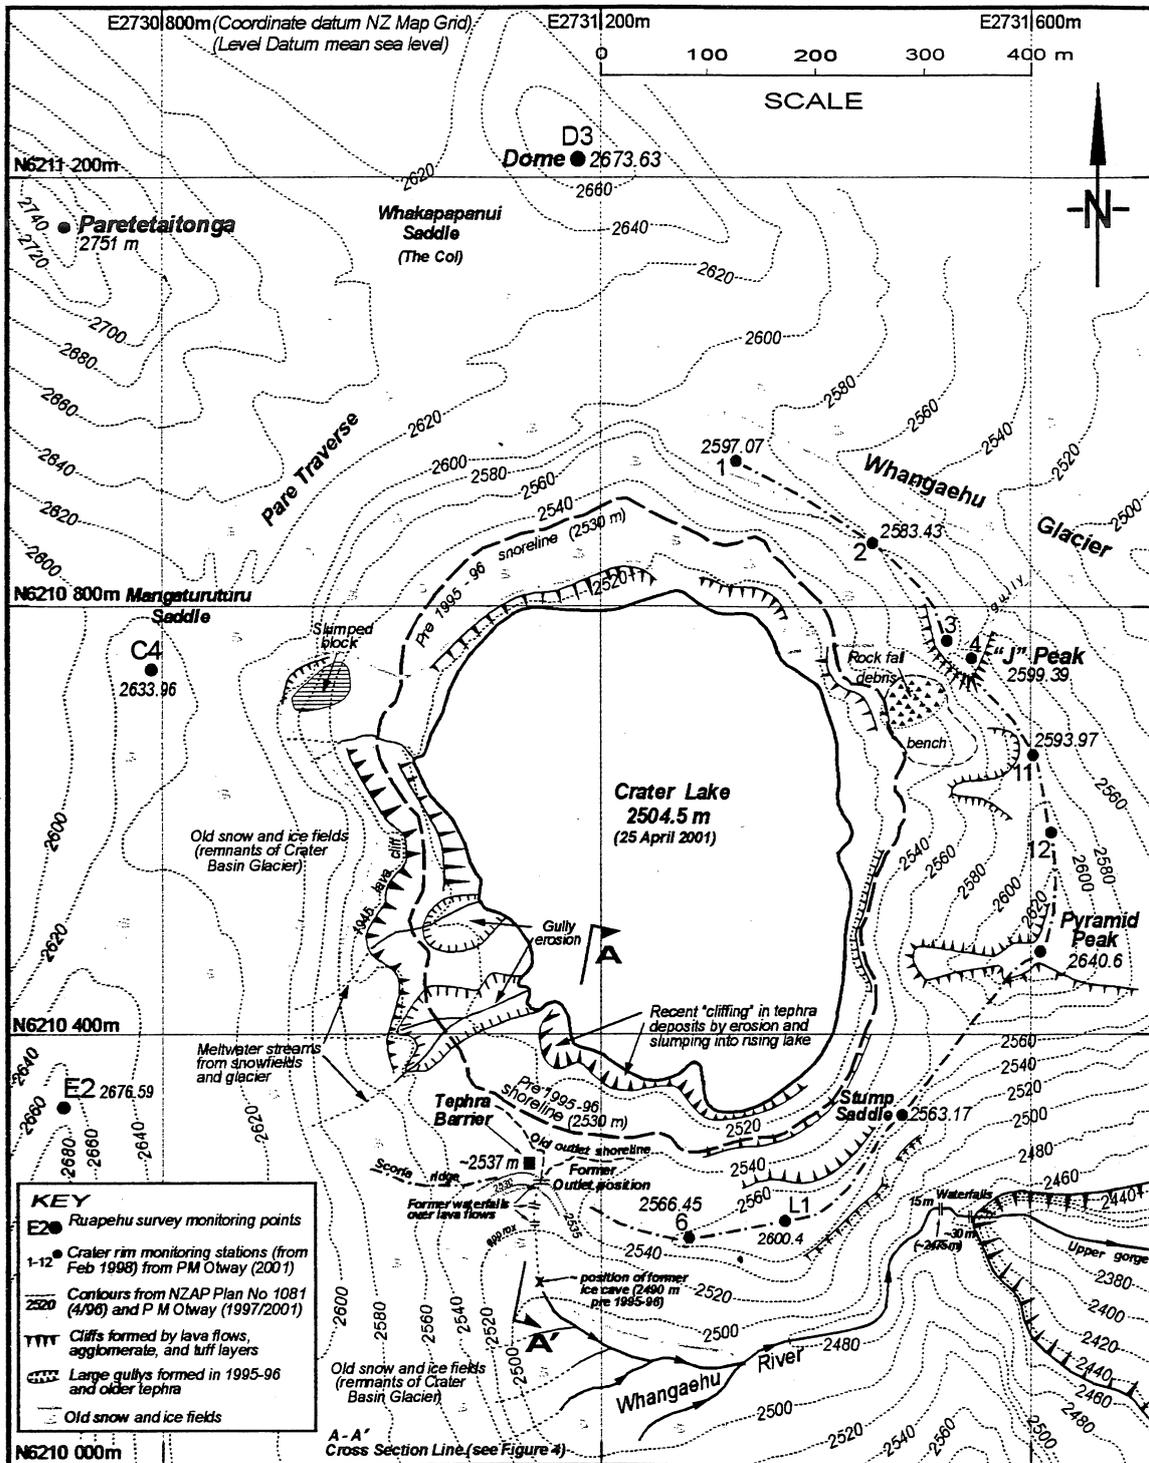
Figure 3. Map of the Mt Ruapehu crater area showing the topography and main geomorphic features developed after the 1995-1996 eruptions. Recent erosion and lake filing effects (as at 25 April 2001) and some crater rim survey stations and monitoring pegs are also shown.

The 1995-96 eruptions of Mt Ruapehu emptied the Crater Lake and caused significant changes to the crater area, which have important implications for the hazard from future lahars when the lake refills. Figure 3 shows the topography and important geomorphic features in the Crater Lake area as it was in April 2001. Most of the important features seen following the 1996-96 eruptions (Hancox *et al.*, 1997) are still present, but over the past four years there has been substantial gullying and erosion on the inside walls of the crater. Slumping into the rising Crater Lake has led to extensive cliff formation in the tephra deposits around the lakeshore. These features are also illustrated by cross sections (Figure 4), and photos taken in 1997 and 2001 (Figure 5). The main conclusions resulting from the 1997 study (Hancox *et al.*, 1997) are summarised below. Noteworthy changes seen at the crater in April 2001 are also described.

- (d) The 1995-96 eruptions and lahars greatly reduced the size of the former Crater Basin Glacier to the south of the former lake outlet, with only thin remnants now remaining (see Figure 3). The upper Whangaehu River channel is now very broad and open (see Figures 5a and 5c), compared to conditions that existed from 1953-1982, when the lake outflow stream had to flow through a ~600 m long ice tunnel before reaching the open Whangaehu River channel. Figure 5 (d) shows the thick Crater Basin Glacier and ice cave in February 1954, two months after the 1953 Tangiwai lahar. These changes are thought to be very significant, because in the event of a breach of the tephra barrier at the lake outlet when the lake refills, there is no glacier or ice tunnel to restrict peak outflow from the lake into the Whangaehu River.

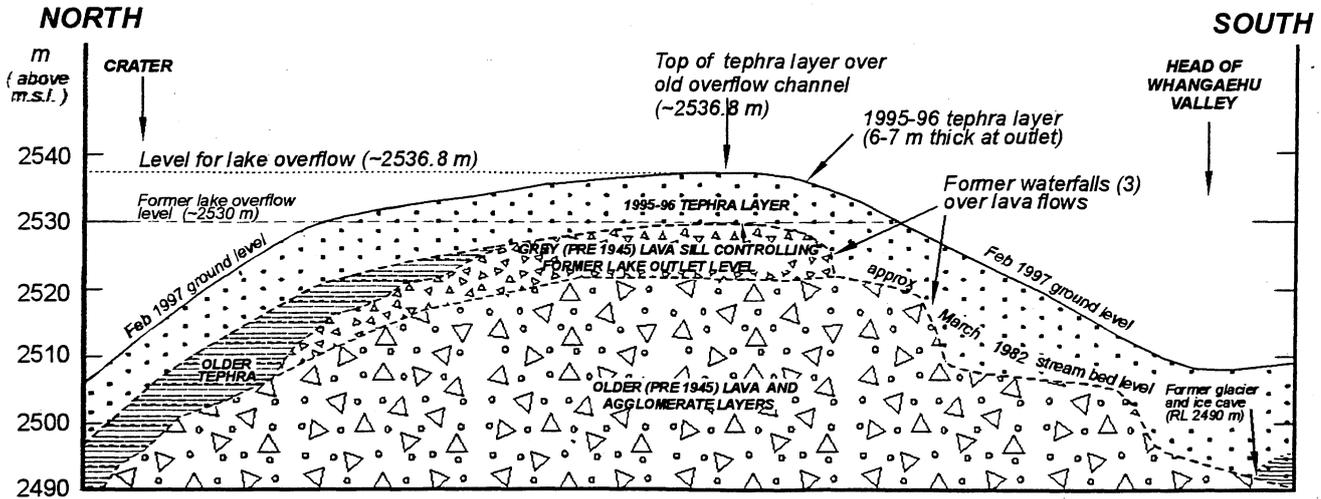
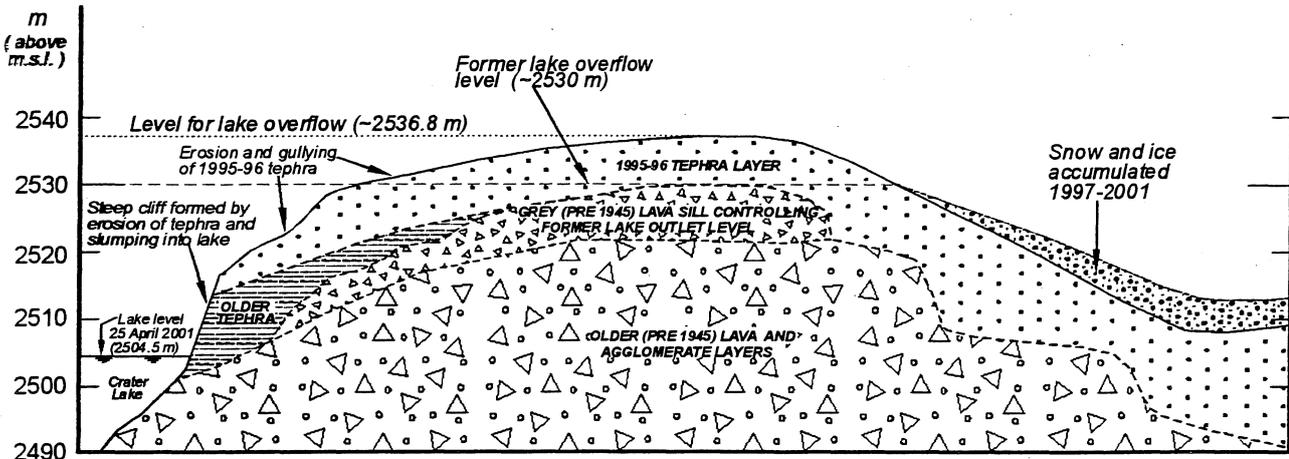
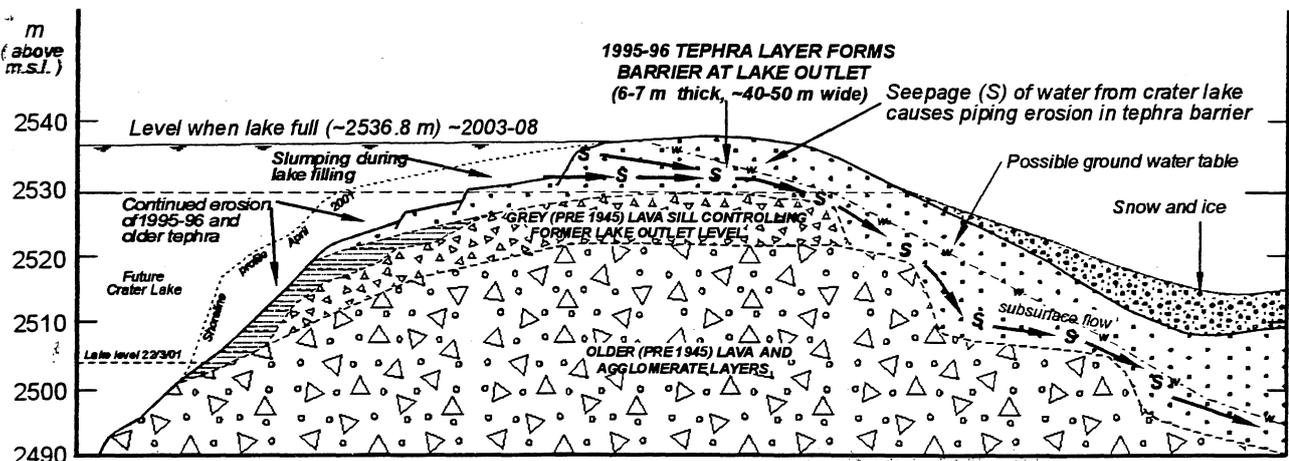
(A) CRATER LAKE OUTLET AREA FOLLOWING THE 1995-96 ERUPTIONS - FEBRUARY 1997

(B) CONDITIONS IN APRIL 2001 (LAKE LEVEL 2504.5 m, ~54% FULL)

(C) PREDICTED SITUATION AFTER LAKE REFILLS (2003-2008)

Figure 4. Cross section of the Ruapehu Crater Lake outlet area (Section A-A' in Figure 3) showing the tephra layer deposited by the 1995-96 eruptions (A), conditions as at 25 April 2001 (B), and the predicted situation when the lake refills in 2003-2008 (C).

- (a) The 1995 and 1996 eruptions covered most of the crater and lake outlet channel area with about 5 to 15+m of *tephra* (weak bedded ash and blocky scoria) with intercalated layers of snow and ice. At the lake outlet, about 6-7 m of this material was deposited on the grey lava sill, which previously controlled the lake overflow level (Figure 4, Section A). On the inside of the crater, erosion and slumping has produced a steep cliff around the lake edge (Figure 4, Cross Section (B), and Figure 5c).

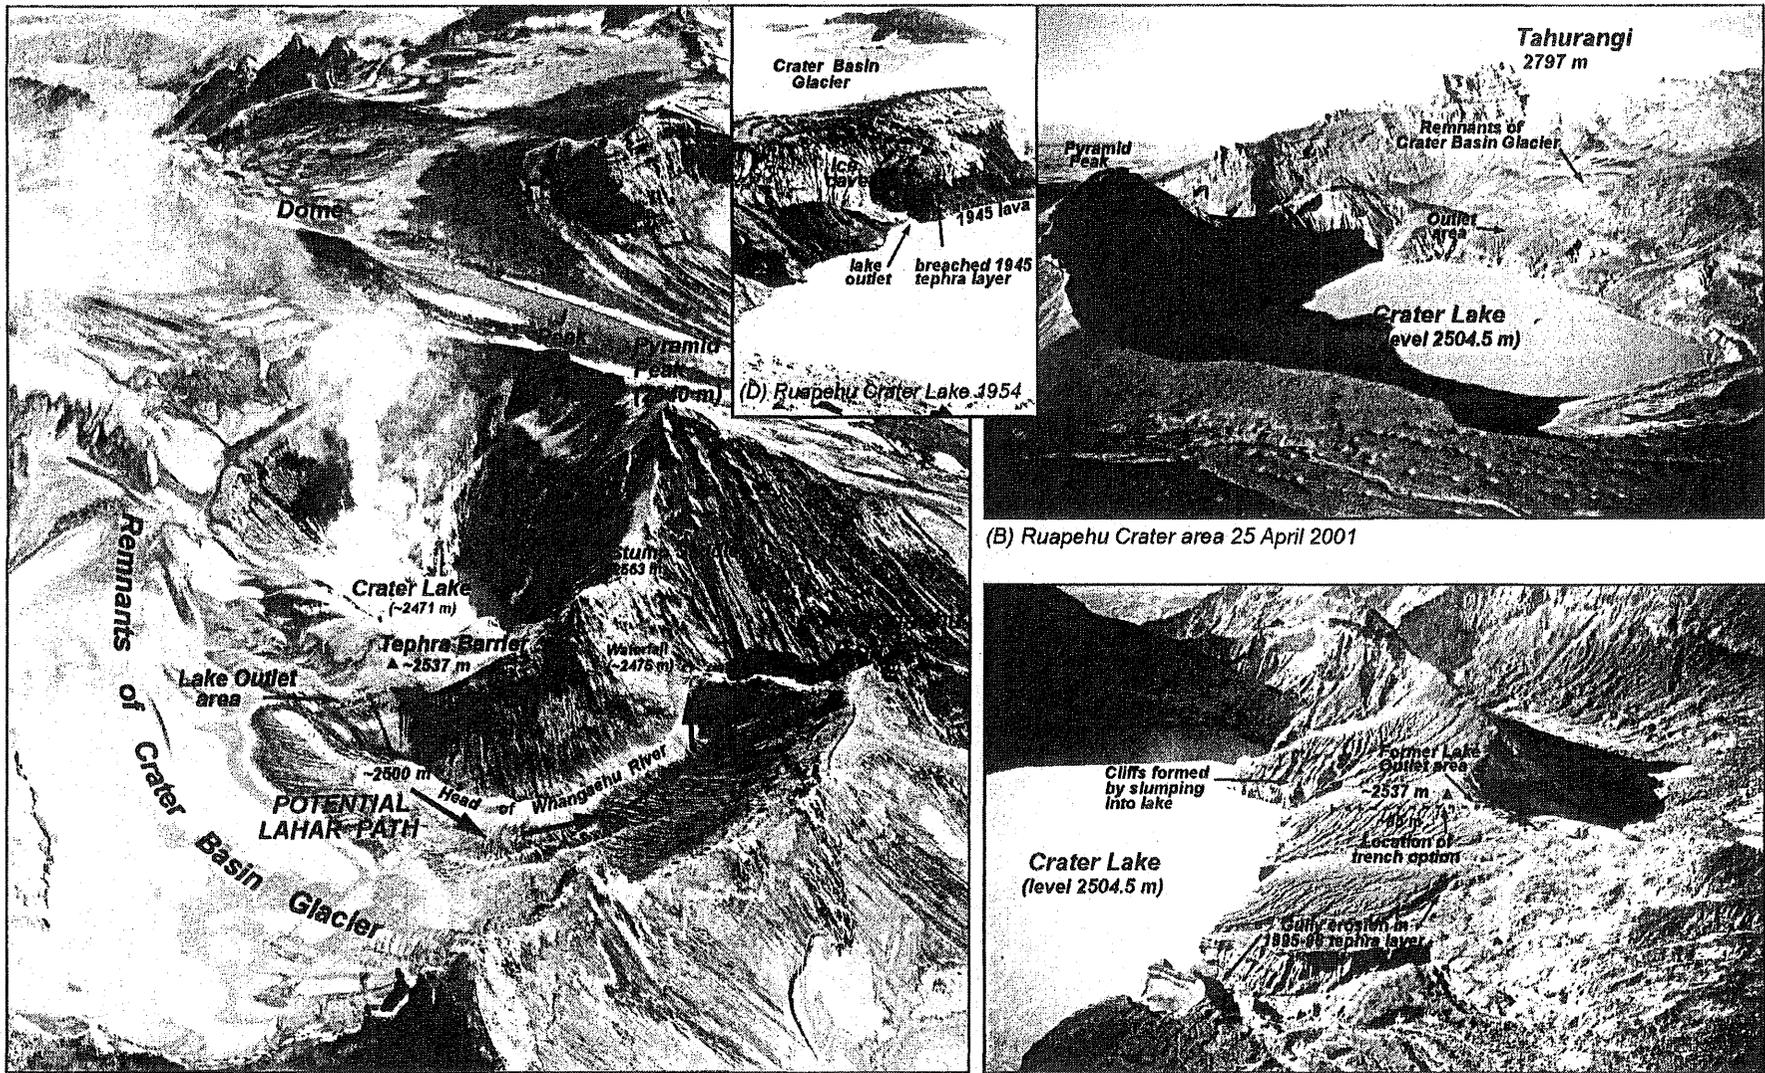
(A) Ruapehu Crater Lake and outlet area February 1997.

(B) Ruapehu Crater area 25 April 2001

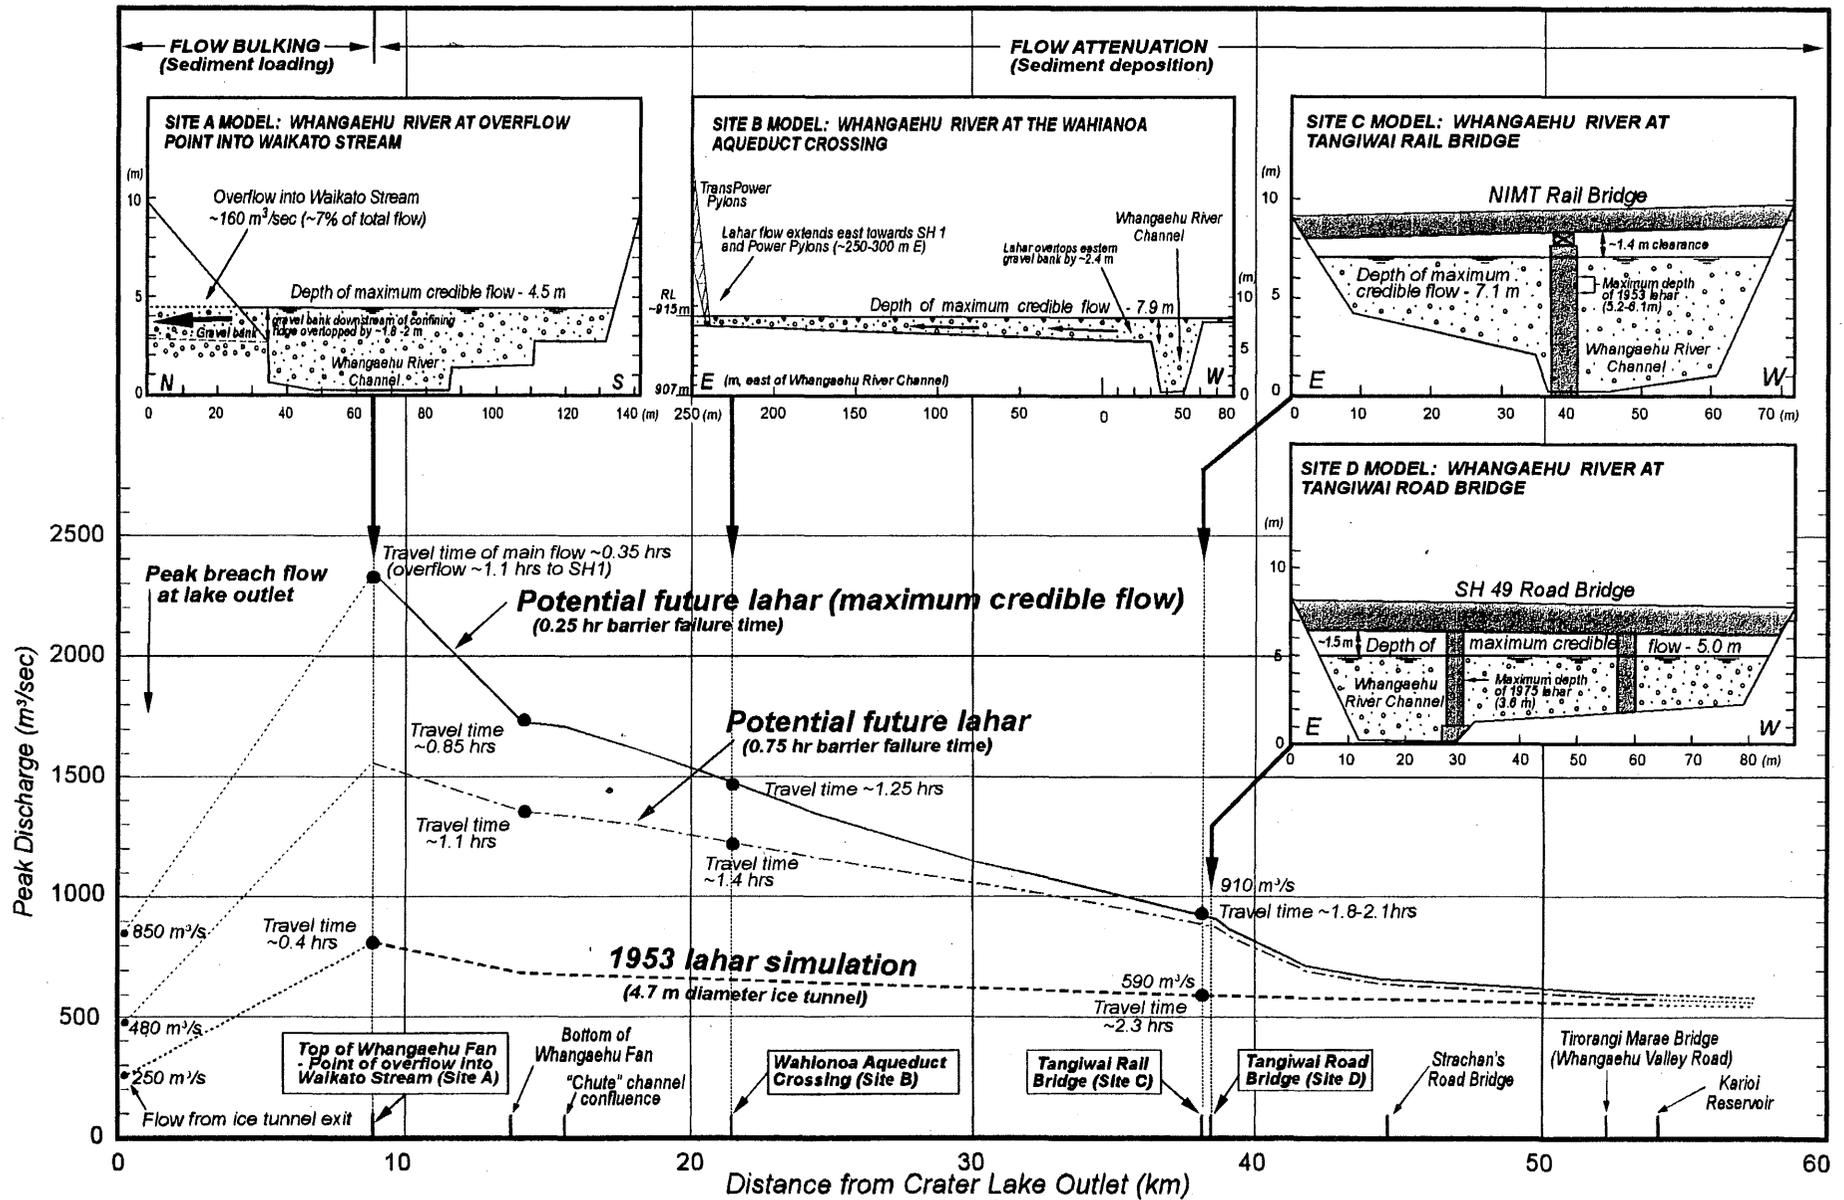
Figure 6. Predicted peak discharge and travel times for simulated tephra dam-break lahars on Mt Ruapehu. MIKE11 hydraulic models (Sites A-D) show the estimated peak flow depths of a maximum credible future lahar at key locations down the Whangaeahu River.

- (8) Because of the greater discharge predicted for the dam-break lahar, it would also travel faster downstream than the 1953 lahar. A travel time to the Tangiwai rail bridge is predicted to be 1.8-2.1 hours for the future event, compared to about 2.3 hours for the 1953 event (Figure 6).

The maximum credible discharge values (Table 3 and Figure 6) indicate reasonable worst case scenario flows for a future dam break lahar at various points down the Whangaehu River. These estimates are particularly sensitive to the peak outflow at the Crater Lake outlet, and hence the method, time, and dimensions of the tephra barrier breach. Some breach development models (e.g., slow piping and breach erosion) result in outflows 50-60% lower than the modelled worst case scenario range (480-850 m³/s). On the other hand, some failure models involving multiple piping failures and "flow sliding" may result in more rapid collapse (~5-15 minutes) and a wider (~90 m) breach, giving much higher initial outflow (~1000-1200 m³/s). Although such an extreme outflow for a future dam-break lahar is possible, the modelled outflow range of 480-850 m³/s is considered to be realistic and appropriately conservative for estimating flows downstream, and for hazard and risk assessment. *Lahar flow bulking* within the river channel is another debatable parameter, with bulking factors as high 5 (with proportionately higher peak flows) observed in lahars on some overseas volcanoes (Pierson, 1998, 2001). However, evidence from historical Ruapehu lahars suggests that such extreme flow bulking (beyond the modelled range of 1.8-3.3, Table 2) is unlikely in the Whangaehu River channel during the future dam break lahar.

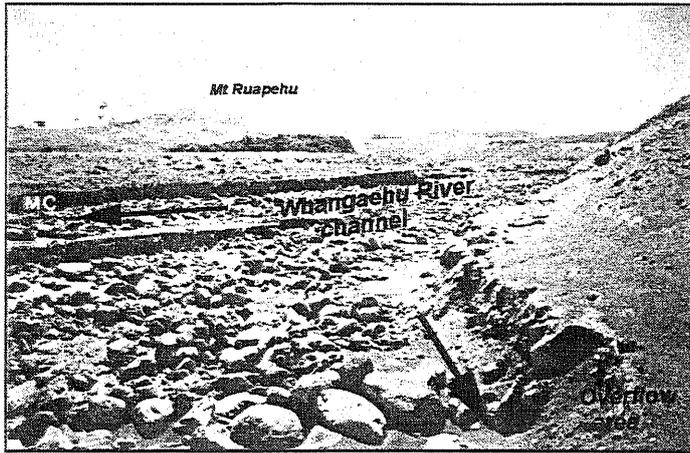
(A) Whangaehu River channel at the point of potential lahar overflow towards Waikato Stream, and from there to the Tongariro River and Lake Taupo (see Figure 1). (Site A, on Figures 2 and 6).

Figure 7. Photos of sites along the flow path of a possible future lahar on the Whangaehu River, formed by collapse of the tephra barrier at the lake outlet (Sites A & B, see Figure 6). The SH 1 Road Bridge across Waikato Stream, which is at risk from a lahar overflow from the Whangaehu River at Site A is also shown (Photo B above).

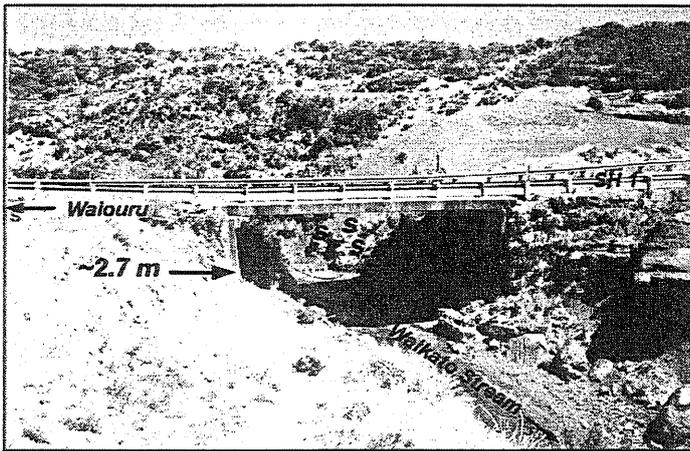
(B) SH 1 Bridge across Waikato Stream showing the depth of a possible lahar, due to overflow from the Whangaehu River. The lahar flow could cause scouring of the north abutment (s), and possibly damage the bridge.
