Engineering & Development

in **HAZARDOUS TERRAIN**

NEW ZEALAND GEOTECHNICAL
SOCIETY 2001 SYMPOSIUM

Hazardous Terrain – An Engineering Geological Perspective

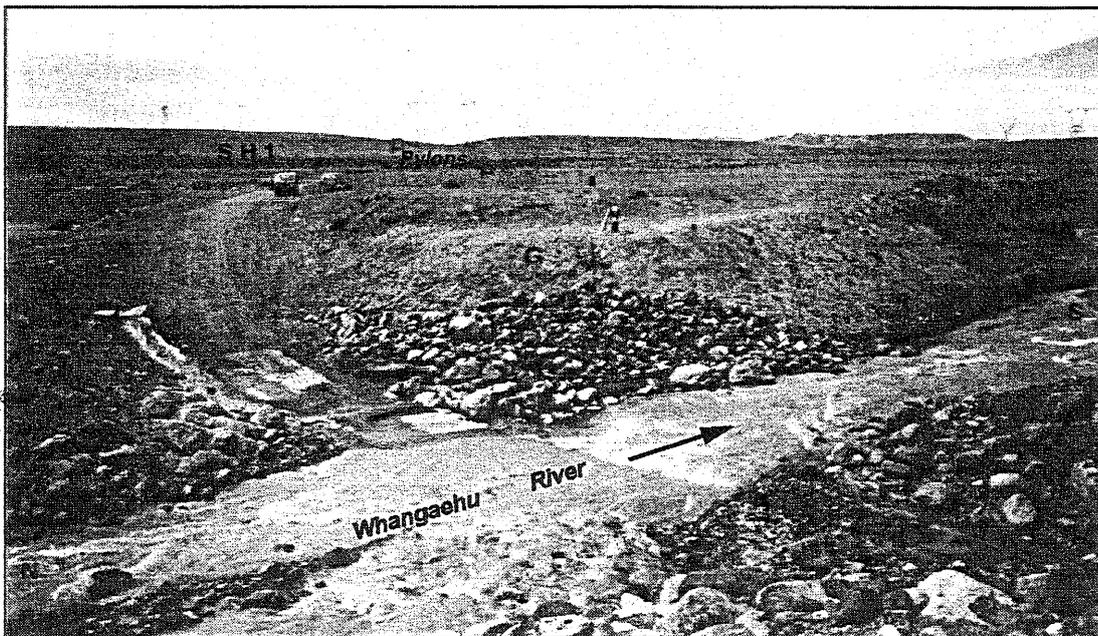
(C) Whangaehu River at the Wahianoa Aqueduct crossing. SH 1 and power pylons at risk from a potential tephra barrier collapse lahar are shown in the distance (Site B in Figure 6).

Figure 7. Photos of sites along the flow path of a possible future lahar on the Whangaehu River, formed by collapse of the tephra barrier at the lake outlet (Sites A & B, see Figure 6). The SH 1 Road Bridge across Waikato Stream, which is at risk from a lahar overflow from the Whangaehu River at Site A is also shown (Photo B above).

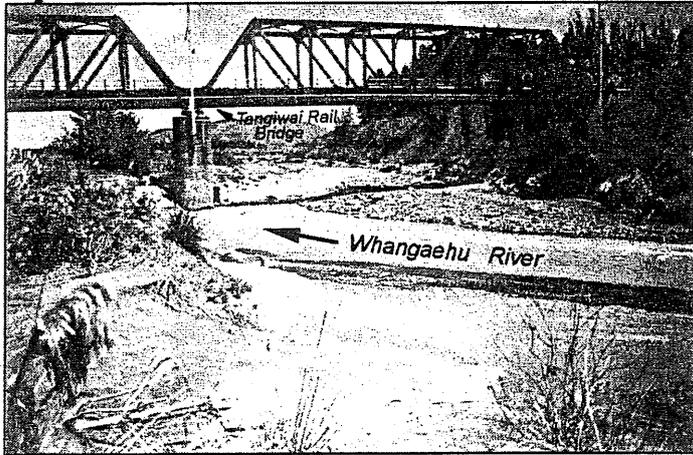
(B) Existing Rail Bridge at Tangiwai (Site C, Figure 6).

Figure 8. Photos of the 1953 lahar disaster site on the Whangachu River at Tangiwai. The existing rail and road bridges are at risk from a potential future lahar formed by collapse of the tephra barrier at the lake outlet. That lahar is predicted to be 54-72% larger at Tangiwai than the 1953 lahar. Figure 5 shows the likely peak flow depths at the bridge sites (Sites C and D).

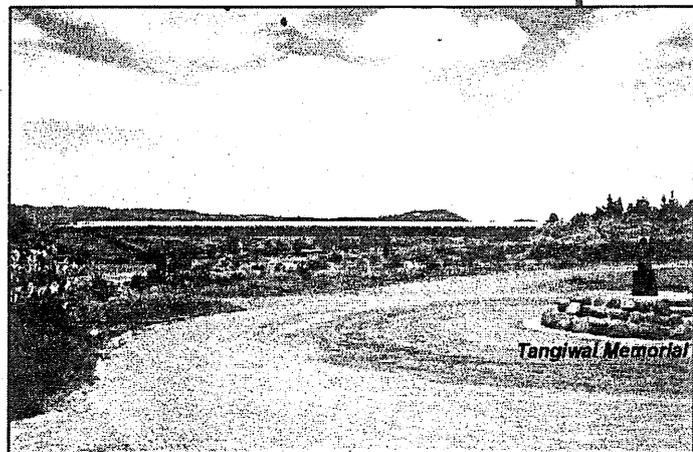
(C) New SH 49 Road Bridge at Tangiwai (Site D, Figure 6).

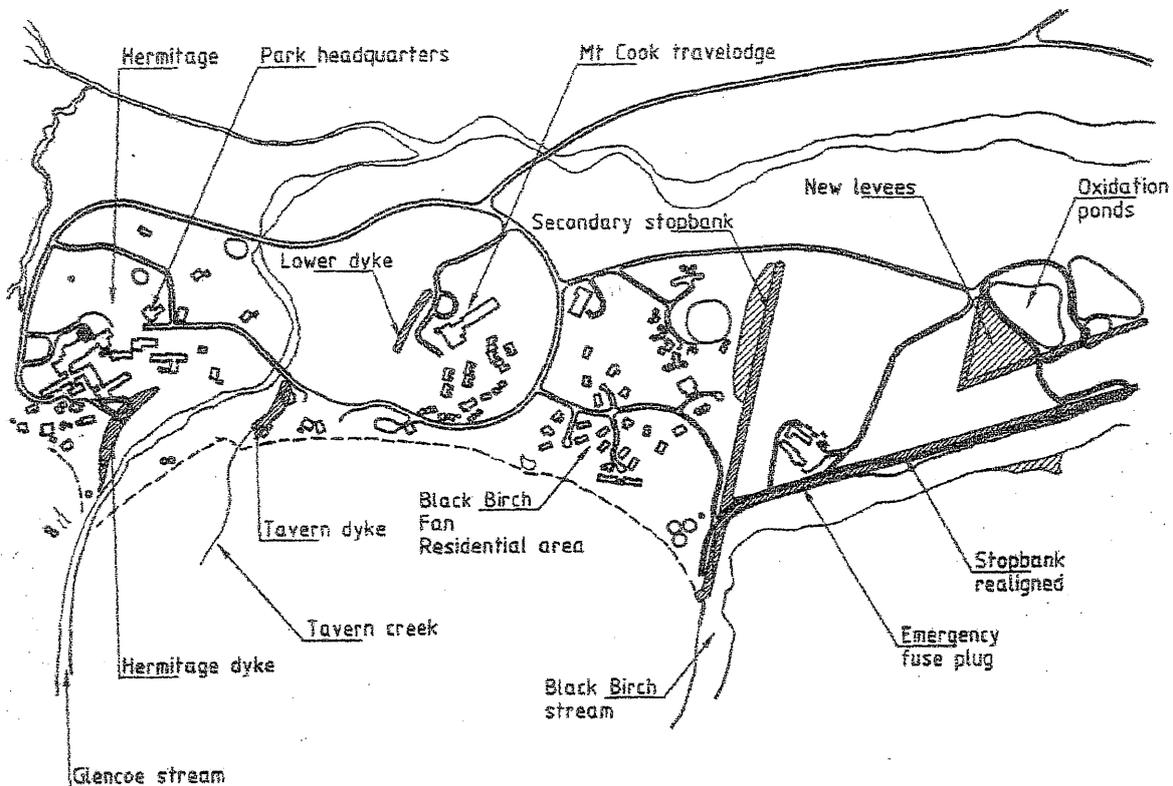
FIGURE 1 : Plan of Mt Cook Village
Proposed Flood Protection Works

Black Birch Stream is a more typical, flood flow plus aggradation, hazard and was studied by Montgomery Watson. The mitigation work consisted mainly of constructing and strengthening stopbanks, but also involved a debris training wall, a debris storage area, secondary flow routes and the relocation of some services. The village and main mitigation structures are shown in Figure 1. The construction work was completed in late 1999 at a cost of \$1.3million.

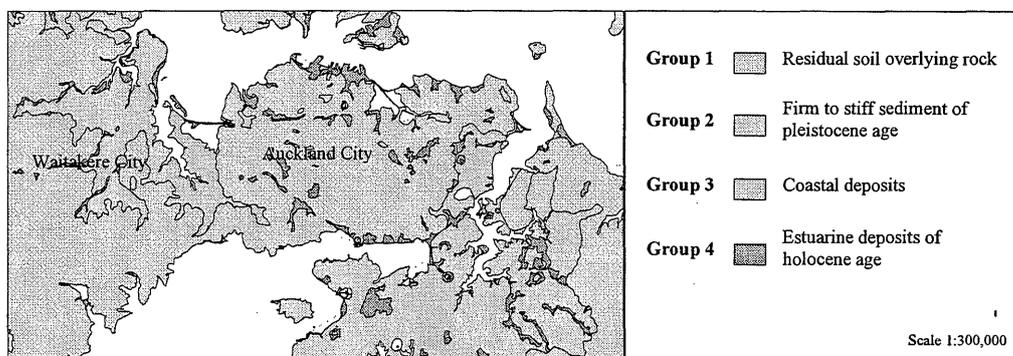
Figure 2. Extract from ground shaking hazard map showing the distribution of soil/rock mass categories defined in Table 2

The earthquake scenario chosen was a magnitude 6 event 20 km due east of Auckland with a focal depth of 10km. The ground shaking hazard is shown in Figure 2. This map has been constructed by overlaying the attenuation grid with the soil class grid and calculating the appropriate PGA from the amplification factor based on site type. Companion studies using Modified Mercalli intensities were also carried out. The map indicates that much of Auckland

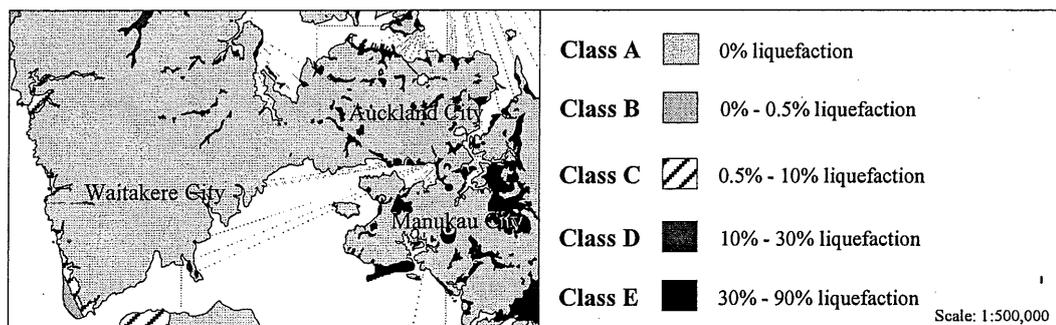
Figure 3. Extract from Liquefaction Hazard map: scenario earthquake with epicentre 2.5km east of the northeastern corner of map

At PGA's of 0.1 – 0.15g, the risk of liquefaction was considered to be low. At PGA's of 0.2g or more, the risk becomes high, with some 30-90% of all potentially liquefiable soils expected to exhibit liquefaction behaviour. The 2000-year return period earthquake scenario is expected to generate PGA's in excess of 0.2g within 20km of the epicentre, equating to a high risk of liquefaction in this zone (that is, in the order of 30 – 90% of potentially liquefiable soils might liquefy). The selected scenario event suggests that on average, 0.5 – 10% of such soils in the northernmost part of the region will also liquefy (Figure 3).

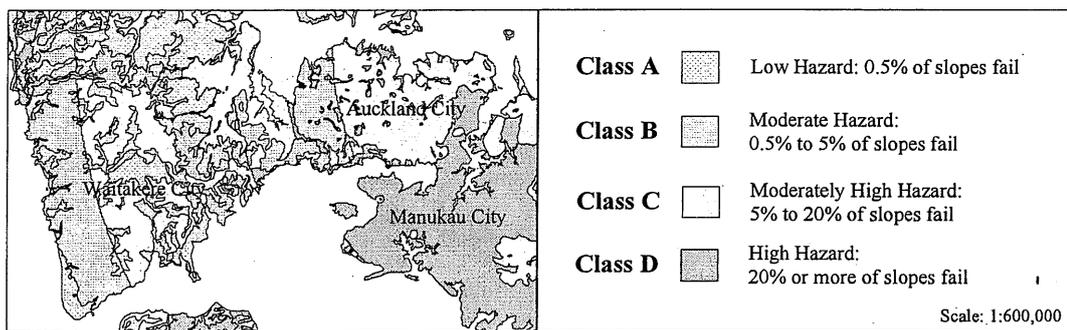
Figure 4. Extracts from earthquake induced slope instability hazard maps: scenario earthquake; epicentre 2.5km east of northeastern corner of map

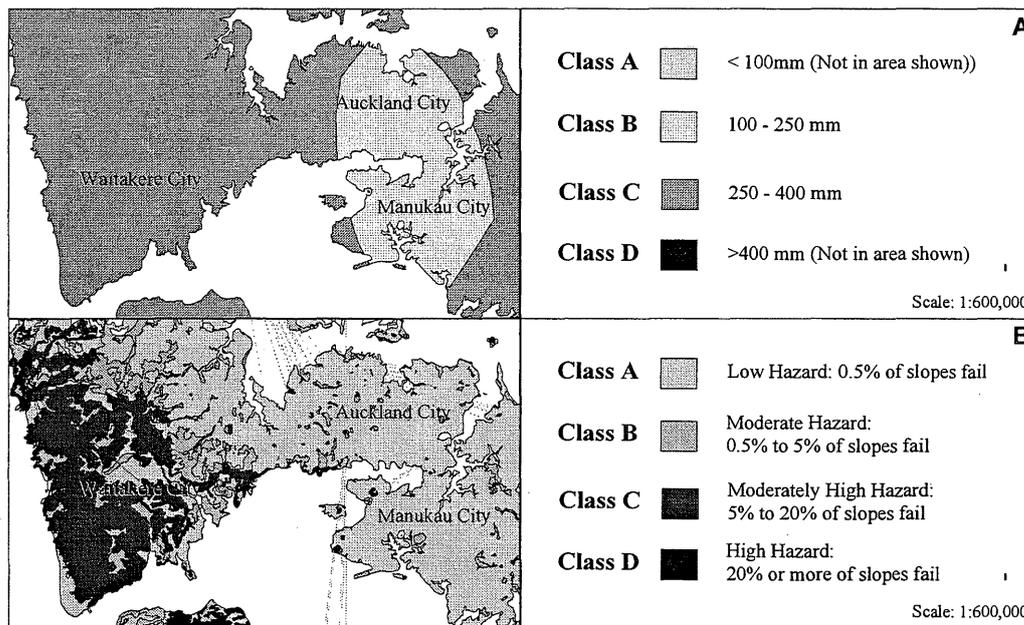
Figure 5. A. 100-year cyclone scenario; B. Extract from rain induced slope instability hazard map

Contributing factors were adjusted, in a similar way to that described for earthquake induced slope instability, to produce rain-induced slope instability hazard maps. The hazard maps designate areas of low to high hazard corresponding to expected percentages of all slopes within each hazard zone likely to fail as a result of the proposed 100 year cyclone scenario (Table 3). Within the medium to high population and services density part of the region, the scenario would result in only low or moderate rain-induced slope instability hazard (ie in the order of 0.5% to 5% of slopes in the region might fail). However, in areas where higher rainfall is predicted and steeper slopes occur, for example in the Whitford and Hunua areas in the southeast, the Waitakere Ranges in the West, and coastal cliffs, failure of 5 – 20% of slopes is anticipated.

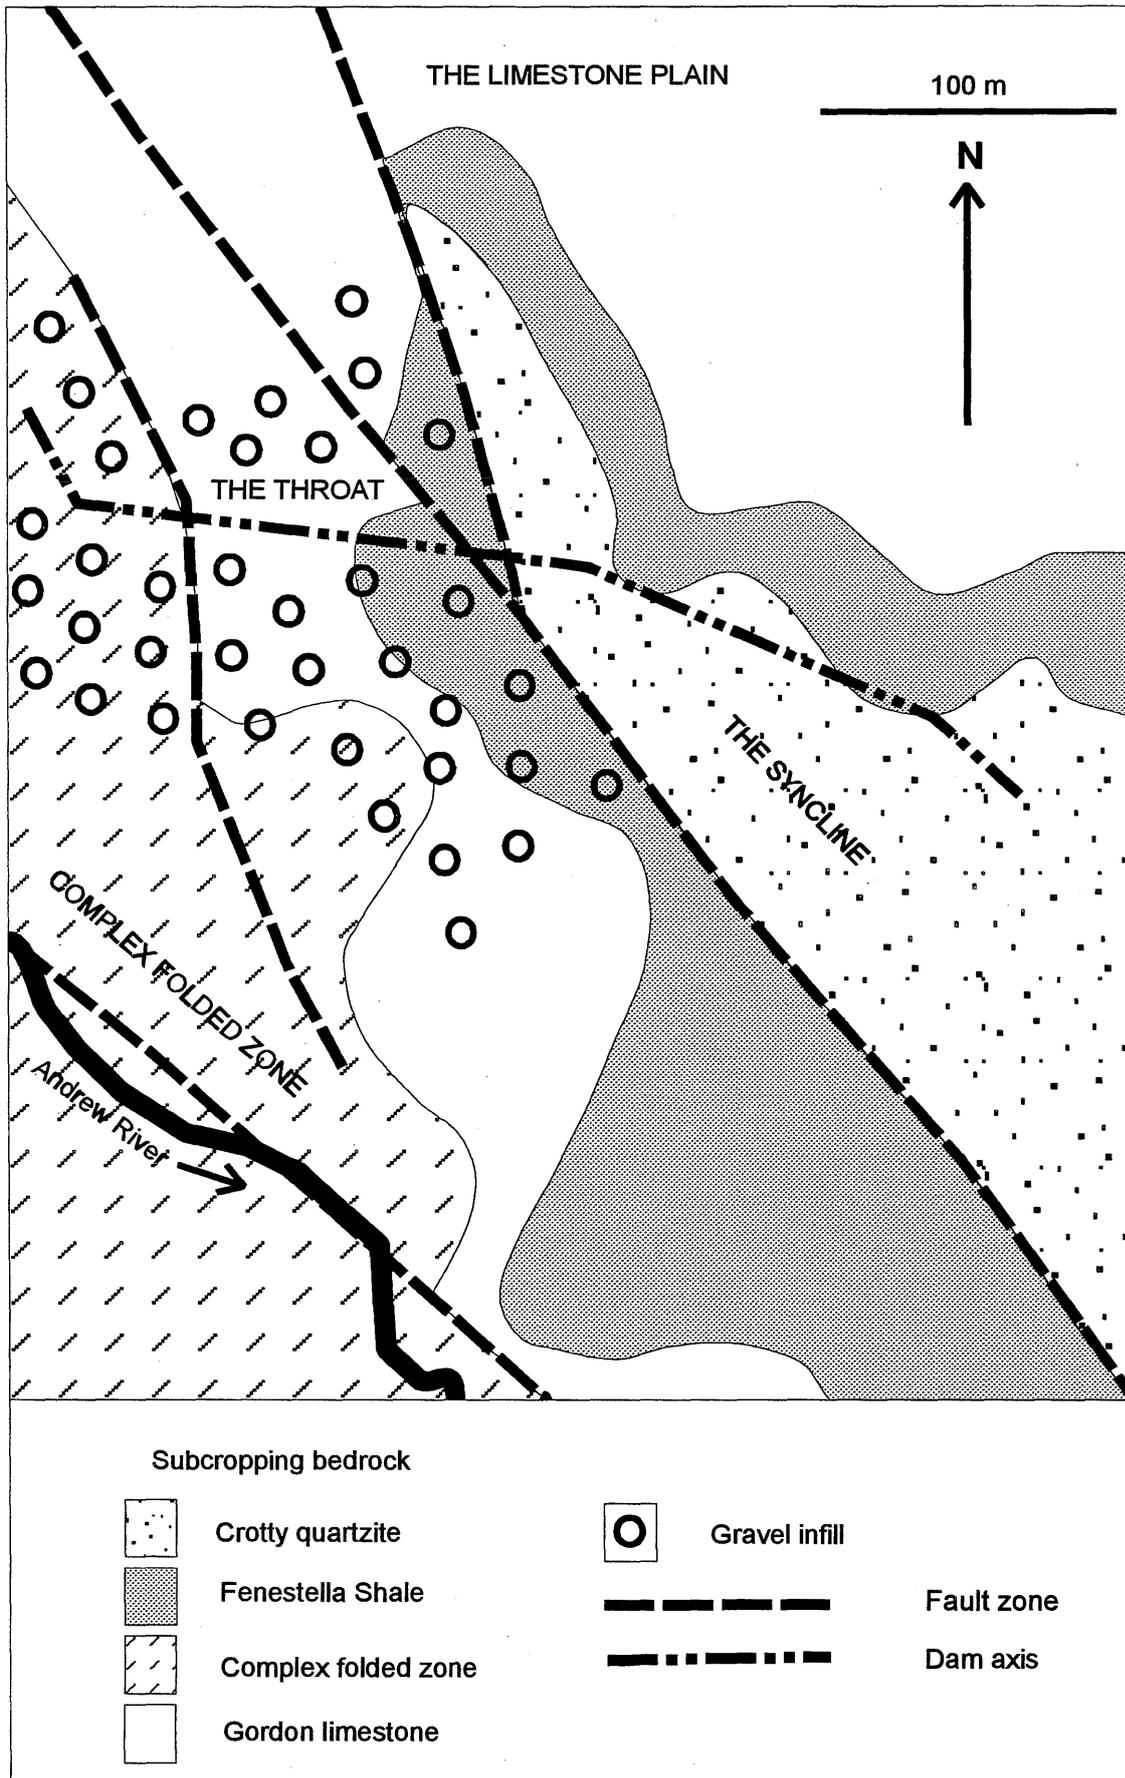
Figure 1 - Geology and features of the Darwin damsite

The Darwin Dam functions as a saddle dam across a low divide on the reservoir rim and consists of a gravel filled embankment about 400 m long with a maximum height of about 20 m. The Divide is underlain in part by gravels and sandstones and in part by gravels and silts overlying cavernous limestone. The gravels also infill a deep buried channel between the Divide and the Andrew River (Figure 1).

The geological conditions are summarised in Figure 1 and Figure 3.

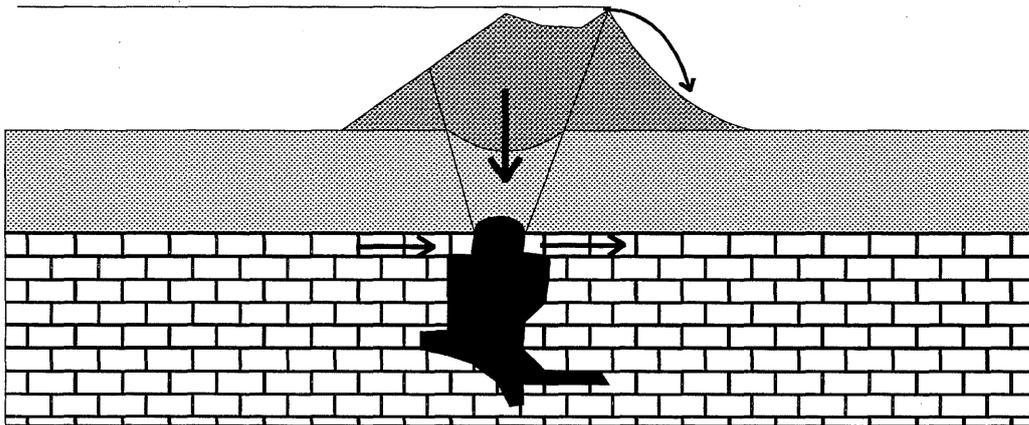
Local subsidence or collapse into an existing cavity leads to loss of freeboard and breaching of embankment and/or permeable leakage paths

These hazards are depicted in Figure 2. The potential for these hazards to adversely impact on the project led to a very detailed series of investigations.

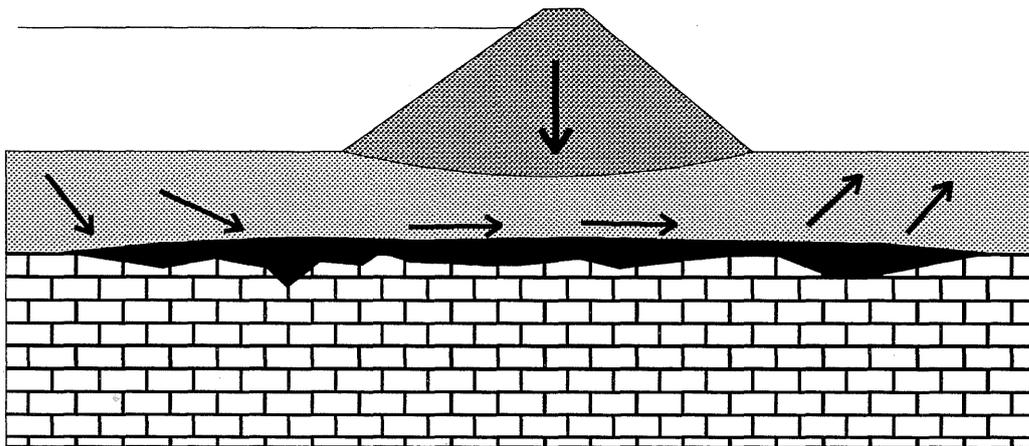
Groundwater flow along permeable zones at the superficial/bedrock interface leads to internal erosion of silts, increasing leakage and the possibility of piping failure and/or subsidence leading to loss of freeboard

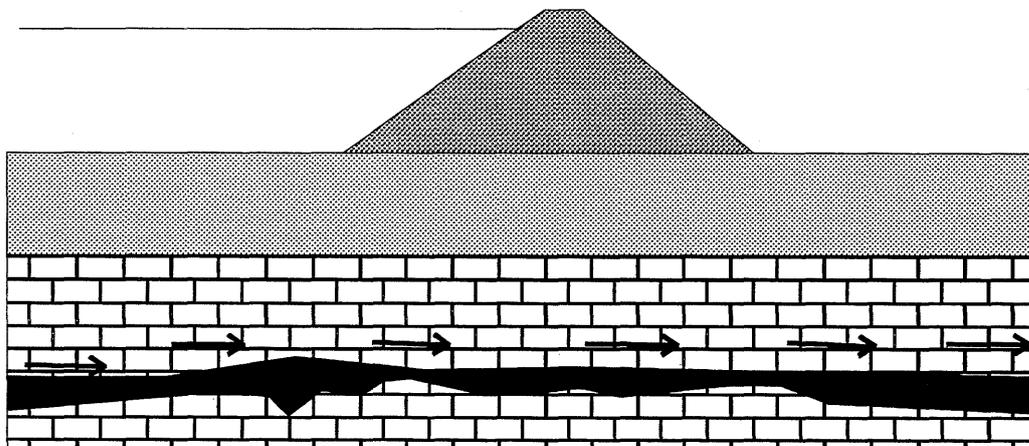
Groundwater flow along permeable fissures and cavernous ground leads to gross leakage and loss of stored water

Figure 2 - Karst geohazards to dam engineering

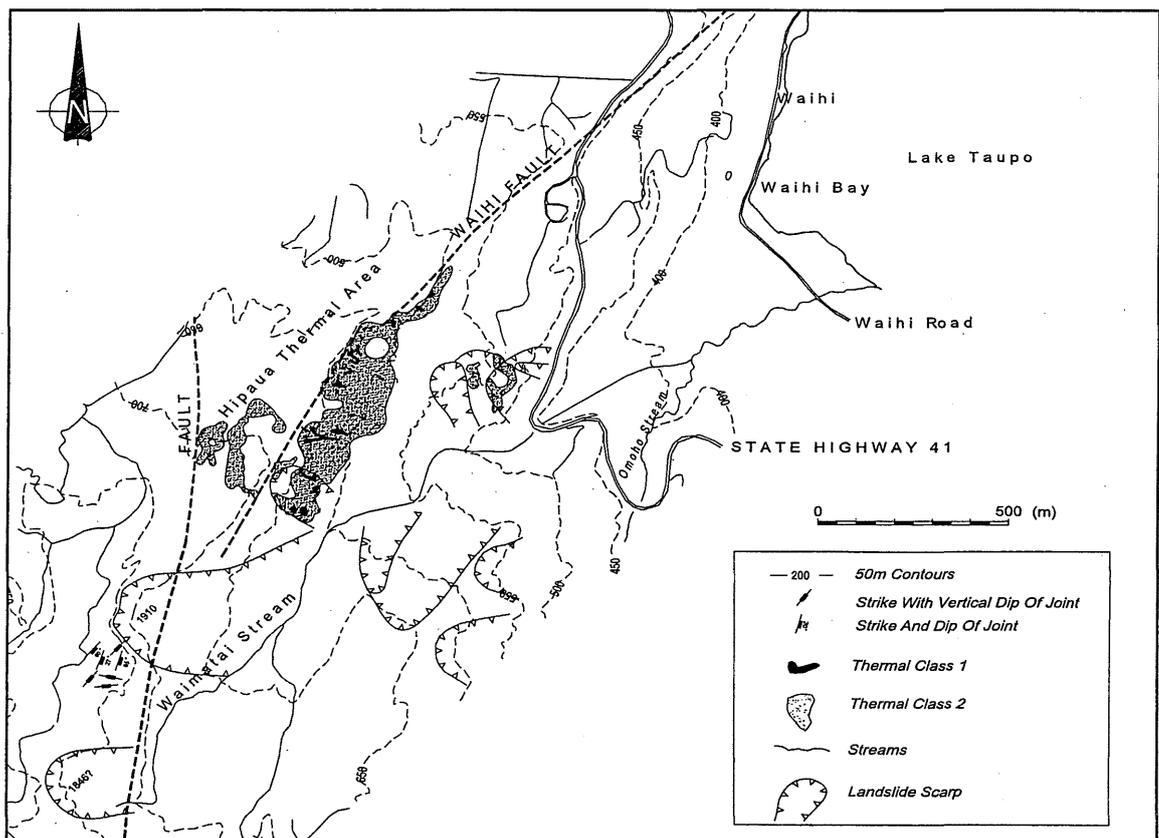
FIGURE 2 - Hipaua Thermal Area

The extent of the thermal ground is shown on Figure 2. Three areas of thermally altered ground are shown. The main thermal area follows the escarpment south of the SH41 lookout area terminating abruptly in the Waimatai Stream. A second smaller thermal area is developed behind the escarpment terminating against a small-unnamed stream to the west. A third thermal area exists immediately above SH41 where it crosses the Waimatai Stream.

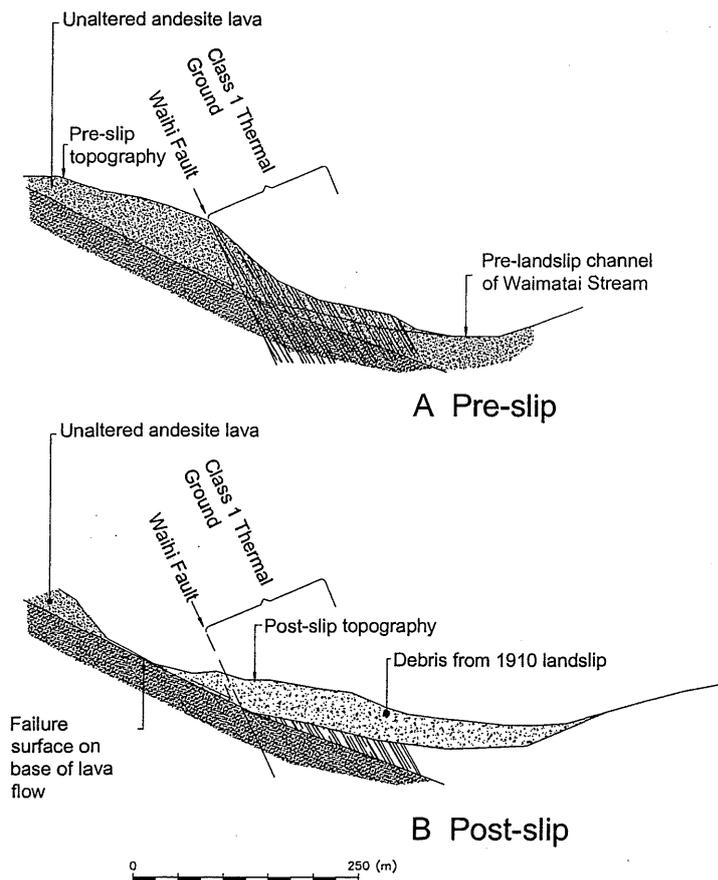
FIGURE 3 - 1910 Landslip Geometry

Our reconstruction of the pre-failure slope (Figure 3) shows a lower toe area of the original slope consisting of thermally altered ground backed by unaltered lava with a platy jointing dipping at approximately 30°E (down slope) behind the Waihi fault. This geometry is similar to that existing at the present time immediately to the north.

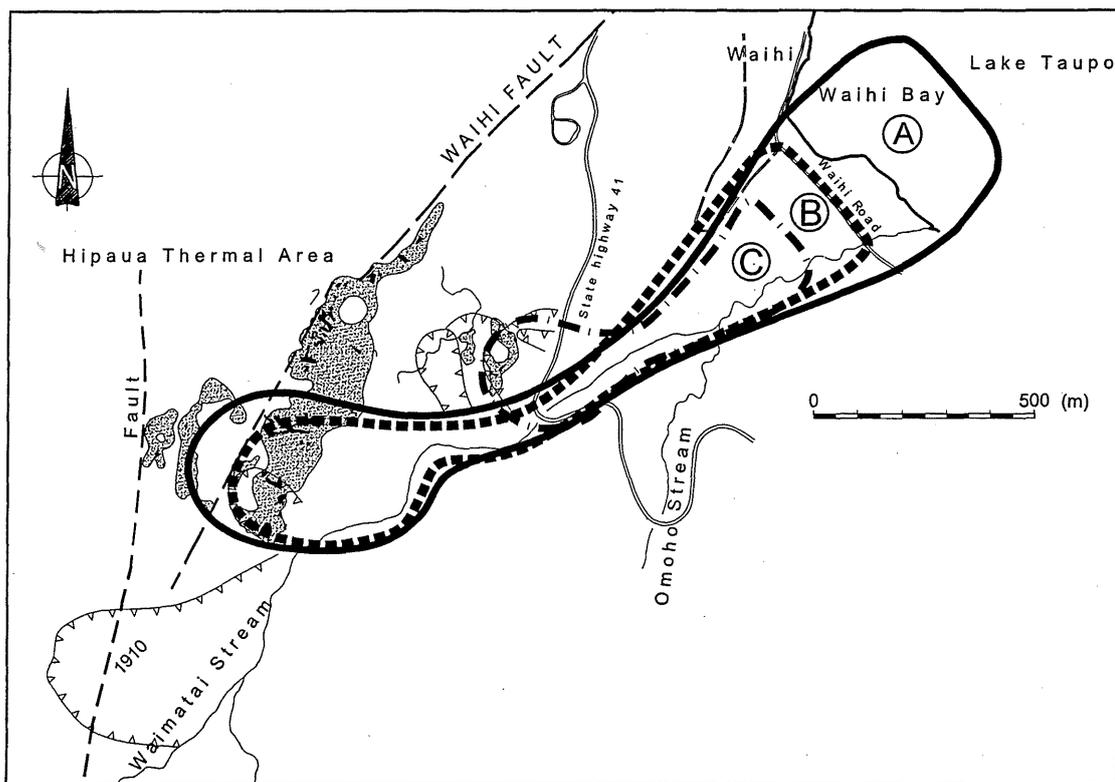
FIGURE 4 - Runout Areas for Potential Landslides A, B, & C.

Estimates of the volumes of each of the possible landslides have been made based on the assumed geometry of the landslide mass. Using these volumes the run-out distance of each has then been calculated using the approximate relationship that the width is half the length of the run-out distance. The potential landslides source and run out distances are listed below and illustrated on Table 1 and on Figure 4.

- Event A - 700 m north of the 1910 event extending but back behind the fault
- Event B - 700 m north of the 1910 event with material from the thermal alteration zone only
- Event C - Immediately above SH41
