Waste not want not – A unique industrial waste disposal facility

Keywords: landfill, waste, pulp & paper

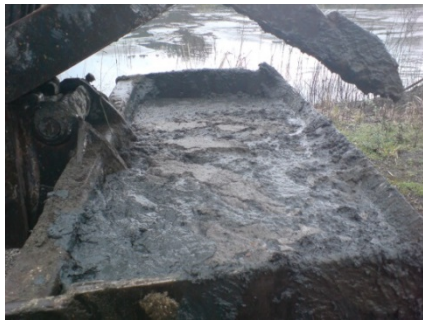
Figure 1. Dewatered Dredgings

Secondary solids comprise a slurry of dewatered dredgings from wastewater treatment plant ponds and consist primarily of settled solids and biosolids (the residue generated by bacterial breakdown of waste as a part of the wastewater treatment process). The dredgings are thickened to around 20% solids prior to disposal. The secondary solids naturally dewater to around 30% solids insitu. Previous disposal in the West Valley site was done by excavating the dewatered dredgings (see Figure 1) and transporting by means of tip trucks.

The secondary solids surface cakes easily resulting in cracks that appear on the surface of deposited material. These cracks progressively get filled by additional material that is placed on top of the fill. The resultant fill material is a well pressed and dewatered material with a low permeability. Secondary solids has the potential to behave like a liquid (thixotropic characteristics) when energy is driven into the material before it has sufficiently dewatered.

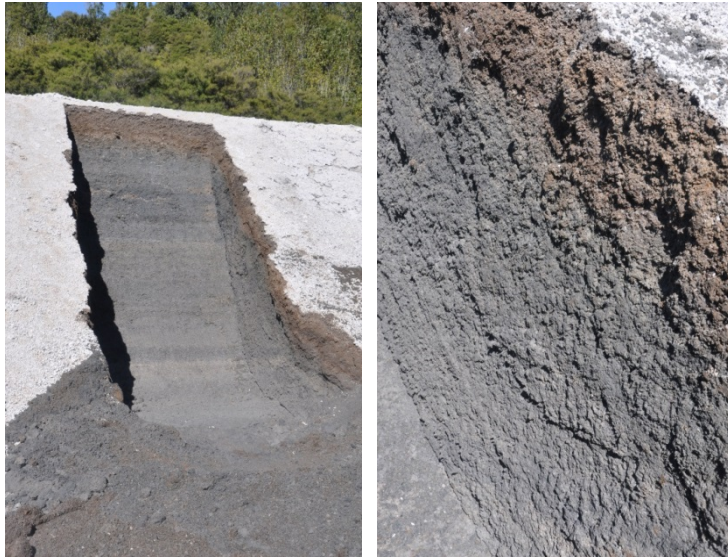
Figure 3. Compacted Primary Solids

The primary solids are currently being compacted to form a stable bund (See Figure 2). Deposition of primary solids began in December 2012 and has been ongoing to-date. The solids are deposited by tip truck and spread and compacted by a bulldozer and excavator. The compaction is tested by means of scala penetrometer to ensure the required compaction is achieved. Six monthly site inspections and walkovers are undertaken by a suitably qualified person and regular monthly meetings are held between CHH and the Contractor.

In order to understand the behaviour of the primary solids when utilised as a bulk fill material, a pilot test embankment of primary solids (Figure 3) was constructed at the site of the existing primary solids landfill in 2009. The embankment was constructed from compacted primary solids and left for a period of 6 months. The embankment was visually assessed on a regular basis and examined for any loss in integrity. After this period the embankment was excavated and samples taken to determine the geotechnical properties of the compacted primary solids. The test results indicated that there was no increase in bulk density and shear strength with depth and that the material exhibited the same strength as determined by the laboratory testing. This indicated that the material once compacted retained its density. In situ shear strength testing of the compacted primary solids indicated an average undrained shear strength of 10 kPa with a variability of 2 kPa to 40 kPa. No consolidation testing was done.

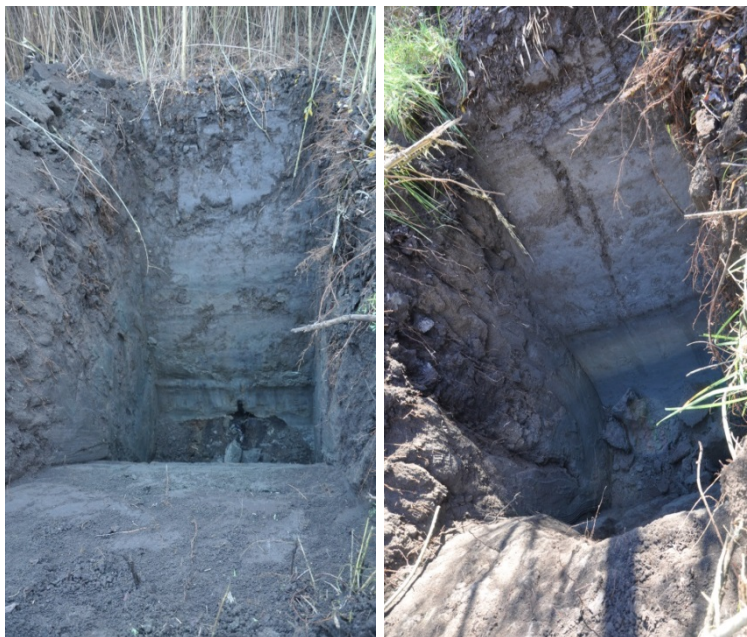
Figure 4. Drained Secondary Solids

to be tipped around the entire perimeter of the secondary solids thus controlling the formation and position of any pool of supernatant water. The intention is to create a “beach” of secondary solids which directs the supernatant water to the back of the deposition area and away from the containment bund. The high permeability underlying soils will drain the secondary solids allowing the formation of an unsaturated body of a soil like material (See Figure 3)

It should be noted that the above represent worst case scenarios and that these are not considered to represent expected or day to day operational conditions. Experience with the previous secondary solids deposition site indicates that any free water drains away and that the secondary solids effectively drains to form an unsaturated soil like structure.
